## **NATIONAL TRANSPORTATION SAFETY BOARD**

### **On Site Report**

**WPR19FA172**

Location: Porter Ranch, California  
Date: June 15, 2019  
Aircraft: Airplane, Registration Number: N111XX, Serial #: 3532007  
NTSB IIC: WPR19FA172

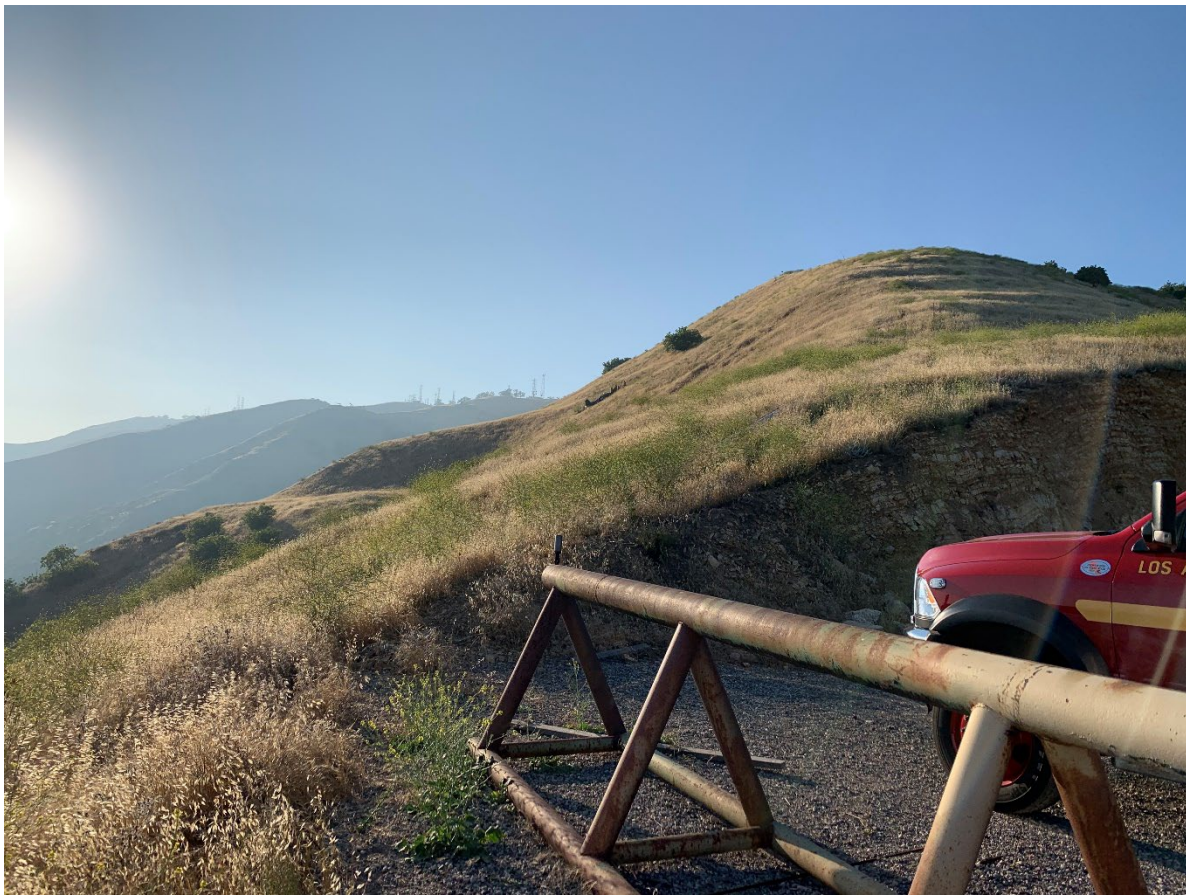
Airplane wreckage was located in the Santa Susana Mountains by Sempra Energy on a hillside at an elevation of 3,000 ft. The airplane came to rest upright and flush with the hillside; a 45-degree slope.

Photo 1 - Overview of Accident Site (Courtesy of NTSB)

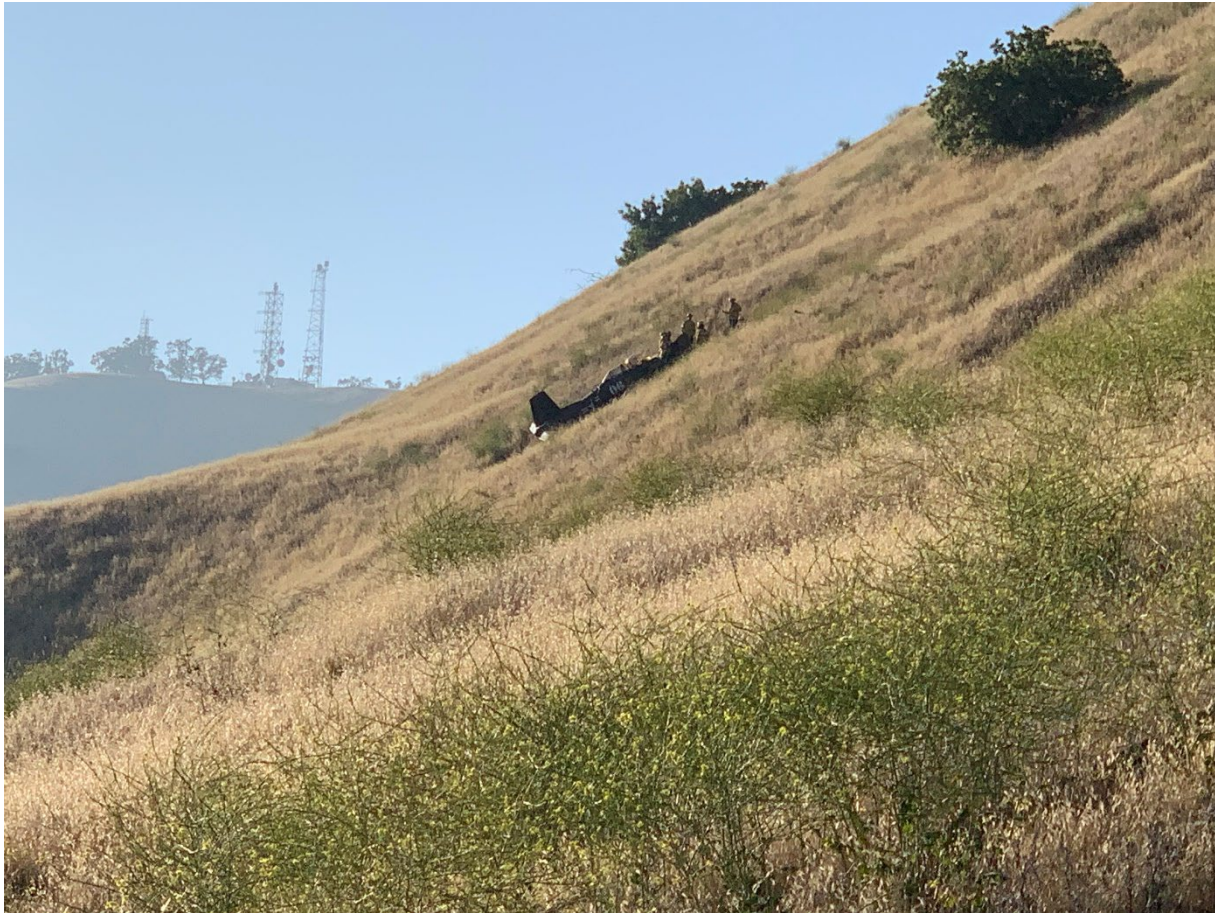
Photo 2 - Close up view of accident site (Courtesy of NTSB)

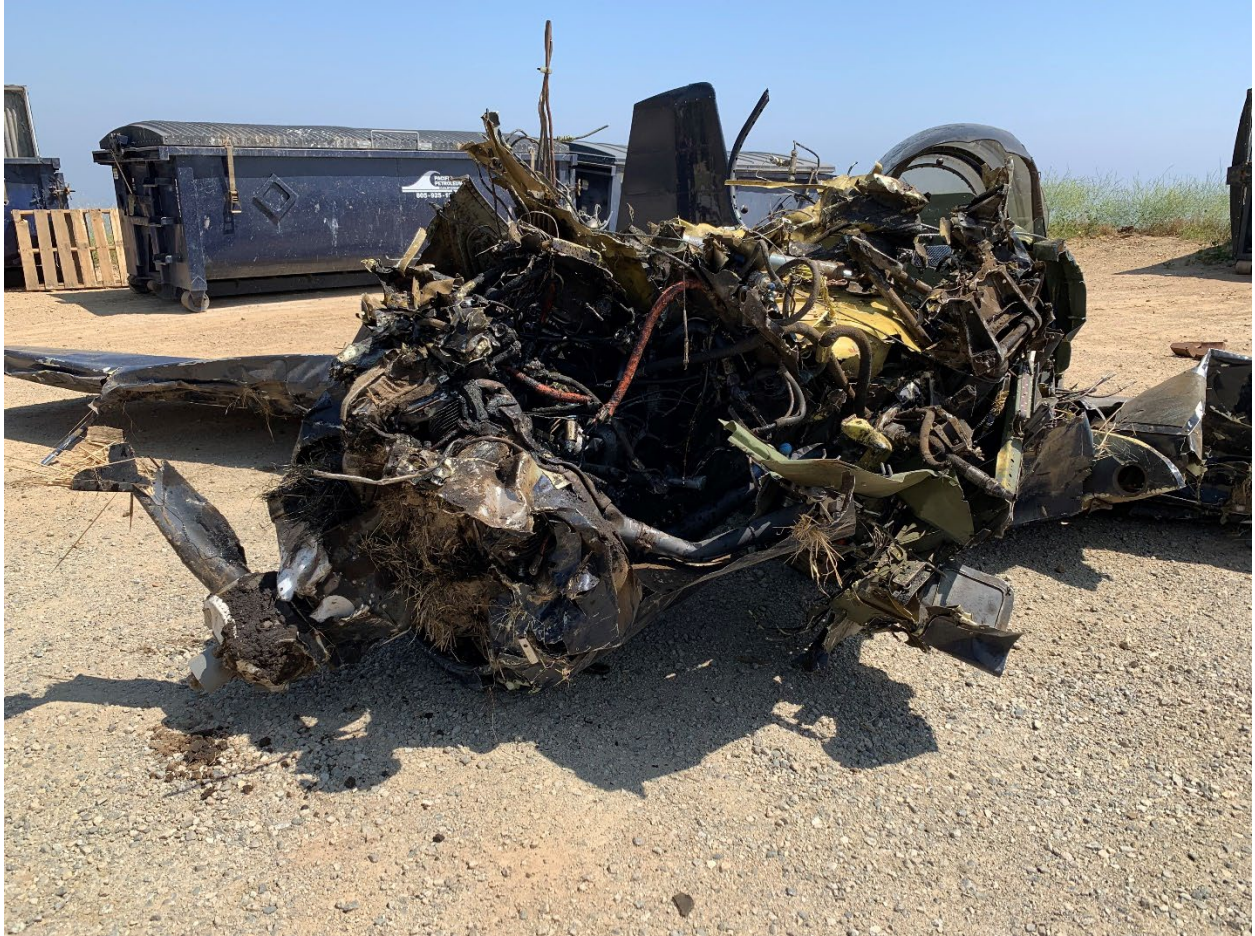
The airplane remained intact, and the debris field was contained to the main wreckage. The engine remained attached to the airframe; the propeller assembly remained attached crankshaft. Two of the three wood propeller blades had separated at the hub and a portion of a third blade remained attached to the propeller hub.

Photo 3 - Front View of Airplane (Courtesy of NTSB)

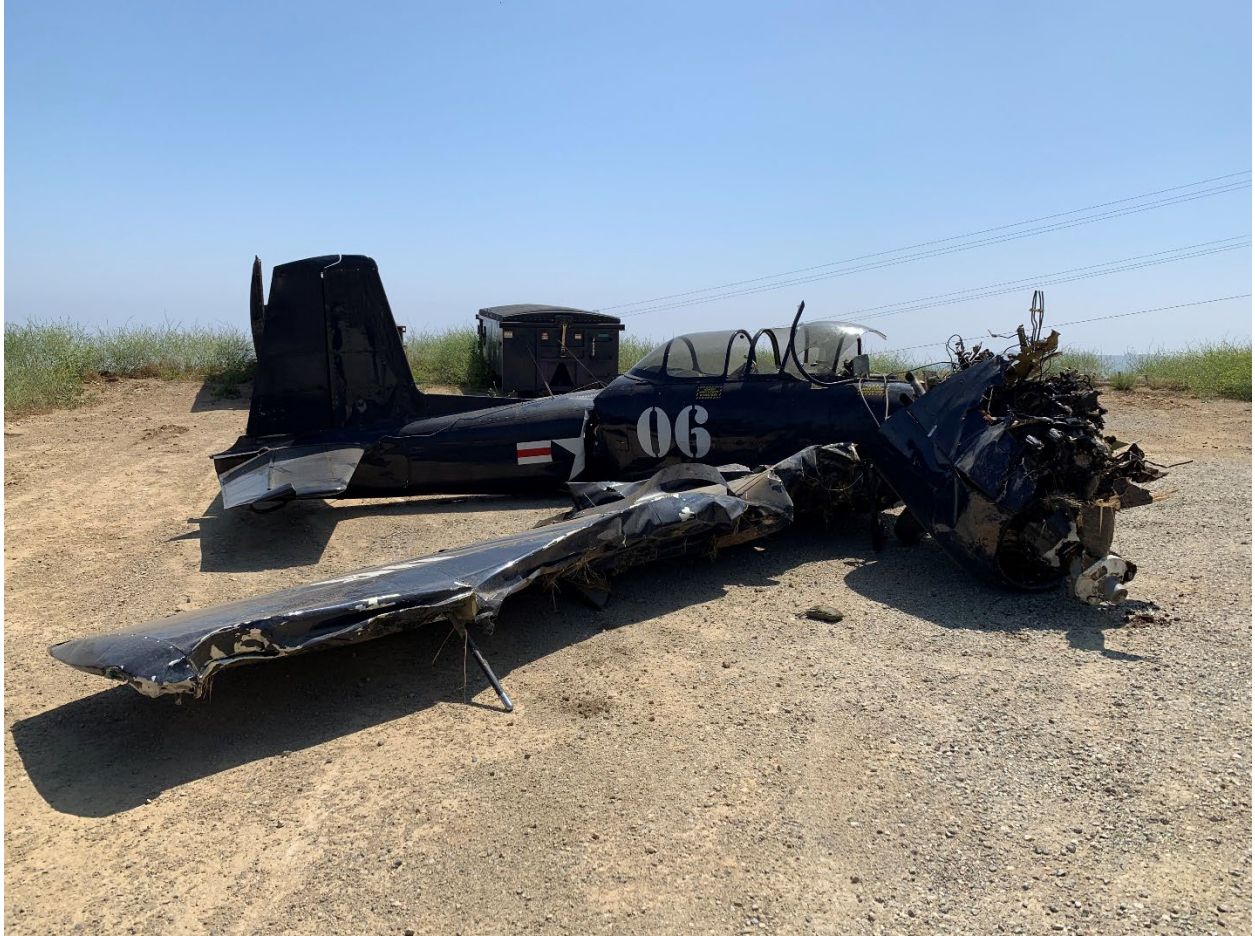
Photo 4 - Right side view of airplane (Courtesy of NTSB)

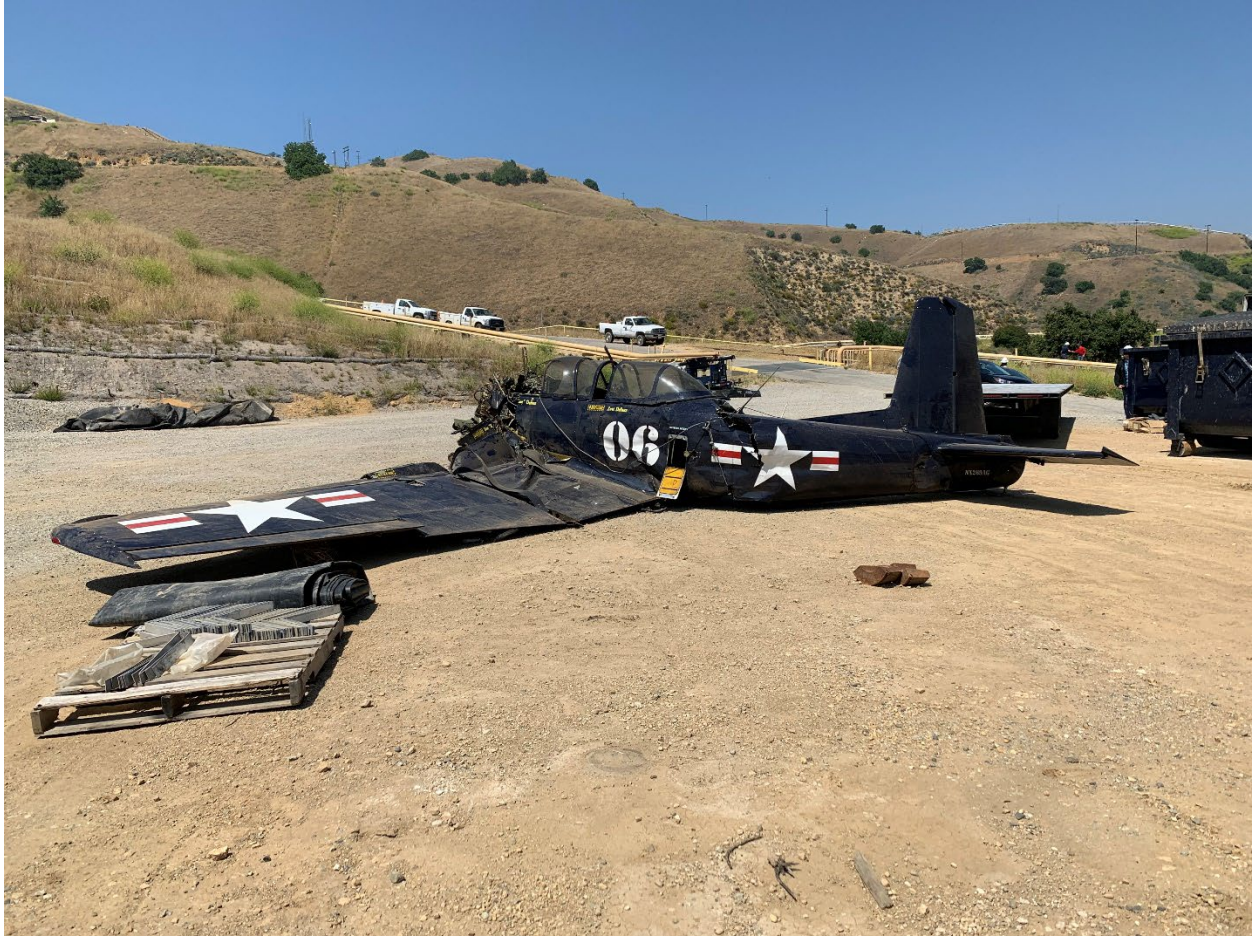
Photo 5 - Left side view of airplane (Courtesy of NTSB)

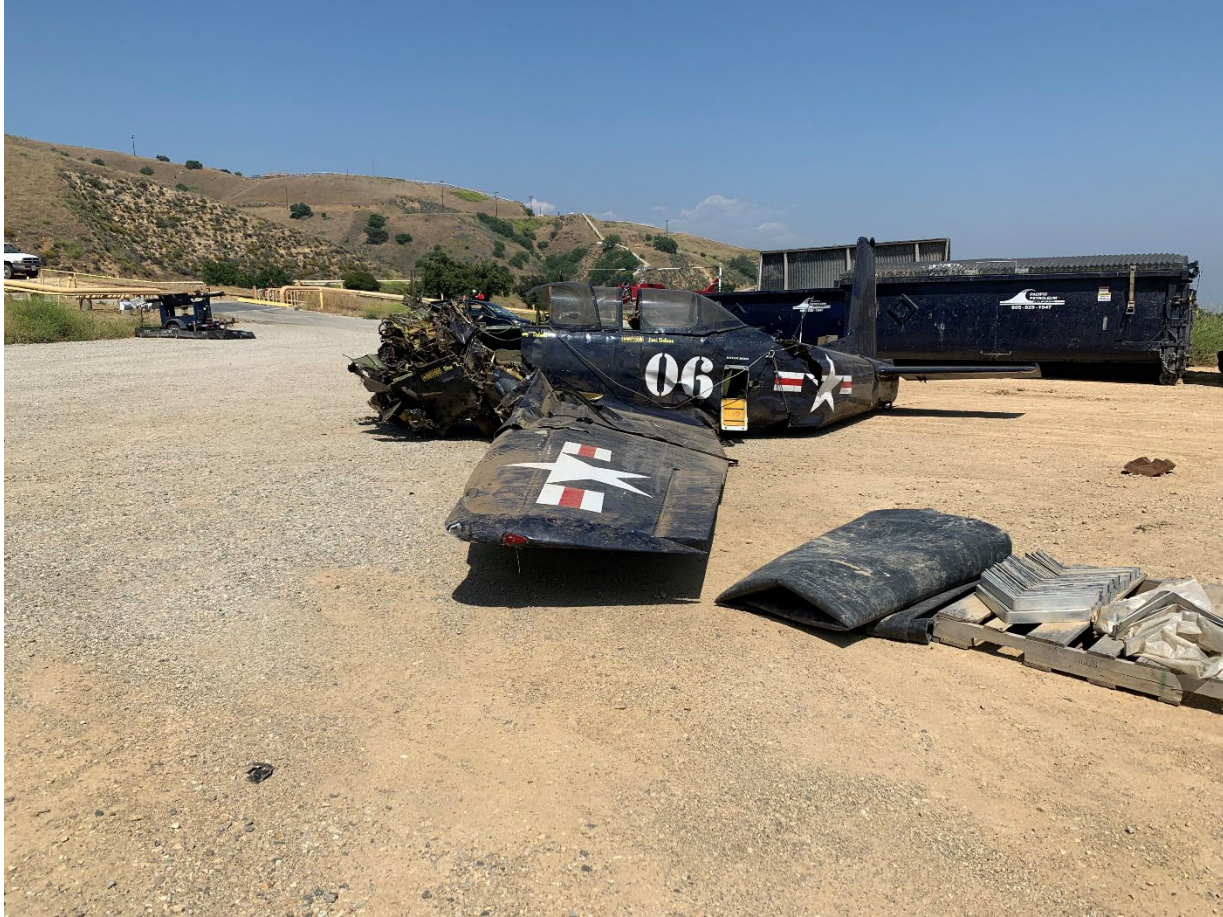
Photo 6 - Left side view of airplane (Courtesy of NTSB)

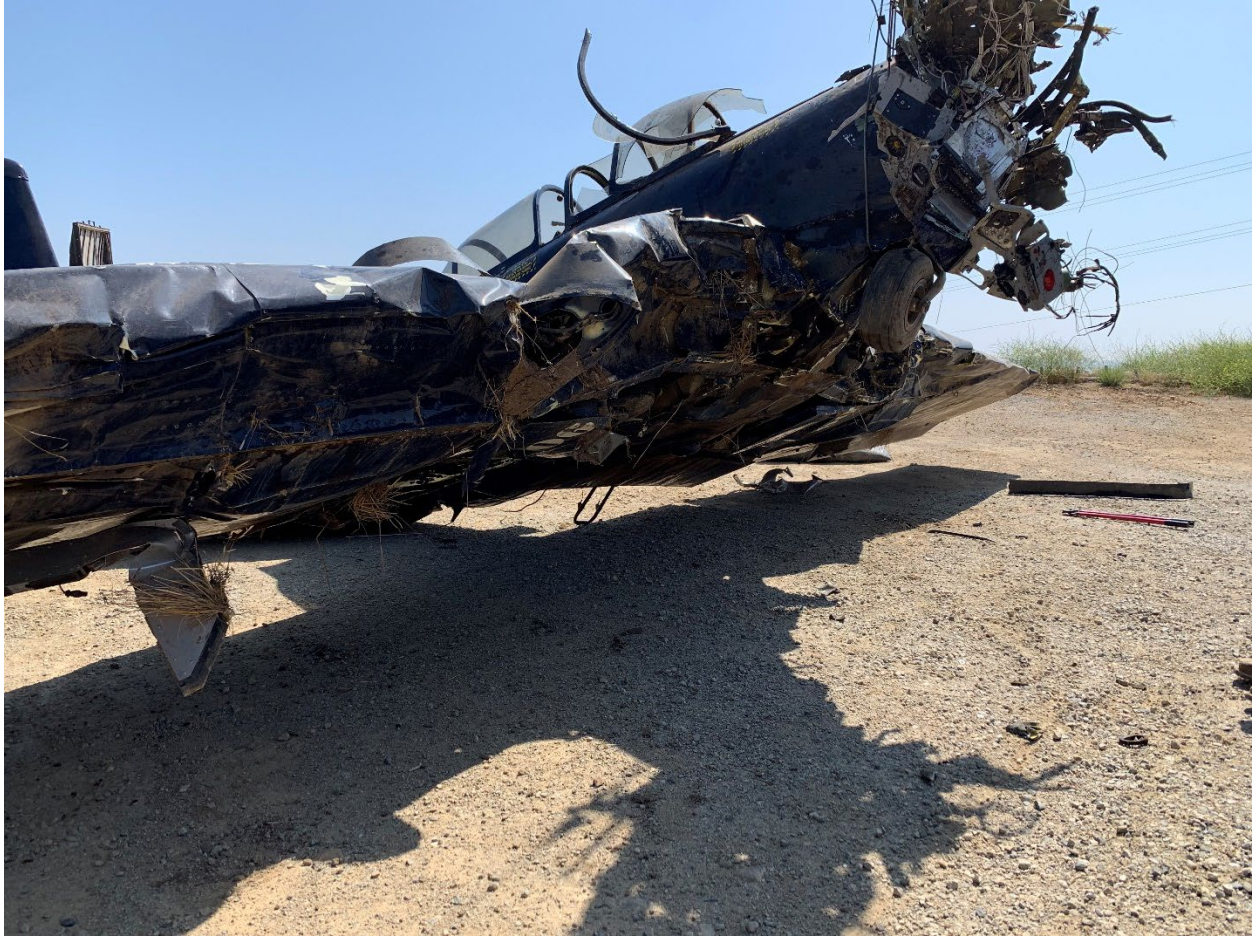
Flight control continuity from the cockpit to each flight control surface was established on scene. The undercarriage as well as the undersides of both wings sustained crush damage upward. The inboard sections of both wings were partially separated at the root and crushed. There was also leading-edge crush aft of both wings. The empennage remained attached to the fuselage but had partially separated. The tail section had minor damage.

Photo 7 - View of undercarriage and right wing (Courtesy of NTSB)
