## **NATIONAL TRANSPORTATION SAFETY BOARD**

# **ACCIDENT SITE EXAMINATION SUMMARY**

**WPR19FA175**

Location: Santa Catalina Island, CA  
Date: June 17, 2019  
Aircraft: Robinson R44, N7187D  
NTSB Investigator-in-Charge: Maja Smith

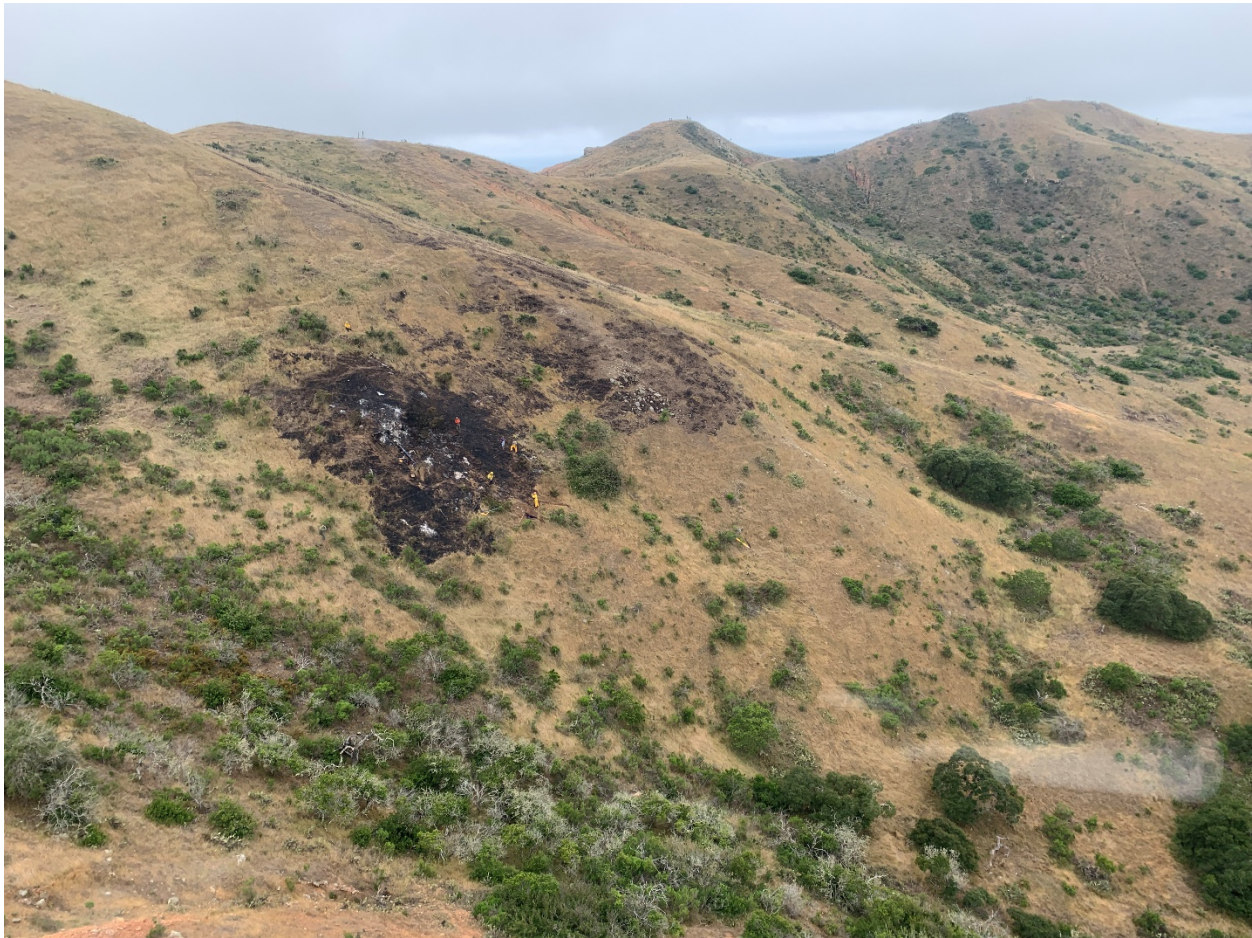
Figure 2. Aerial photo of the wreckage

The helicopter impacted mountainous terrain about 2 miles south-east of the most northern tip of the island. It came to rest about 860 feet north of the east-west oriented ridgeline bordered by vegetation that primarily consisted of shrubbery. The elevation at the main wreckage was about 1293 feet msl. The wreckage path proceeded downhill along a heading of about 325° magnetic and was about 70 ft long. All major components of the helicopter were located at the accident site. The wreckage was significantly fragmented and consumed by a postcrash fire. Continuity from the controls to the main and tail rotor systems could not be confirmed due to impact and fire damage, however, all control rod ends were found in the wreckage path.

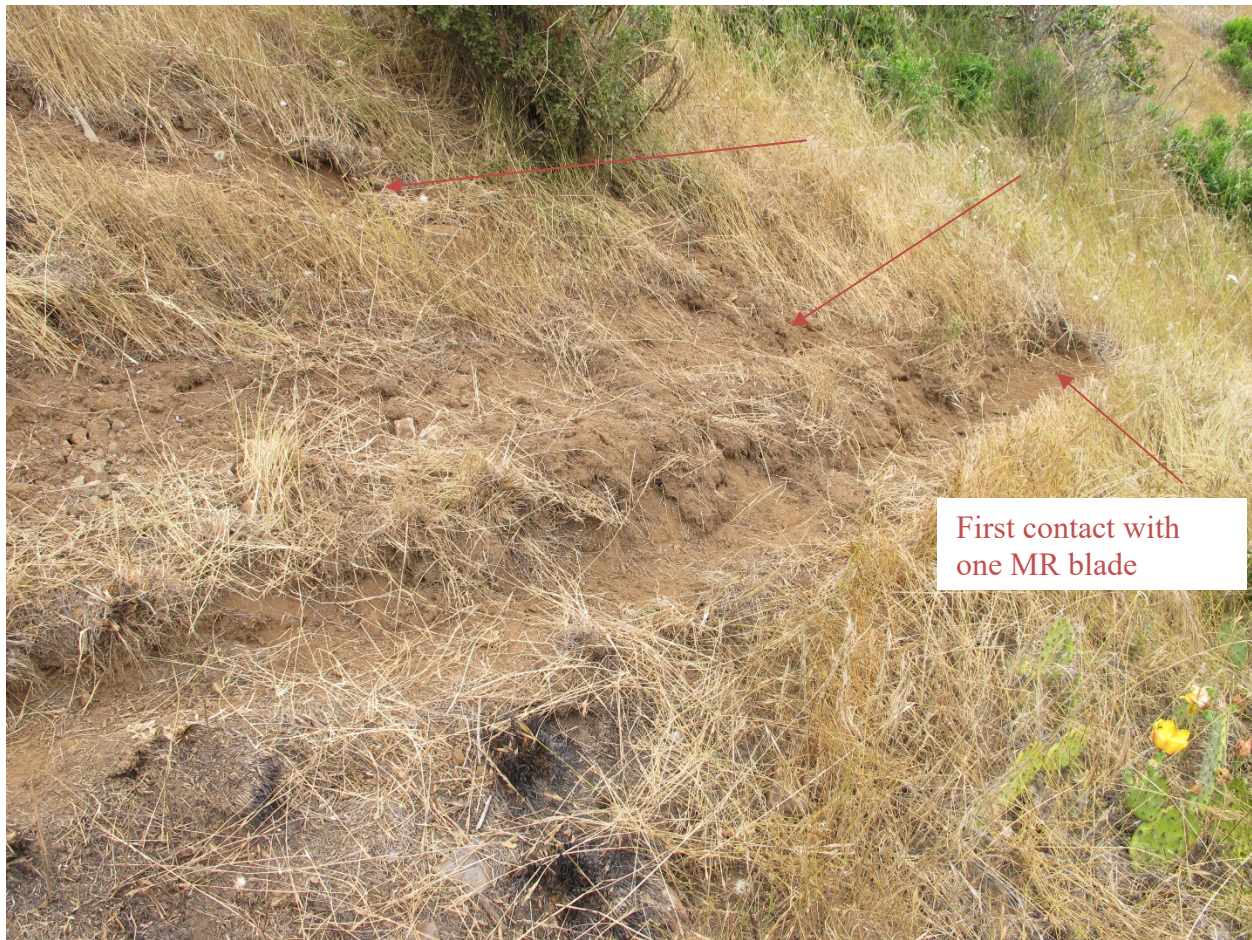
Figure 3. First point of impact

The first identified points of contact (FPOI) consisted of disrupted dirt on the far northern end of the debris field, about 70 feet from the main wreckage. Two additional markings created nearly parallel indentations in the vegetation and dirt spaced a foot apart. Those markings were consistent with both main rotor blades contacting terrain while still rotating.

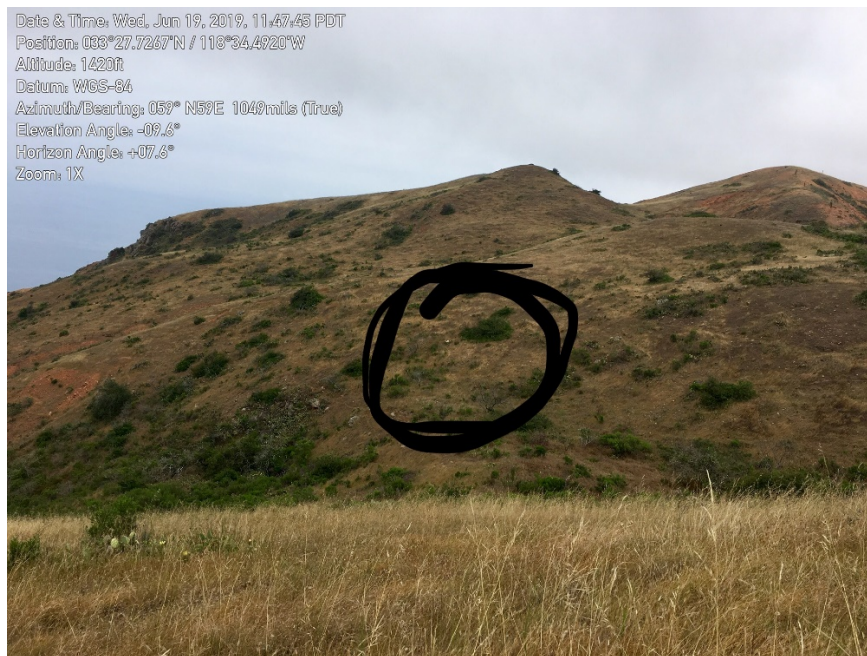
Figure 4. View from the main wreckage towards the outboard piece of a main rotor blade

The main wreckage consisted of the remnants of fuselage, the tailboom, the engine and the main rotor (MR) blade assembly. Both MR blades were separated from the mast; outboard portion of one MR blade was located at the adjacent hill about 240ft east of the main wreckage.
