## **NATIONAL TRANSPORTATION SAFETY BOARD**

### **ENGINE EXAMINATION SUMMARY**

**WPR19FA175**

| Aircraft: | Robinson R-44, N7187D |

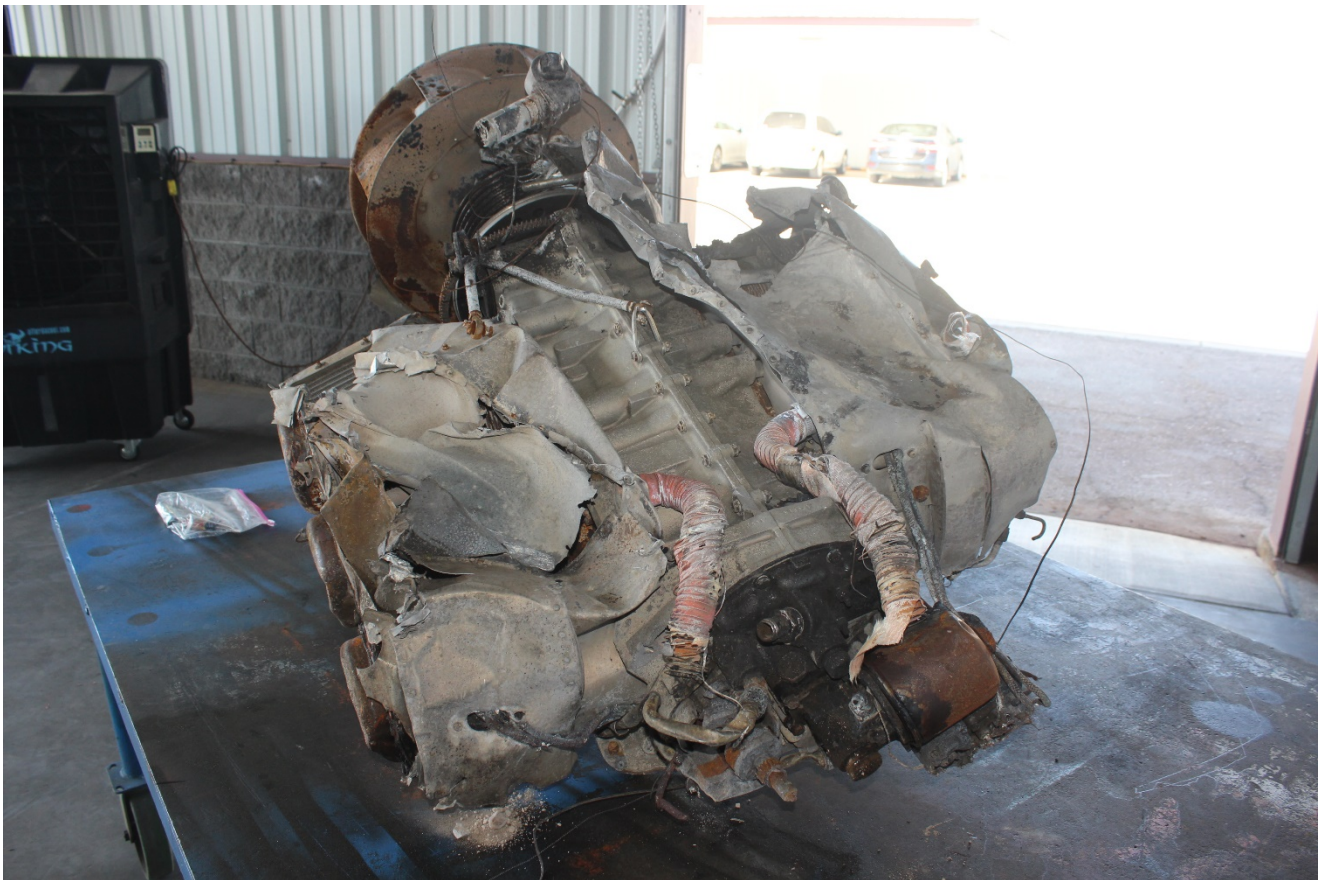
Figure 1. Engine

The engine separated from the airframe upon impact and it sustained significant thermal energy damage. Visual examination of the engine revealed no evidence of pre-impact catastrophic mechanical malfunction or fire.

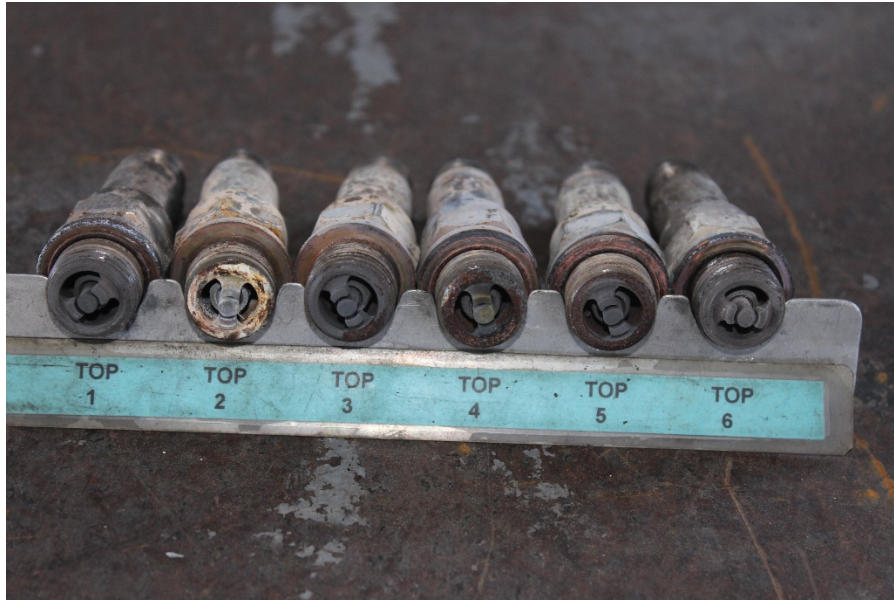
Figure 2. Spark plugs

The top spark plugs were removed and visually inspected. The top spark plugs electrodes remained mechanically undamaged, and displayed varying coloration attributed to thermal effects of the post impact ground fire.

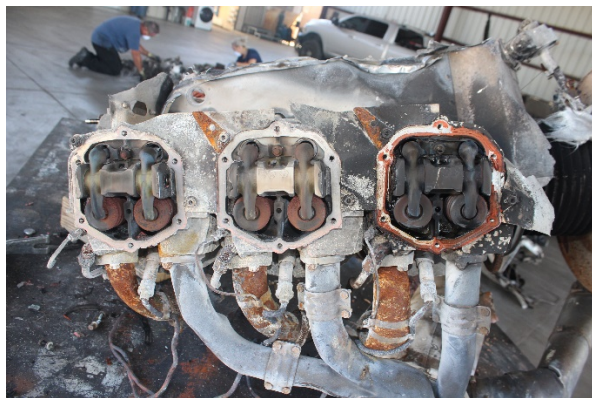
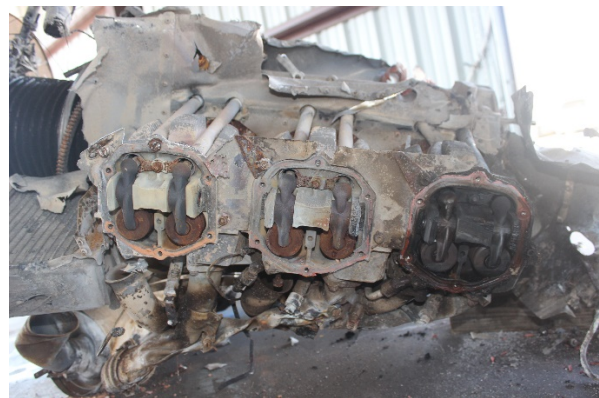
Figure 3. #1,#3 and #5 intake and exhaust valve

Figure 4. #2, #4 and #6 intake and exhaust valve

The rocker covers were removed. The complete valve train within the rocker box areas appeared to be free of any pre-mishap mechanical malfunction. The combustion chamber of each cylinder was examined through the spark plug holes utilizing a lighted borescope. The combustion chambers and bottom spark plug electrodes remained mechanically undamaged, and there was no evidence of foreign object ingestion. The valves were intact and undamaged. There was no evidence of valve to piston face contact observed. There was no oil residue observed in the exhaust system gas path. There was significant ductile bending of the exhaust system components.

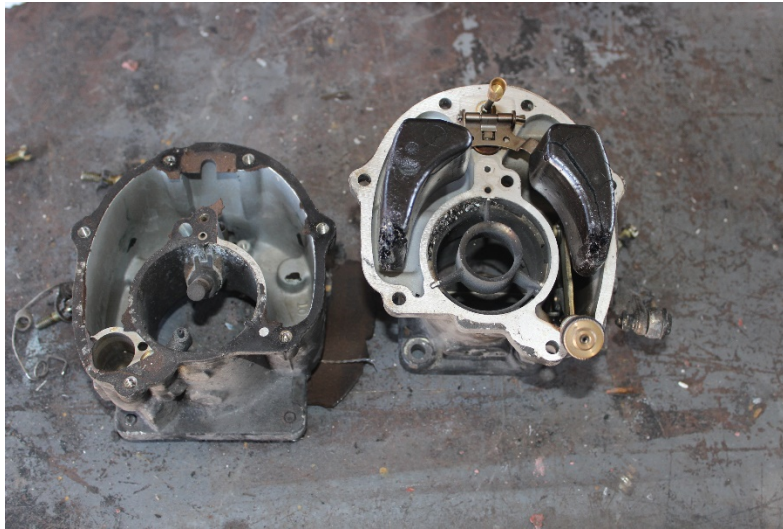
Figure 5. Carburetor

The carburetor was displaced from the engine at the mechanical attachments that secured it to the engine. The fracture surface signatures were consistent with overload. The throttle control rod-end was found securely attached at the control arm of the carburetor. The mixture cable had been pulled from the end of the arm. Both the throttle and mixture controls had been moved beyond the normal operating range (pulled) during the accident. A reliable setting at the time of impact could not be determined. The castellated nut and cotter pin remained secure and the serrated interface at the throttle arm remained securely mated. The carburetor was opened for examination. The fuel bowl remained free of visible pre-impact contaminants. The float assembly remained secure at the mounting and free of damage. The heat damaged float pontoons exhibited no evidence of rubbing against the wall of the bowl. All internal locking tabs and safety devices of the carburetor were in place and properly secured. The fuel inlet screen was found properly installed and free of contamination. No external fuel staining was observed.

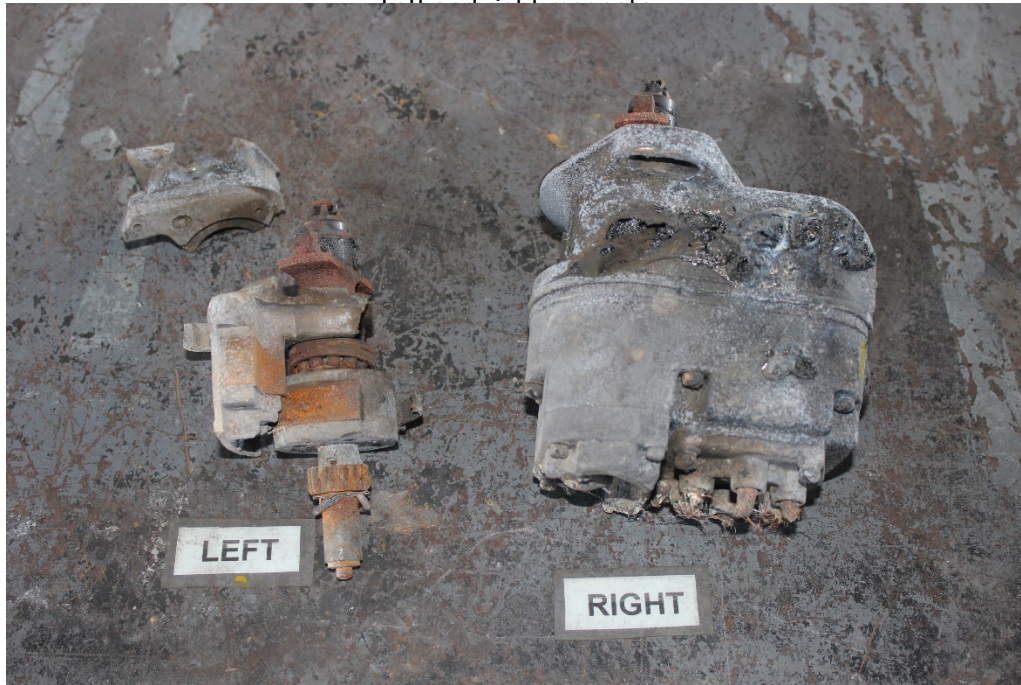
Figure 6. Left and right magneto

The left magneto had sustained impact and thermal energy damage. The pieces of magneto flange that remained at the mounting pad were securely clamped. Magneto to engine timing could not be ascertained. The drive was found intact and secure. The magneto sustained varying degrees of damage that rendered the unit inoperative and therefore, could not be functionally tested.

The right magneto was found securely clamped at the mounting pad. The magneto had been subjected to thermal effect as a result of the post impact ground fire. The magneto sustained varying degrees of damage that rendered the unit inoperative and therefore, could not be functionally tested. Magneto to engine timing could not be ascertained. The drive was found intact and secure.
