## **NATIONAL TRANSPORTATION SAFETY BOARD**

### **ONSITE EXAMINATION NOTES**

**WPR19FA182**

Location: Moab, UT  
Date: June 30, 2019  
Aircraft: N66DN  
NTSB IIC: Albert Nixon

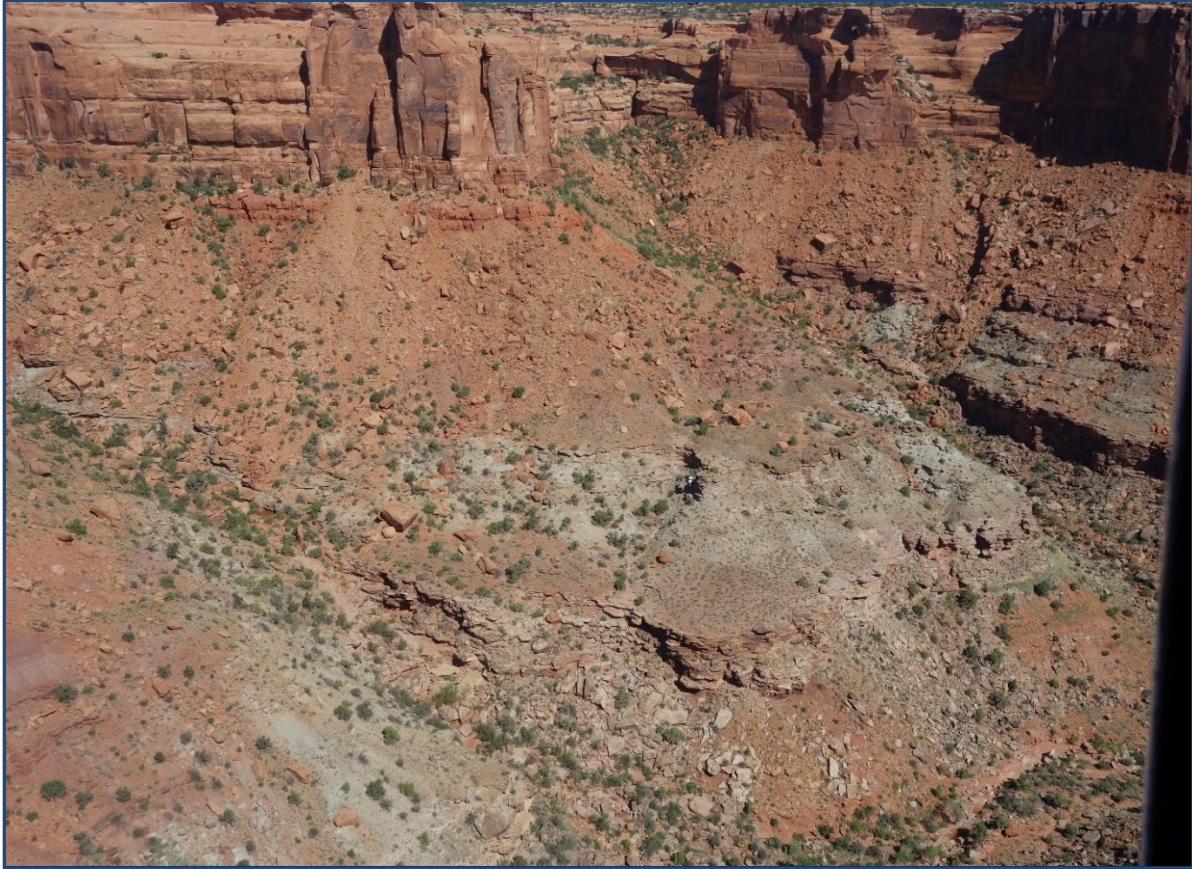
**Figure 1: Airplane wreckage as viewed from above.**

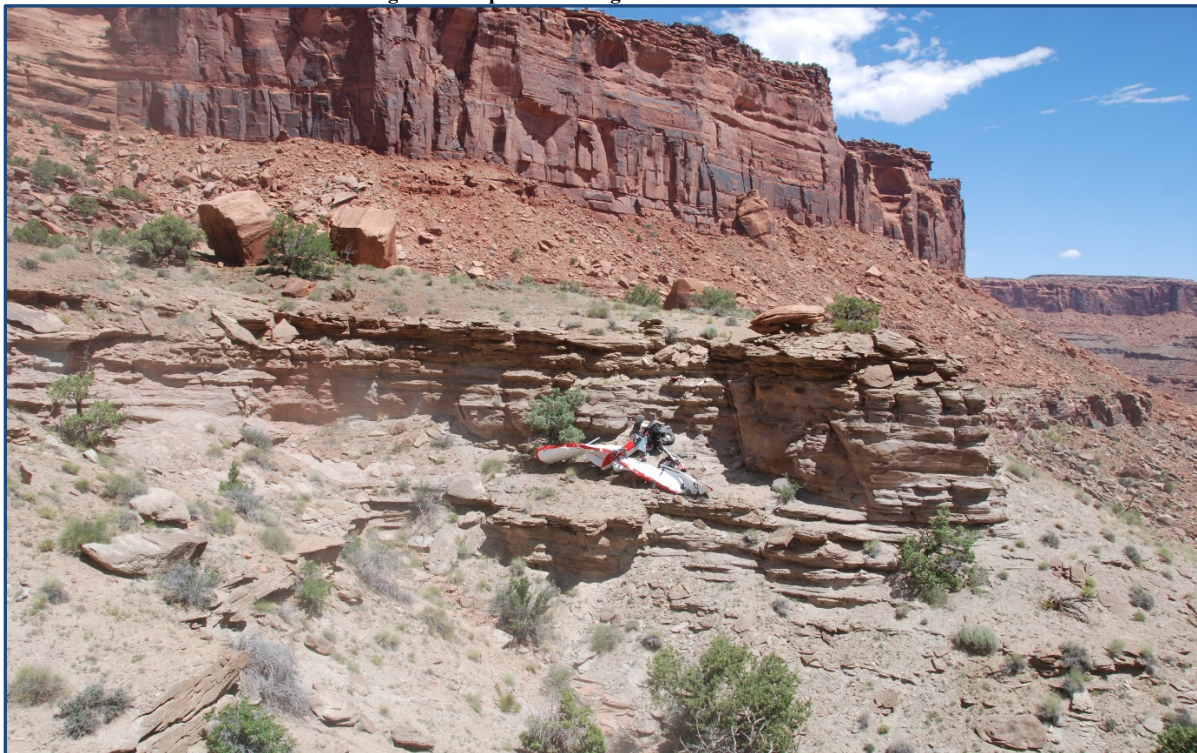
**Figure 2: Airplane wreckage as viewed from the rear.**

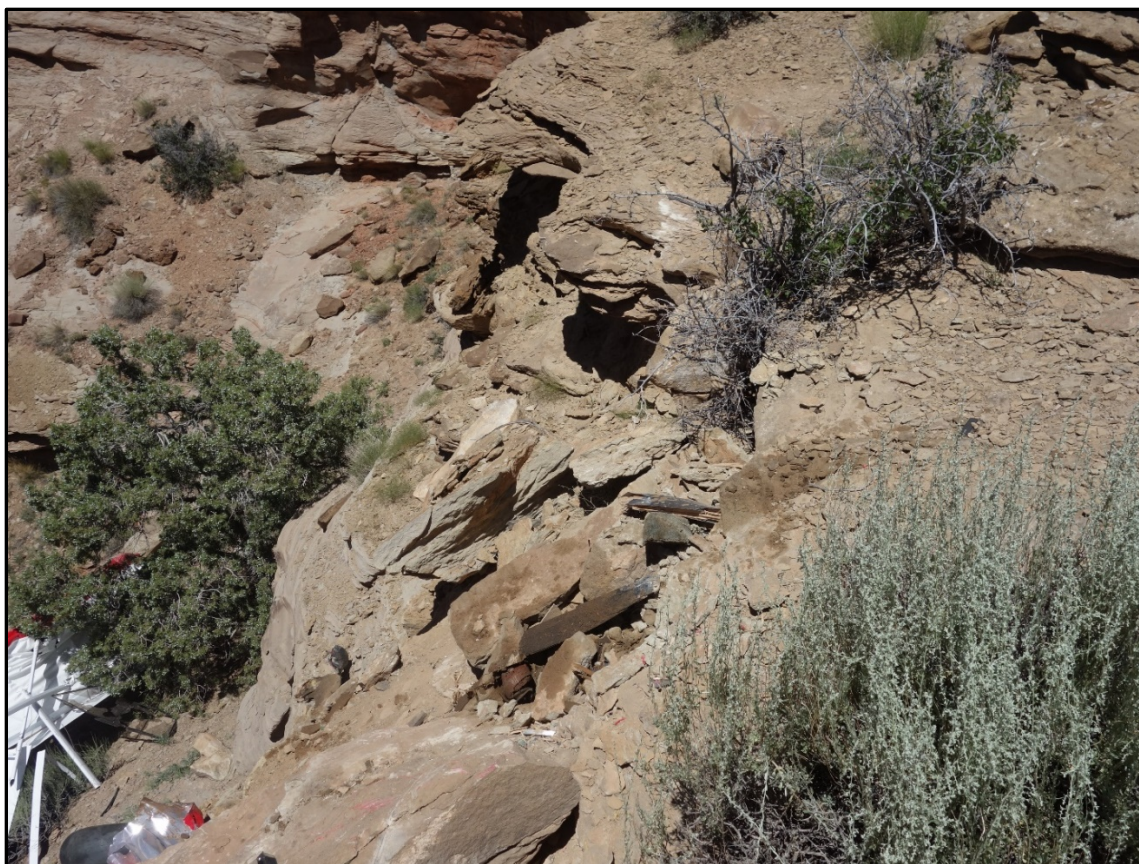
**Figure 3: Top of ridgeline with oil stain visible.**
