## ACCIDENT AND EXAMINATION NOTES

On August 05, 2019, about 1445 mountain daylight time, a Cessna 182L, N3469R, departed controlled flight and collided with terrain while attempting to land on a private road in Wolf Point, Montana. The pilot, the registered owner, was operating the airplane under the provisions of 14 *Code of Federal Regulations* (CFR) Part 91. The private pilot and front-seated passenger sustained fatal injuries; the airplane was destroyed. The business flight departed from Frank Wiley Field Airport, Miles City, Montana, about 1350 with a planned destination of the private road. Visual meteorological conditions prevailed and no flight plan had been filed.

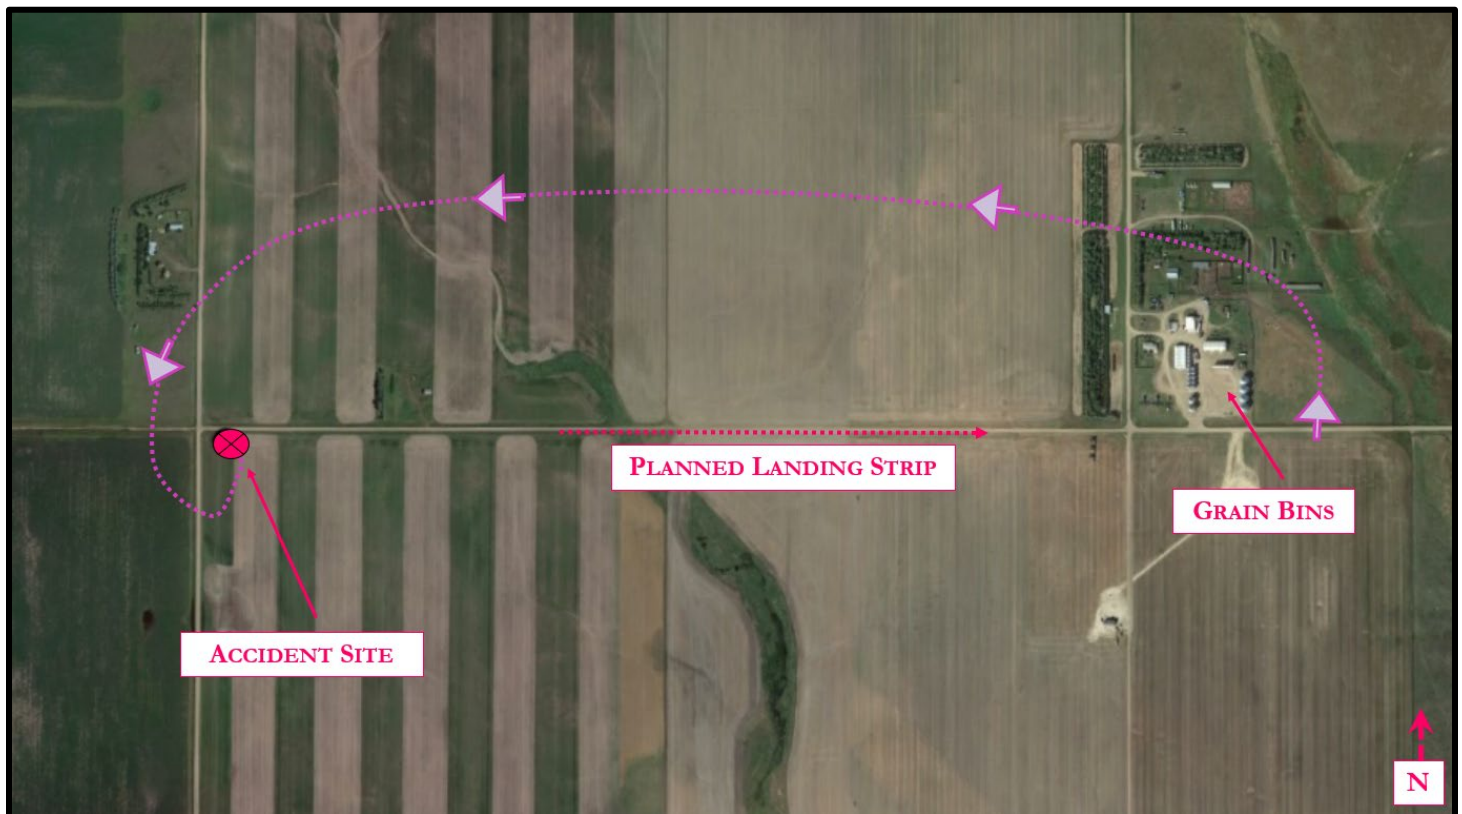
Figure 1: Presumed Accident Flight Path (According to Witness)

A witness stated that he owned the farm adjacent to where the accident site was located. The pilot had built grain silos for him in the past and he had contracted him to build more. The pilot and passenger, an employee at the pilot's company, had planned to visit the farm that day and had discussed with the witness landing at the farm. The pilot had been to farm on prior occasions, but had never flown there. The witness recalled the pilot called him at 1423 saying that he was flying over the town of Wolf Point and would be landing at the farm shortly. The witness, positioned near his silos, observed the airplane fly over his location and make a left turn to the west paralleling the dirt road he intended to land. The airplane then began a turn to the east to come back and land. He observed the airplane make a sharp turn and descend into terrain. Upon impact, the airplane burst into flames in the witness drove his water truck to put up the fire.

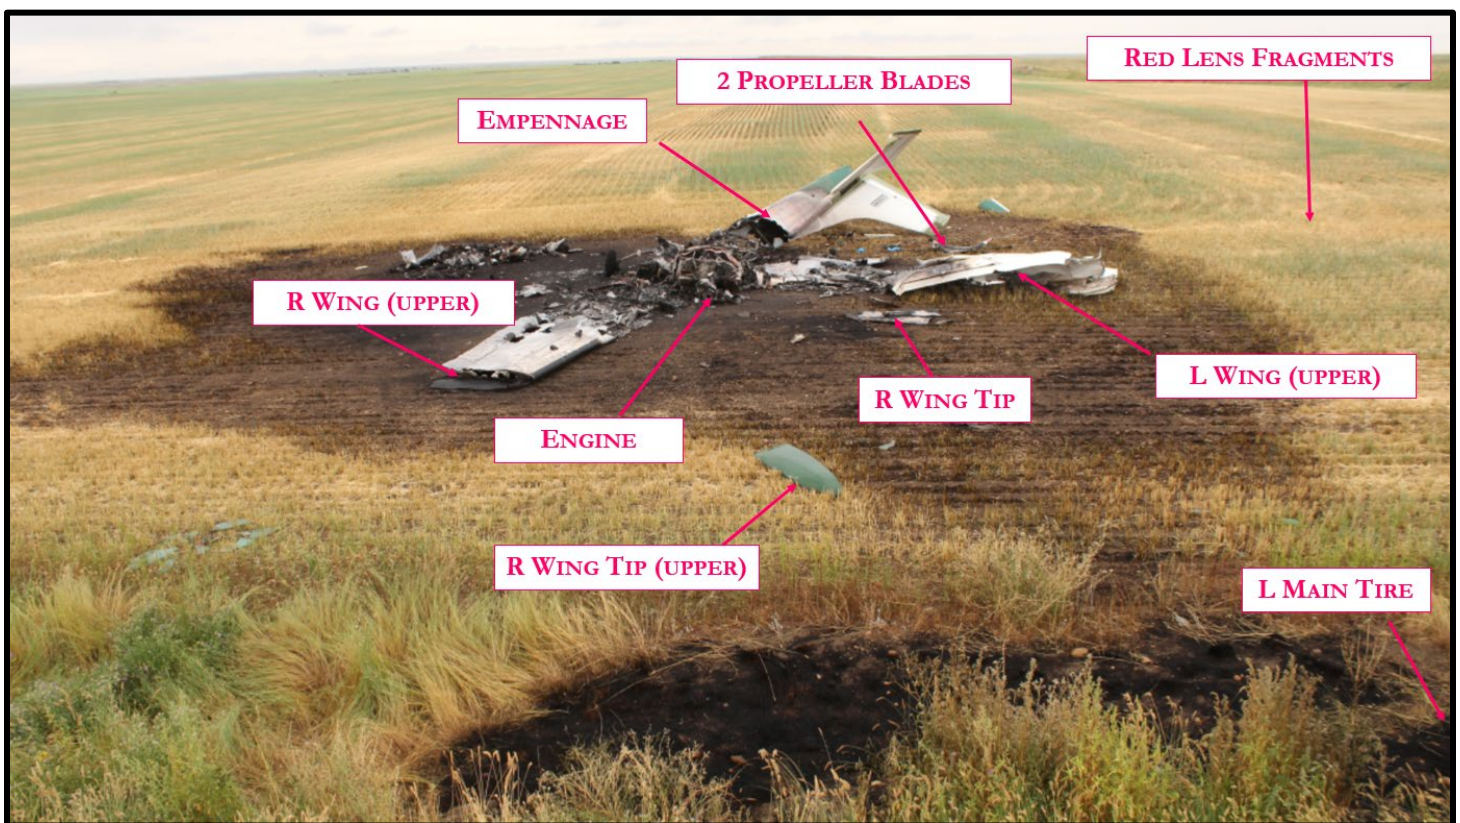
Figure 3: Wreckage

The accident site was located on a flat field about 21 nautical miles north of Wolf Point at the following coordinates: 48°26'9"N / 105°45'39 "W. In character, the terrain was composed of hard, dry dirt and short vegetation. The wreckage was found distributed over a 40-foot distance with the nose pointed on a median magnetic bearing of about 340°. The main wreckage, consisting of all of the major control surfaces, was about 60 feet south of the road. The fuselage and inboard sections of the wings had been consumed by fire.

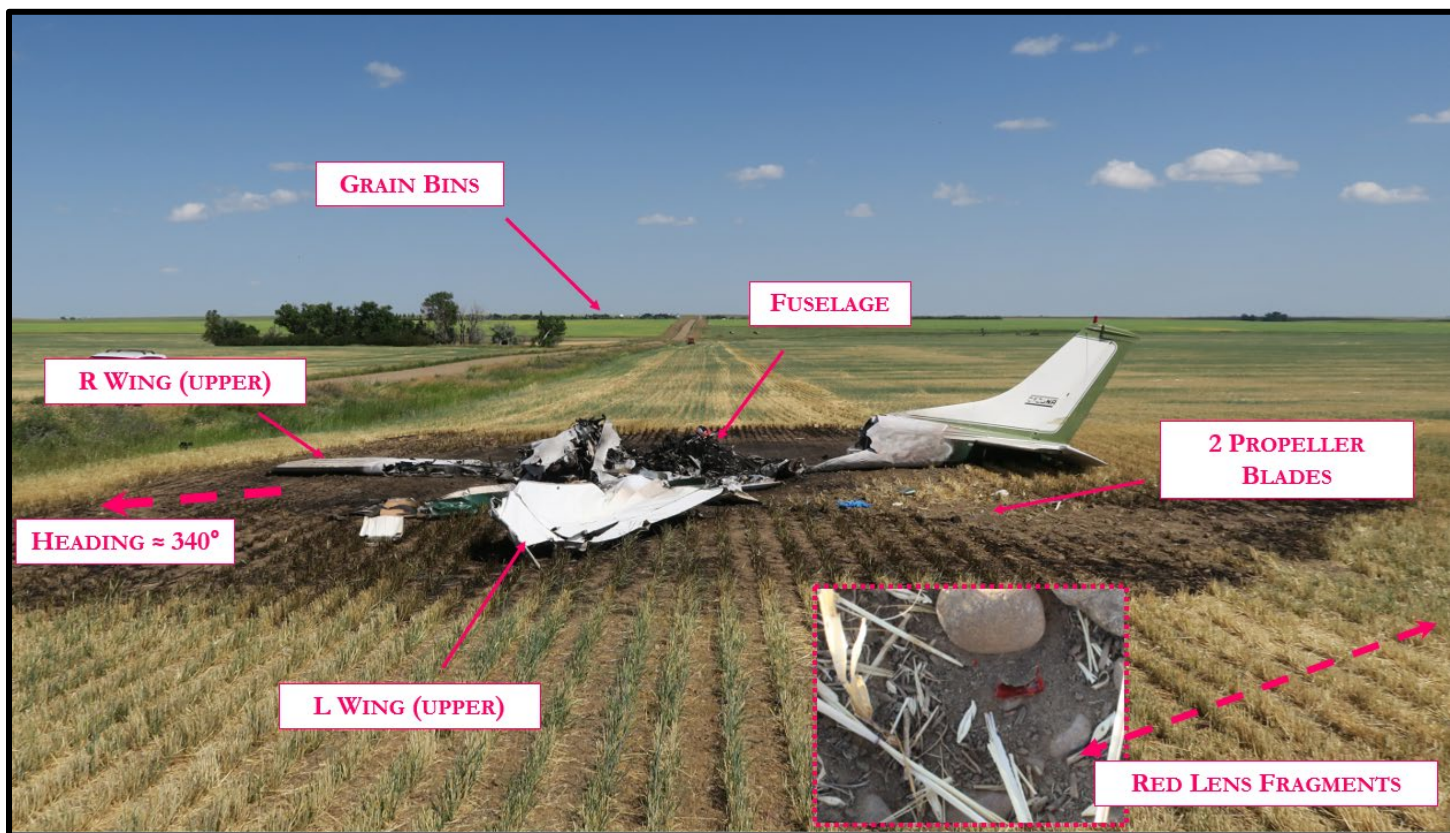
Figure 4: First Identified Point of Impact

The first identified piece of debris was fragments of red lens, consistent with the tip of the left wing contacting the ground at the beginning of the accident sequence. From the lens was a disruption in the vegetation similar in shape and size to that of the leading edge of the left wing and pieces of lens consistent with the land light were in the dirt. Thereafter was a crater in the dirt with two propeller blades imbedded.

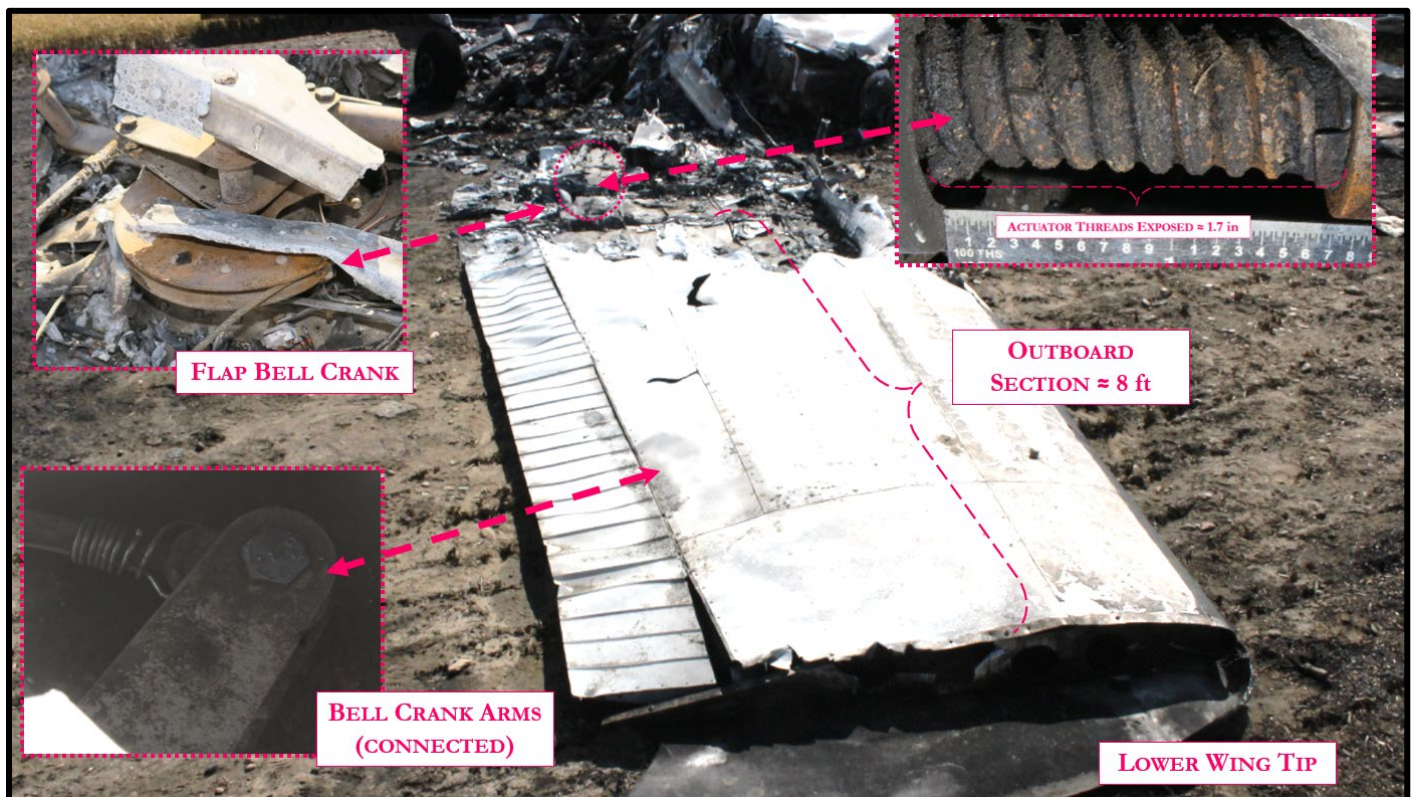
Figure 7: Left Wing

The right and left wing came to rest upright and the flap and aileron control surfaces remained attached at their respective hinges. The right direct cable was continuous from the right cable drum in the cockpit to the bellcrank. The carry-through cable was attached to the right bellcrank and separated with a broom-straw appearance several feet outboard consistent with overload. The other end had a similar broom-strawed appearance and that portion of the cable was continuous to the left bellcrank, where it was secured. The flaps cables were attached at the drive pulley. The flap actuator was measured at 1.7 inches, which the Textron representative stated was consistent with the flaps extended between 5-10°.

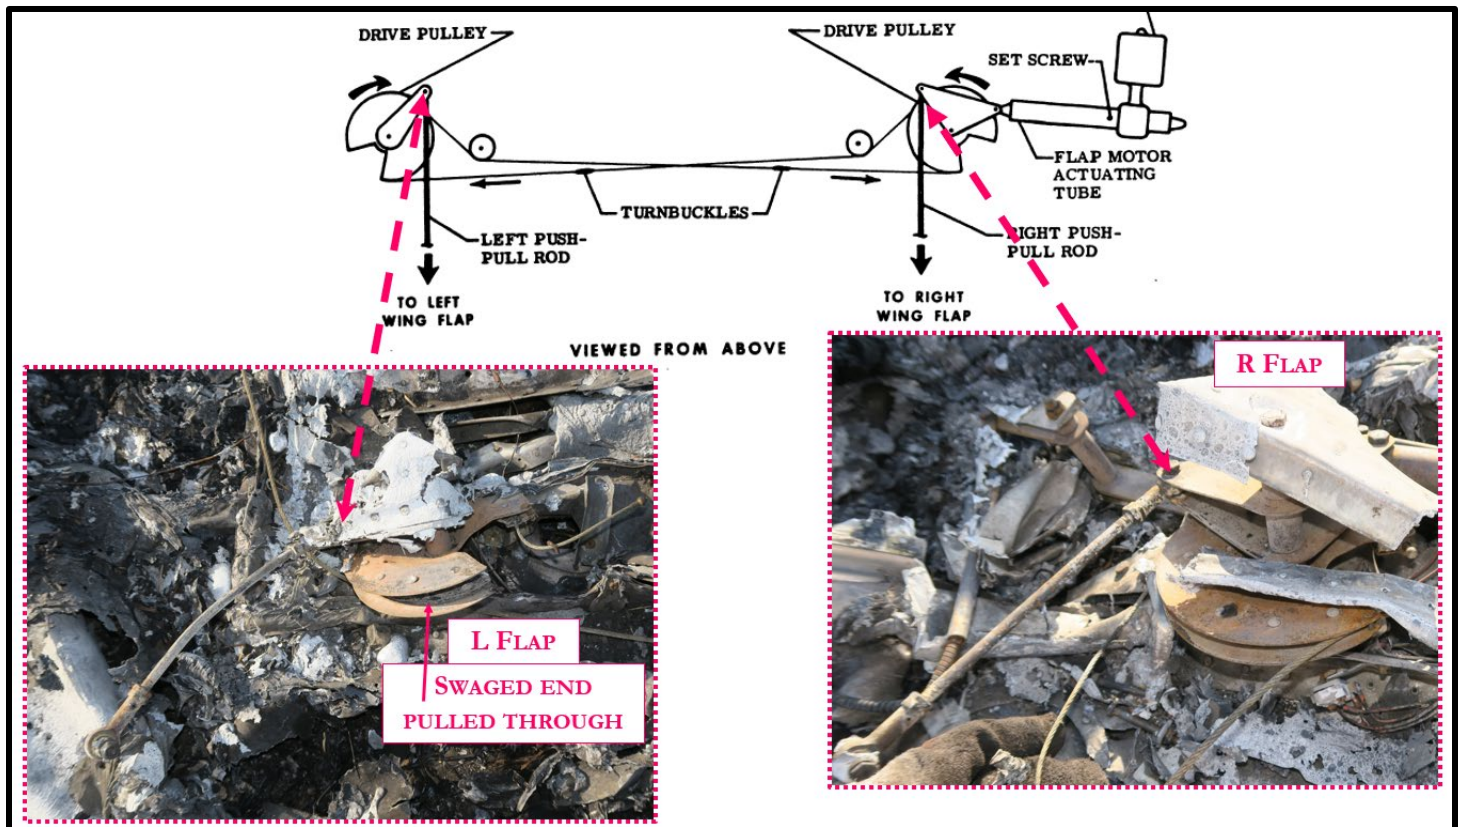
Figure 8: Flap System

The left direct cable was attached to the bellcrank and the cable was continuous to an area it was trapped in the folded fuselage airframe. From that area the left cable was seen routed through the cable drum. The lower inner connect cable had been separated at the right drum. The left flap drive pulley had the direct cables swaged end pulled through and the retract cable swaged end was in the pulley.

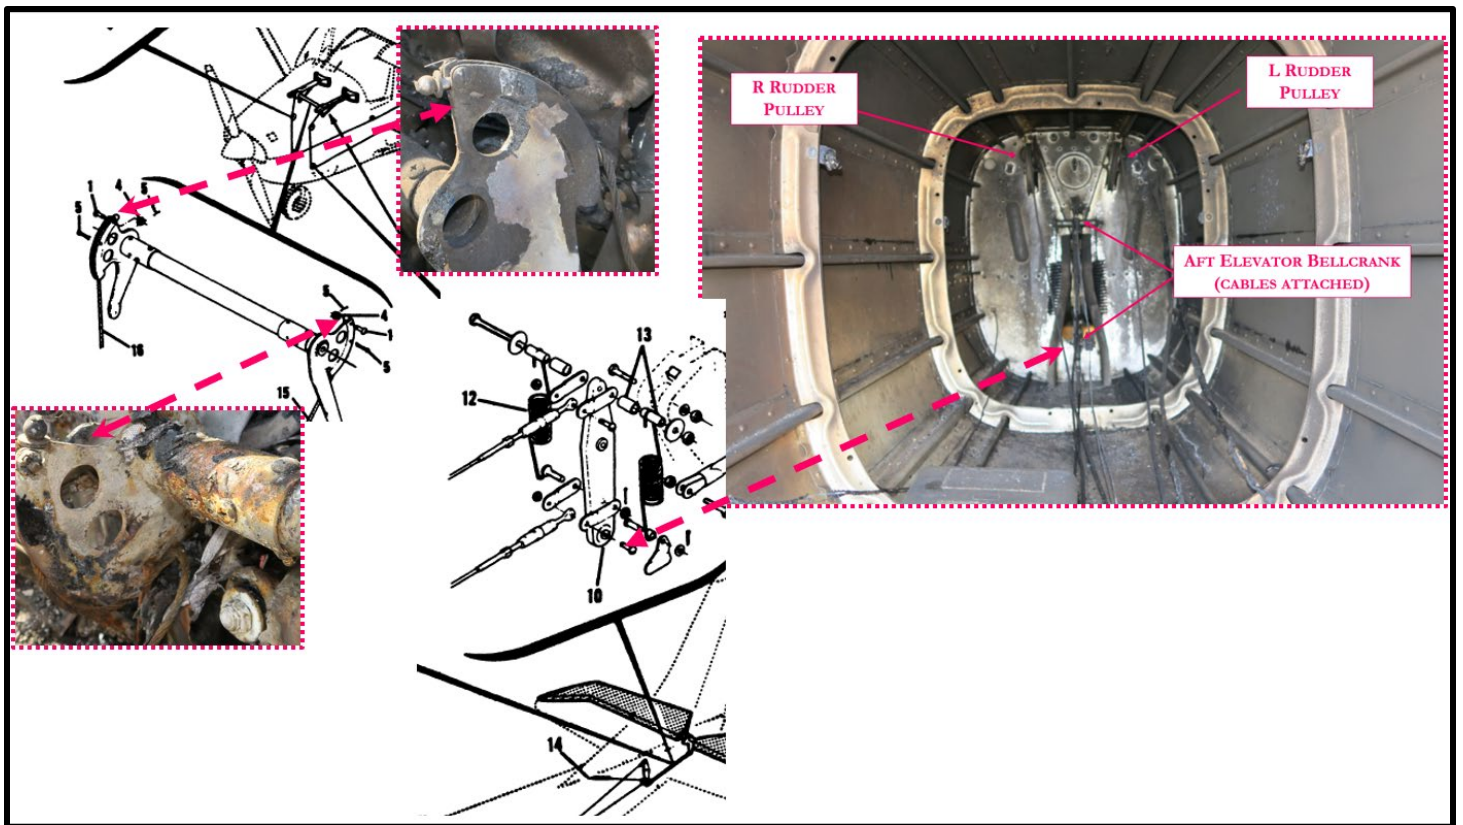
Figure 9: Elevator System

The elevator cables were connected in the cockpit and could not be traced through the crushed fuselage. From the fuselage they were continuous aft to the aft bellcrank. The push-pull tube was connected to the aft bellcrank (mounted on the aft bulkhead<sup>1</sup>) and to the elevator control arm. There were marks on both the left and right torque-tubes where the bolt ends from the hardware that attaches the rudder cables to the rudder horn.

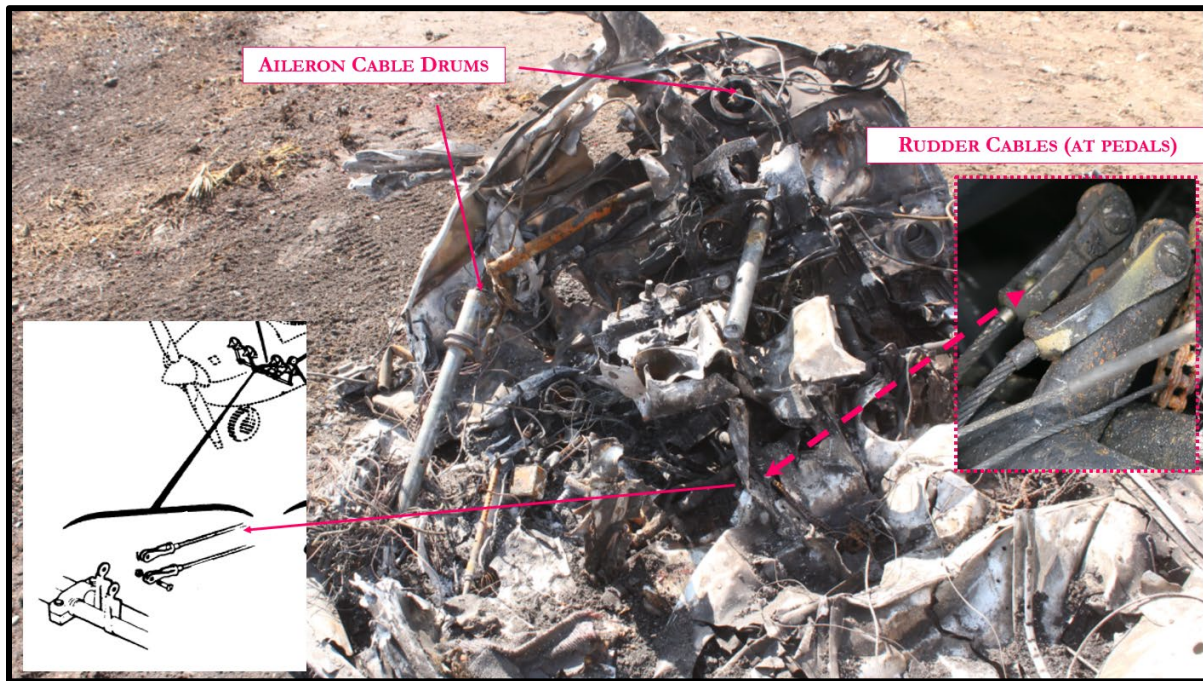
Figure 11: Rudder Cables

The rudder cables were attached at the pedal in the cockpit and could not be traced through the crushed fuselage. From the fuselage, the cables continued back through the pulleys mounted on the aft bulkhead and were attached to their respective arm on the rudder horn.

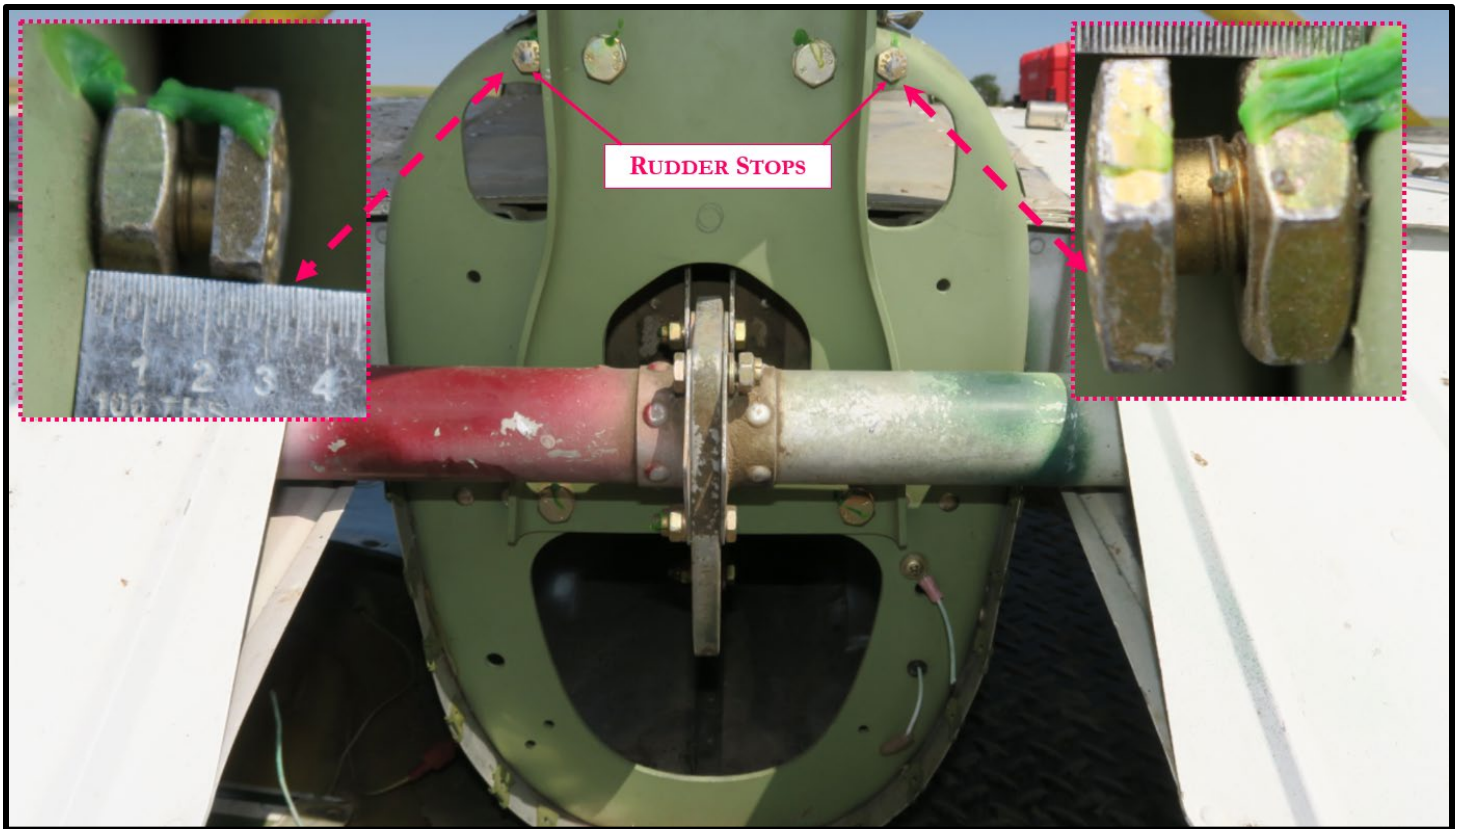
*Figure 13: Rudder Stops*

Investigators moved the rudder to the full left and right deflection where the rudder would hit the stops.

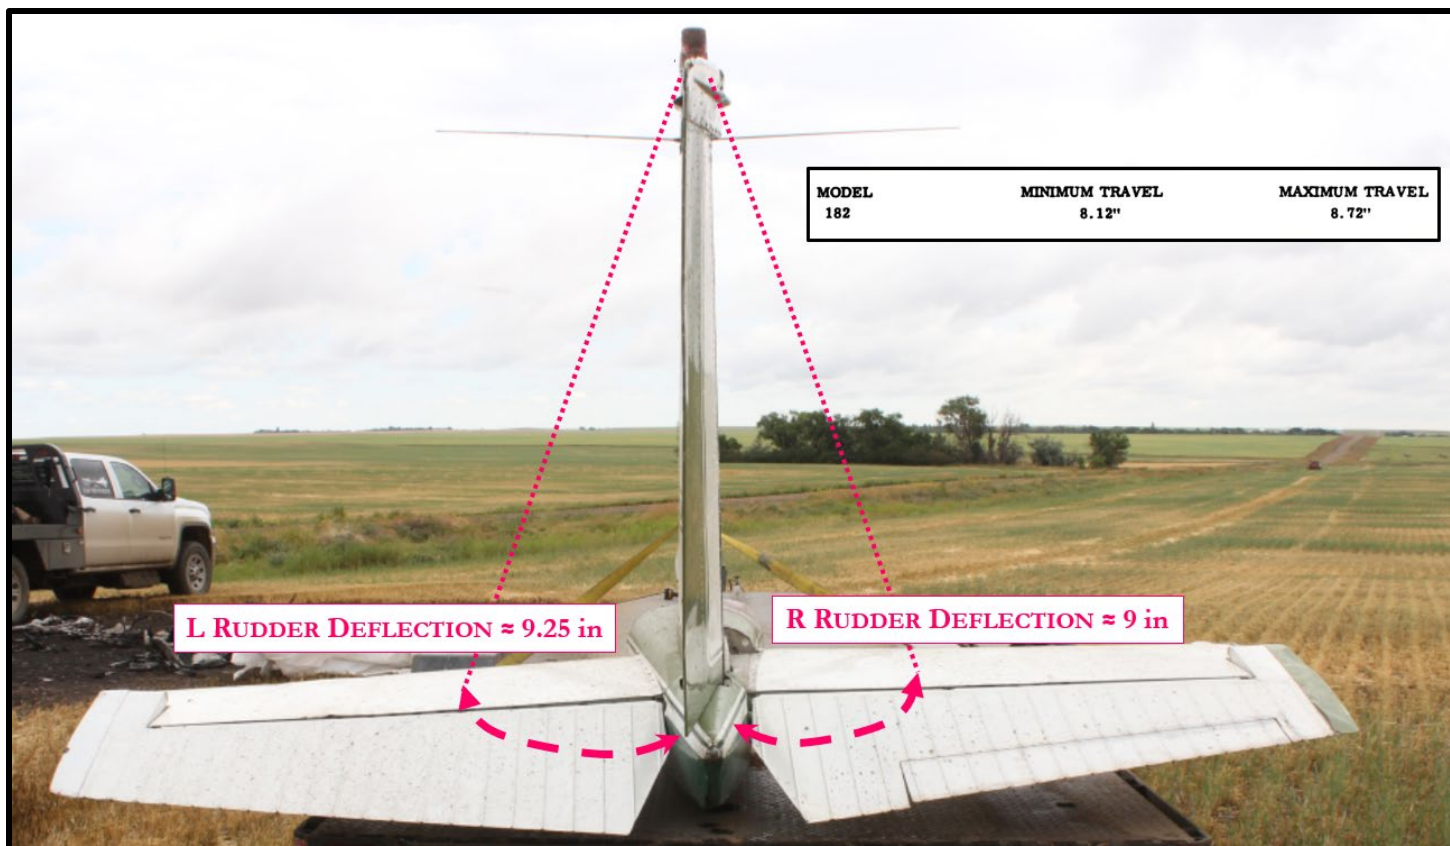
Figure 14: Rudder Deflection

The rudder deflection was measured to be 9.25 inches left and 9 inches right (see picture below). The Maintenance Manual shows the rudder travel limits are 8.12 inches minimum to 8.72 inches maximum. The left elevator was measured 23° up and 20° down; the right elevator was measured 25° up and 17° down (see pictures below). The Maintenance Manual shows the elevator travel limits were up: 26° +/- 1° up and 17° +/- 1° down.

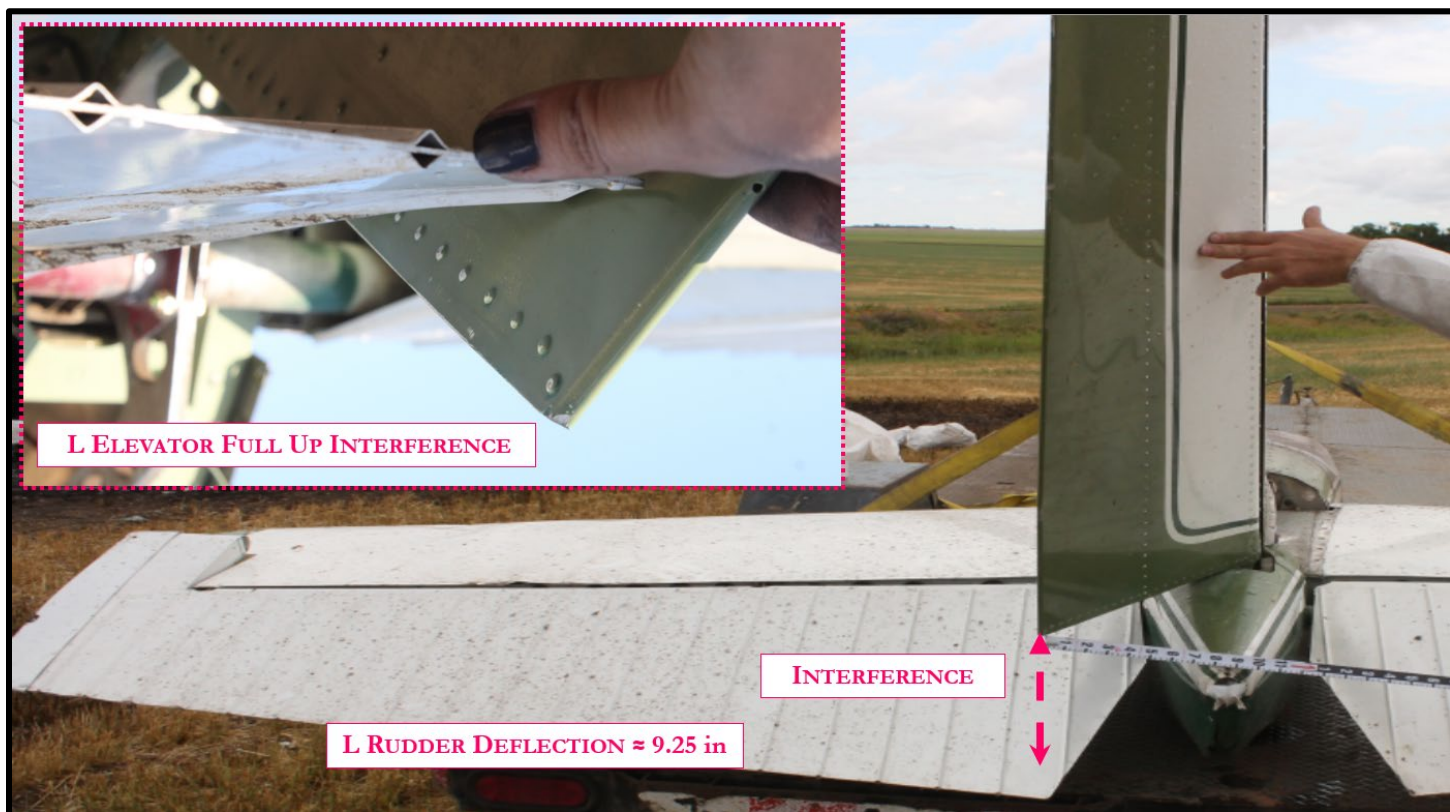
Figure 15: Interference Between Rudder and Elevator

With the elevator control surface in the down position. When the rudder was near full deflection (both right and left), investigators attempted to move the elevator up, but the travel was hindered from the elevator contacting the bottom of the rudder surface. When the elevator was in the up position, investigators moved the rudder to the stops. When the rudder was near full deflection (both right and left), investigators attempted to move the elevator down, but the travel was hindered from the elevator contacting the rivets on the rudder control surface. There were signatures of rubbed-off paint from the rivets located at the bottom of the rudder consistent with the interference occurring in the past. Additionally, the area the elevator control surface contacted the rudder appeared to have paint that was reapplied.

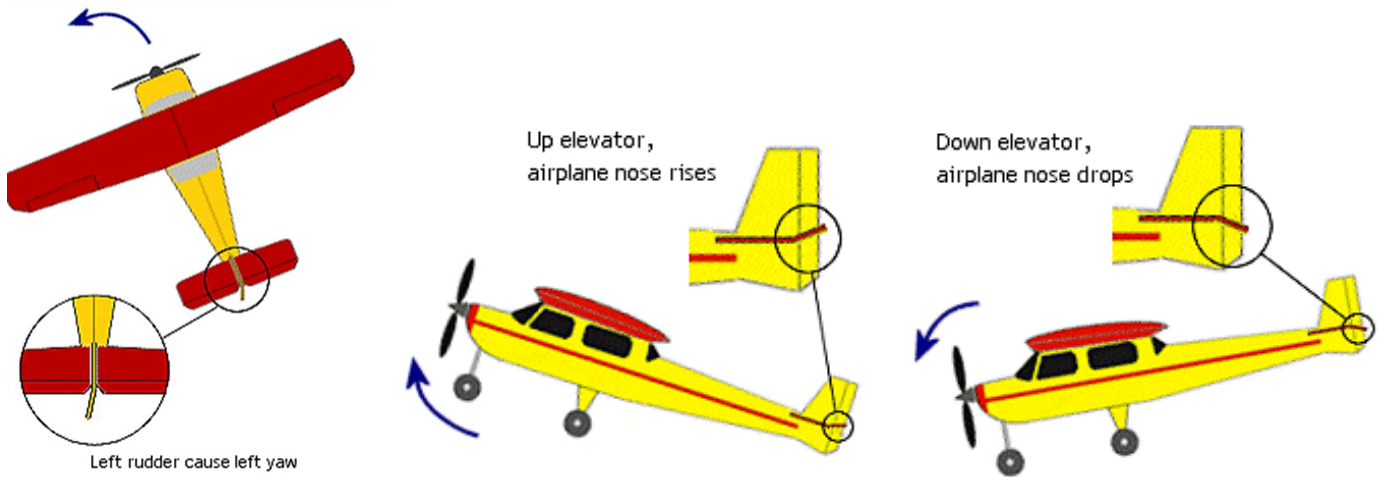
Figure 20: Illustrations of Flight Controls Positions

If the airplane was in a nose-low pitch the elevator would be down; if the airplane was making a left turn, the rudder would be deflected left. Depending on which was initiated first, the rudder would either not be able to fully deflect left or the rudder would not be able to deflect up.
