**NATIONAL TRANSPORTATION SAFETY BOARD**

Accident Site Notes  
WPR19FA212

Location: Camarillo, CA  
Date: 8/7/2019  
Aircraft: Experimental Express 2000, Registration Number: N43FD  
NTSB IIC: Jack Vanover

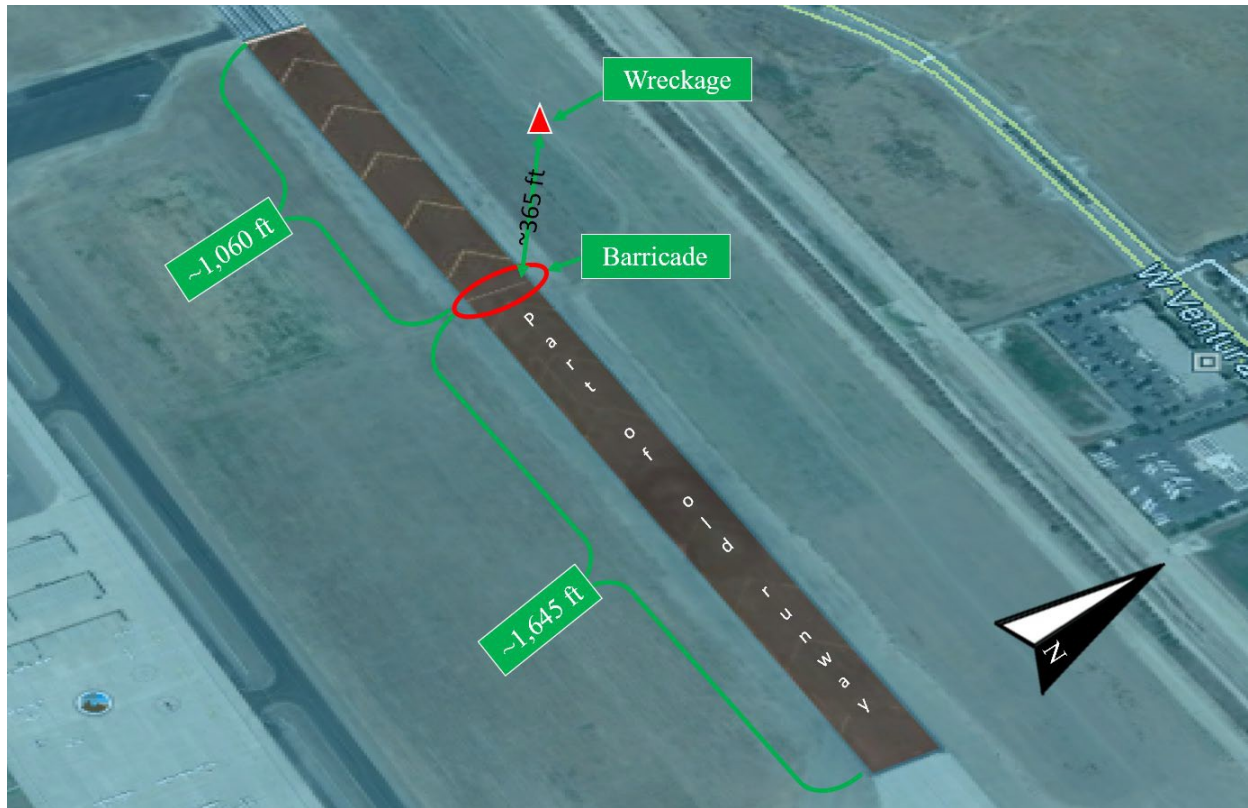
Figure 2: View of Wreckage relative to runway 26.

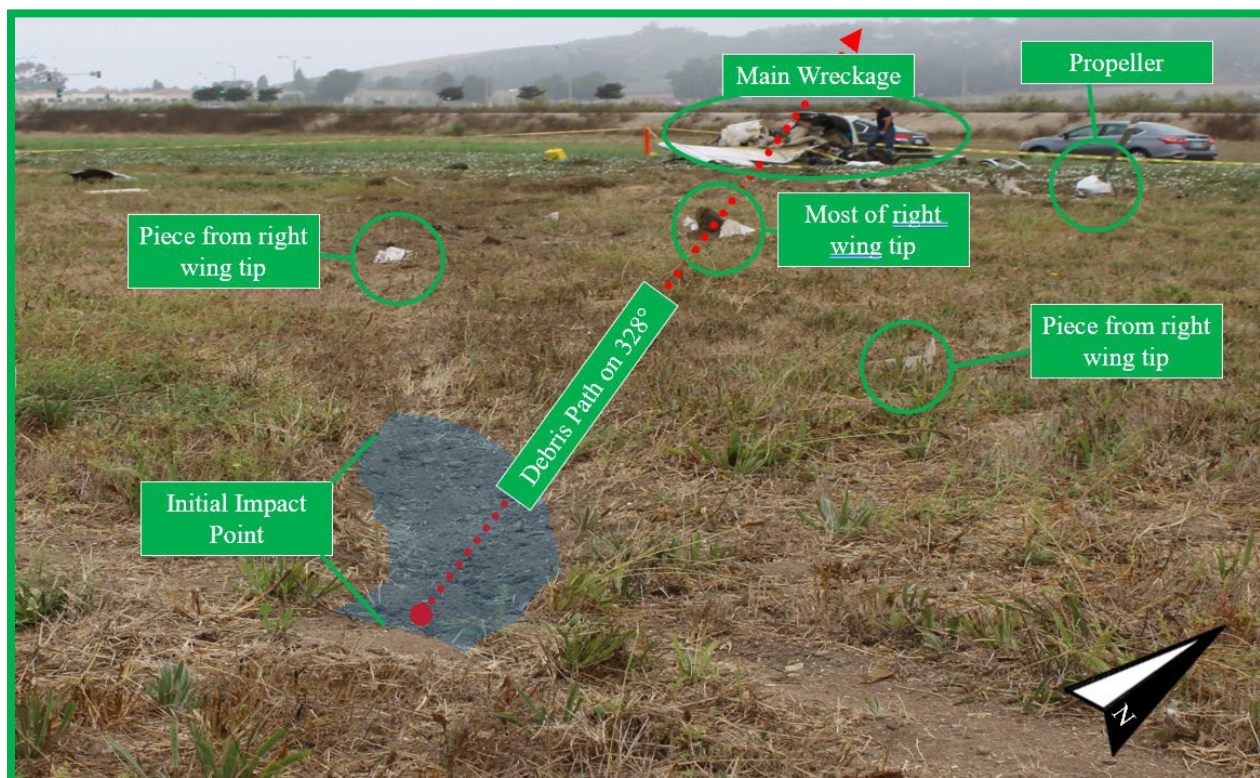
The wreckage debris field was from the initial impact point to the main wreckage was approximately 130 ft in an overall southeast to northwest orientation. The first identified point of contact with ground was located at GPS N34°12'50.94" and W-119° 4'55.26", which consisted of ground scarring and contained composite fragments from the right-wing tip. The main wreckage was located at GPS N34°12'52.07" and W-119° 4'56.11". The main wreckage consisted of the fuselage, empennage, engine, and both wings.

Figure 3: View of wreckage site.

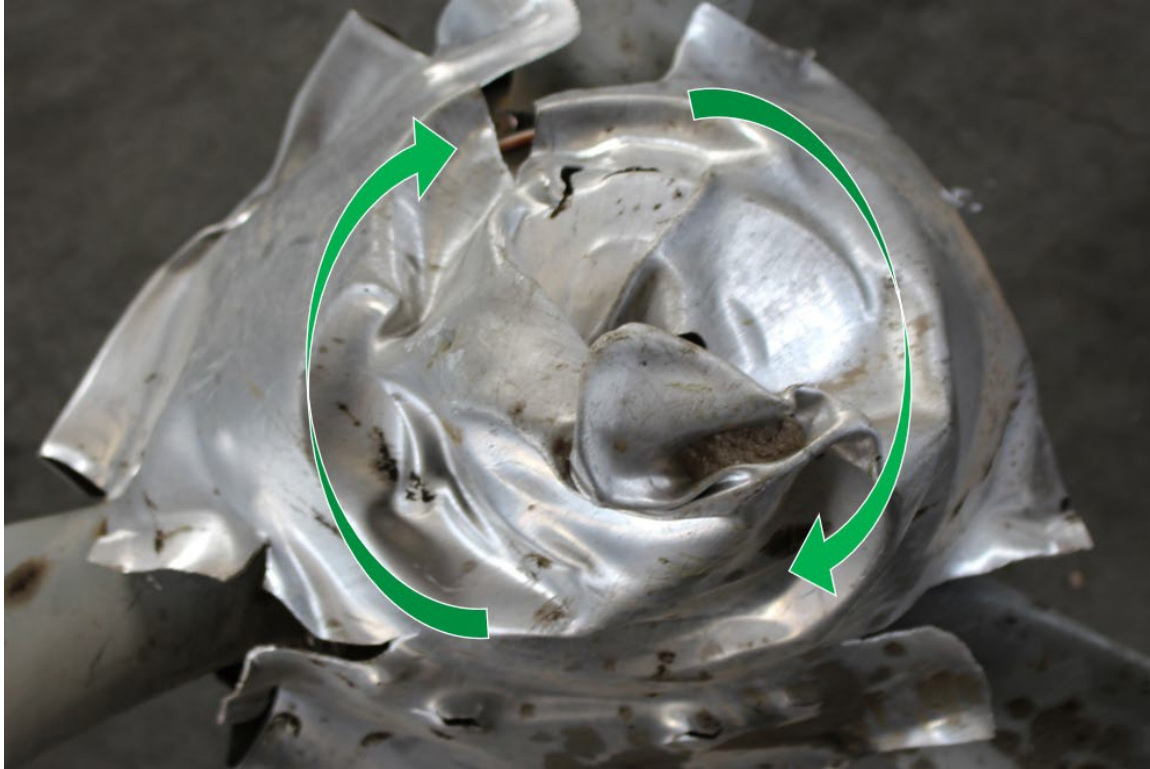
The propeller was located at GPS N34°12'51.66" and W-119° 4'55.51" which was about 75 ft north of the IIP. Photos of the propeller were sent to a Hartzell investigator. He stated the following.

Signs of Power

1. Compound bending and twisting.
2. Remarkable leading-edge gouging

3. Being opposite rotation
4. Chord-wise/rotational abrasions
5. Some “ratcheting” on the crankshaft fracture surface

**Figure 4: View of rotational forces on propeller spinner.**
