## **NATIONAL TRANSPORTATION SAFETY BOARD**

### **ACCIDENT SITE / AIRFRAME / ENGINE EXAMINATION SUMMARY**

**WPR19FA215**

Location: Ontario, Oregon  
Date: August 9, 2019  
Aircraft: North American T28A  
NTSB Investigator-in-Charge: Joshua Cawthra

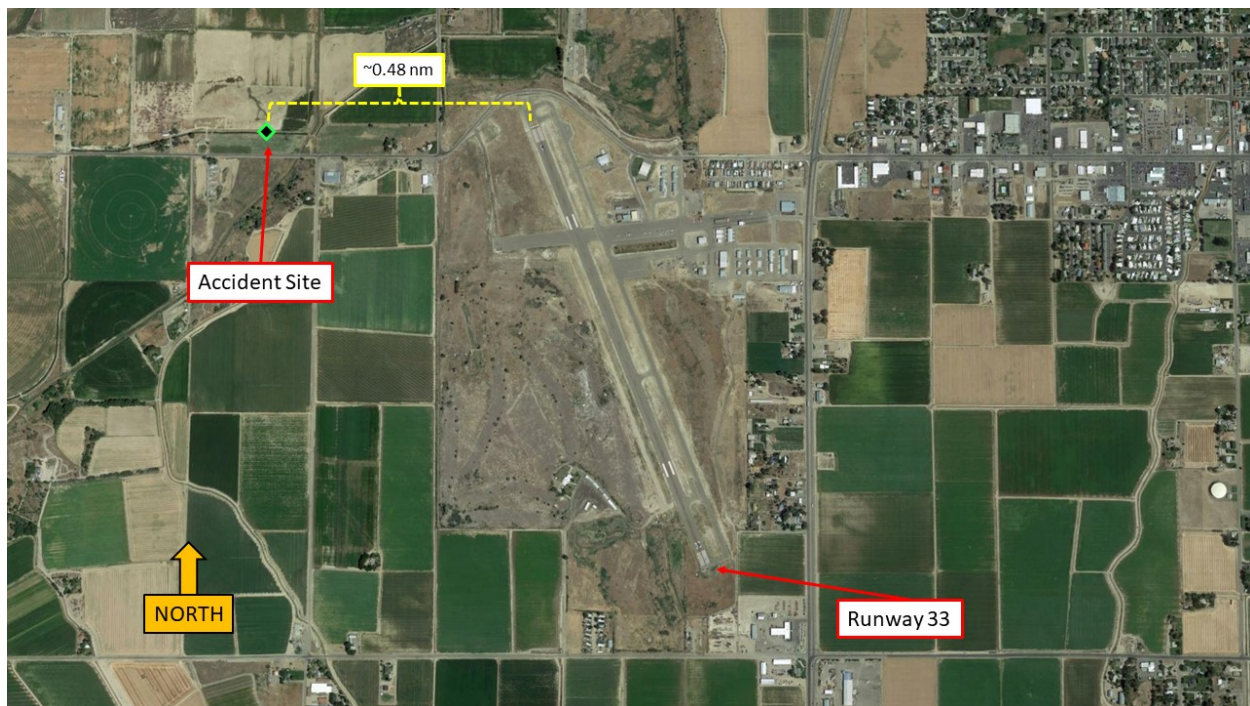
Examination of the accident site revealed that the airplane impacted an open field about 0.8 nm northwest of the airport. The debris path was about 77 ft in length oriented on a magnetic heading of about 266°. The first identified point of impact (FIPC) was a ground impression about 1-ft by 2-ft in size. Throughout the debris path, the left and right main landing gear doors, paint chips, nose landing gear, and right main landing gear were observed. The propeller assembly was located adjacent to the main wreckage. The main wreckage came to rest upright on a heading of about 303°. First responders reported no fuel odor was present following the accident. Additionally, no fuel odor was noted by investigators the following morning, until the right fuel cap was removed.

Figure 1: Accident site and airport location plot.
