## **NATIONAL TRANSPORTATION SAFETY BOARD**

# **CARBURETOR EXAMINATION SUMMARY**

**WPR19FA215**

Location: Ontario, Oregon  
Date: August 9, 2019  
Aircraft: North American T28A  
NTSB Investigator-in-Charge: Joshua Cawthra

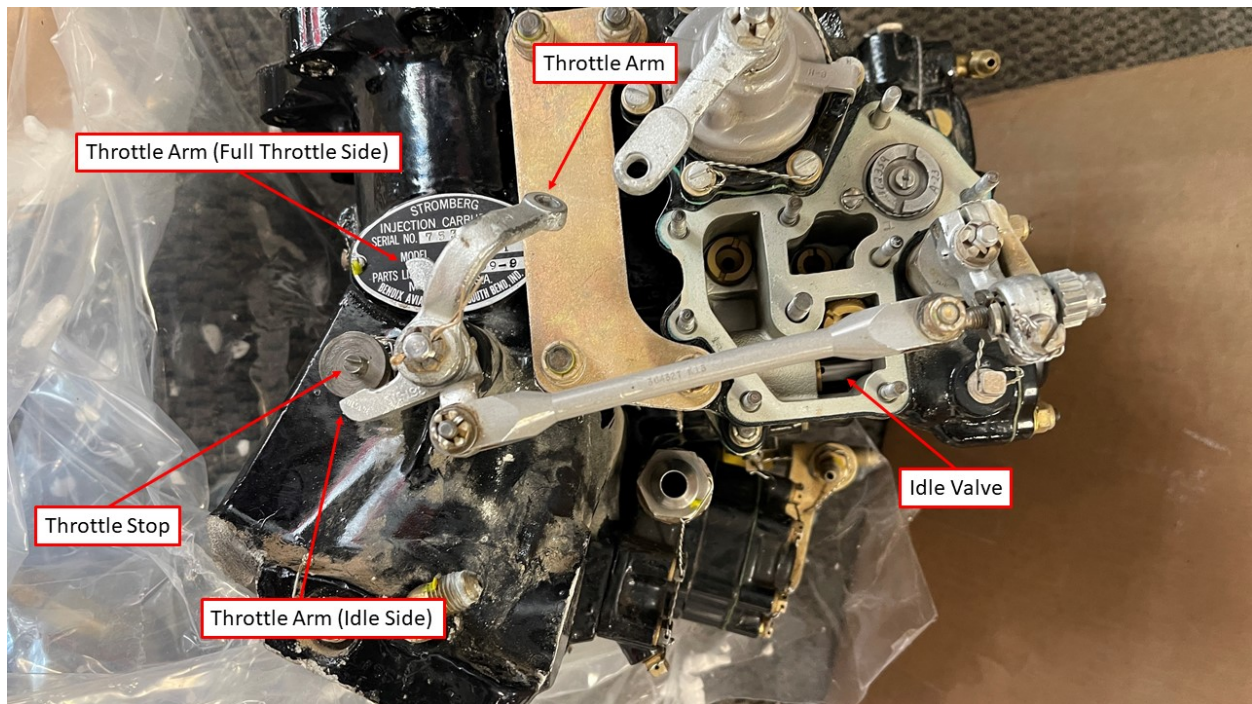
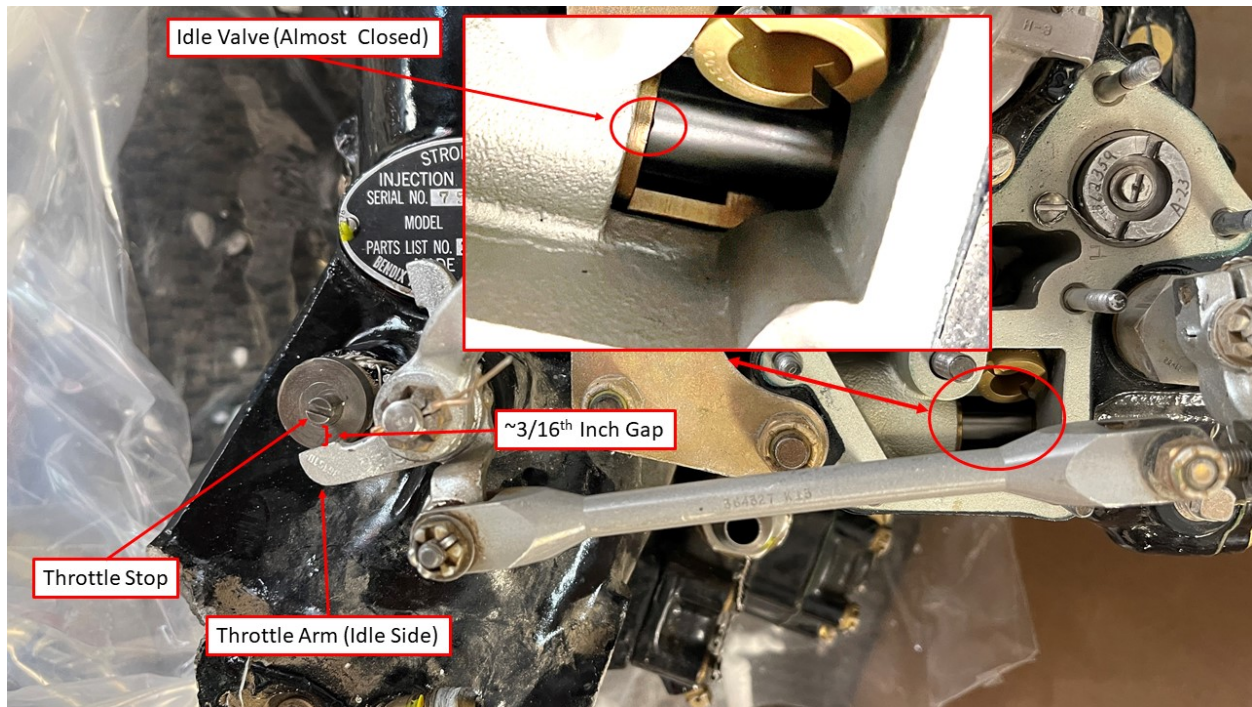
Following the examination of the carburetor at Vintage Carburetors, the carburetor was further examined. When the throttle arm was moved toward the idle position until the idle valve was nearly closed, the idle side of the throttle arm was about 3/16ths of an inch from the throttle stop.

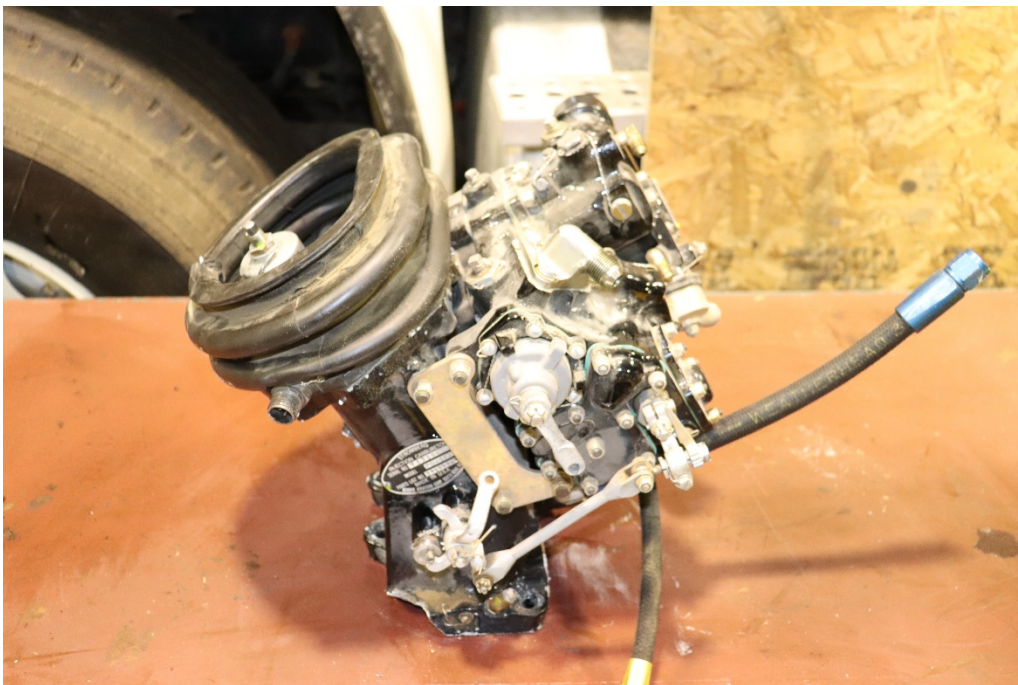
Additionally, prior to shipment to Vintage Carburetors, the cotter pin installed in the castellated nut that secured the throttle arm to the shaft was partially bent and appeared to have been previously removed and reused.
