## **NATIONAL TRANSPORTATION SAFETY BOARD**

### **ENGINE EXAMINATION SUMMARY**

**WPR19LA215**

| Aircraft: | North American T28A, N9862C |

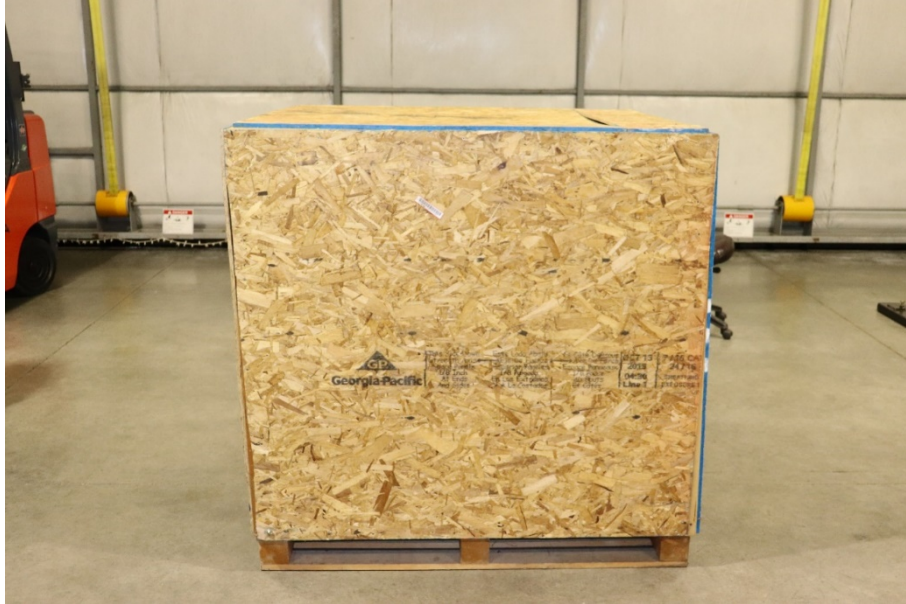
Examination of the recovered engine revealed that it was shipped in a secure wooden crate. All cylinders, with the exception of the number 1 cylinder remained attached to the engine. The engine starter, generator, oil pump, fuel pump, and hydraulic pump remained attached to the accessories case. Both magnetos and the carburetor had been previously removed. The nose case assembly exhibited impact damage, which included separation of the propeller assembly. The rocker box covers on the number 3 and 4 cylinders exhibited impact damage.

Figure 1. View of engine shipment create.

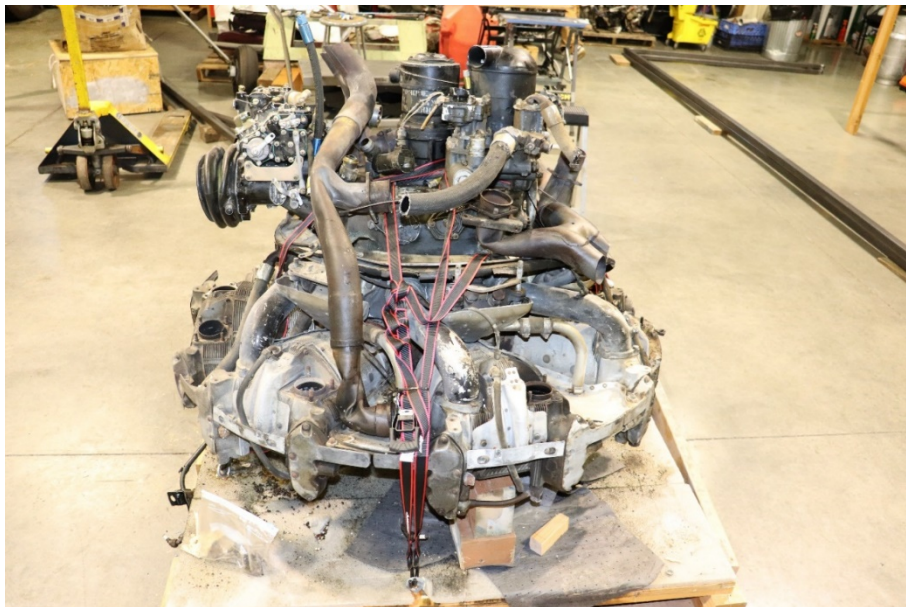
Figure 2. Overview of the engine.

The rocker box covers were removed. All intake and exhaust rocker arms were in place and oil coated. All intake and exhaust push rod tubes were intact. The cylinders were examined internally using a lighted boroscope. All intake and exhaust valves were intact and undamaged. All pistons and internal cylinder areas exhibited normal operational signatures and no evidence of any mechanical failure.

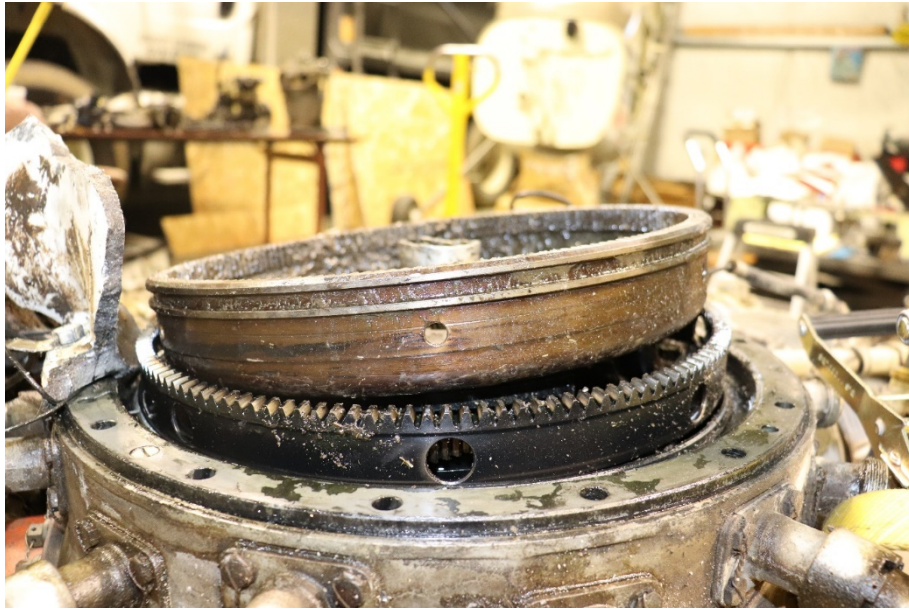
Damage sustained to the nose case and reduction bowl gear precluded the ability to obtain movement of the internal engine components and valve train, despite an attempt to rotate the internal components via the master rod assembly. The internal areas of the engine were examined internally using a lighted boroscope, and mechanical continuity was established throughout the engine and valve train.

Figure 3. View of nose case gear assumably damage.

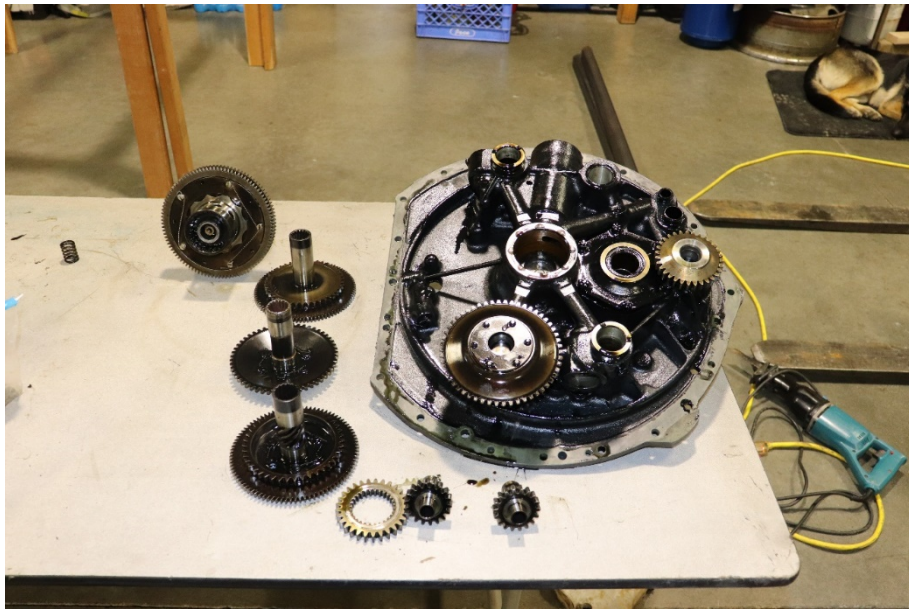
The engine starter, generator, oil pump, fuel pump, and hydraulic pump were removed from the accessories case. The accessories case cover was removed, and all internal components, which included all of the accessory gears, were intact and oil coated. The main scavenge pump oil screen was removed and contained a slight amount of metallic debris.

Figure 4. View of accessories case internal components.

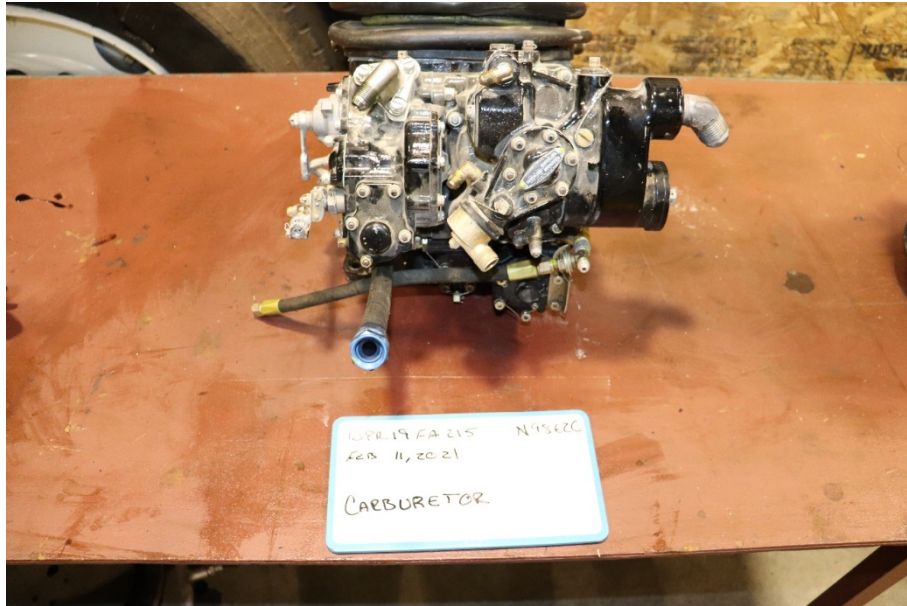
Figure 5. View of carburetor.
