## **NATIONAL TRANSPORTATION SAFETY BOARD**

# **ACCIDENT SITE AND WRECKAGE EXAMINATION SUMMARY**

**WPR19FA216**

Location: Kooskia, Idaho  
Date: August 11, 2019  
Aircraft: N350CL; Lancair IV  
NTSB Investigator-in-Charge: Andrew Swick

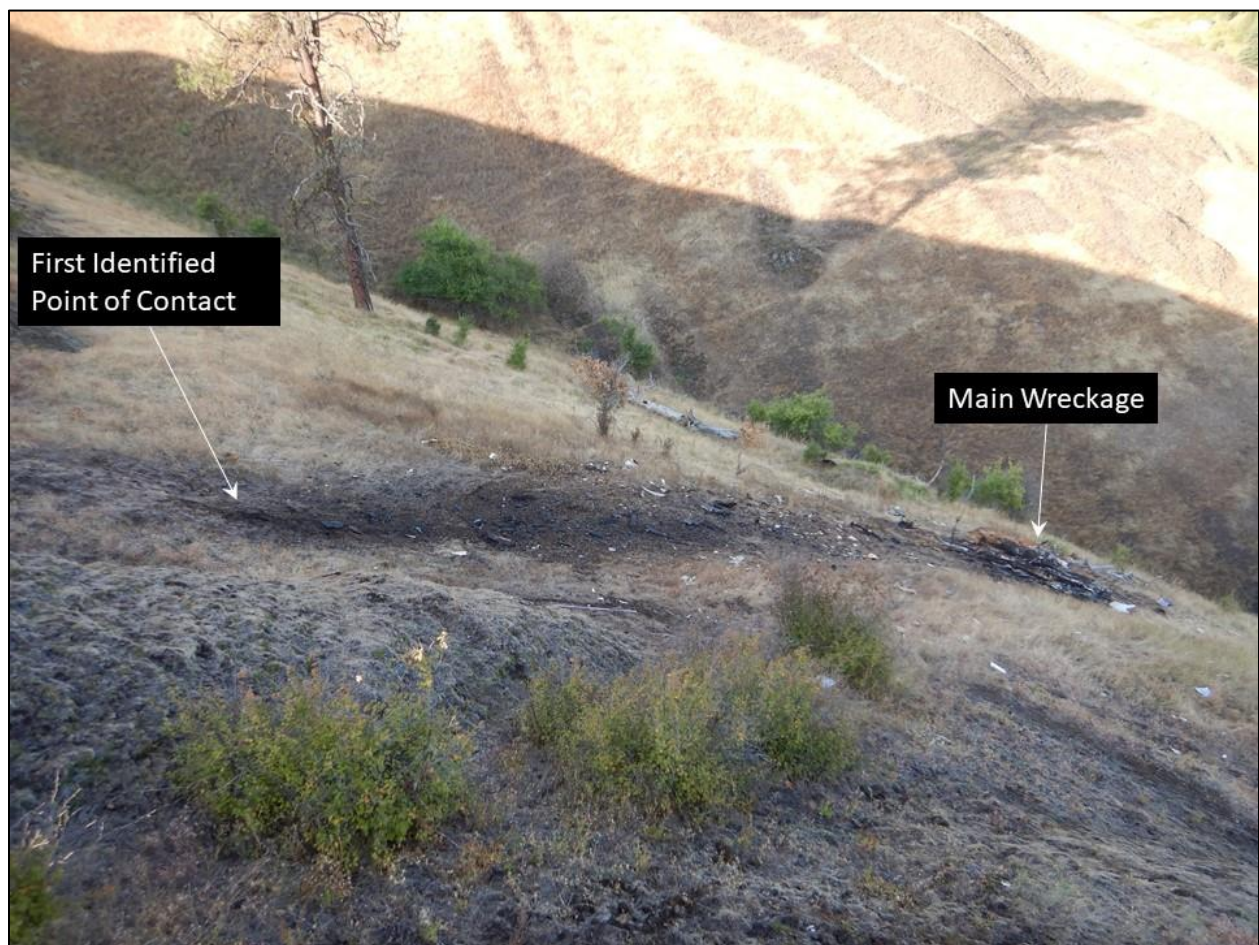
Figure 3-Accident site, view to the east.

The accident site was located on an eastern facing slope, about 1/2-mile uphill from the Clearwater River, and 3 miles east from the town of Kooskia, Idaho. The 40° sloping terrain was grass covered with outcroppings of exposed loose rock near the ridgelines. Fallen timber are scattered on the sloping terrain.

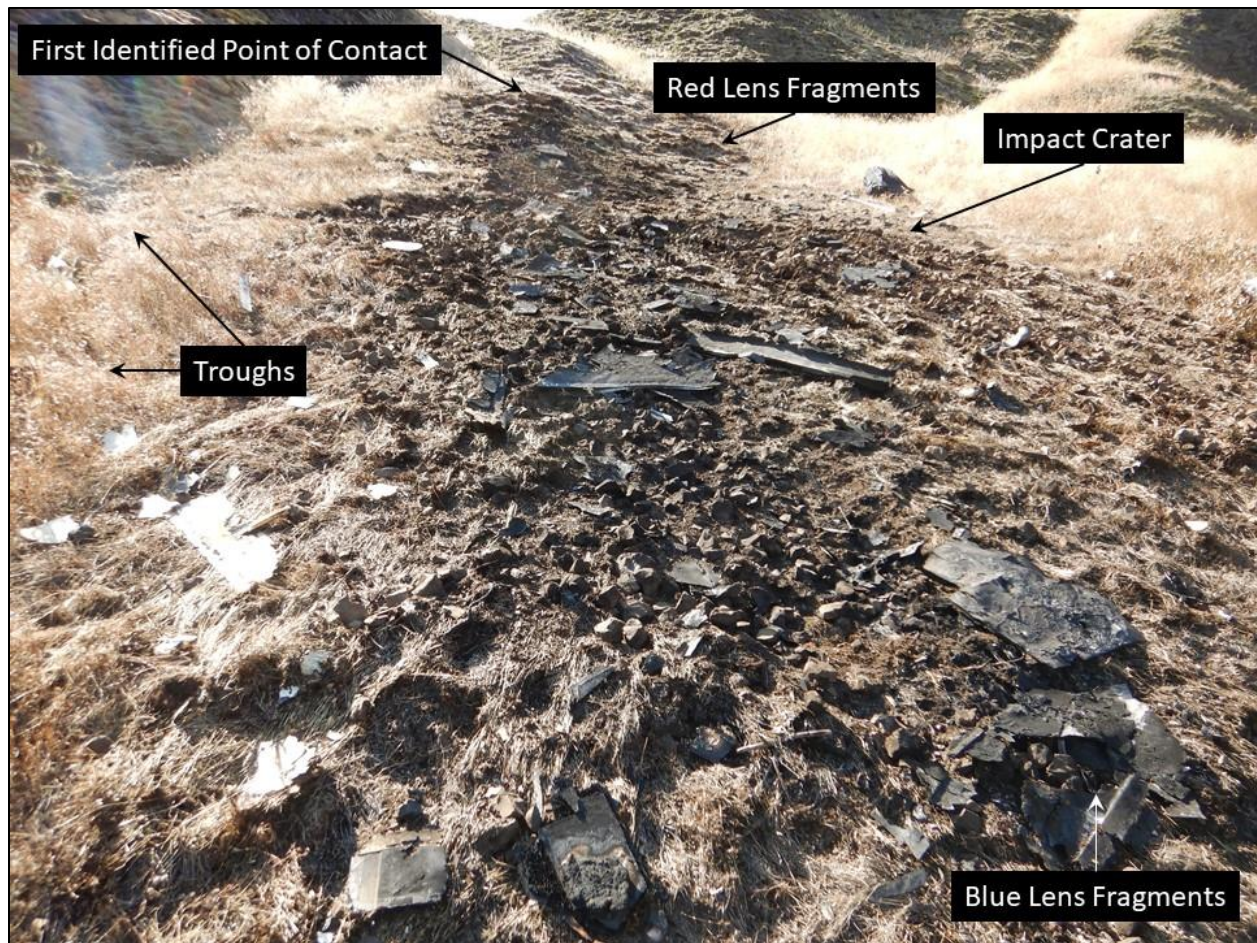
**Figure 4-Debris field, view uphill.**

The debris field was about 180 ft long and about 100 ft wide, with a directional heading of about 94° magnetic. An area of burned grass, about 1,500 square ft, is where a majority of the wreckage was found.

The first identified point of contact (FIPC) was an area of disturbed ground about 2 ft wide that continued downhill about 16 ft to an impact crater. Shattered red lens fragments were scattered to the left side of the debris field near the top end of the FIPC. The impact crater was about 4 ft diameter, about 5 inches deep, and was located on the left side of the debris field. Adjacent to the impact crater was an area of disturbed ground about 6 ft across. Two shallow troughs were located on the right side of the debris field and were found parallel to the FIPC. Further down the debris field was a large area of disturbed ground; about 20 ft long and 10 ft wide. At the end of this disturbed ground were fragments of blue colored lens and the right wing tip fairing. The FIPC and the areas of disturbed ground were covered in burned flat fiberglass sections.

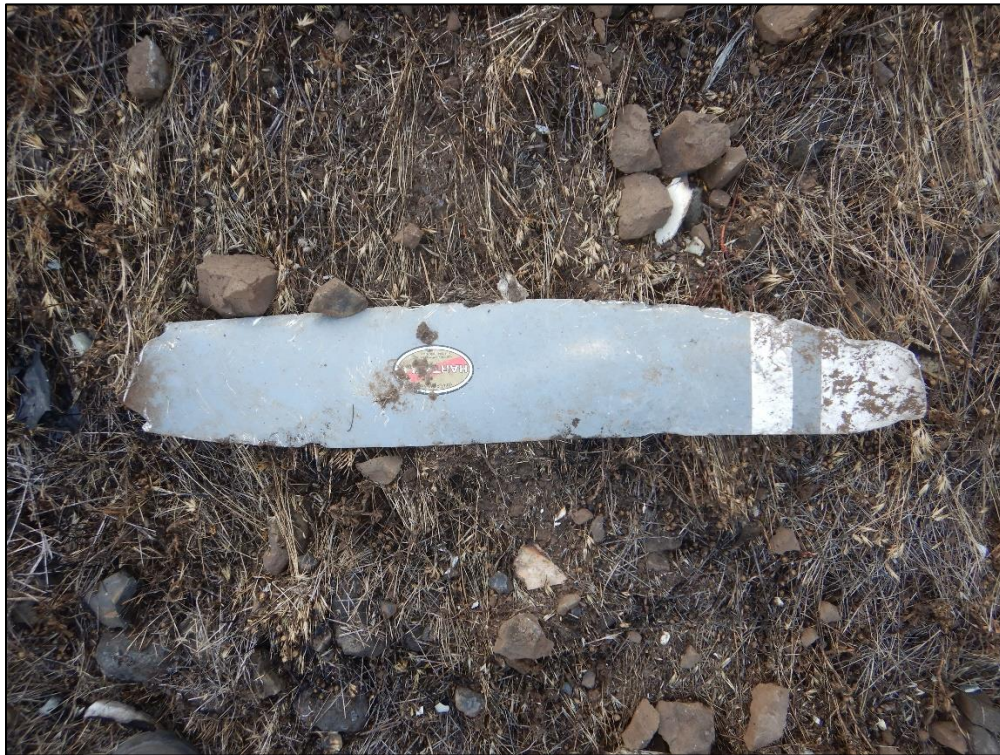
One propeller blade separated at its shank and was found near the impact crater. The blades revealed twisting and deep leading-edge gouging.

**Figure 5-Propeller blade found near the impact crater.**

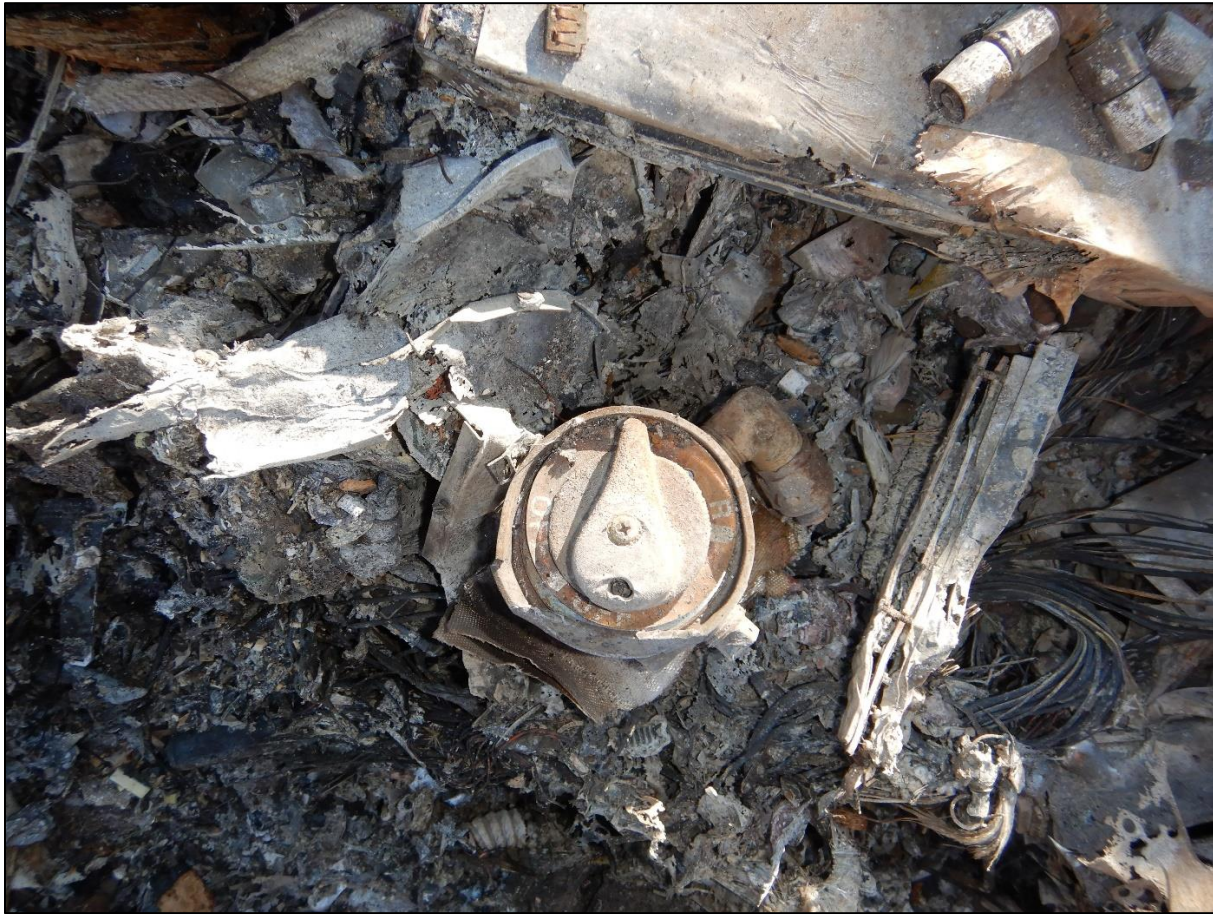
**Figure 7-Fuel selector valve and handle.**

The fuel selector valve handle was found in the left tank position and its associated lines had impact and thermal damage.

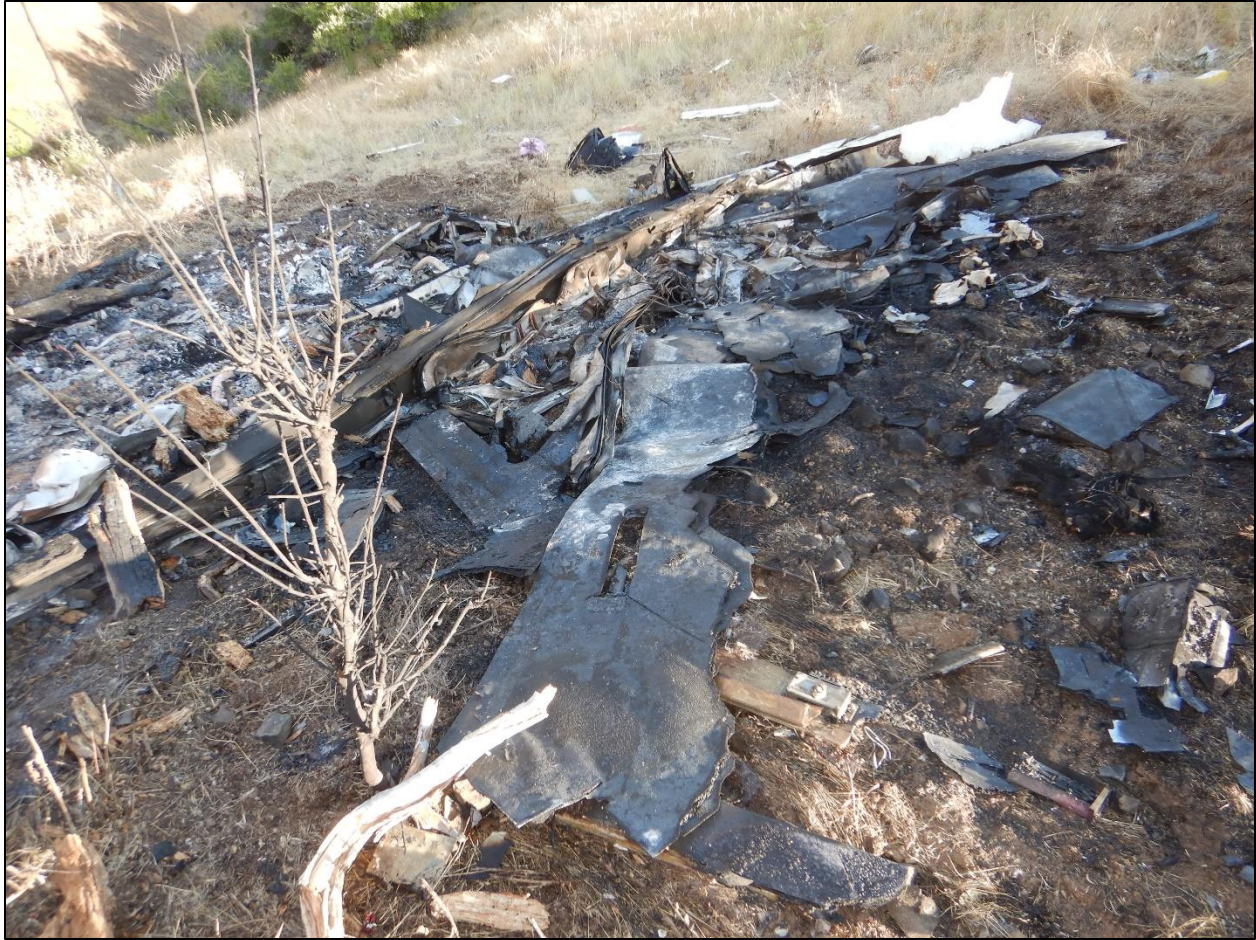
**Figure 8-Debris Field, Wing Spar and Wing Sections**

The debris field continued downhill about 80 ft where the main wreckage was found. Large wing sections and horizontal stabilizers were found stacked on top of each other. The upper wing surfaces, wing spar, landing gear and landing gear structure had thermal and impact damage. The horizontal stabilizer and elevators remained attached and separated from the fuselage near their attachments. The outboard section of the left stabilizer separated and was found in the grass right of the main wreckage. Static wicks were found on the elevator surfaces. On the left side of the debris field, wing leading edge sections were found in the grass. To the right side of the debris field, fuselage sections were found along with a large section of aft cabin structure including the left rear window and baggage door area.

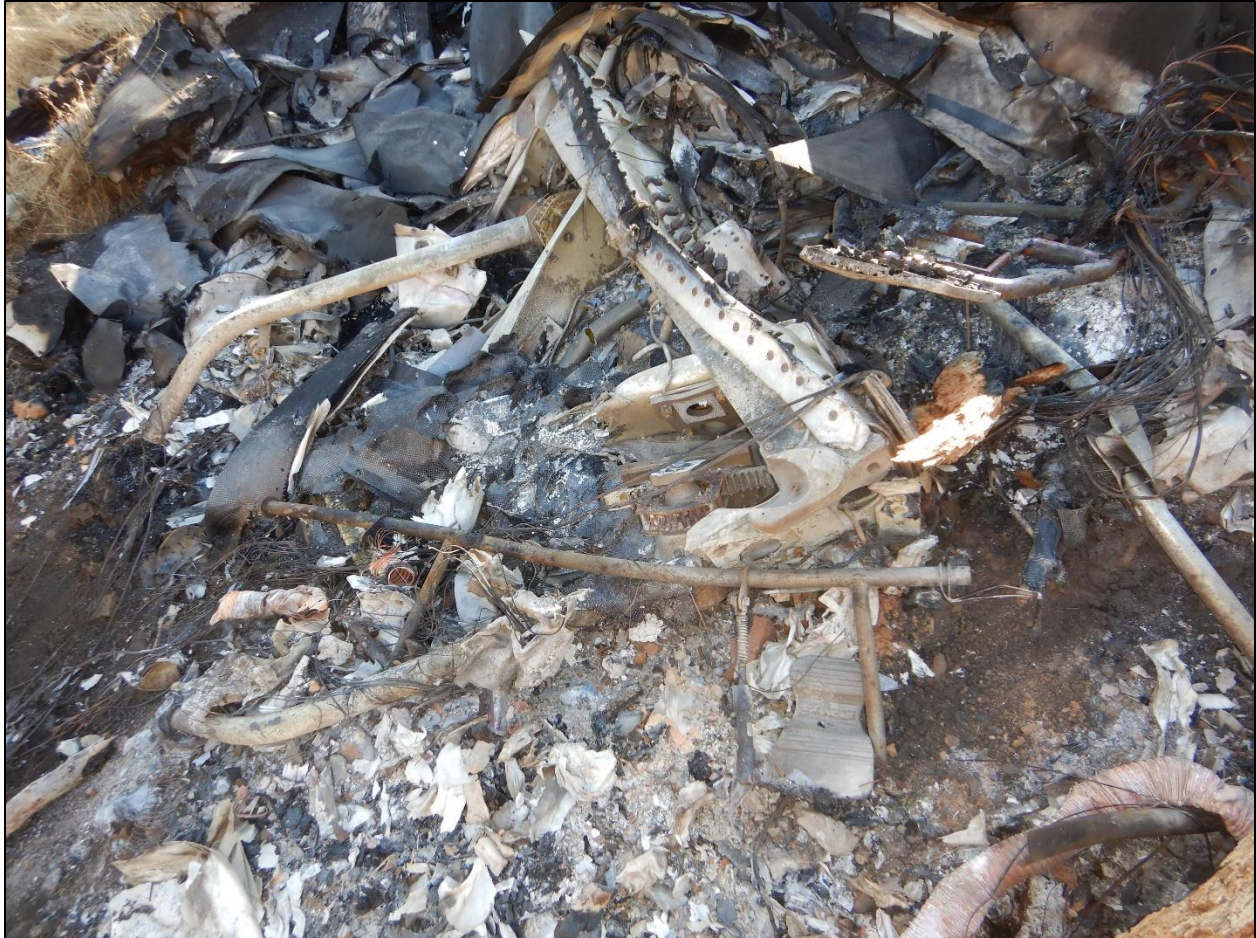
**Figure 9-Main wreckage, landing gear assembly.**

The landing gear appeared to be in the retracted position and remained attached to the gear motor assembly.

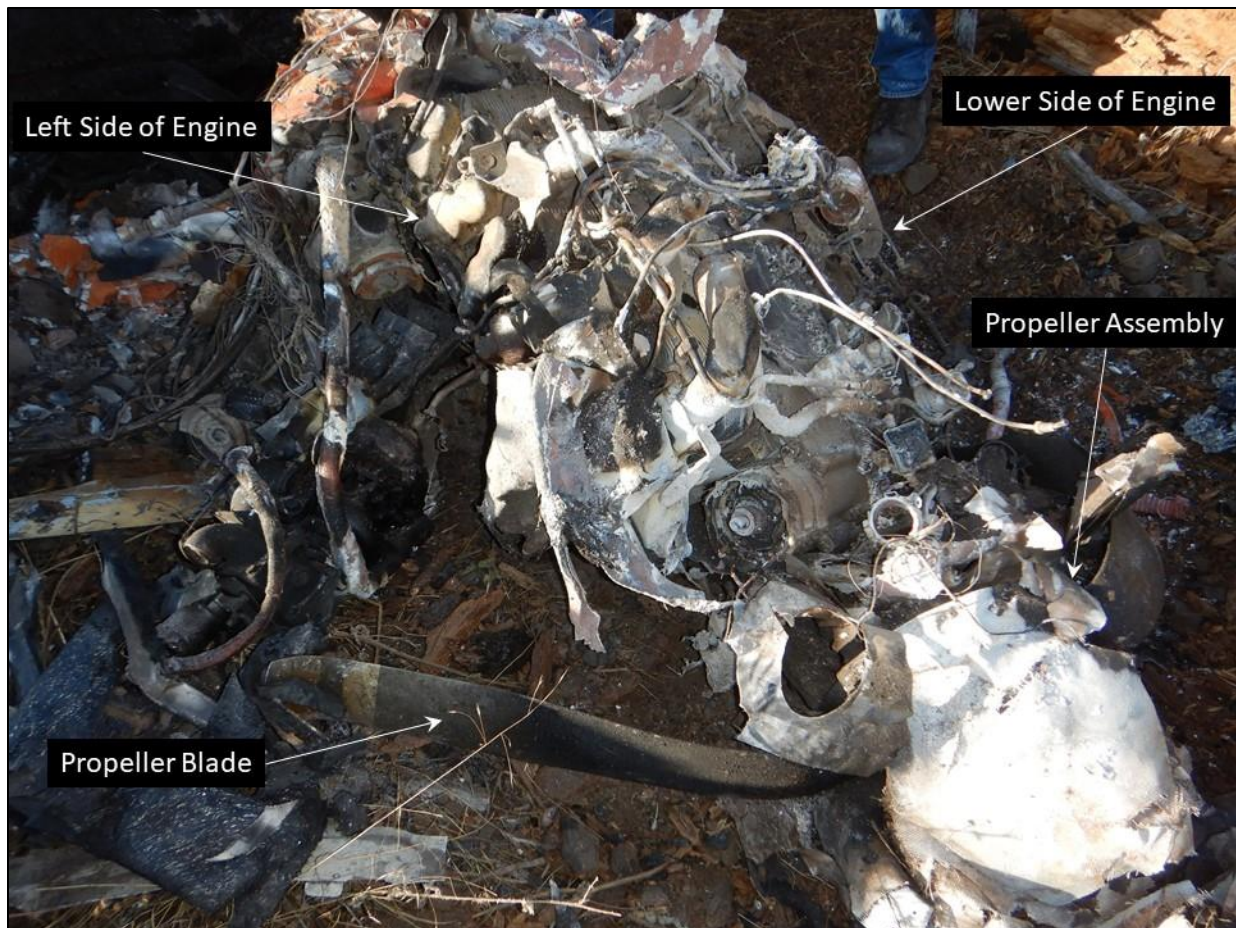
**Figure 10-Debris Field, Engine and Propeller Assembly**

The engine and propeller were found 15 ft further down the debris field and had thermal and impact damage. Two blades remained attached to the hub were twisted and had deep leading-edge gouging. Most of the engine's accessories separated from the engine and had thermal damage. The cylinders and crankcase remained attached and had impact damage. The propeller assembly and crankshaft rotated slightly when the engine was moved.

The induction assembly separated from the engine and parts were found in the debris field. The exhaust stacks were crushed into the lower sides of the cylinders and the turbochargers and associated parts remained partially attached. The oil sump was crushed. The engine support structure had impact damage and was partially attached.

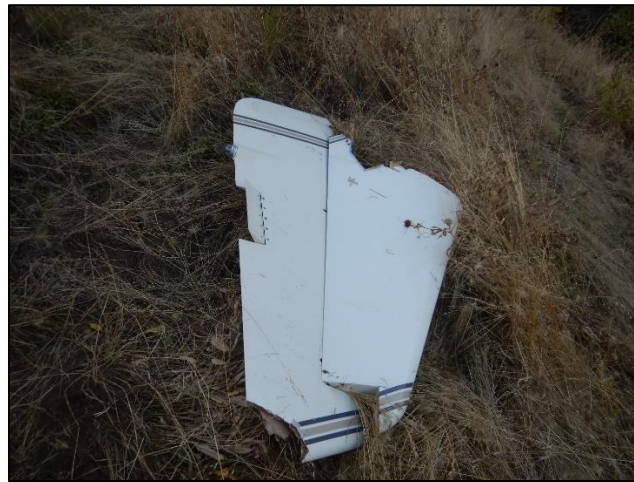
**Figure 12-Vertical Stabilizer and Rudder**

The vertical stabilizer and rudder were found near the ravine about 70 ft downhill from the main wreckage. The rudder counterweight separated from the rudder. Multiple sections of windscreen were found in the ravine.
