## **NATIONAL TRANSPORTATION SAFETY BOARD**

### **ON SCENE OBSERVATIONS**

**WPR19FA219**

Location: Marysville, WA  
Date: August 14, 2019  
Aircraft: Capes Murphy Moose, Registration N525SG, Serial #300  
NTSB IIC: Samantha Link

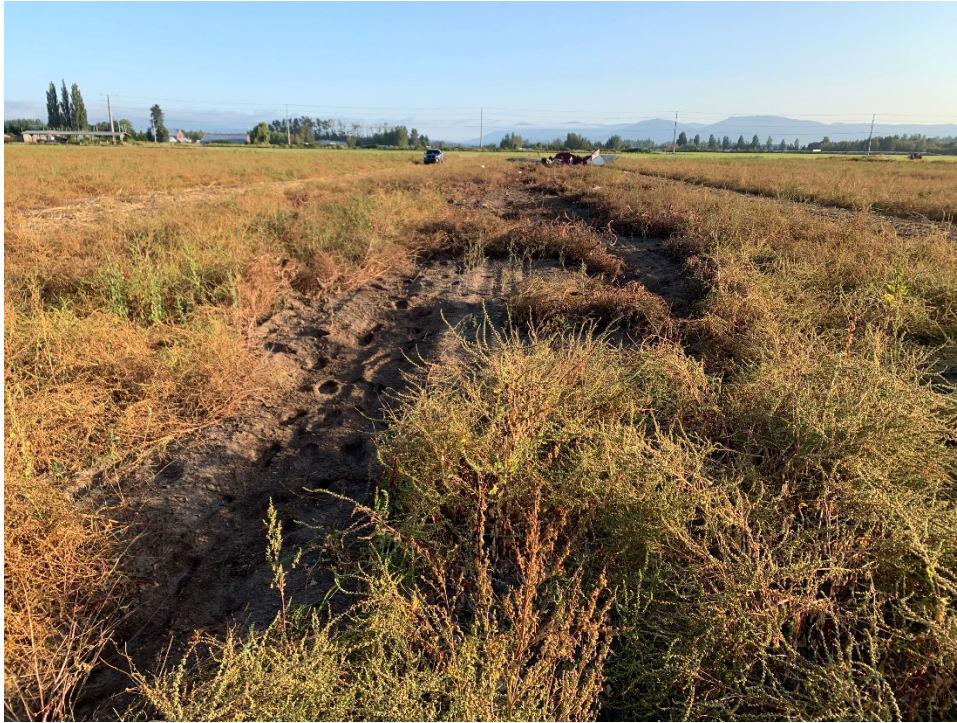
Figure 1: First Identified Point of Impact

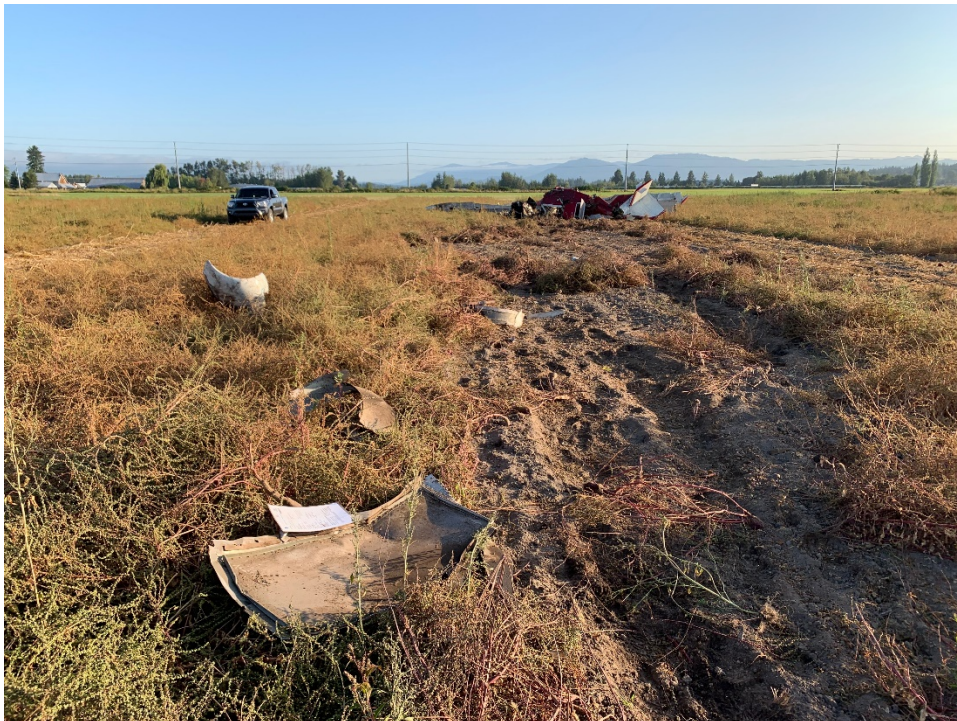
Figure 2: Portions of Engine Cowling

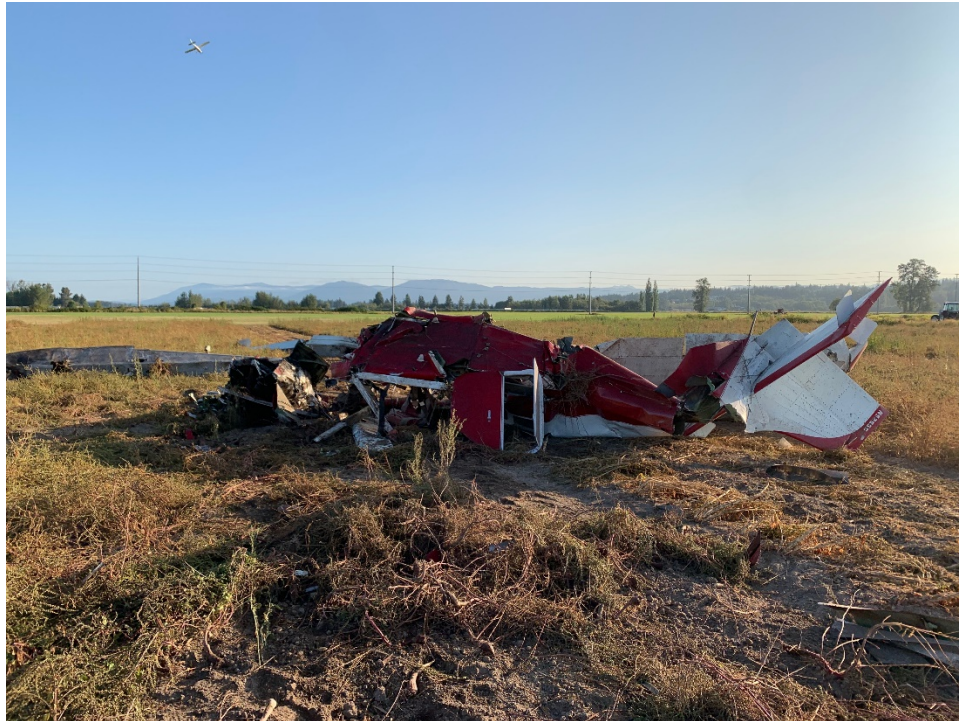
**Figure 3: The Main Wreckage**

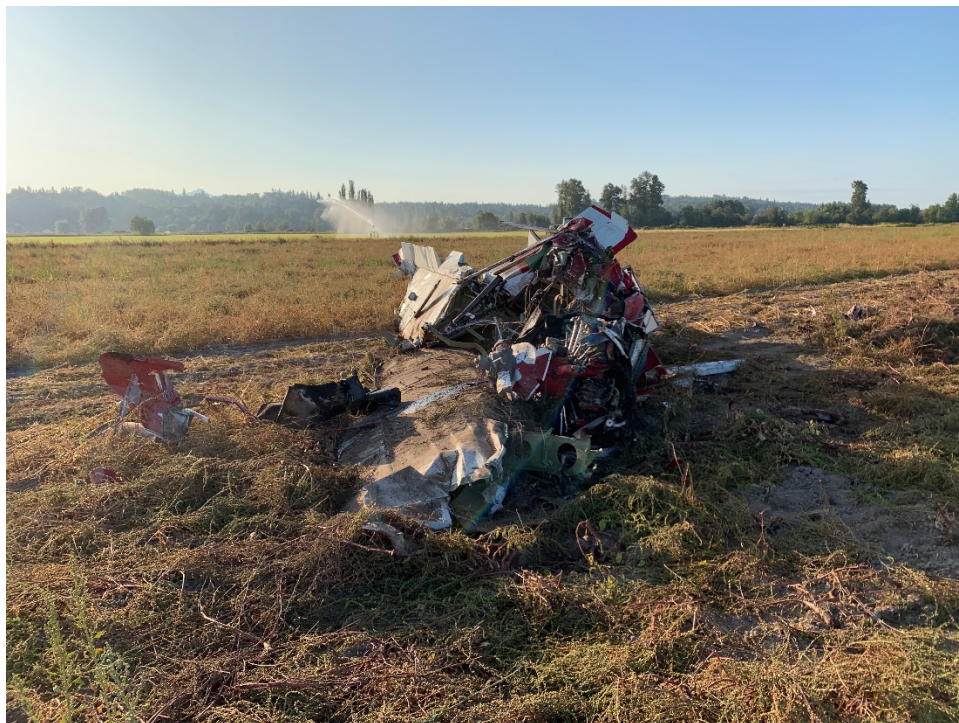
**Figure 4: The Right Side of the Airplane.**

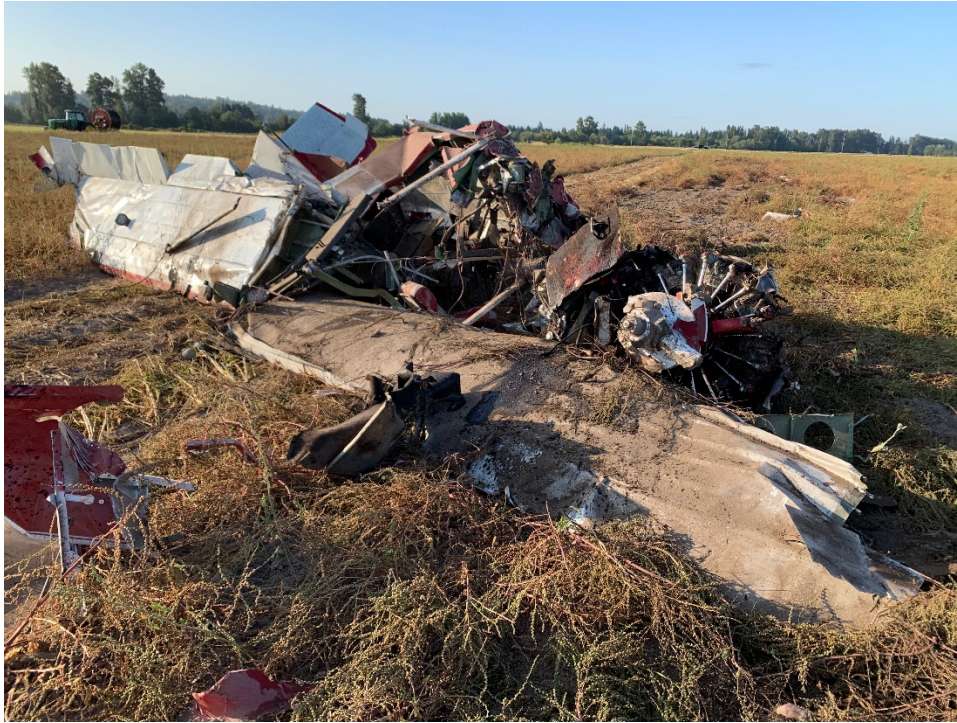
Figure 5: The Right Wing, Left Wing and Engine

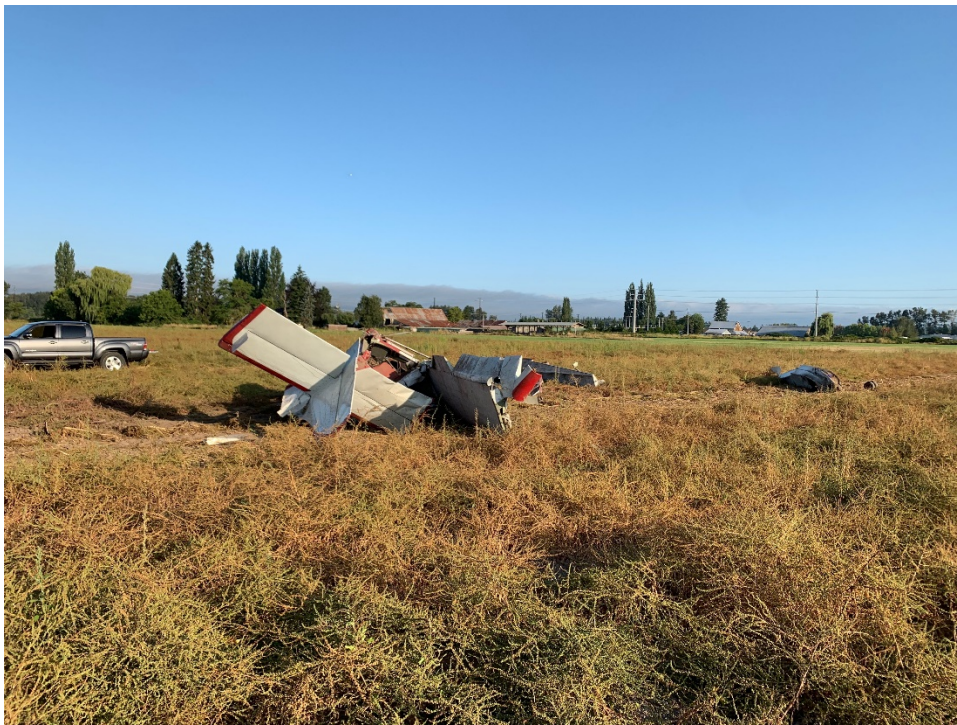
Figure 6: View from the Empennage

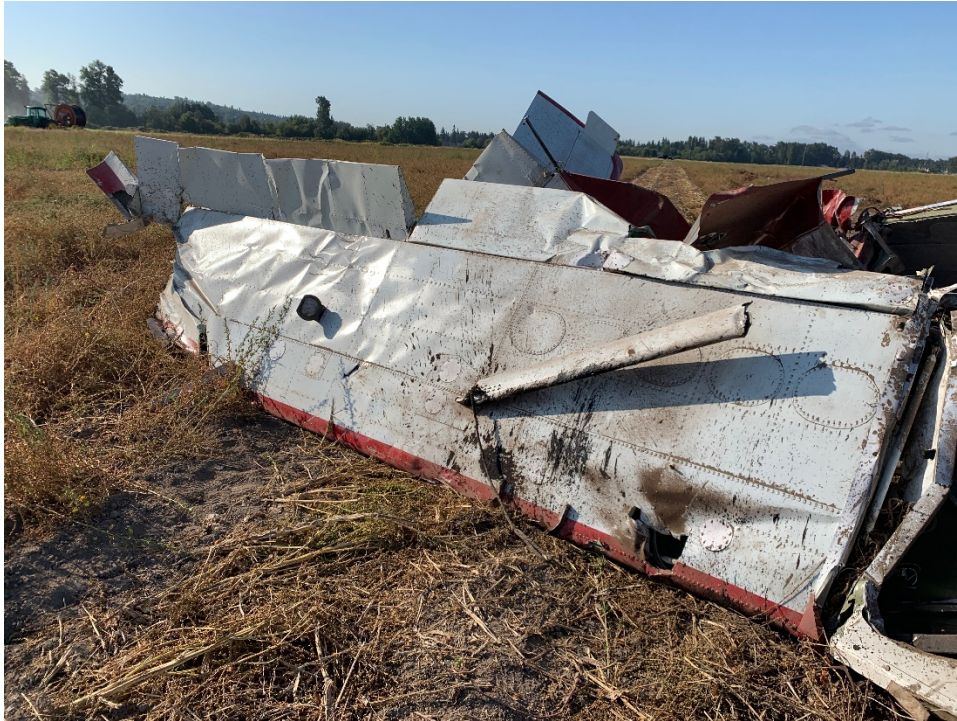
Figure 7: Left Wing

- The airplane was equipped with a 406 mhz ELT and the switch was found in the “OFF” position.
- The left wing exhibited 45-degree crushing along the outboard leading edge of the wing. In addition, the lift strut remained attached to the wing, however, it was separated about mid span.

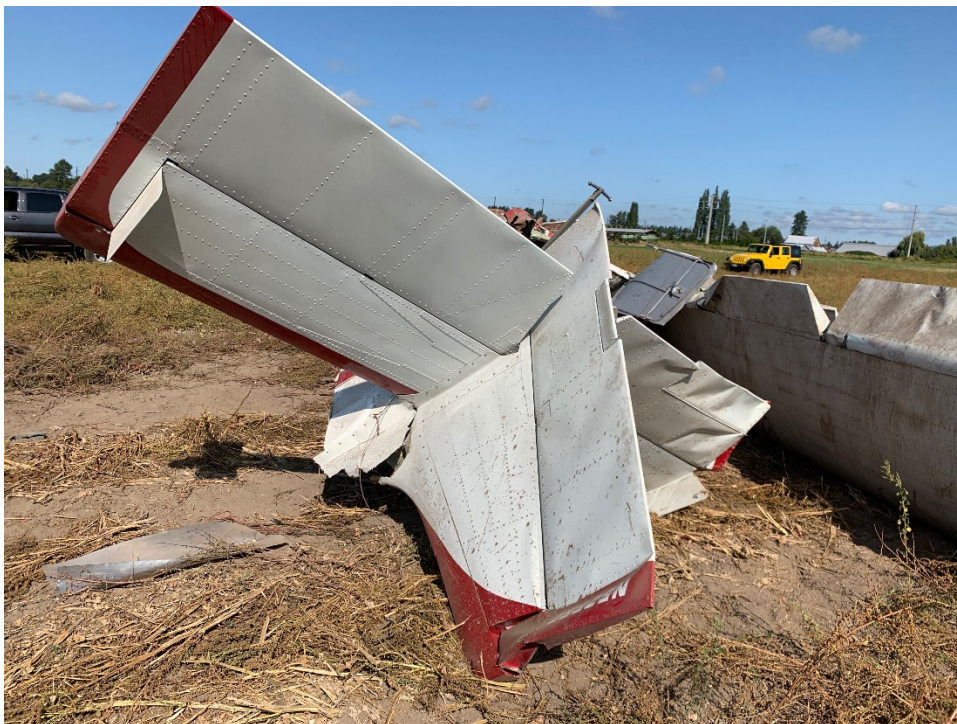
Figure 8: Empennage

- The fuel tank was breached.
- The left stabilizer was buckled throughout.
  - The left elevator remained attached via all mounts and was bent downward about 10 to 12 inches inboard from the tip.

- The trim tab remained attached.
- The right stabilizer was intact, and the elevator remained attached. Both exhibited minimal damage.
- The vertical and rudder remained intact. The upper portion of the rudder was bent.

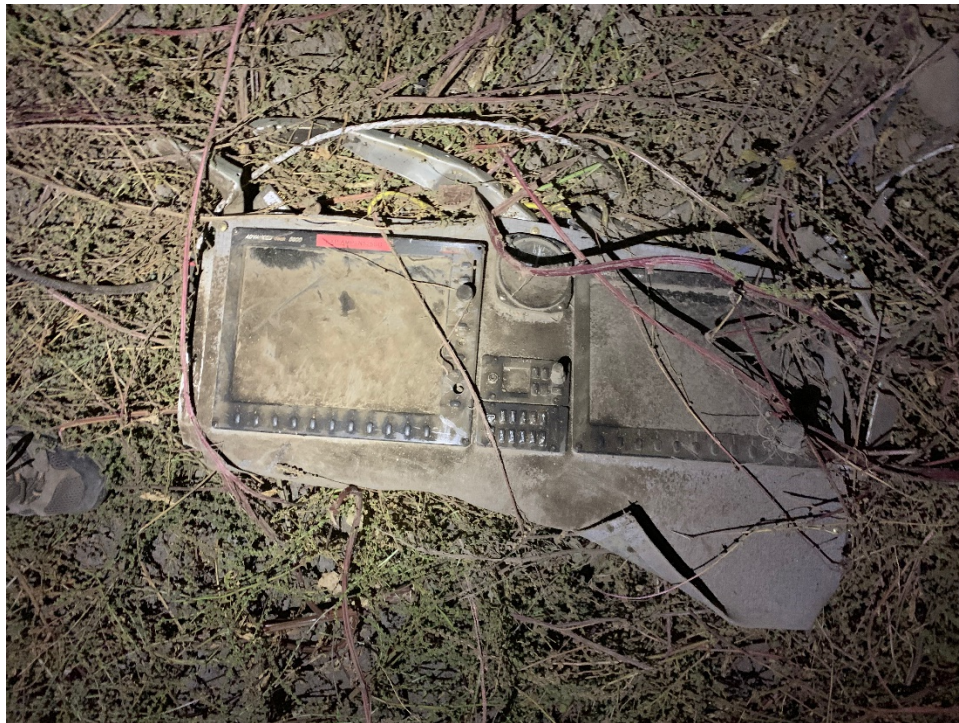
Figure 9: Instrument Panel

- The cabin area was fragmented and torn open.
- The instrument panel was displaced from the airframe and located in the wreckage debris path.
- The left seat 4-point harness was cut by first responders.

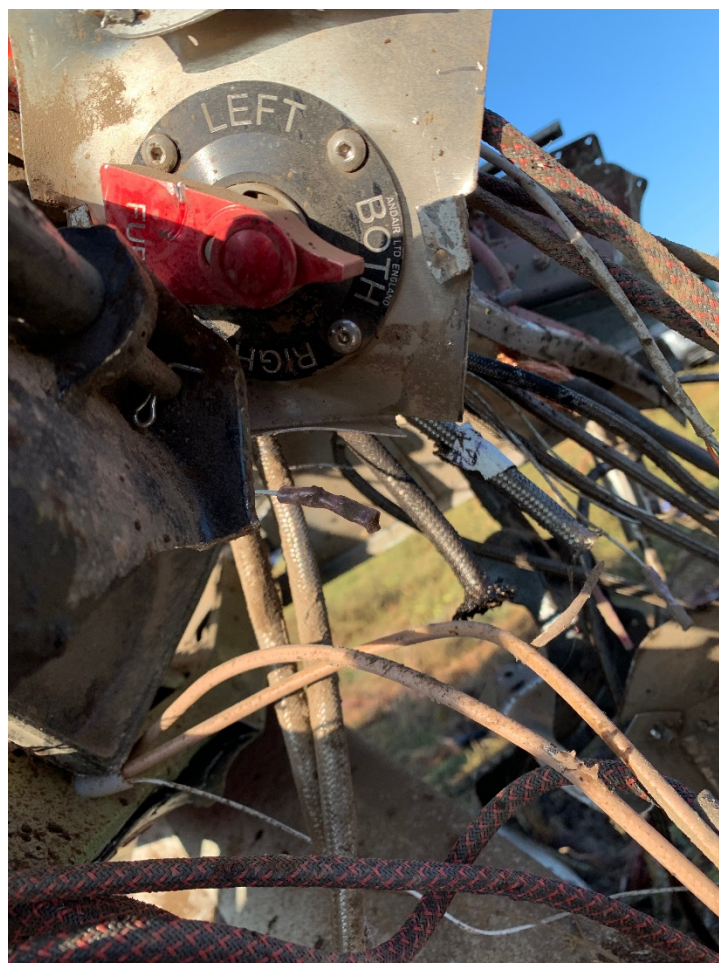
Figure 10: Fuel Selector

- The magneto switch was in the “left” position and the key was bent over 90 degrees/impact damaged.
- The fuel selector was found in the “both” position.

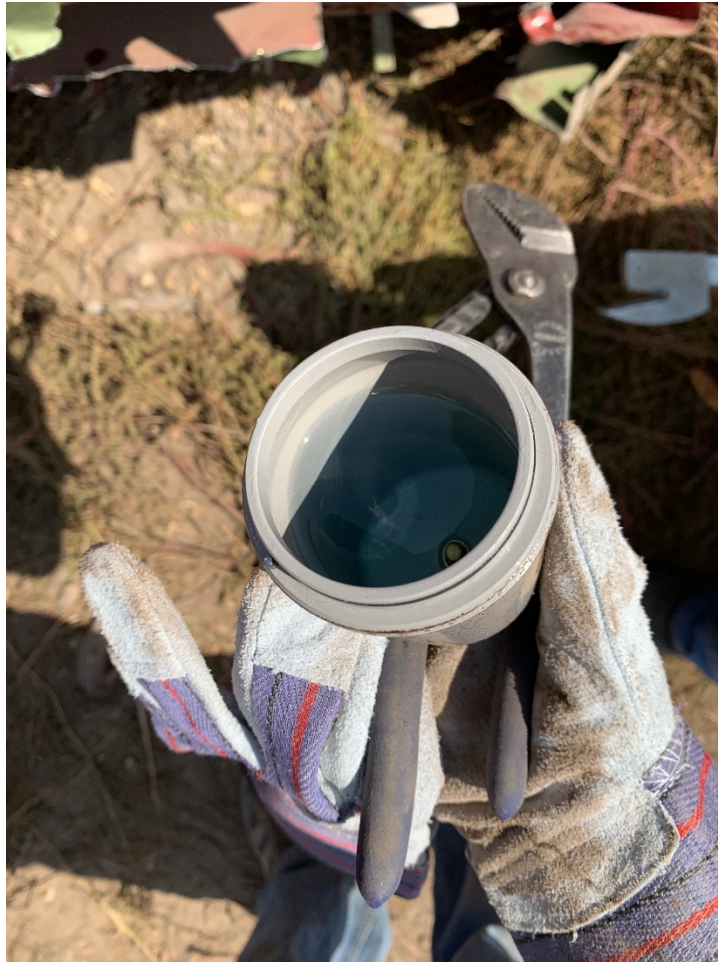
Figure 11: Fuel Strainer Bowl

- The fuel strainer bowl contained blue liquid consistent with 100 low lead fuel, and the screen was free of debris.
- A secondary fuel filter was removed and found to be free of debris.

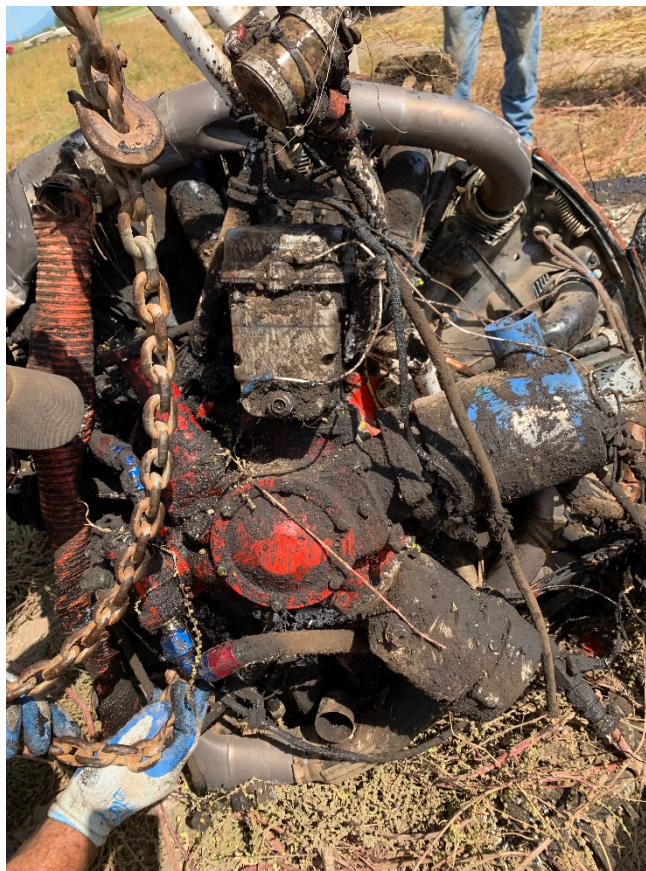
Figure 13: The Accessory Section of the Engine

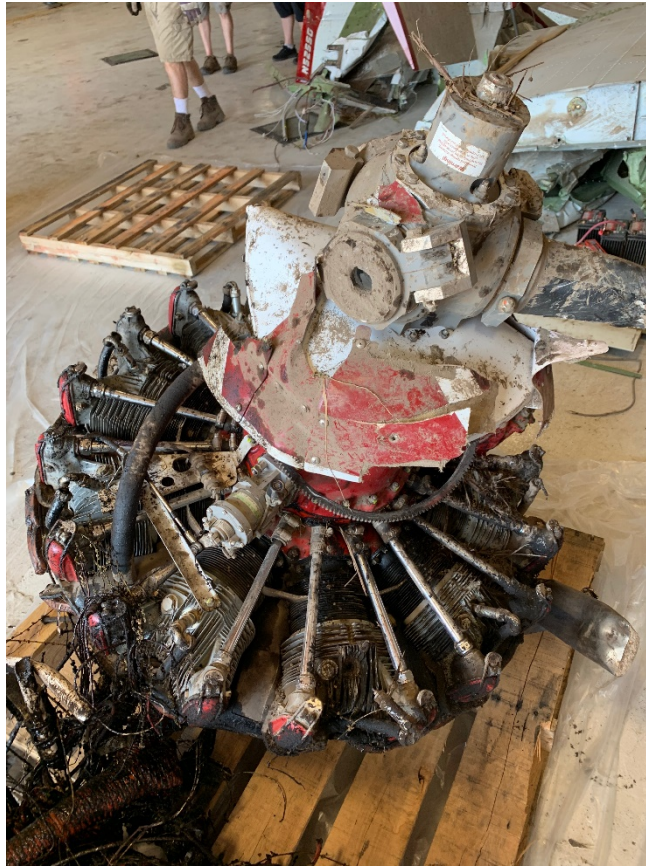
Figure 14: Front of Engine

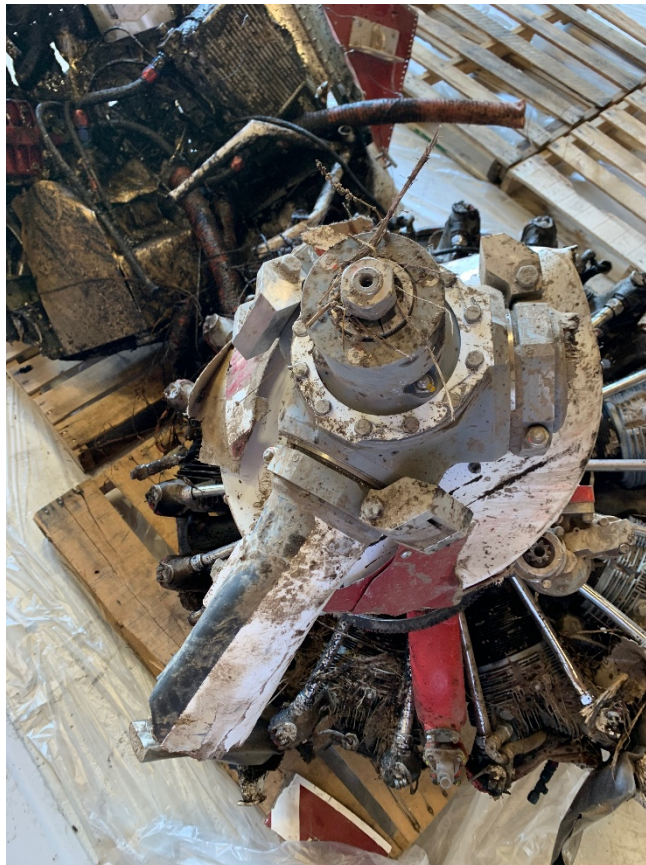
Figure 15: Propeller Hub and Remaining Blades

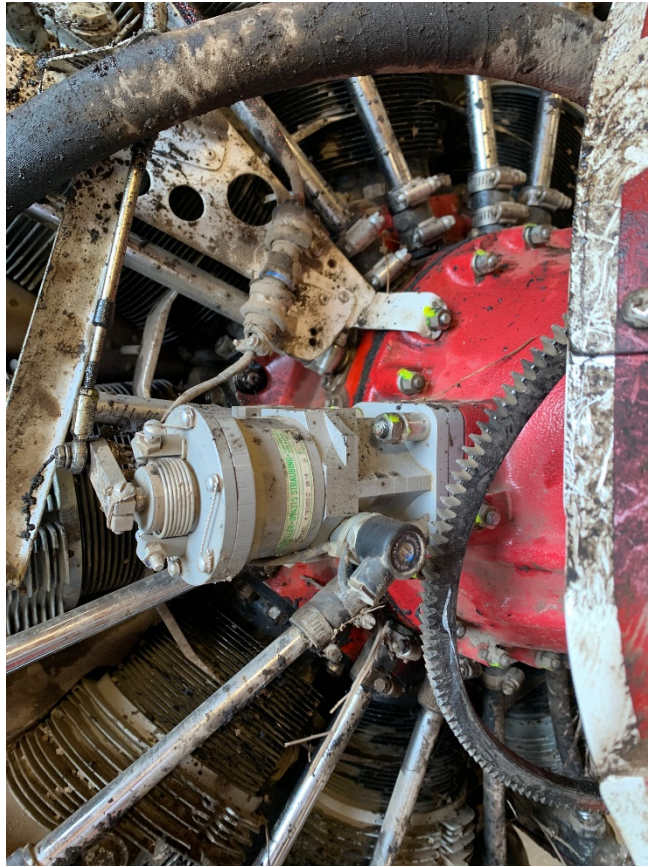
Figure 16: Propeller Governor

- The engine remained attached to its mounts and the firewall.
  - Engine control continuity was established. The throttle was separated from the carburetor consistent with impact damage.
  - The propeller control cable remained attached to the propeller governor.
- All accessories, except the carburetor, remained attached to the engine.
- The propeller hub remained intact, and the three propeller blades were separated/splintered near the blade root.
- The oil lines to the oil cooler exhibited damage consistent with impact
  - Oil was observed throughout the accident site and wreckage.
