## **NATIONAL TRANSPORTATION SAFETY BOARD**

### **Specialist's Report**

# **AIR TRAFFIC CONTROL**

WPR19FA219

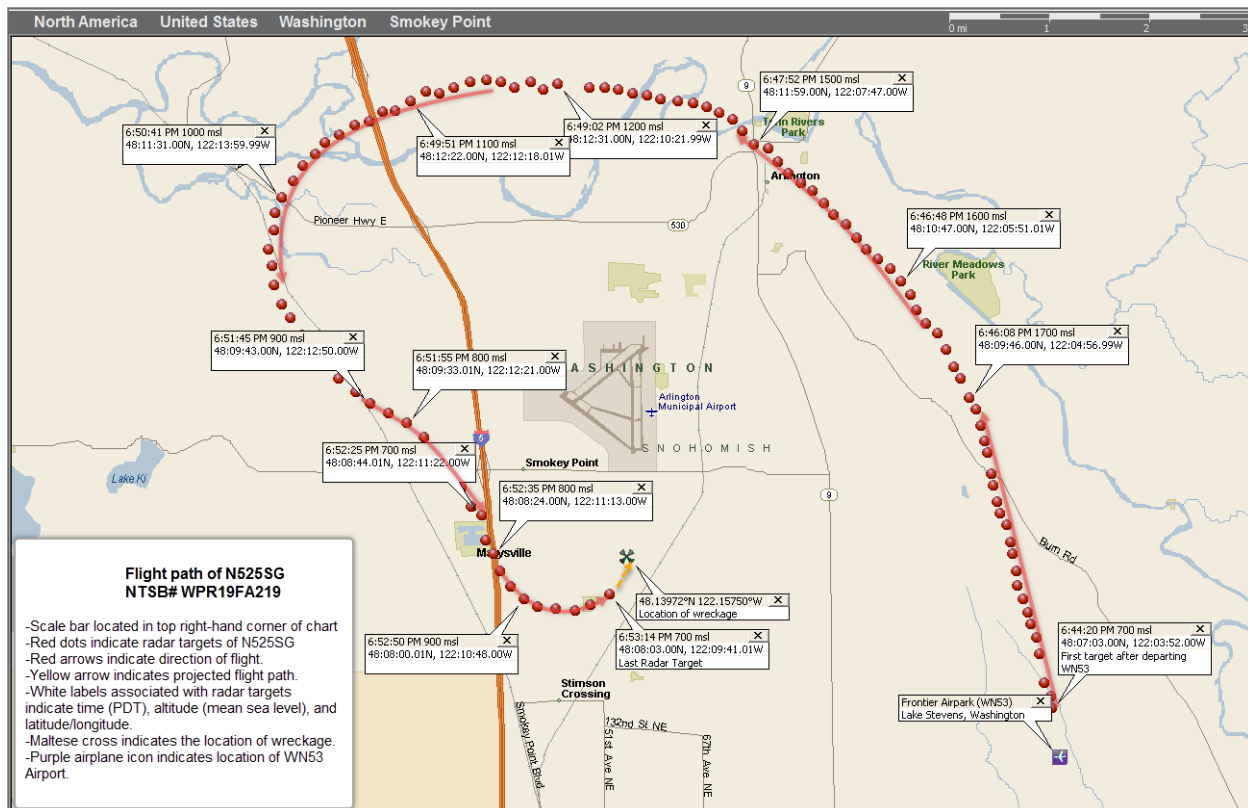
Figure 1. MapPoint screenshot illustrates the flight path of N525SG after departing WN53 until last radar target.

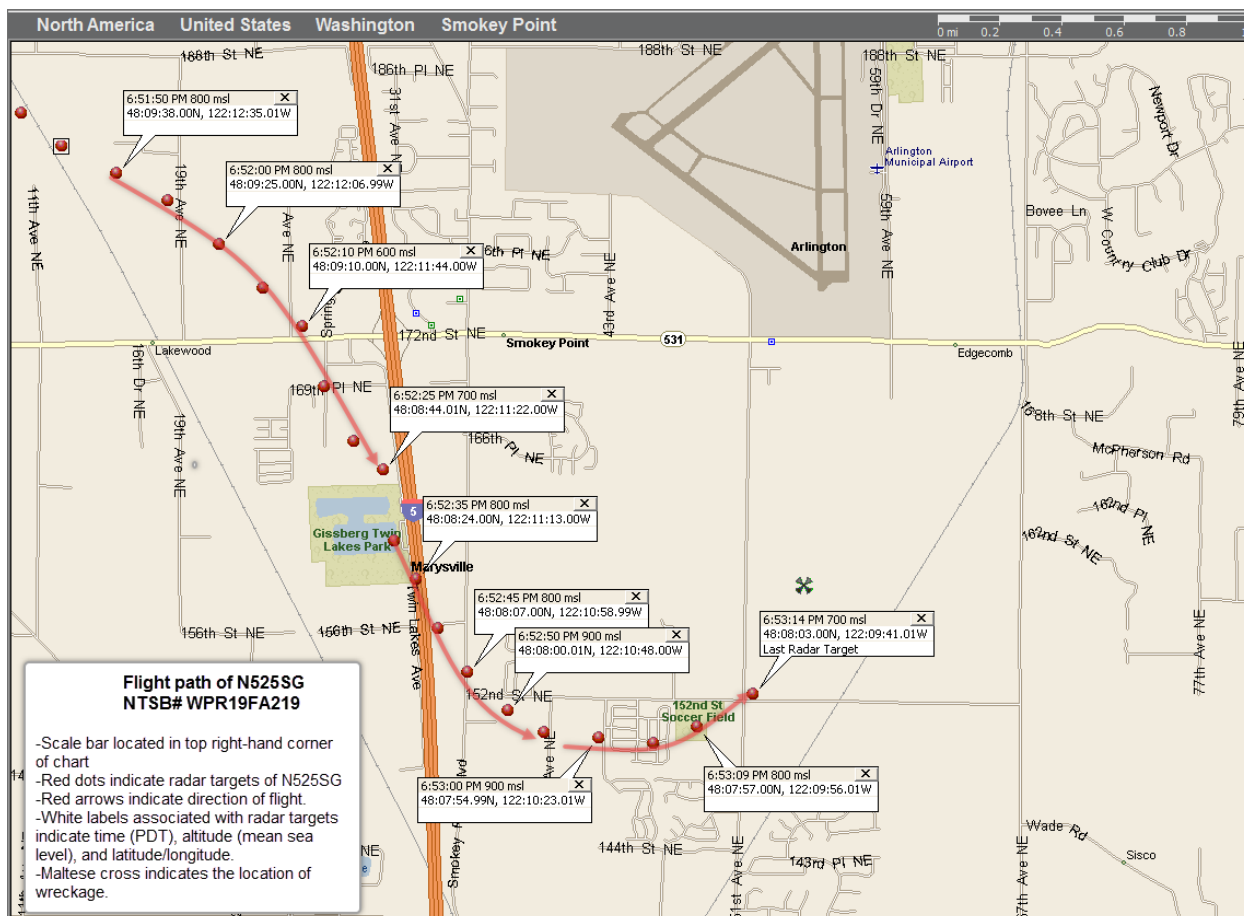
Figure 2. MapPoint screenshot contains detailed information about the final portion of N525SG's flight path.

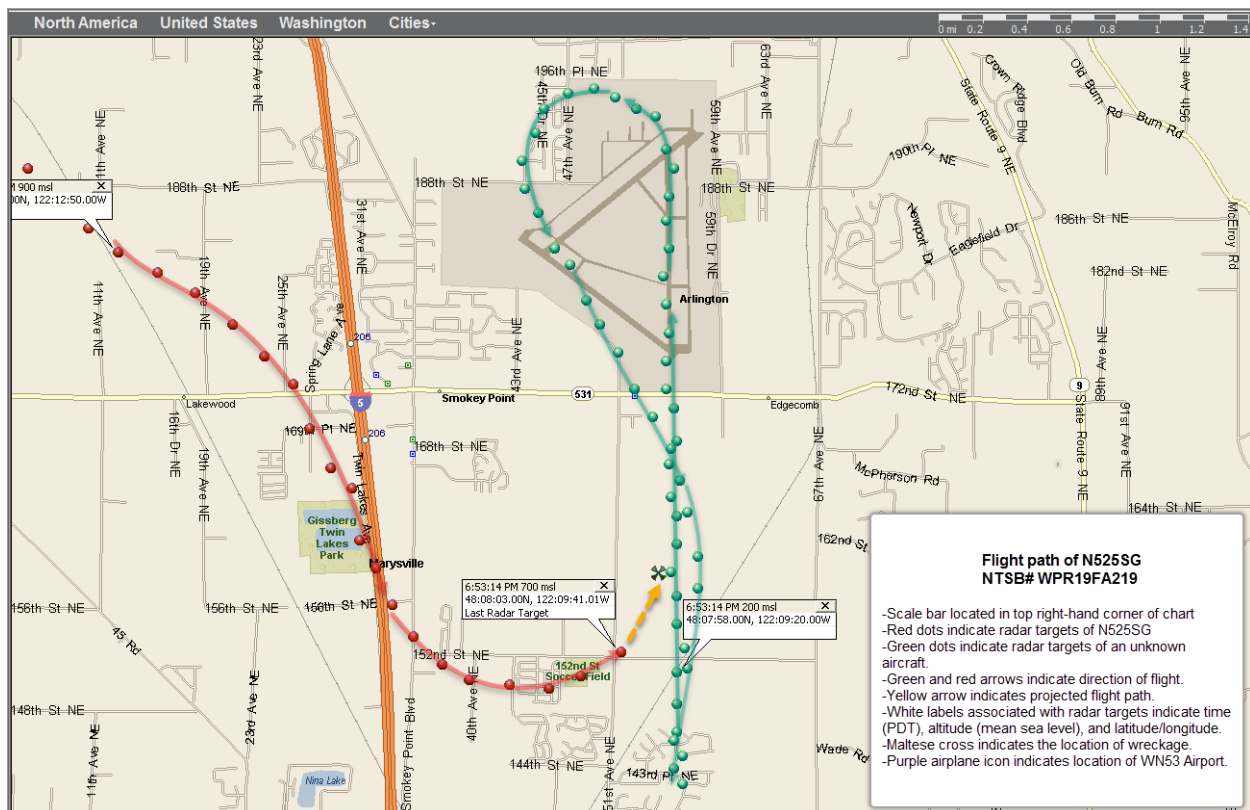
Figure 3. MapPoint screenshot containing detailed information about the final portion of N525SG's flight path and targets of an unidentified aircraft flying in the vicinity of AWO Airport about the time of the accident.
