# **NATIONAL TRANSPORTATION SAFETY BOARD**

## **Unmanned Aircraft System (UAS) Aerial Imagery Factual Report**

### **A. ACCIDENT WPR19FA230**

Location: Oroville, California  
Date: August 21, 2019

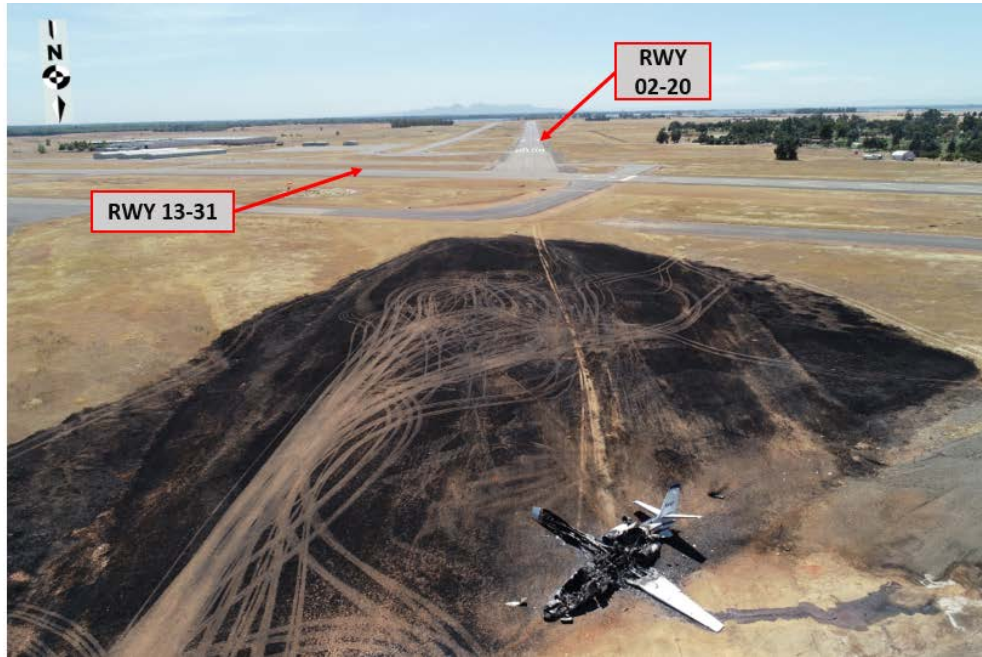
Figure 1 contains a still image of the aircraft wreckage taken from looking towards the aircraft with the departure runway 02/20 in the background.

**Figure 1 - View of aircraft wreckage**

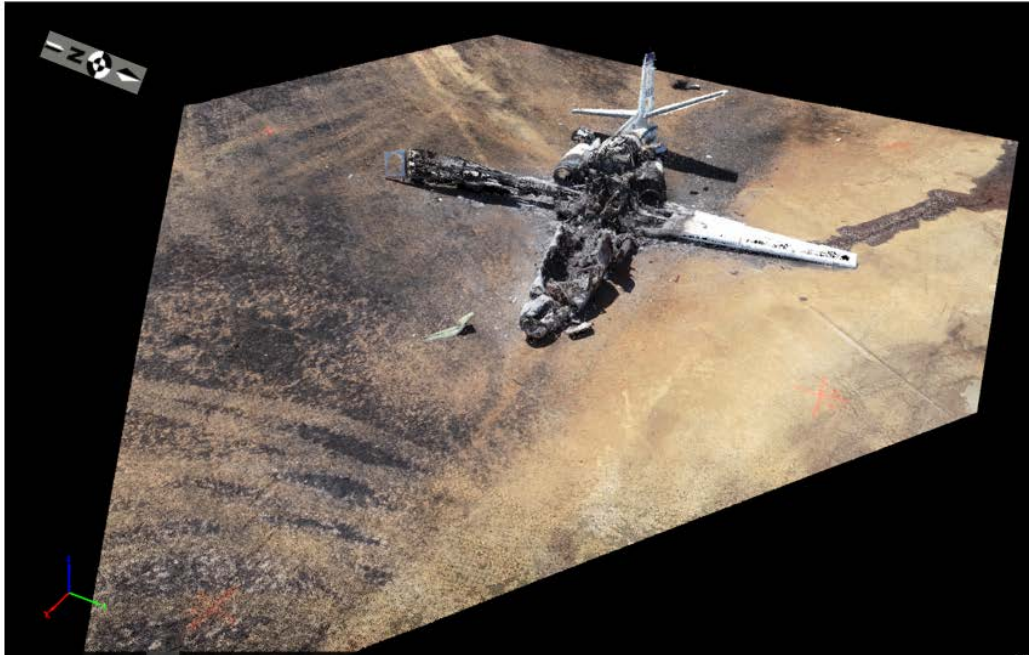
**Figure 2 – Screenshot of point cloud of accident site.**

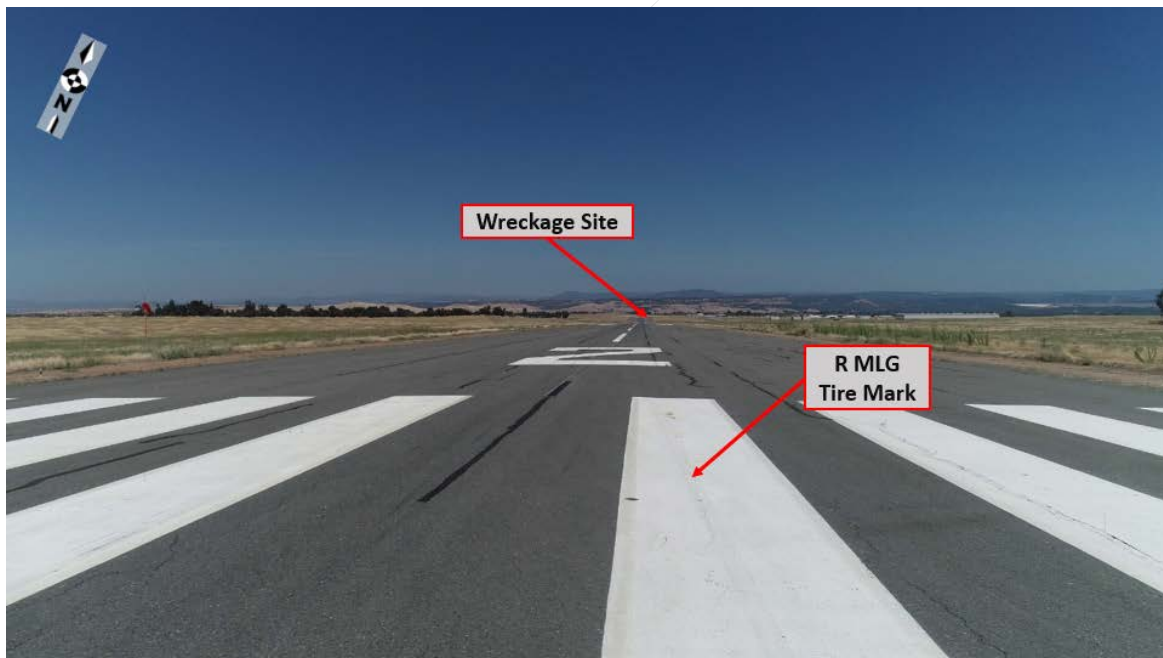
**Figure 3 – Runway 02 at start of take-off point with R MLG tire mark**

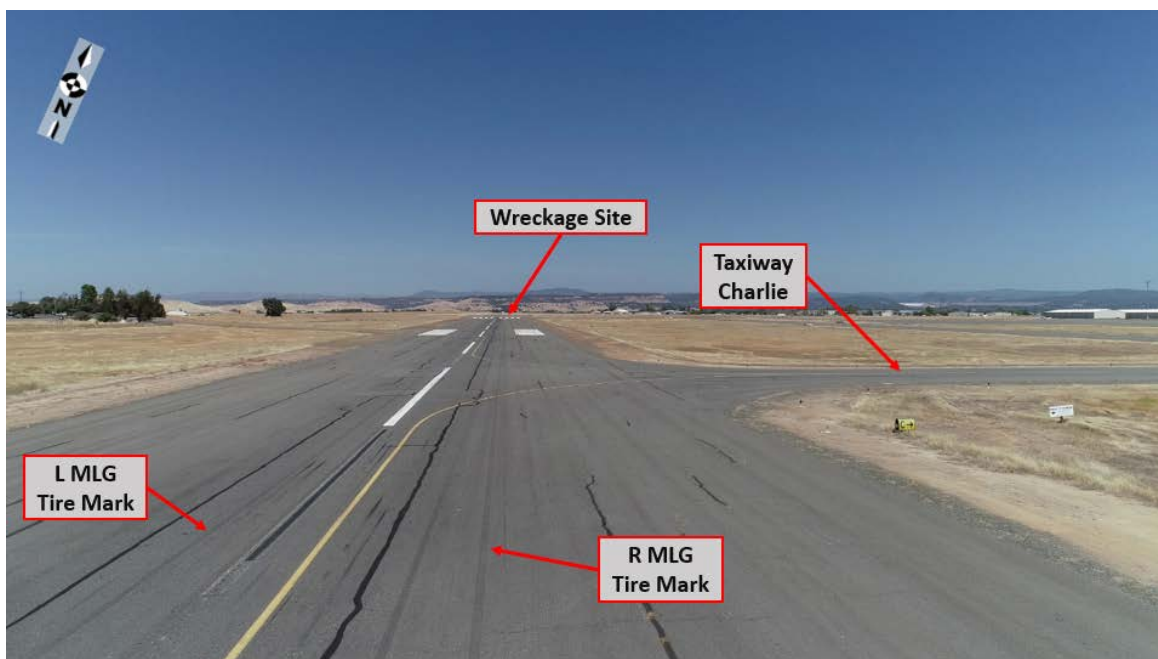
Figure 6 - Runway 02-20 tire marks approaching taxiway Charlie

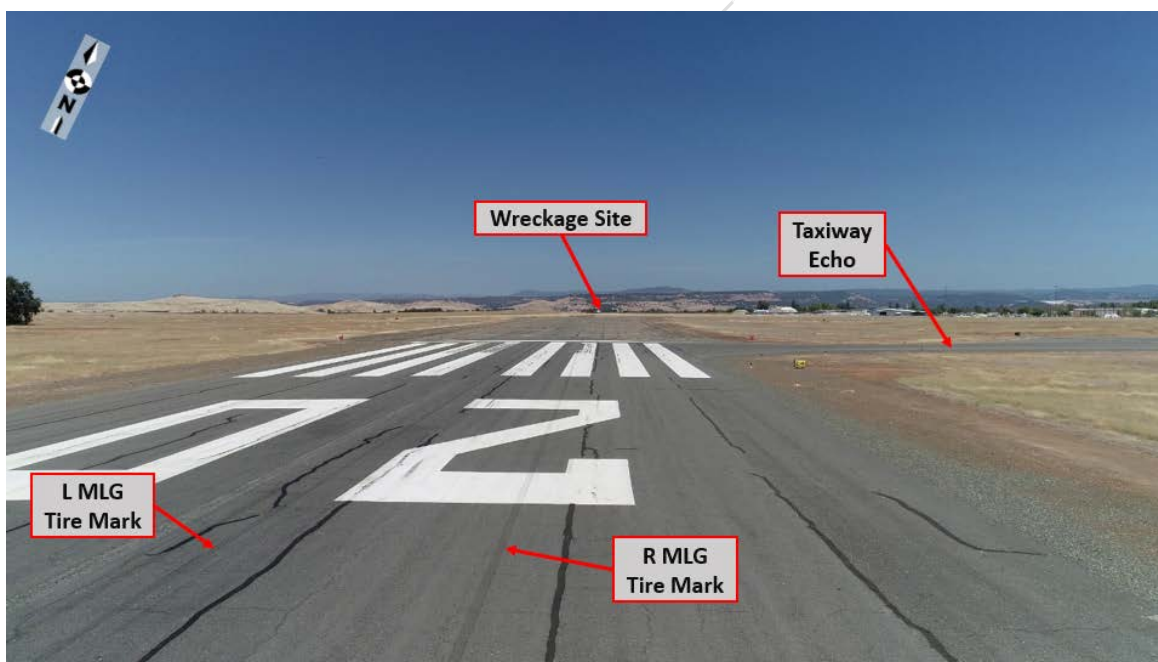
Figure 7 - Runway 02-20 tire marks approaching taxiway Echo

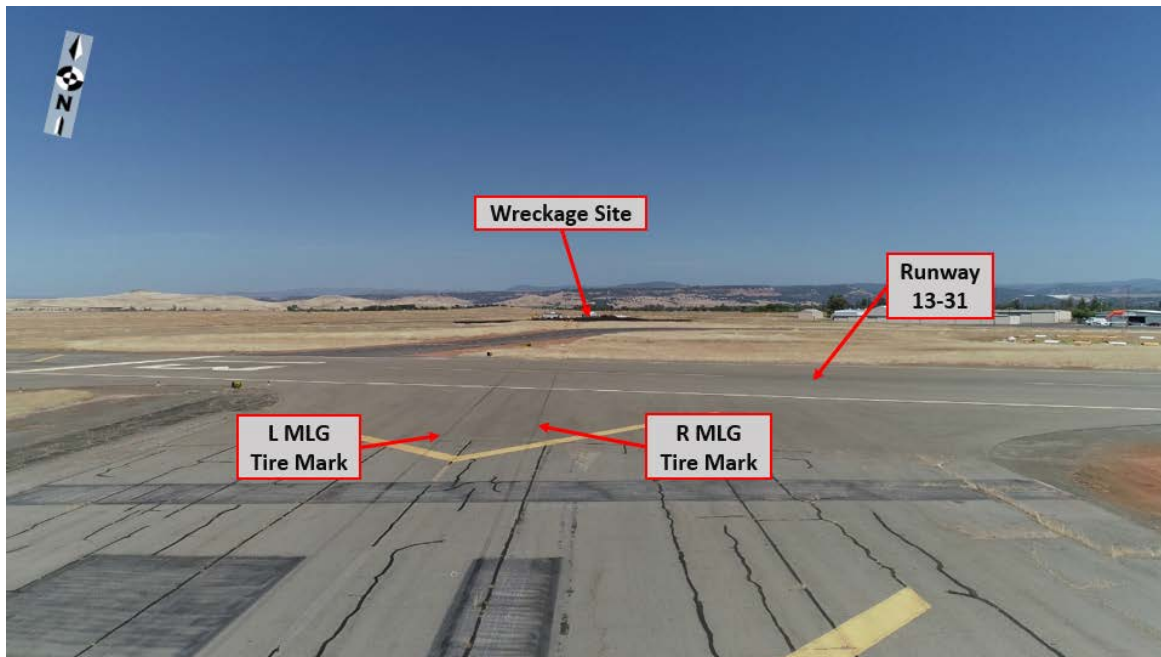
**Figure 8 - Runway 02-20 tire marks nearest runway 13-31**

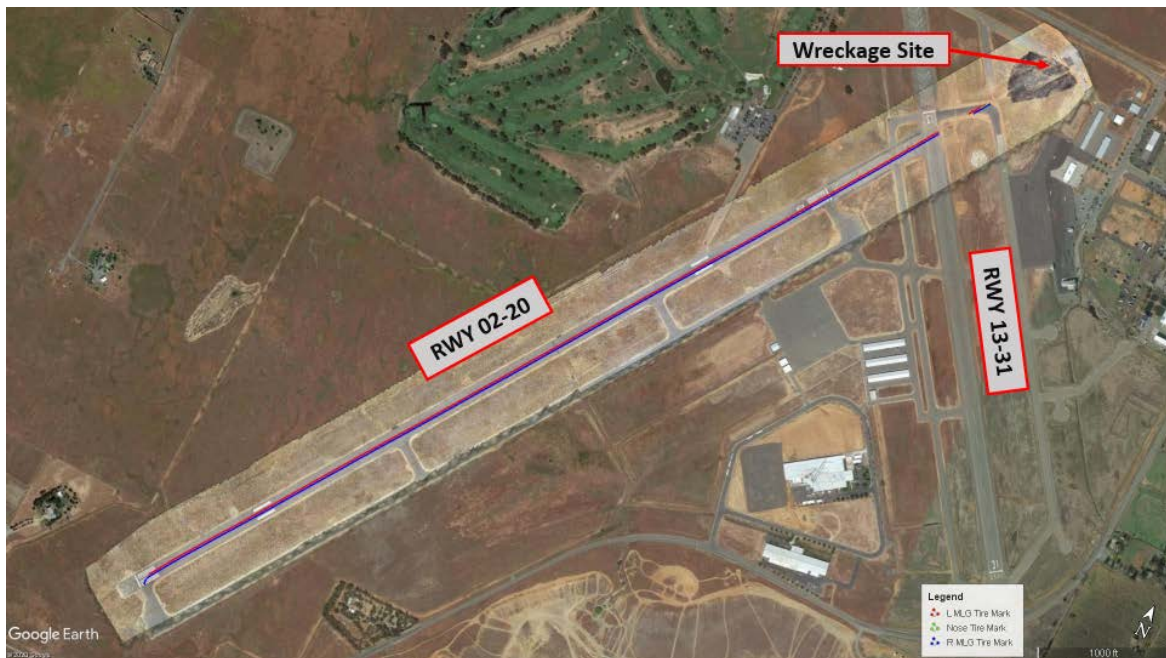
The right MLG tire mark was faintly noticeable on taxiway Alpha (A) around the hold short line. The tire mark became more noticeable on the runway 02-20 threshold markings and continued along runway 02-20. The tire mark was continuous the length of the runway and along the displaced threshold and across runway 13-31. A groove consistent with the right MLG tire continued across the terrain between runway 13-31 and taxiway Romeo (R). A second right MLG tire mark was identified on the paved portion of taxiway R and continued to where the aircraft departed the paved surface. The marks were 6,944 ft and 149 ft, respectively.

The left MLG tire mark was faintly noticeable on taxiway Alpha (A) but was not measurable. The tire mark was more noticeable on runway 02-20 where the measurement was started. The tire mark was continuous the length of the runway and along the displaced threshold and across runway 13-31. A groove consistent with the left MLG tire continued across the terrain between runway 13-31 and taxiway Romeo (R). A second left MLG tire mark was identified on the paved portion of taxiway R and continued to where the aircraft departed the paved surface. The marks were 6,881 ft and 151 ft, respectively.

The nose tire mark was first identified on the paved portion of taxiway R and continued to where the aircraft departed the paved surface. The mark was 78.2 ft.

Figure 9 - Tire mark trails from accident site GPS trail.

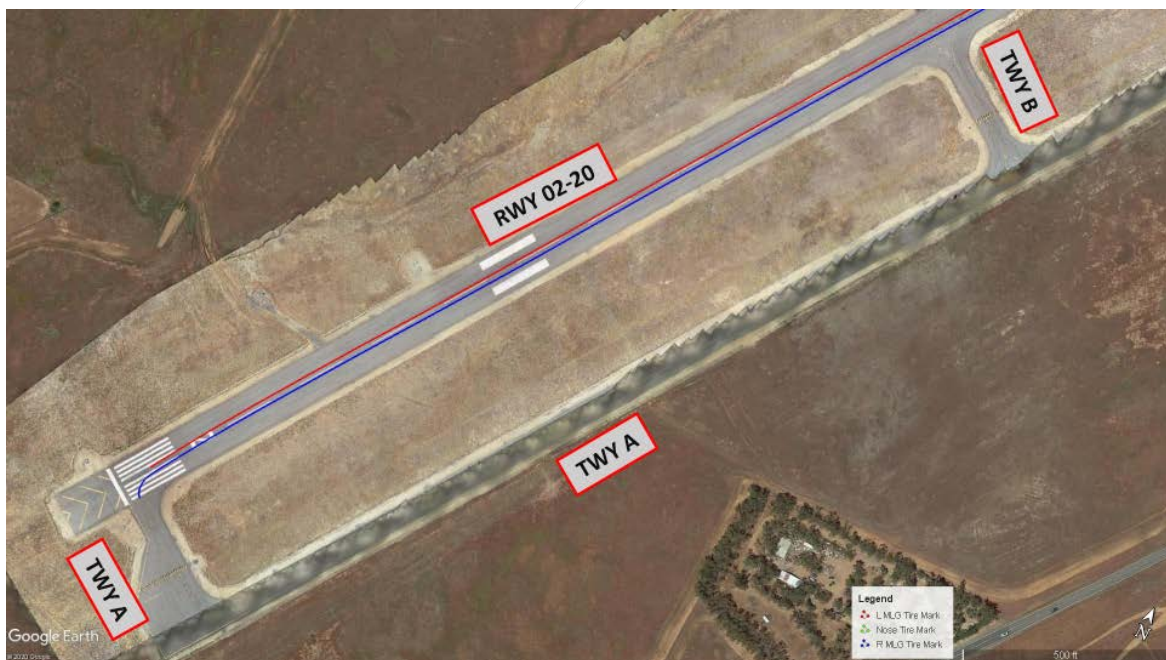
Figure 10 - Tire mark trails from accident site GPS trail at beginning of runway.

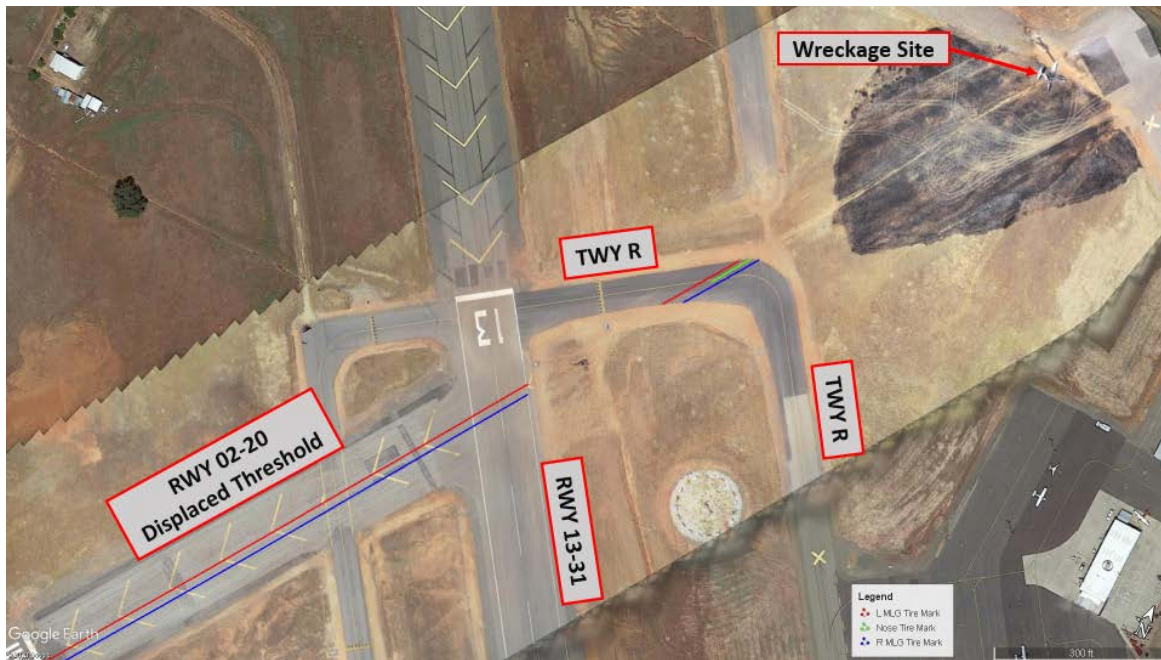
**Figure 11 - Tire mark trails from accident site GPS trail at end of runway.**

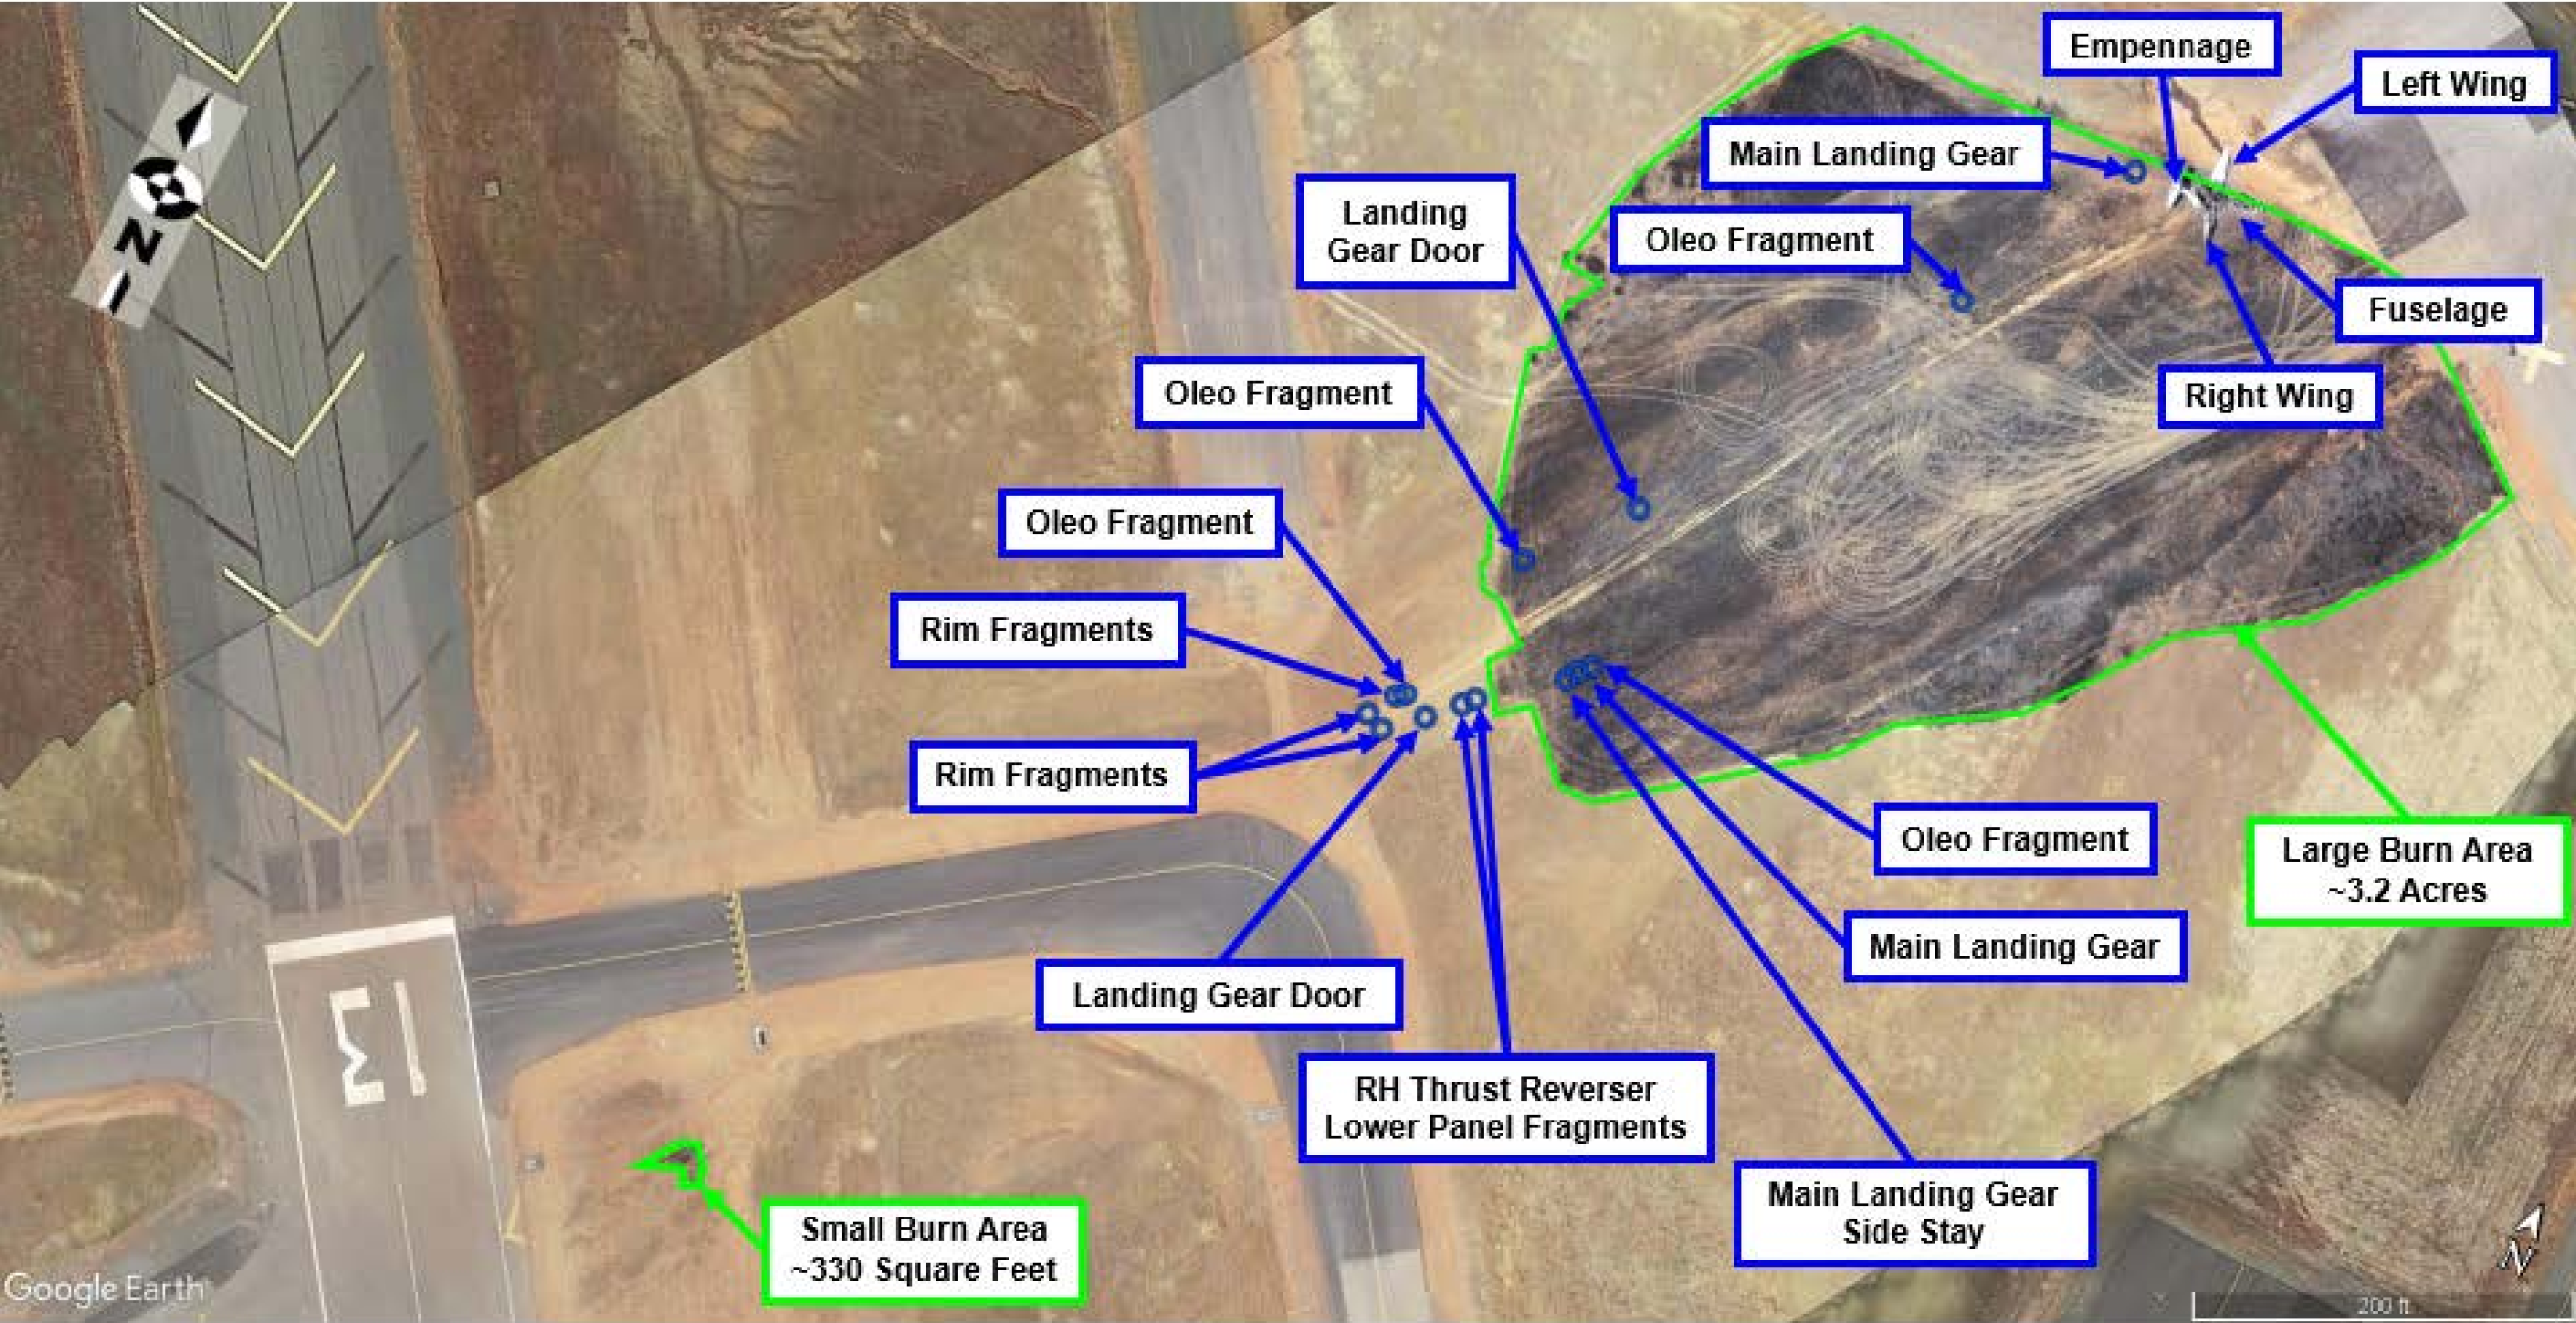
Section 6.0 contains an overhead image (Figure 12), of the accident site and main wreckage area. The images have been annotated with key components as found in the wreckage path.

Figure 12 - Overhead view of orthomosaic of aircraft wreckage site

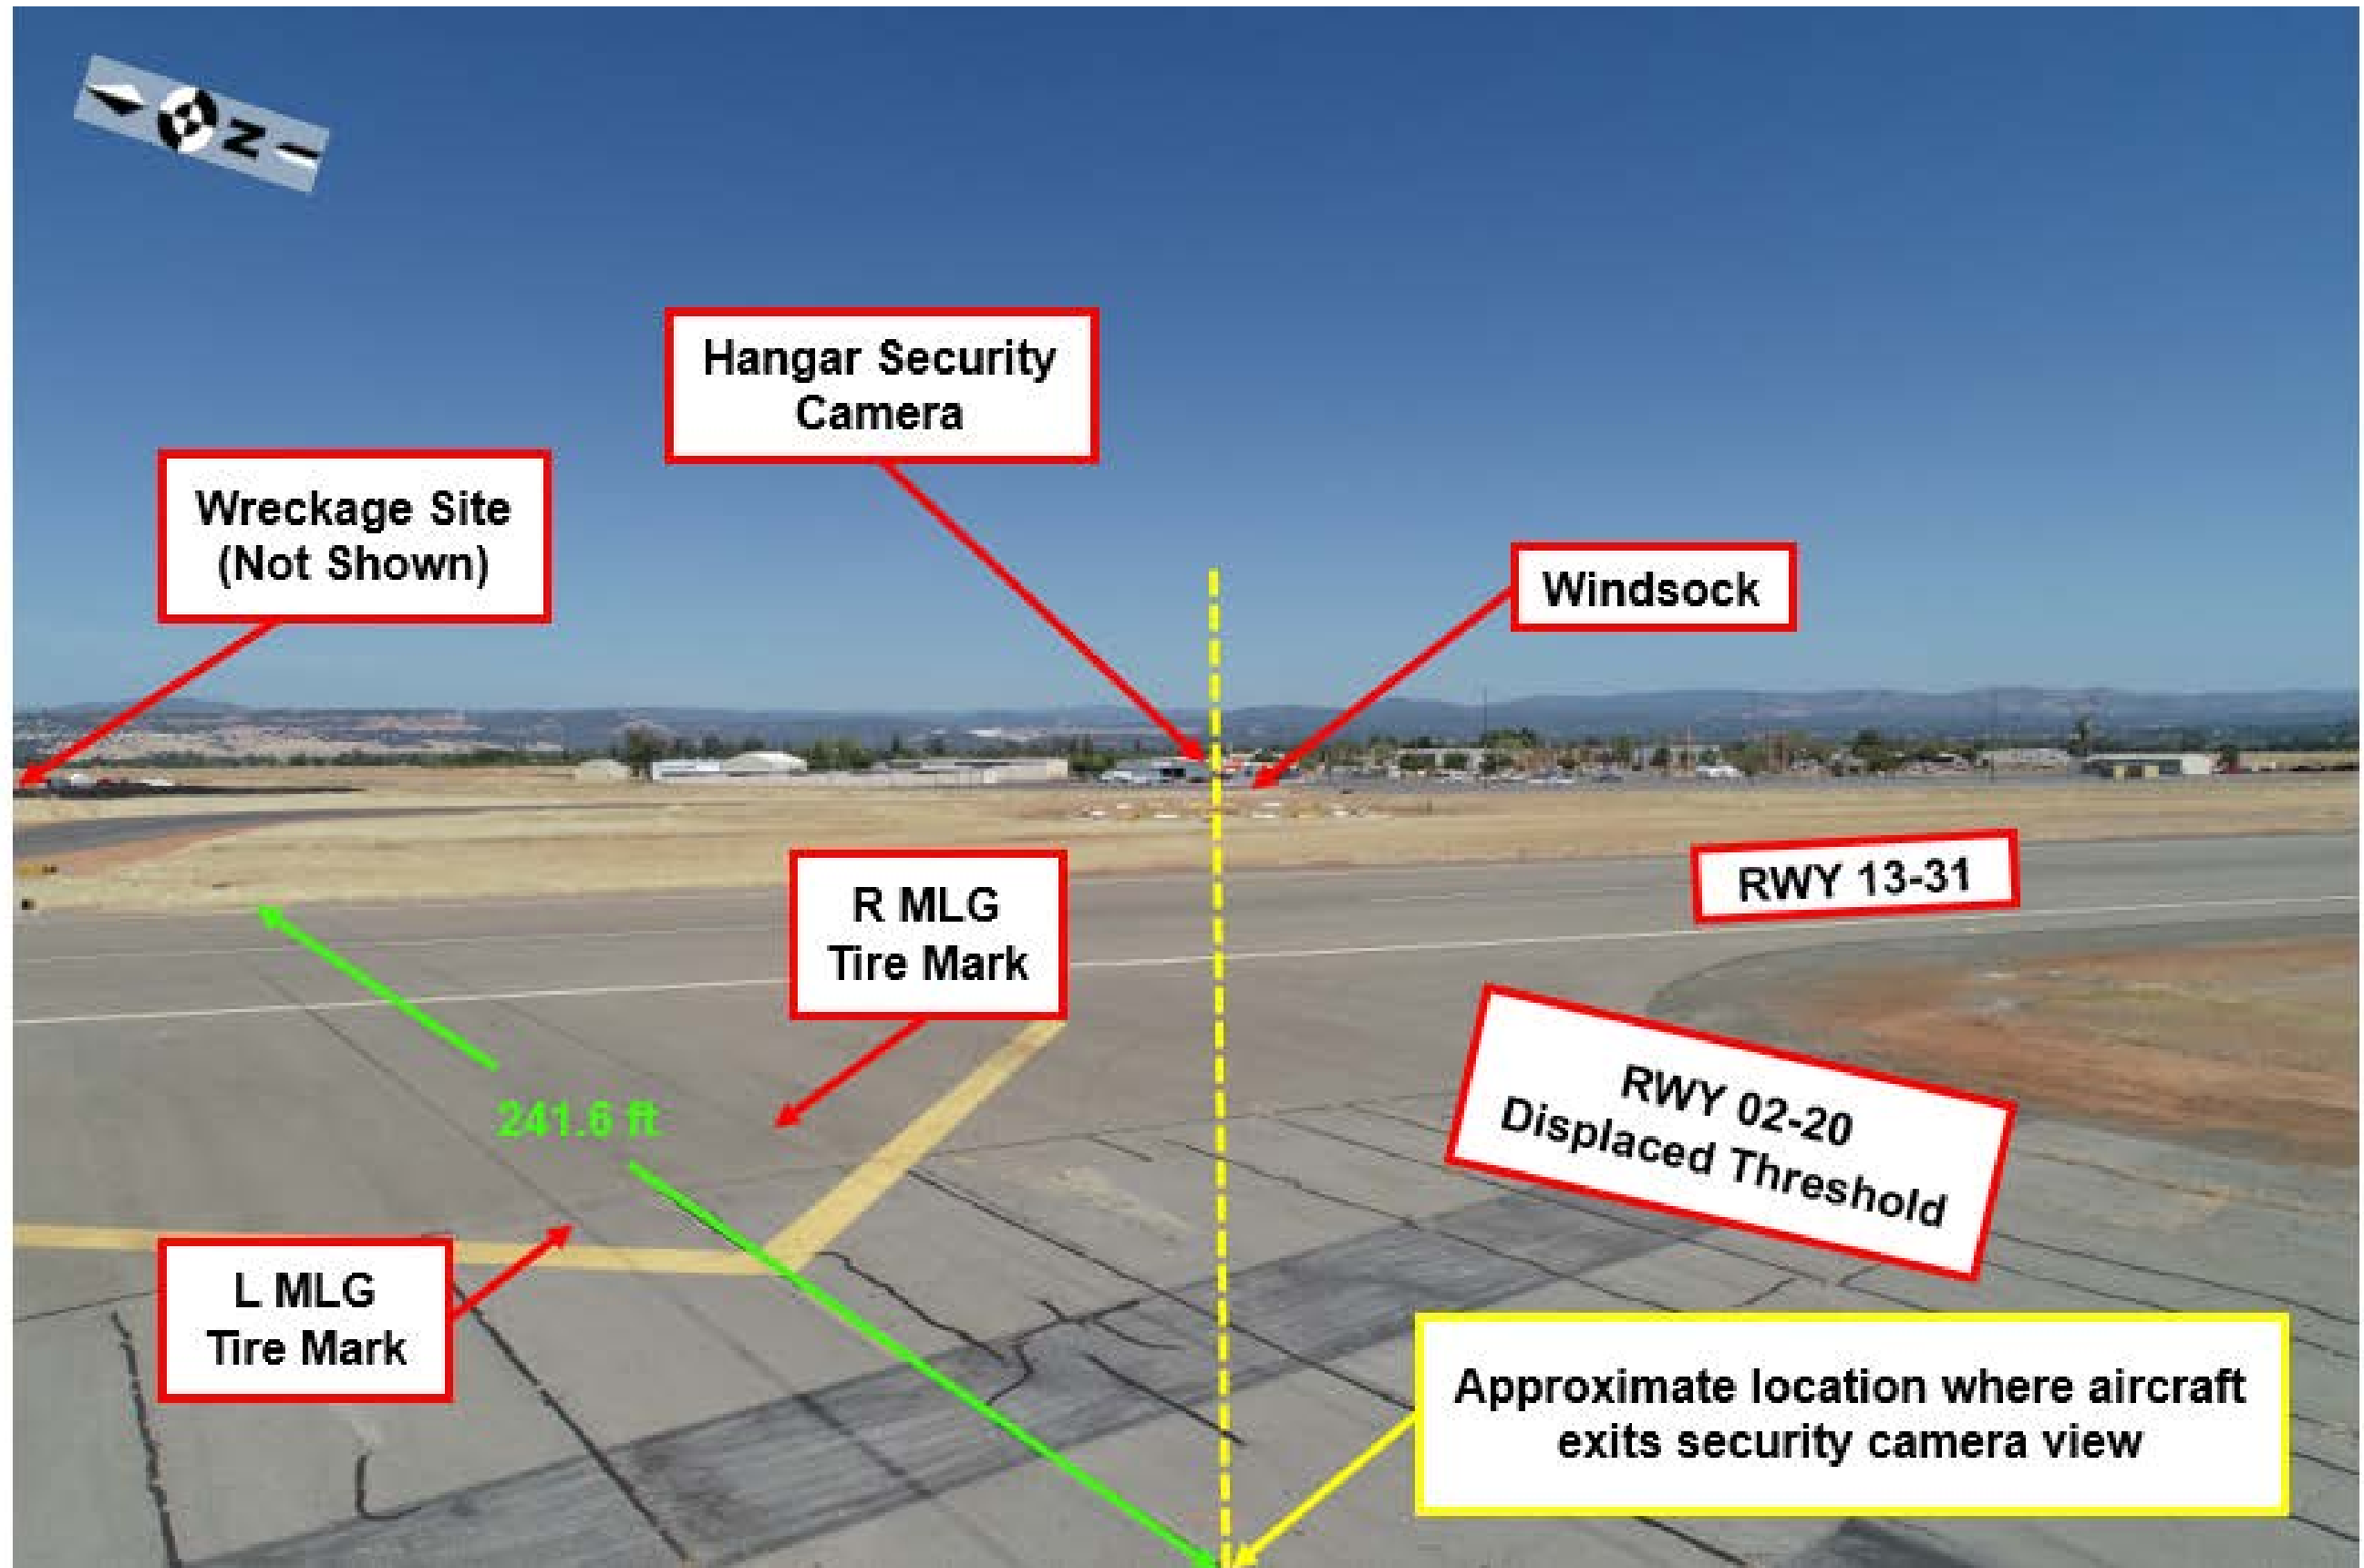
During the on-scene phase of the investigation and review of the airport surveillance video, a point was marked on the displaced threshold of runway 20. The point corresponded to the approximate location in the fixed view containing runway 02-20 and when the aircraft departed the video frame. The point identified was 241.6 ft (as measured using 3D point cloud) from the end of the paved surface between runway 13-31 and taxiway Romeo. Refer to the image in Section 6.0 that contains an oversized image of the mark looking towards the security camera location.

Figure 13 – Image looking back from approximate location where aircraft left security camera view towards the security camera
