## **NATIONAL TRANSPORTATION SAFETY BOARD**

### **SECURITY VIDEO SUMMARY**

**WPR19FA230**

| Aircraft: | Cessna CE-560XL |

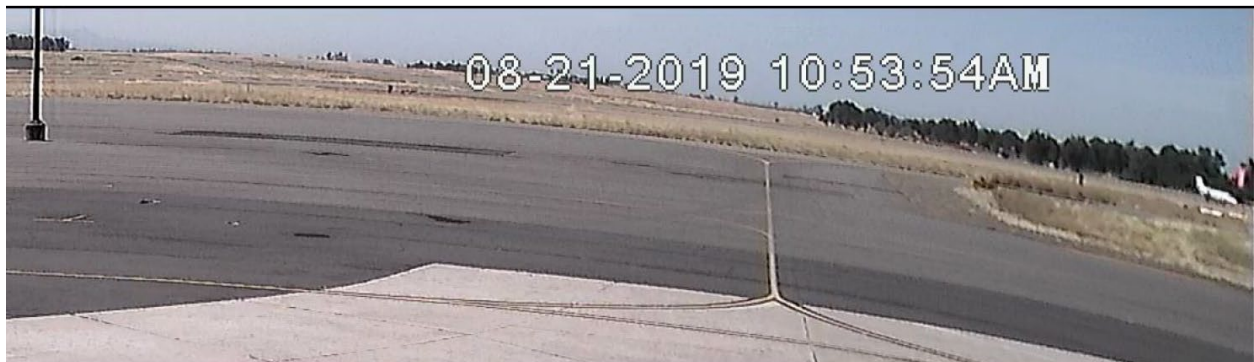
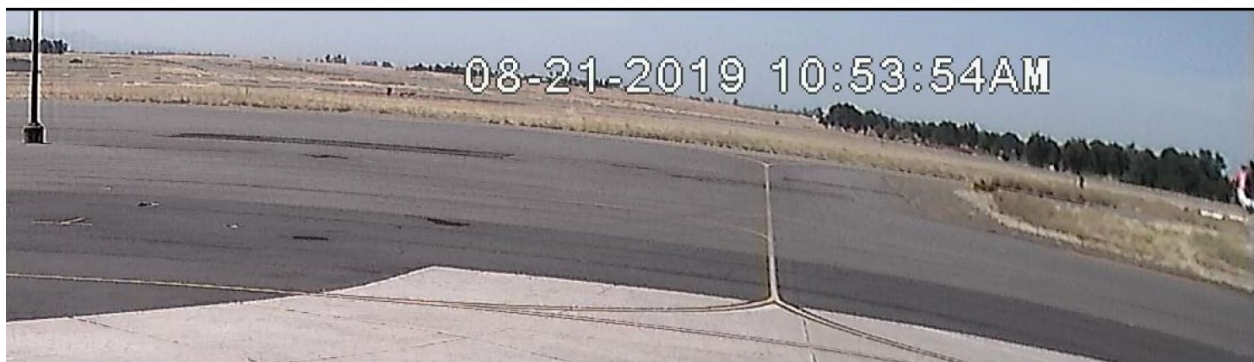
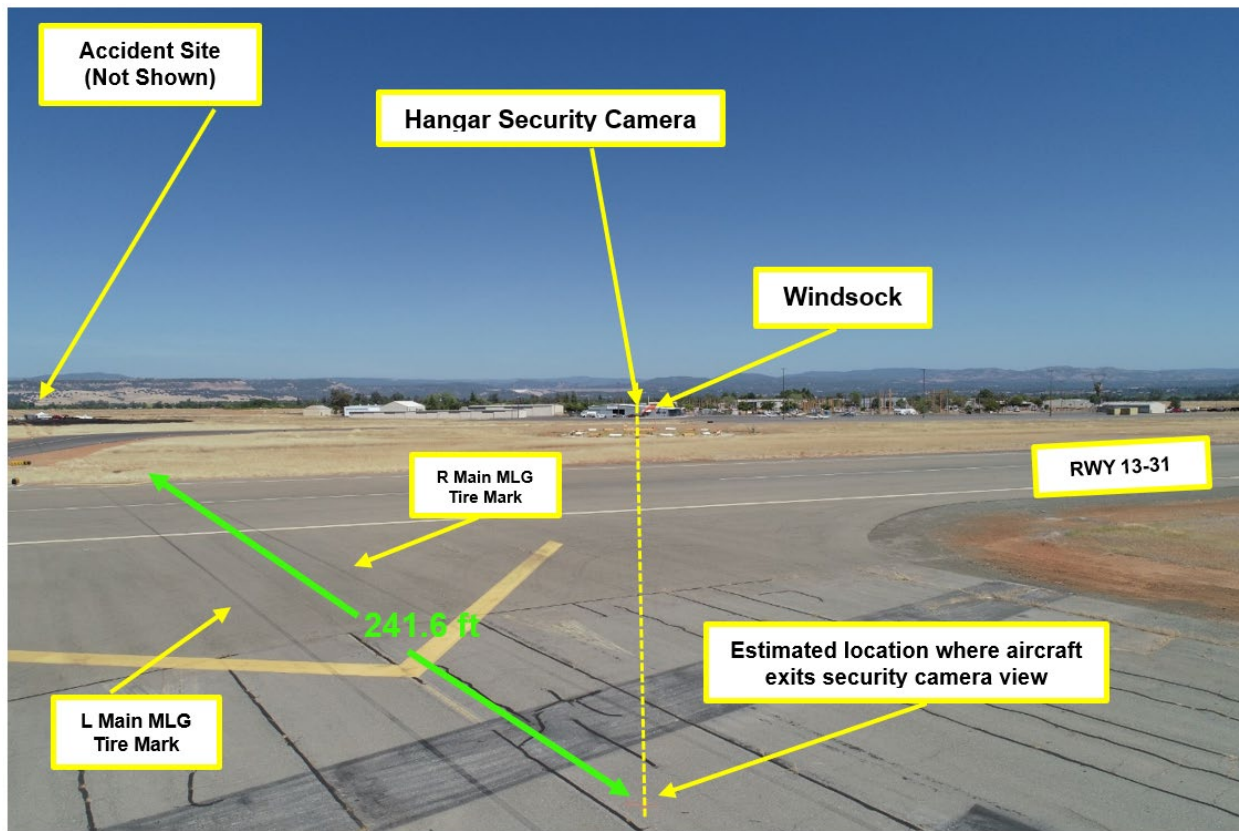
Review of surveillance video from fixed-based operator (FBO) located at Oroville Municipal Airport (OVE), showed the airplane holding short of runway 2 for about 3 minutes, 44 seconds. The airplane then taxied forward toward runway 2, but stopped, and remained stationary for about 18 seconds, until it began to taxi again onto the runway. The airplane remained stationary while lined up on the runway for about 16 seconds. Once the takeoff roll was initiated, the airplane traveled out of the camera frame 48 seconds later. A sound consistent with the application of thrust reversers was heard about 1 second after the airplane traveled out of the camera frame of view. The area where the airplane traveled out of the camera frame was about 730 ft beyond the runway 20 threshold.
