**NATIONAL TRANSPORTATION SAFETY BOARD**

**Computed Tomography Specialist's Factual Report**

WPR19FA230

Location: Oroville Municipal Airport (OVE), Oroville, California  
Date: August 21, 2019  
Time: 1132 Pacific daylight time  
Airplane: Cessna 560XL airplane, N91GY

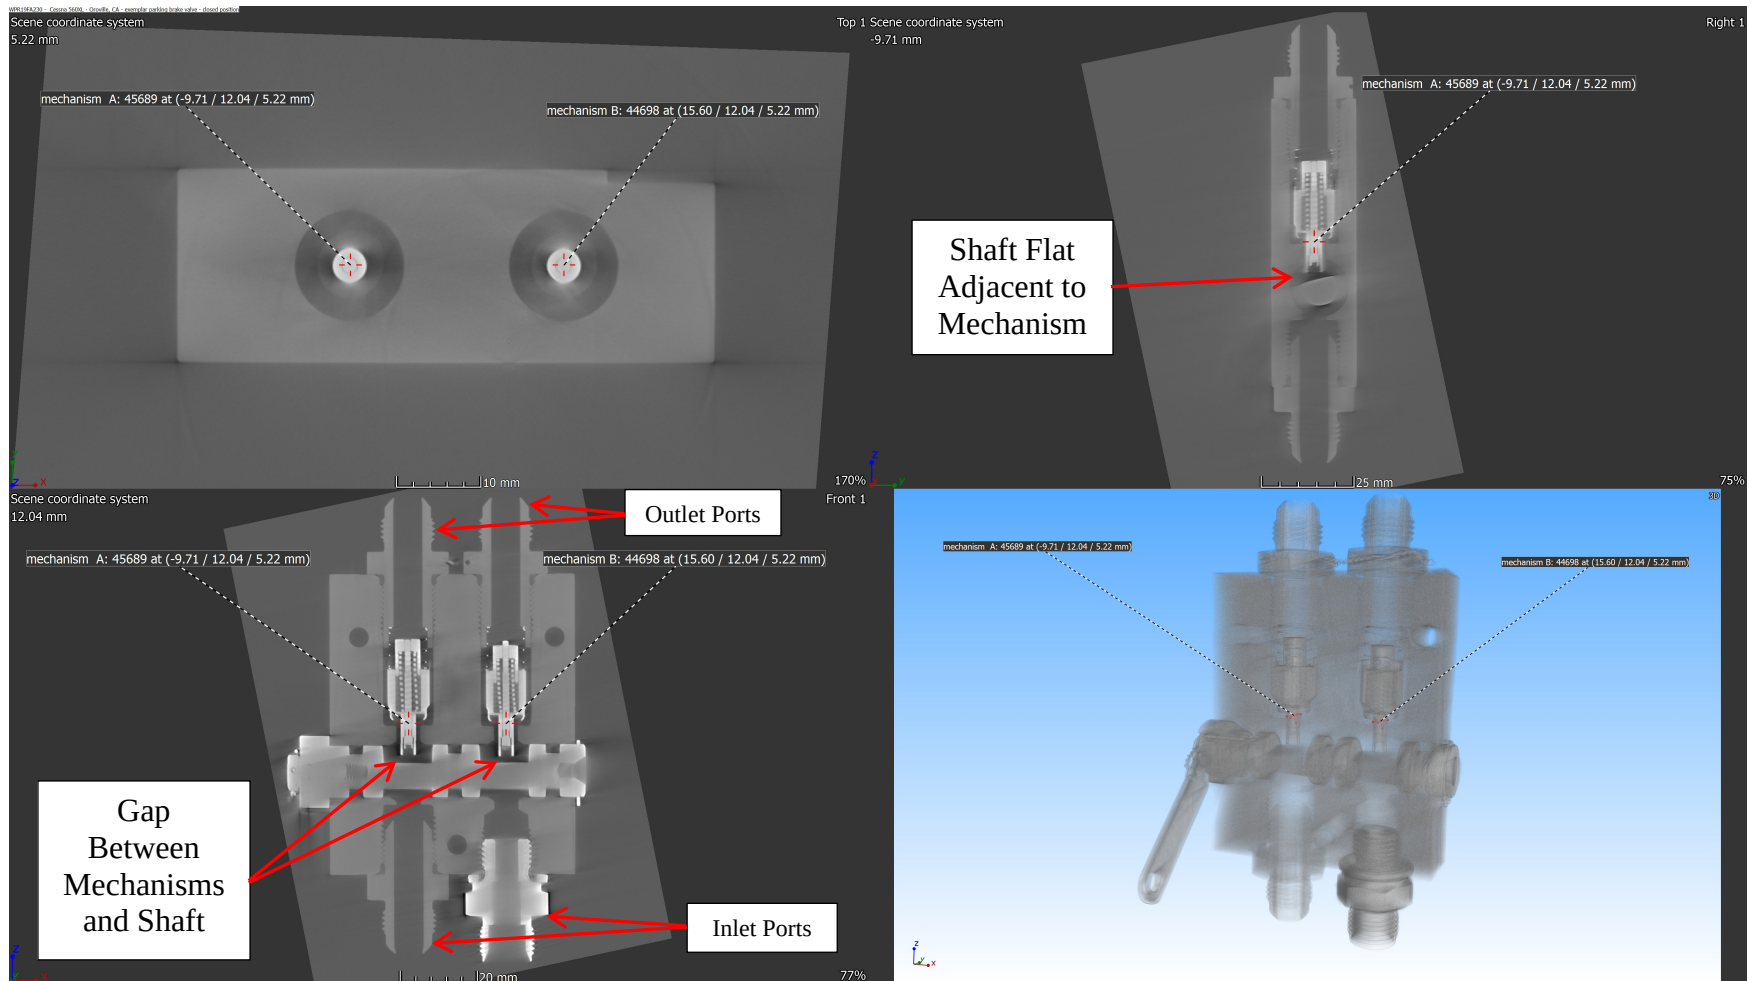
1. For the exemplar valve in the closed position, there was a gap between the mechanisms and shaft, and the flat side of the shaft was adjacent to the mechanisms;

Figure 1  
Exemplar parking brake valve – closed position – mechanism A

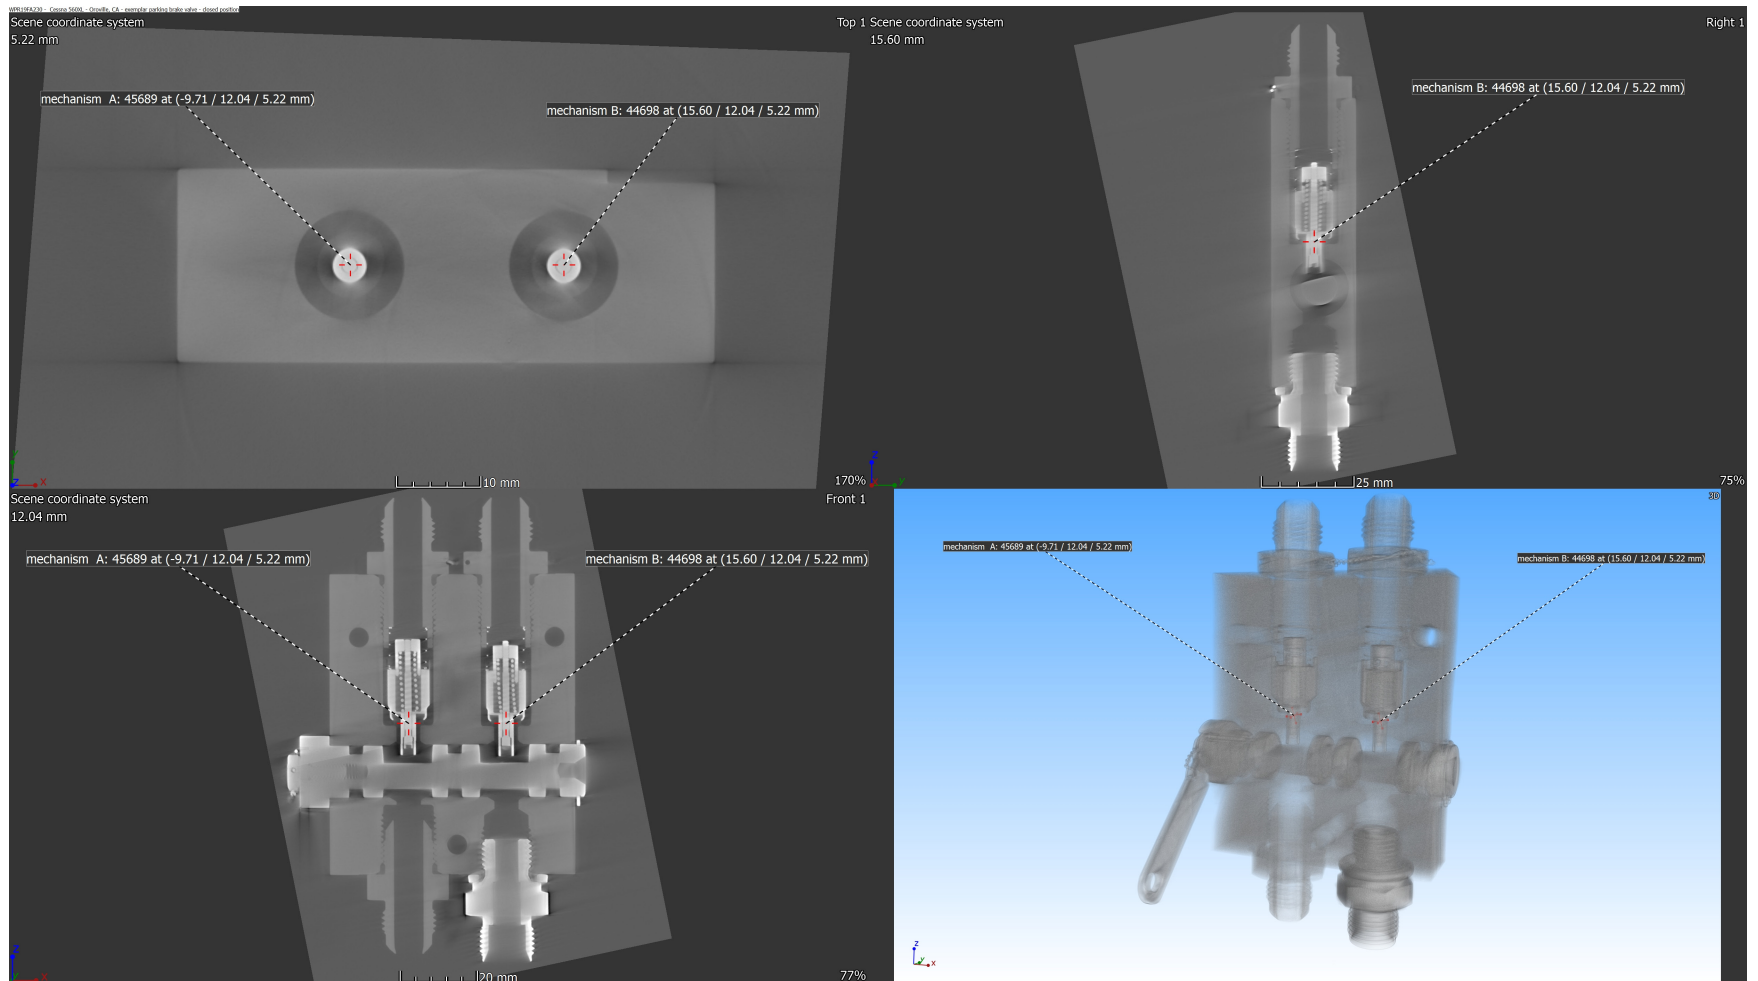
Figure 2  
Exemplar parking brake valve – closed position – mechanism B

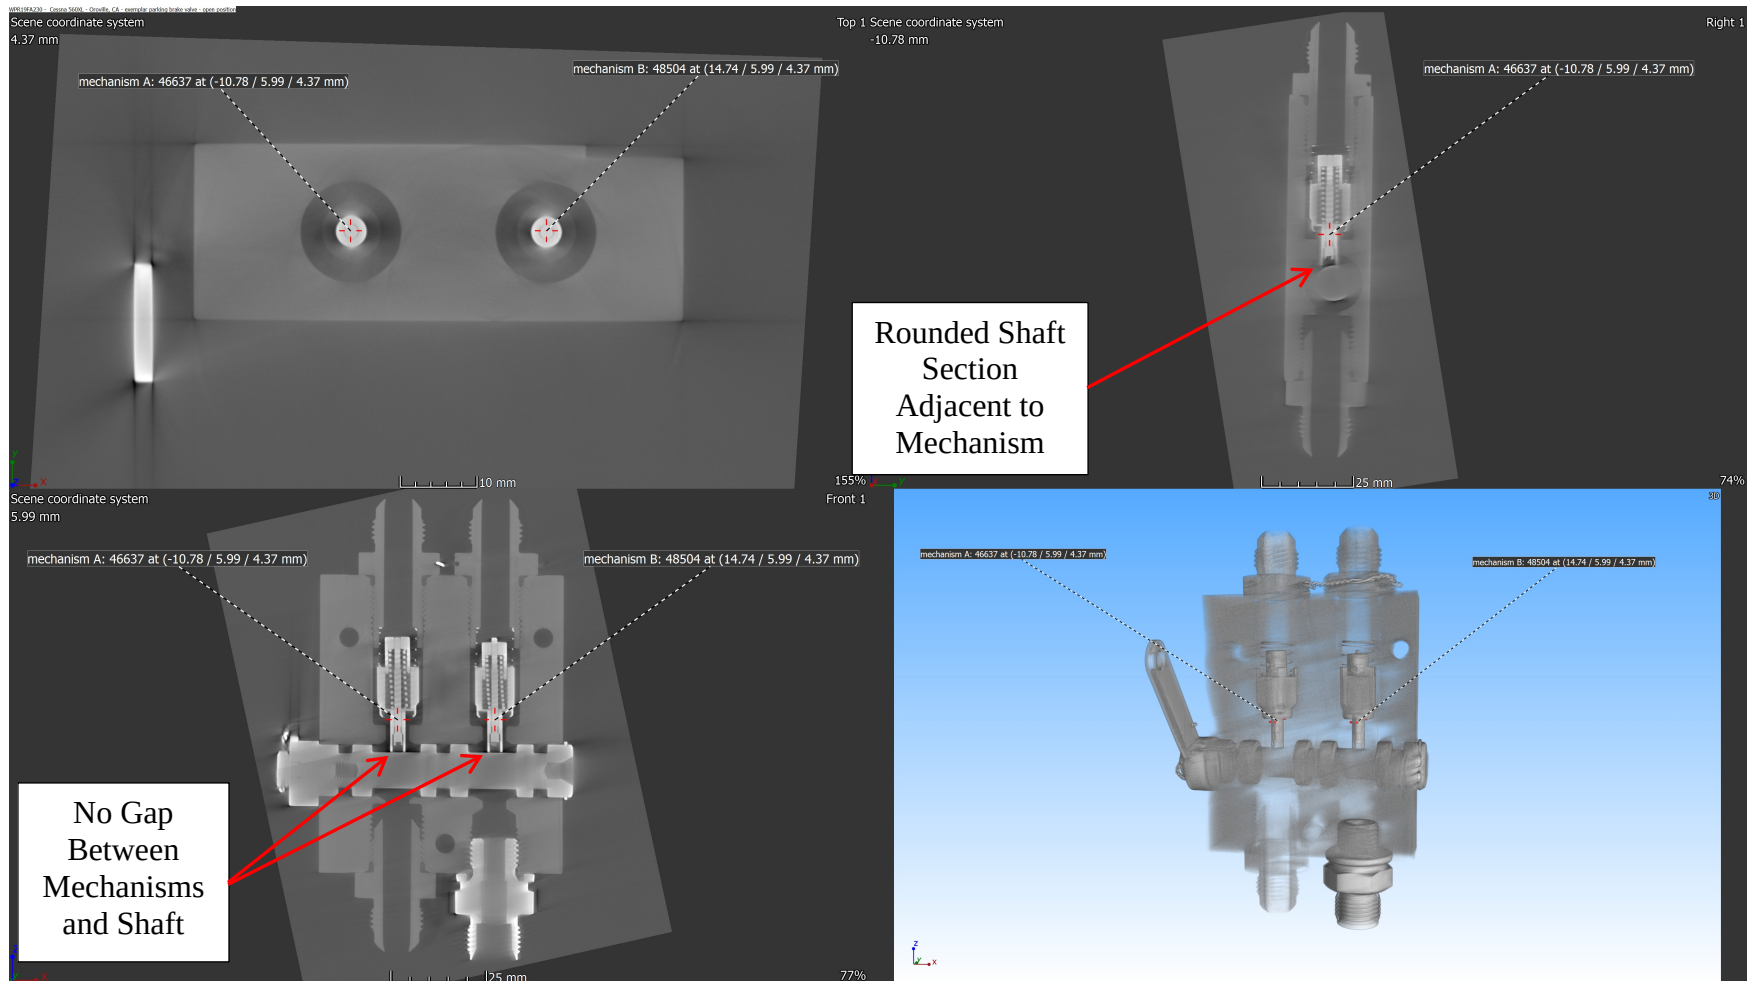
2. For the exemplar valve in the open position, there was no gap between the mechanisms and shaft, and the rounded section of the shaft was adjacent to the mechanisms;

Figure 3  
Exemplar parking brake valve – open position – mechanism A

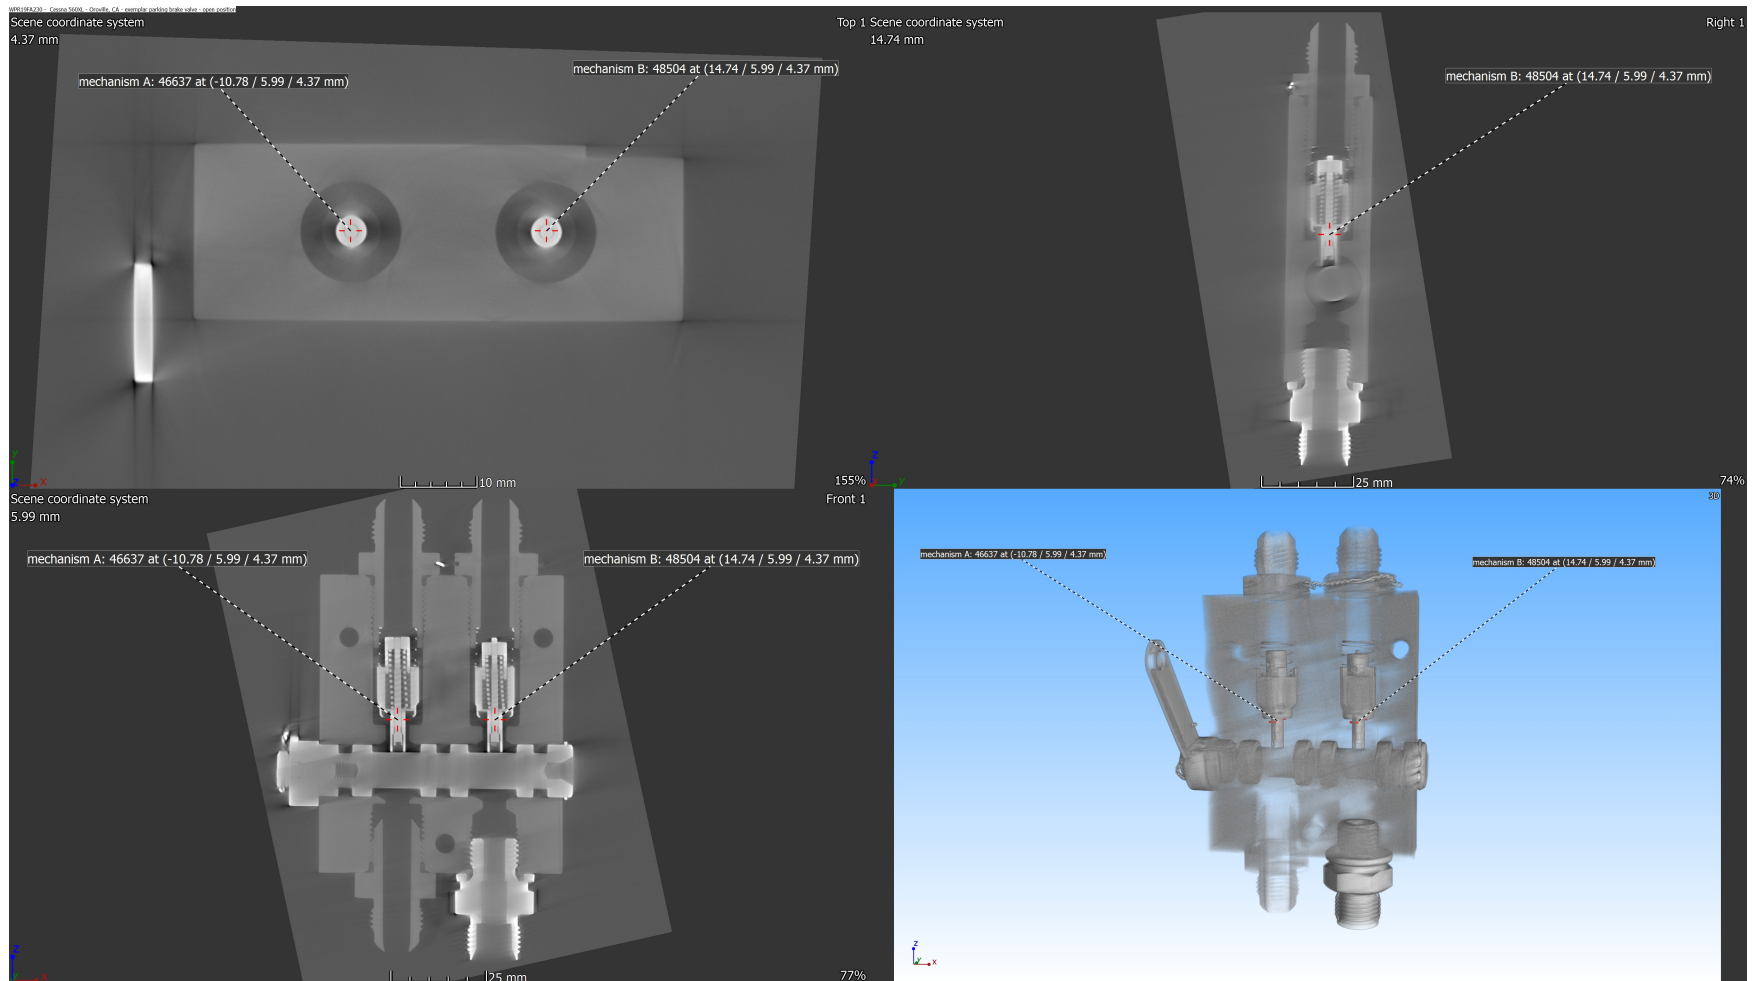
Figure 4  
Exemplar parking brake valve – open position – mechanism B

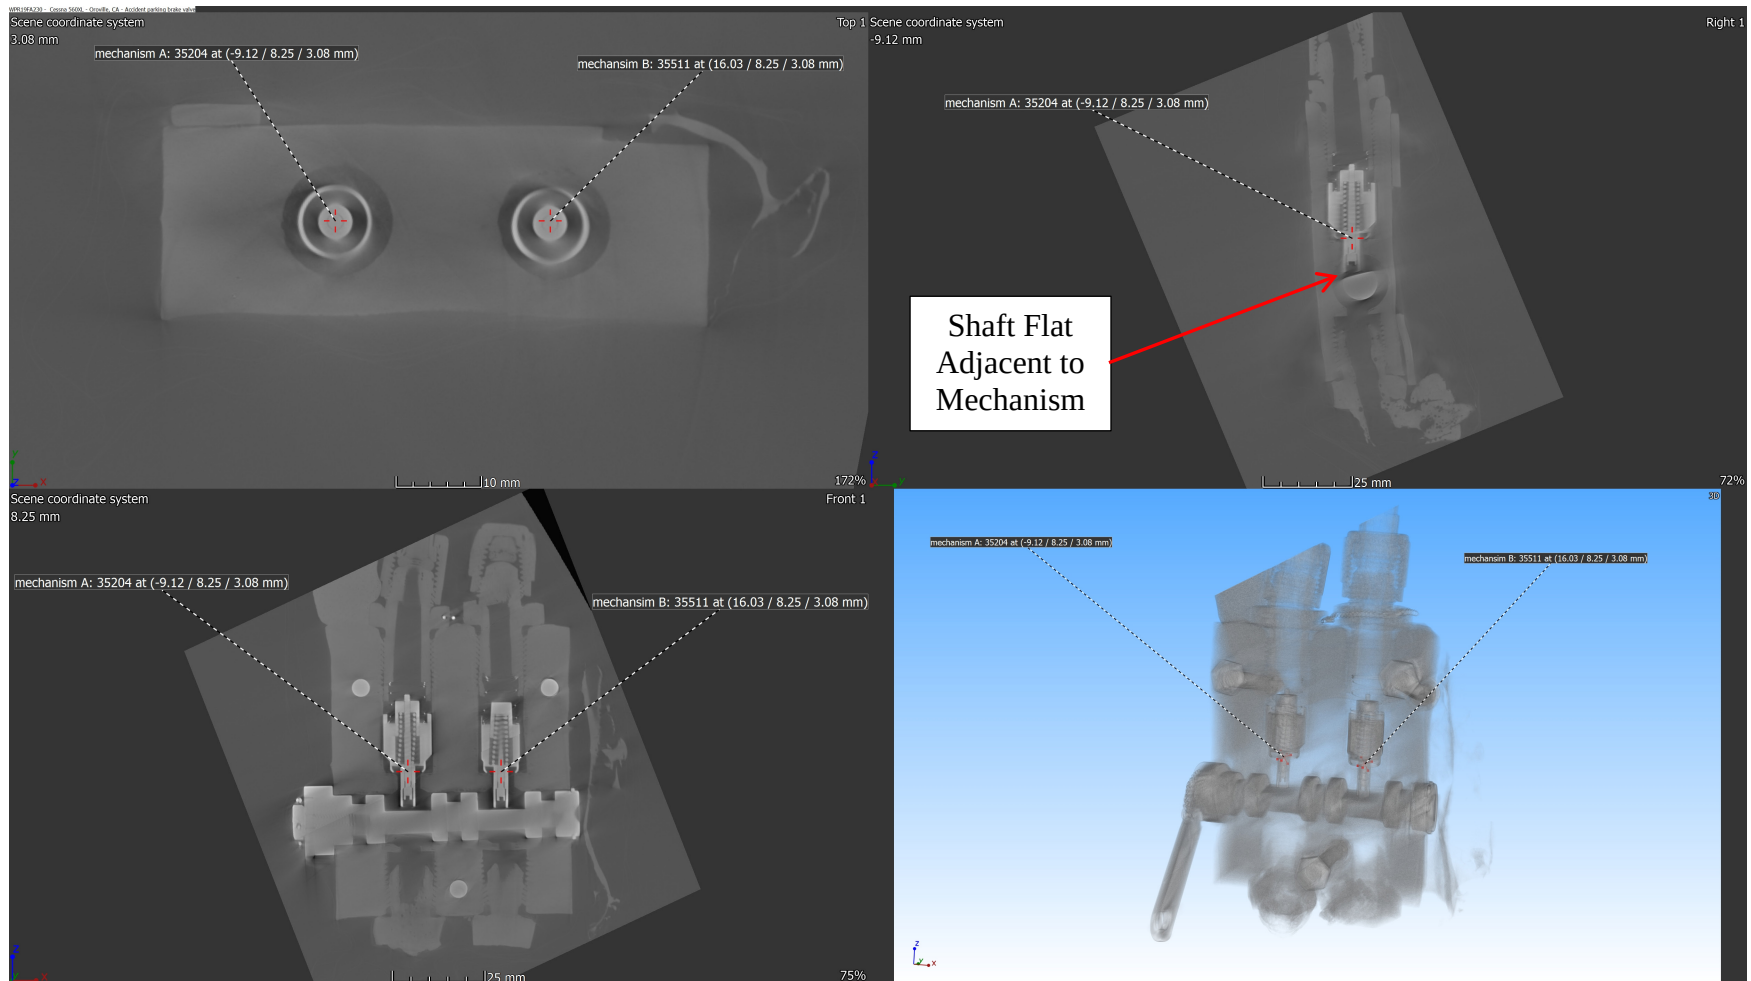
3. For the accident valve, the lever to shaft interface did not show any indications of cracks, missing material, or other abnormalities;
4. For the accident valve, the shaft flat was adjacent to the mechanisms. This position was consistent with the valve being in the closed position;

Figure 5  
Accident parking brake valve – mechanism A

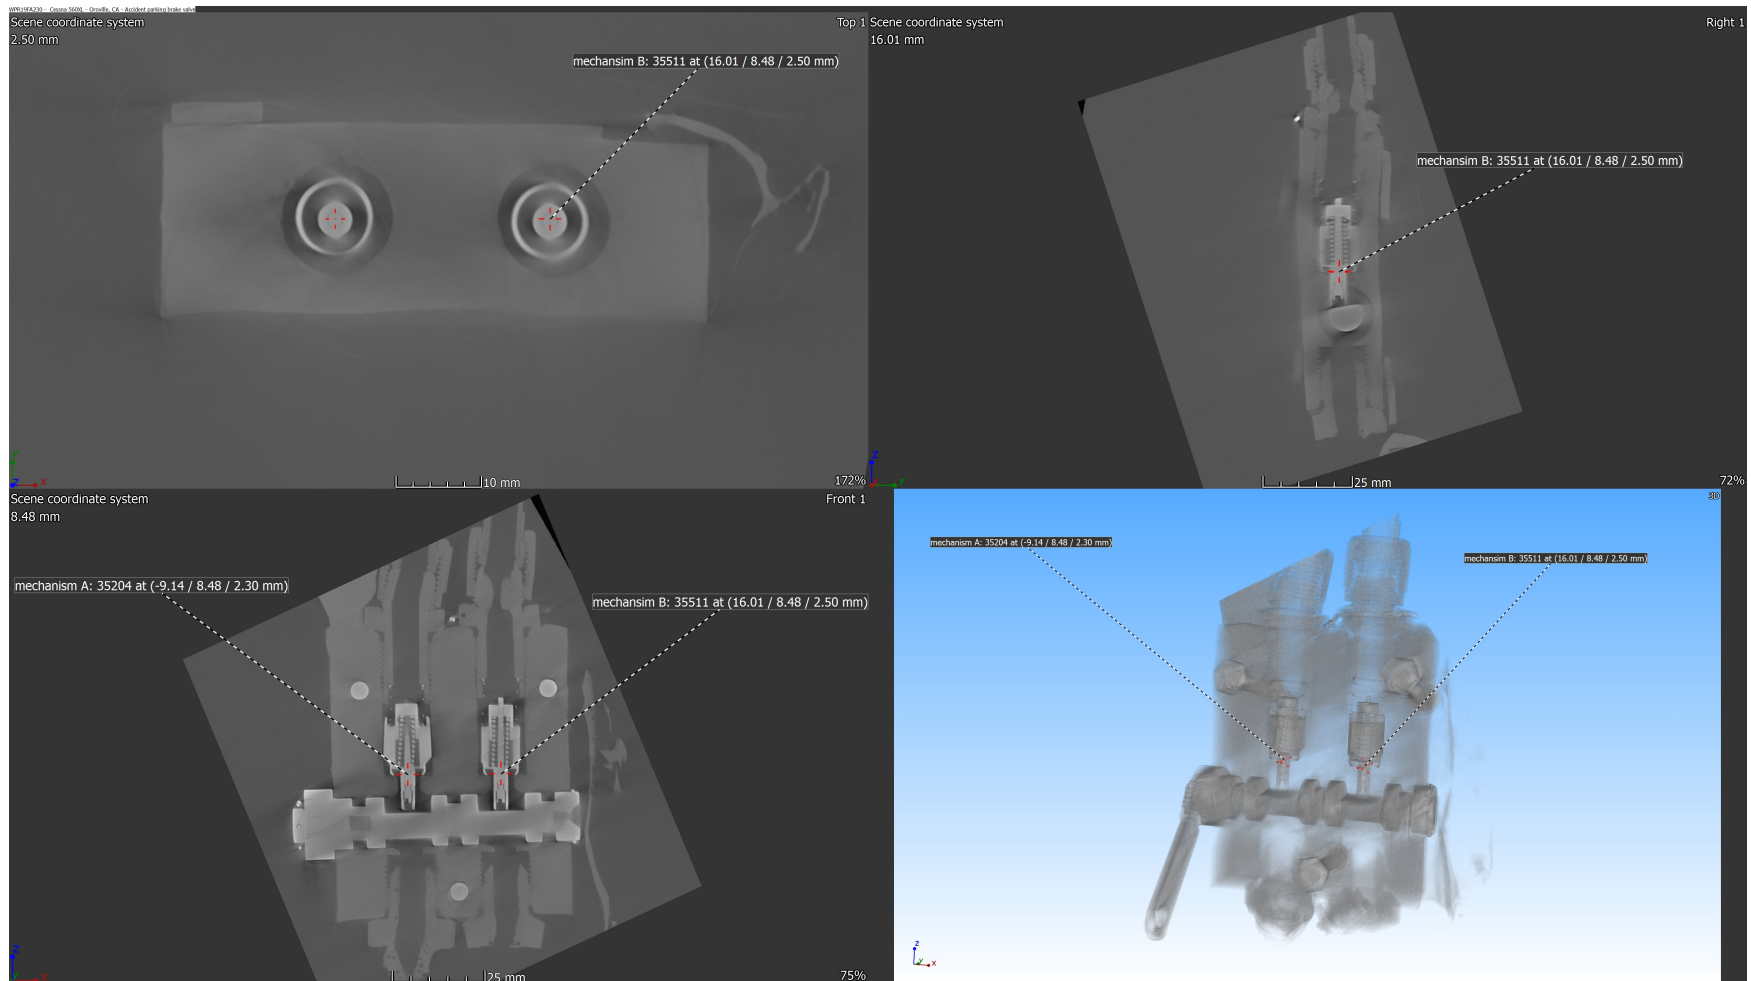
Figure 6  
Accident parking brake valve – mechanism B

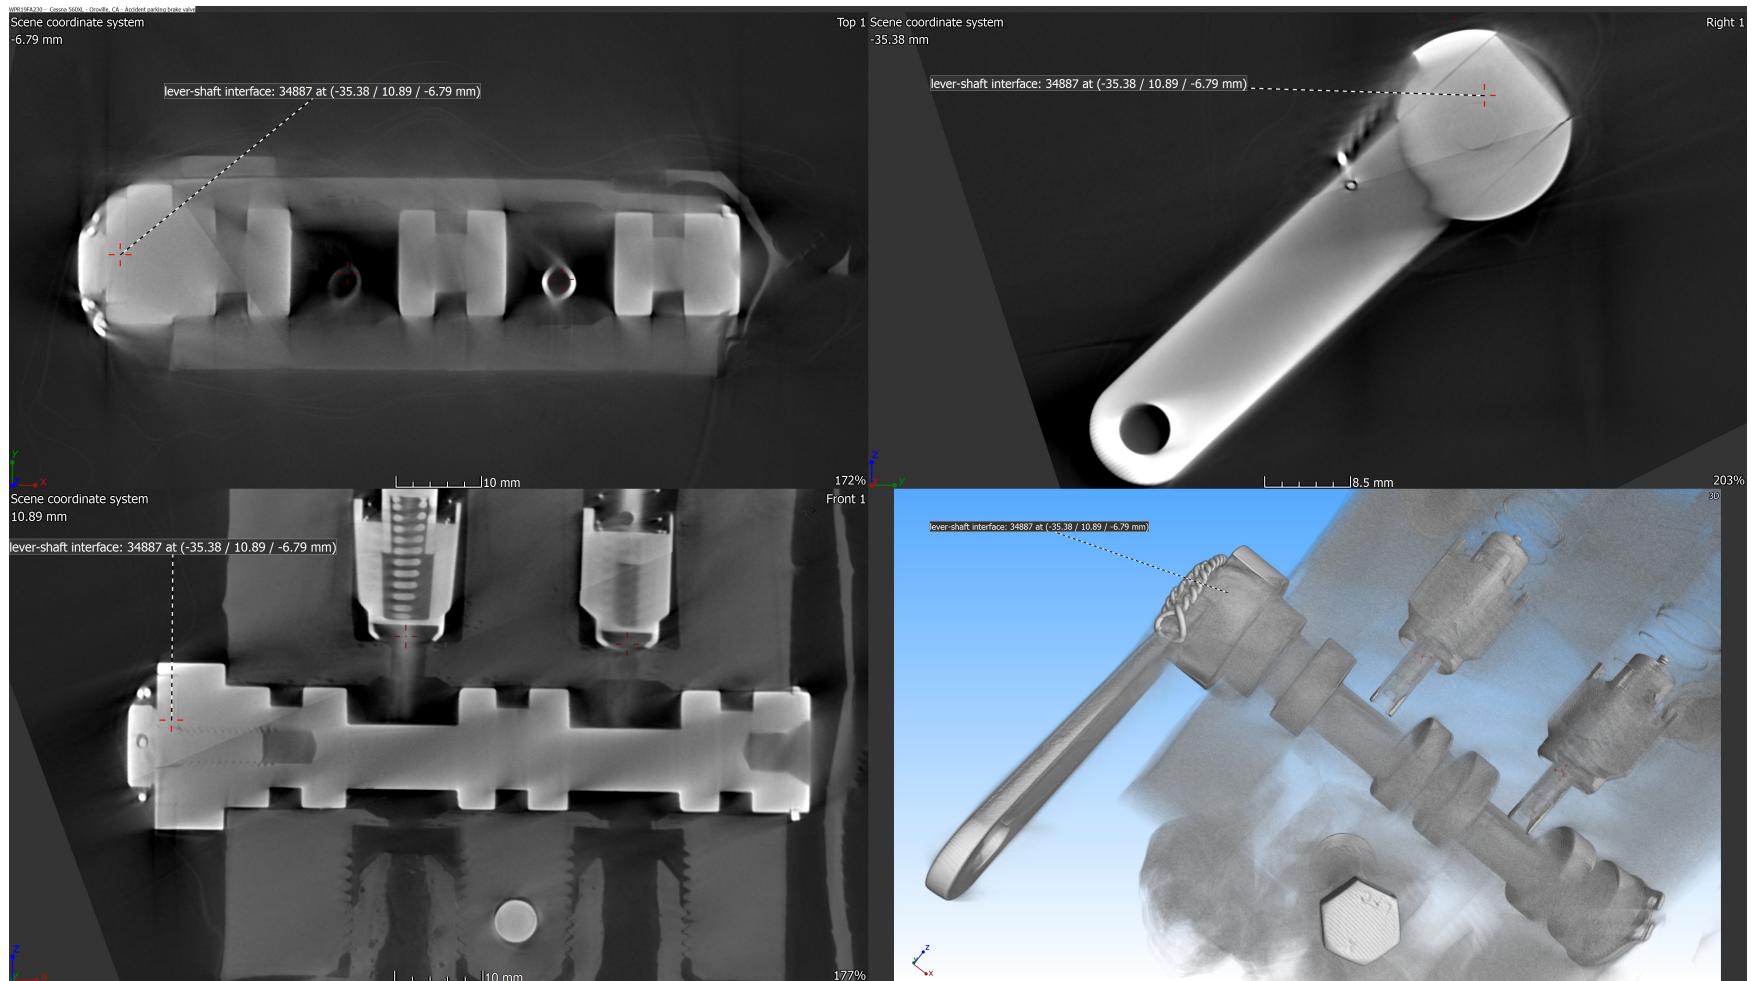
Figure 7  
Accident parking brake valve – lever to shaft interface

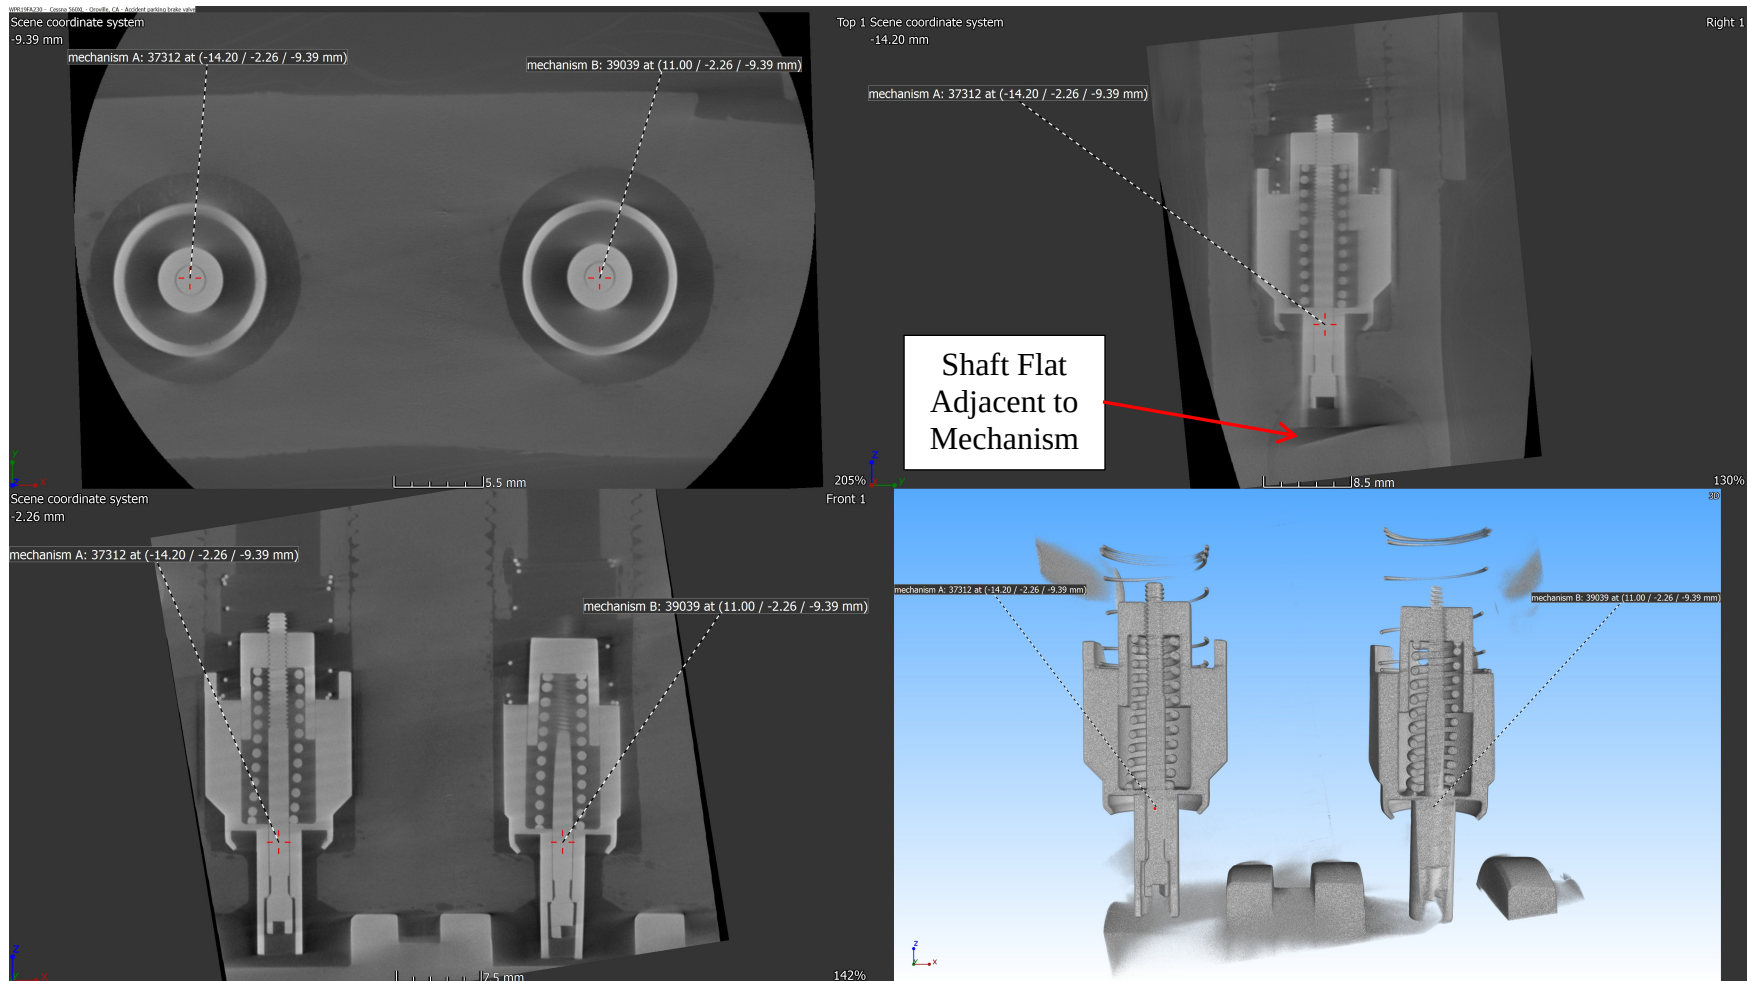
5. For the accident valve, there were indications of distorted fittings and other valve material that were consistent with thermal damage to the valve;

Figure 8  
Accident parking brake valve – target CT - mechanism A

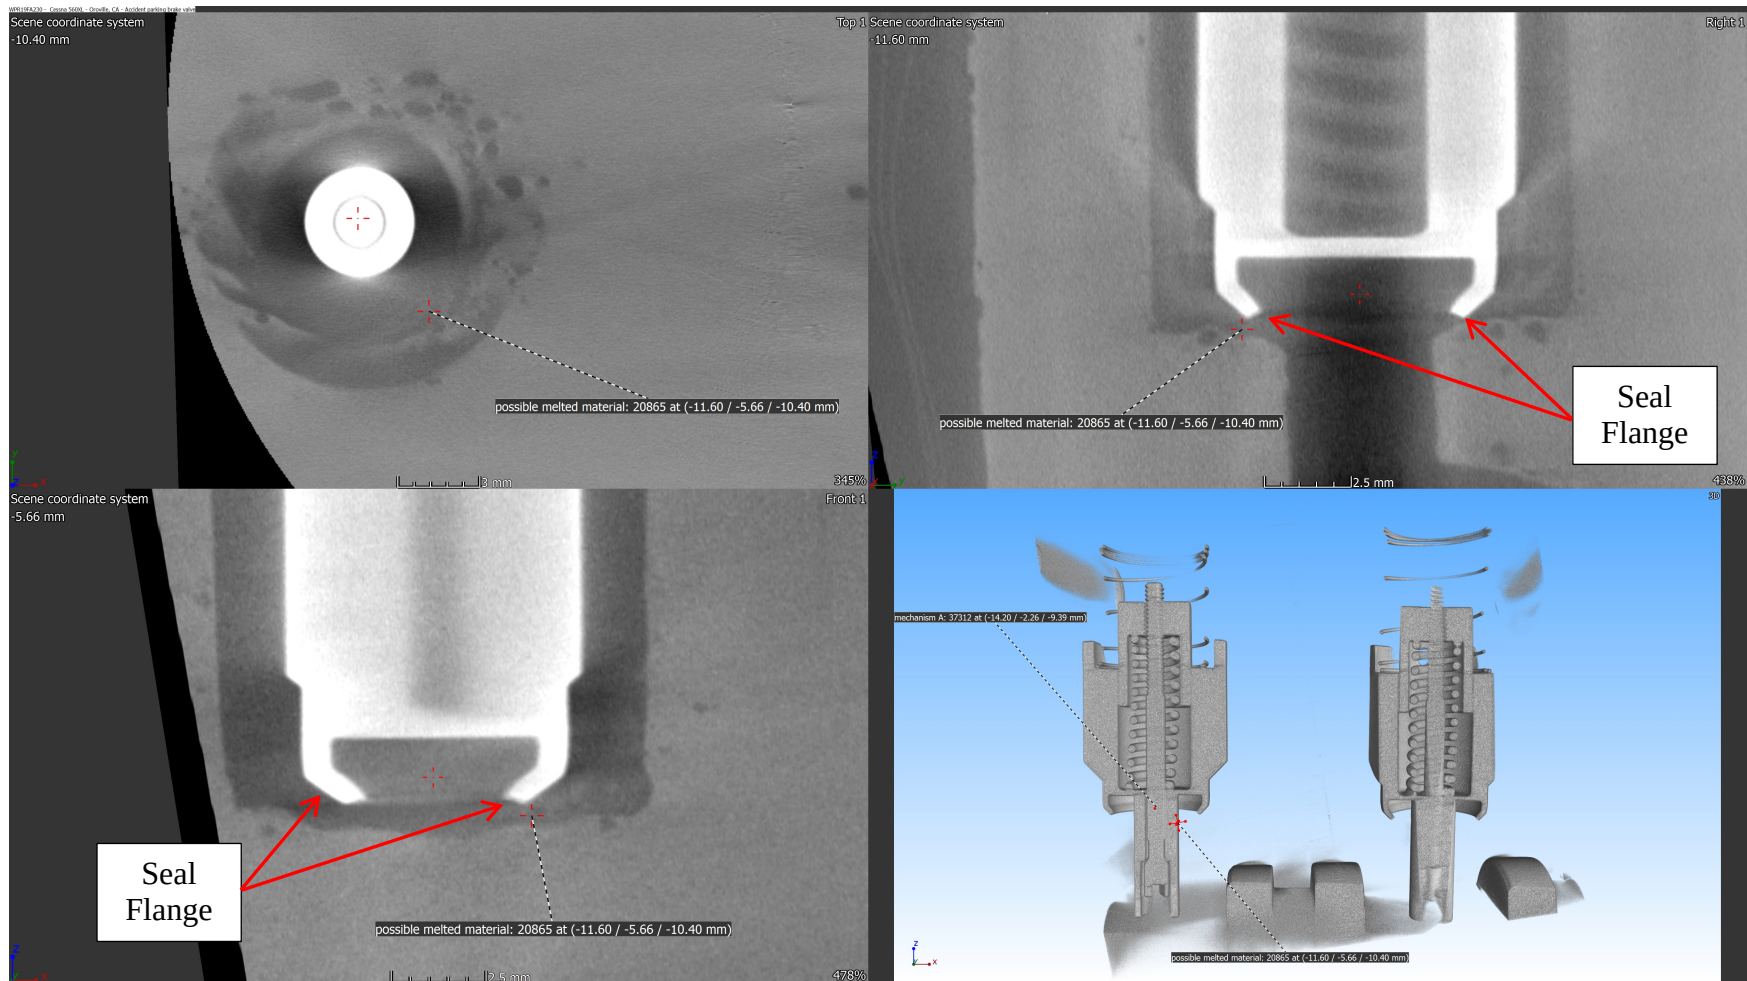
6. For the accident valve, the mechanism seals were not present, and there were indications of melted material at the bottom of the mechanisms in the area of the seal flanges;

Figure 9  
Accident parking brake valve – target CT – mechanism A - possible melted material

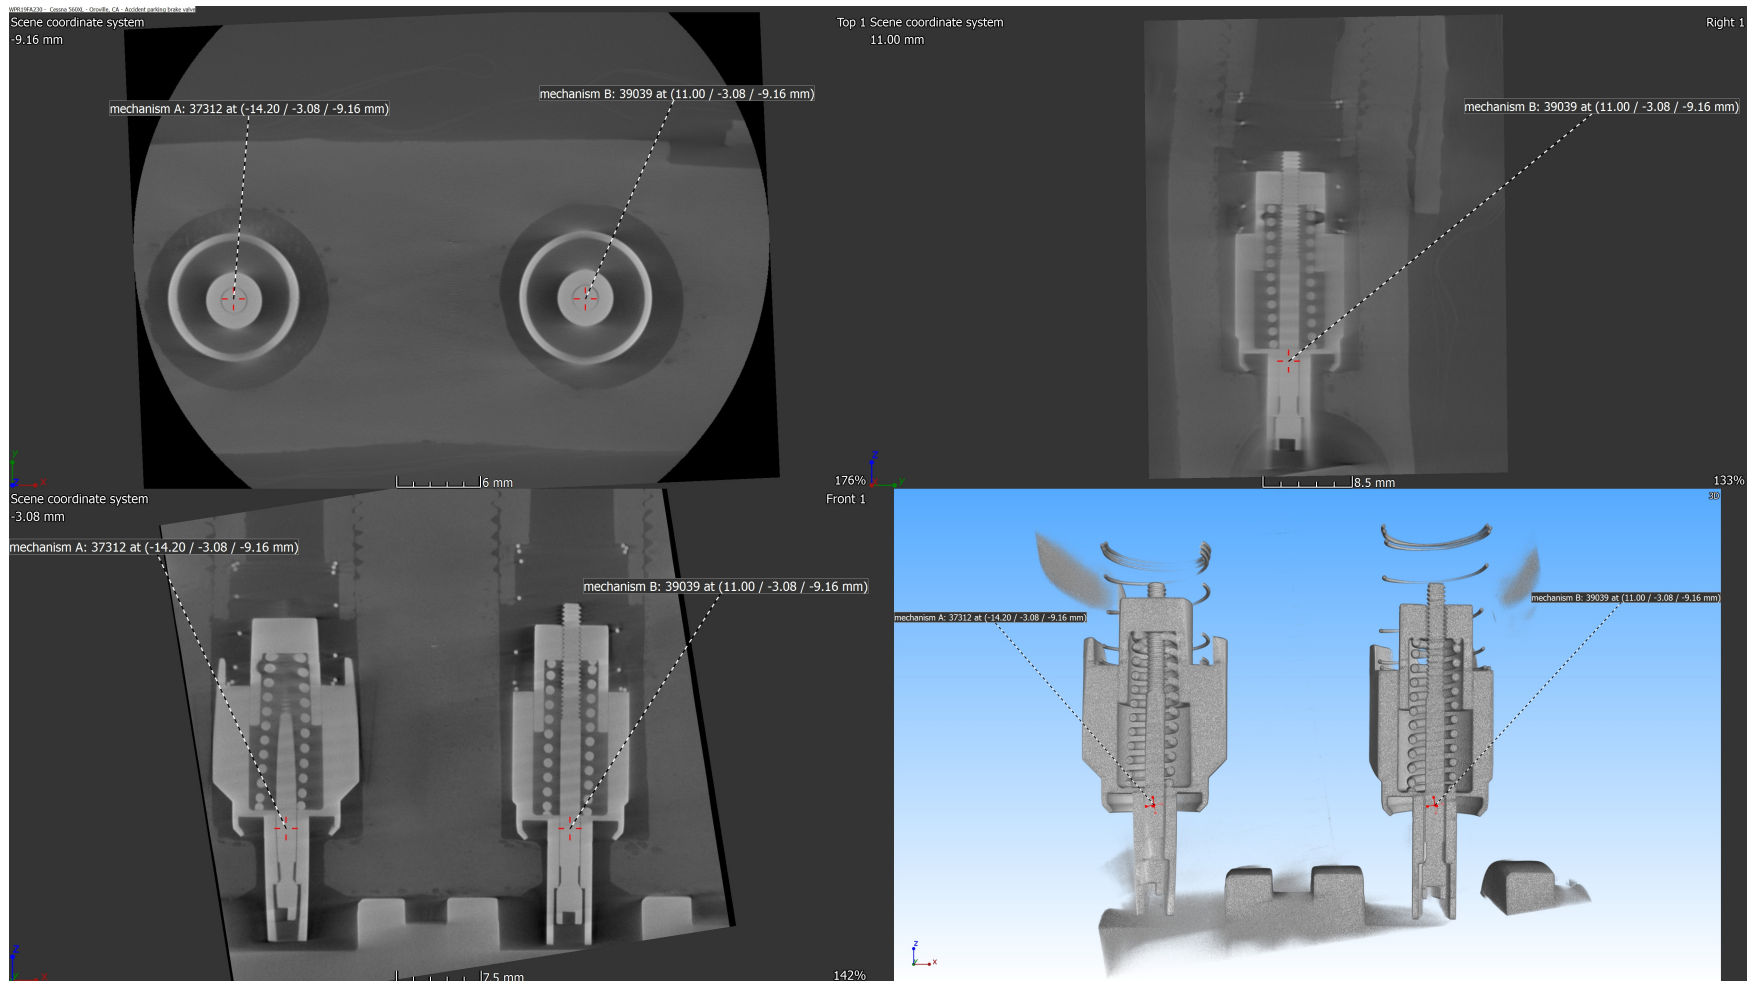
Figure 10  
Accident parking brake valve – target CT - mechanism B

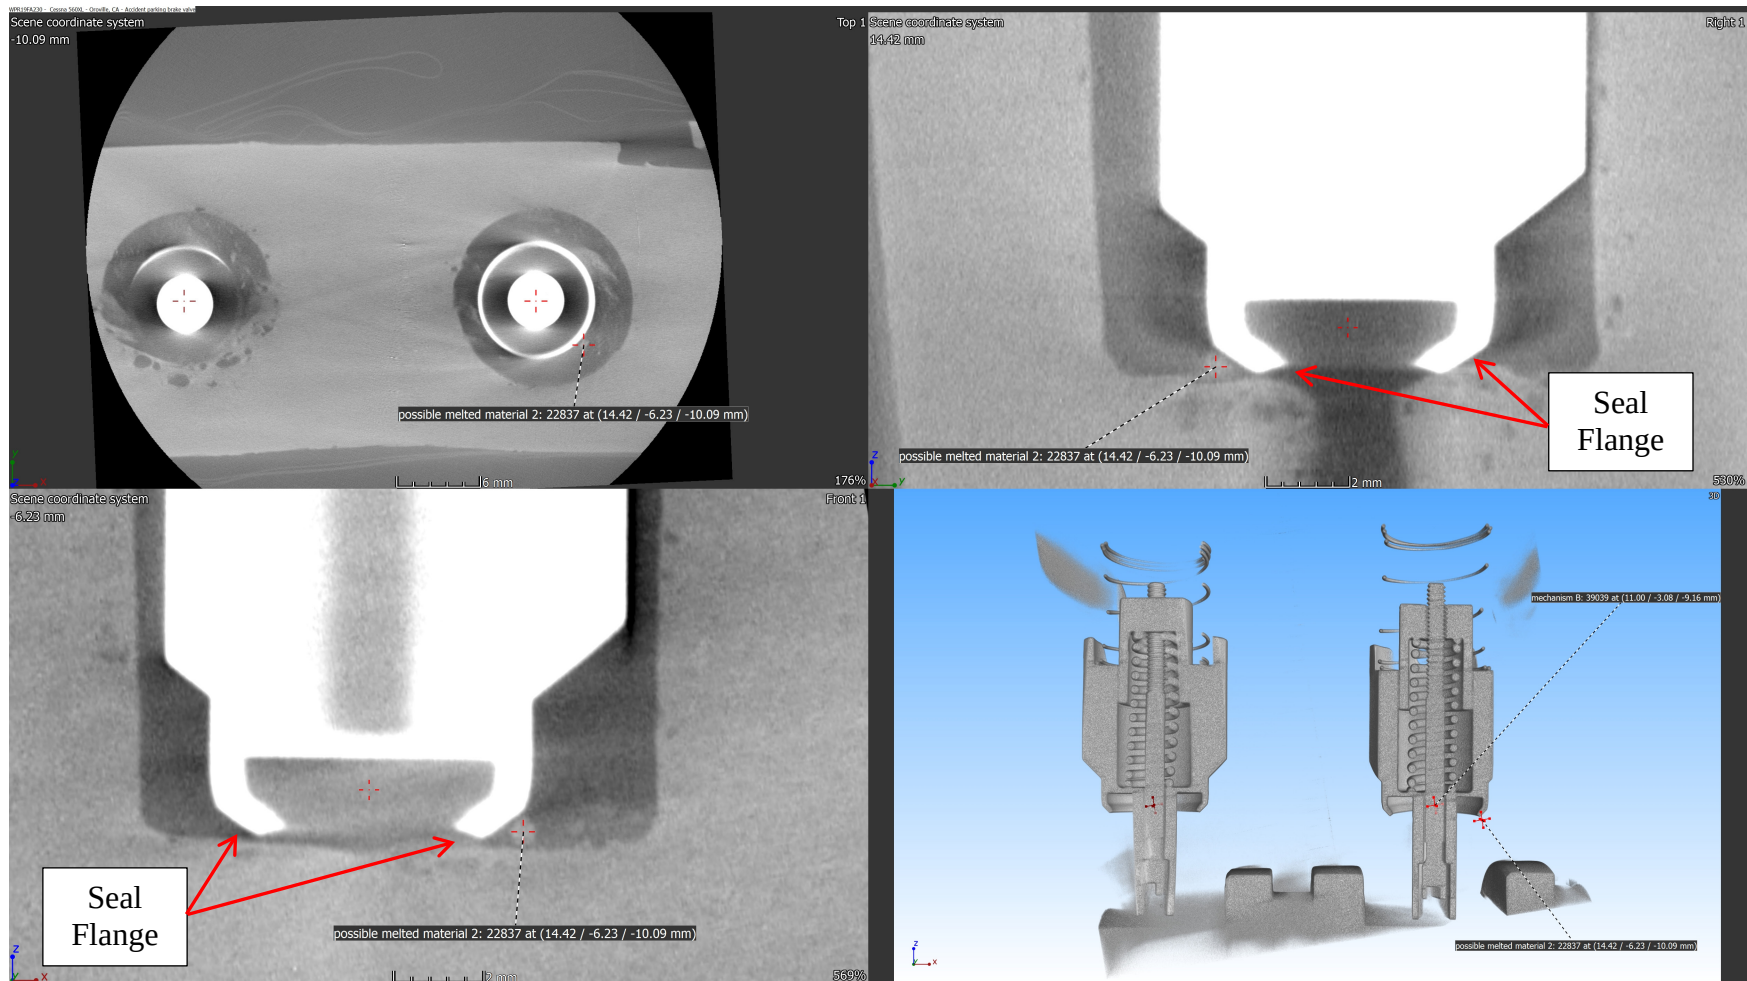
Figure 11  
Accident parking brake valve – target CT - mechanism B – possible melted material

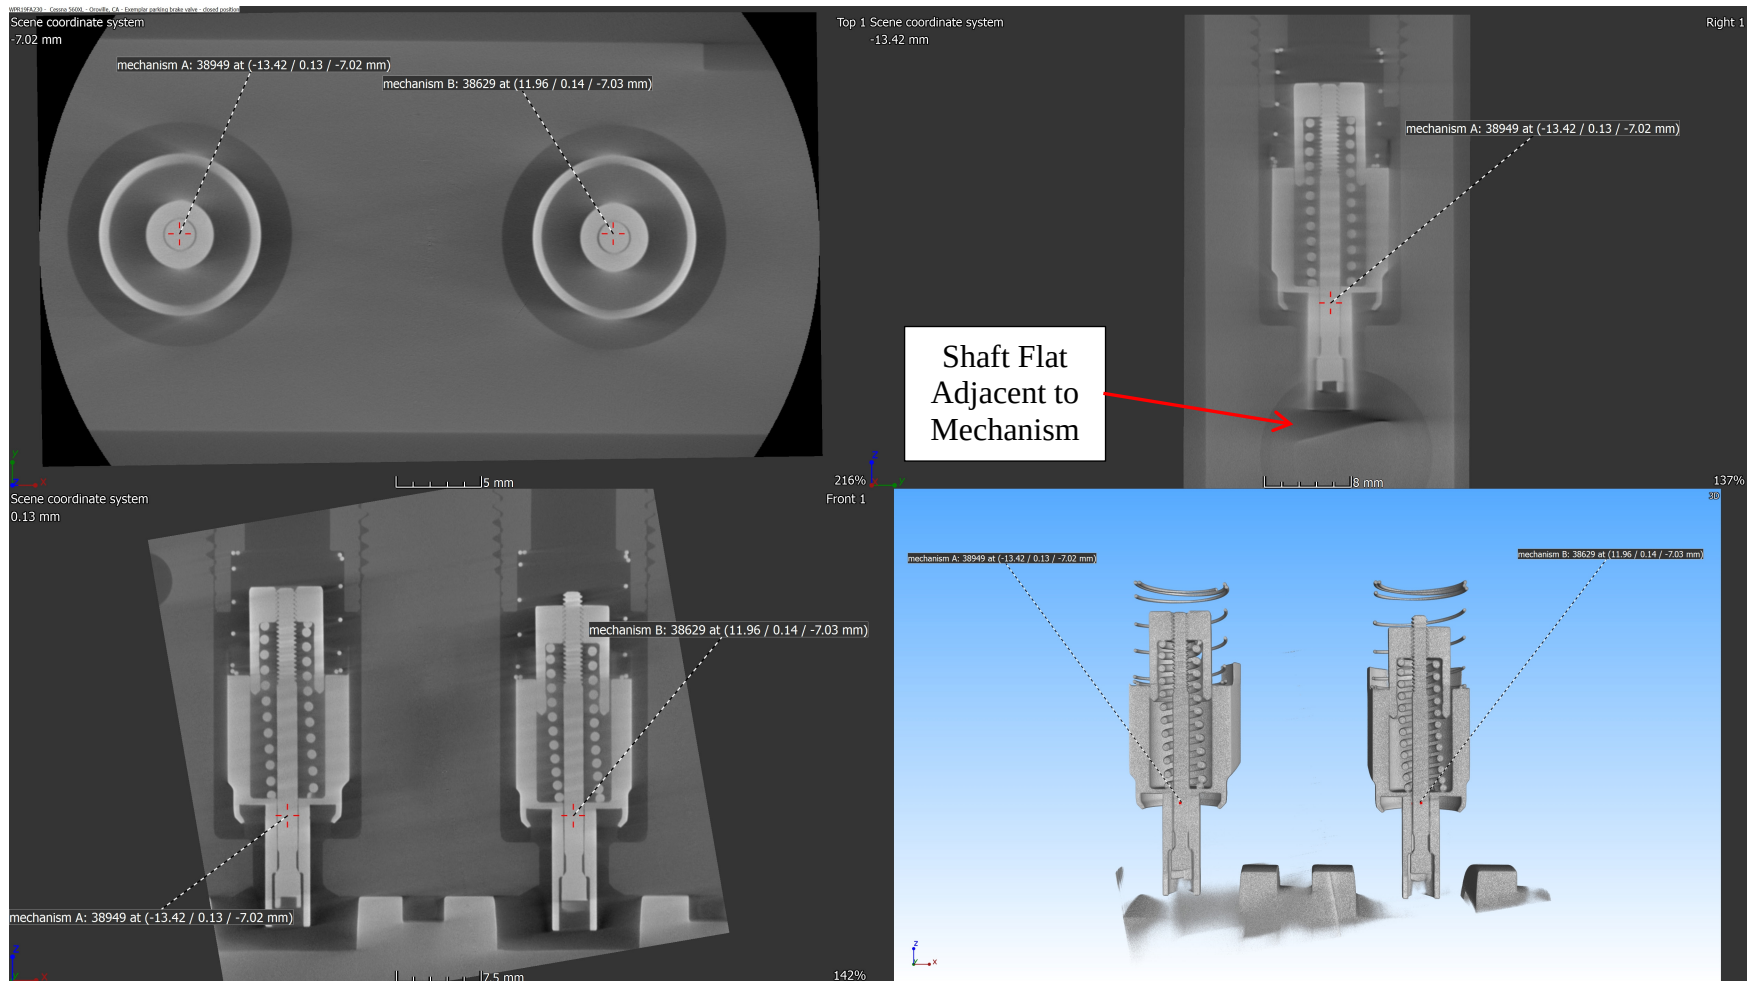
Figure 12  
Exemplar parking brake valve – target CT - closed position - mechanism A

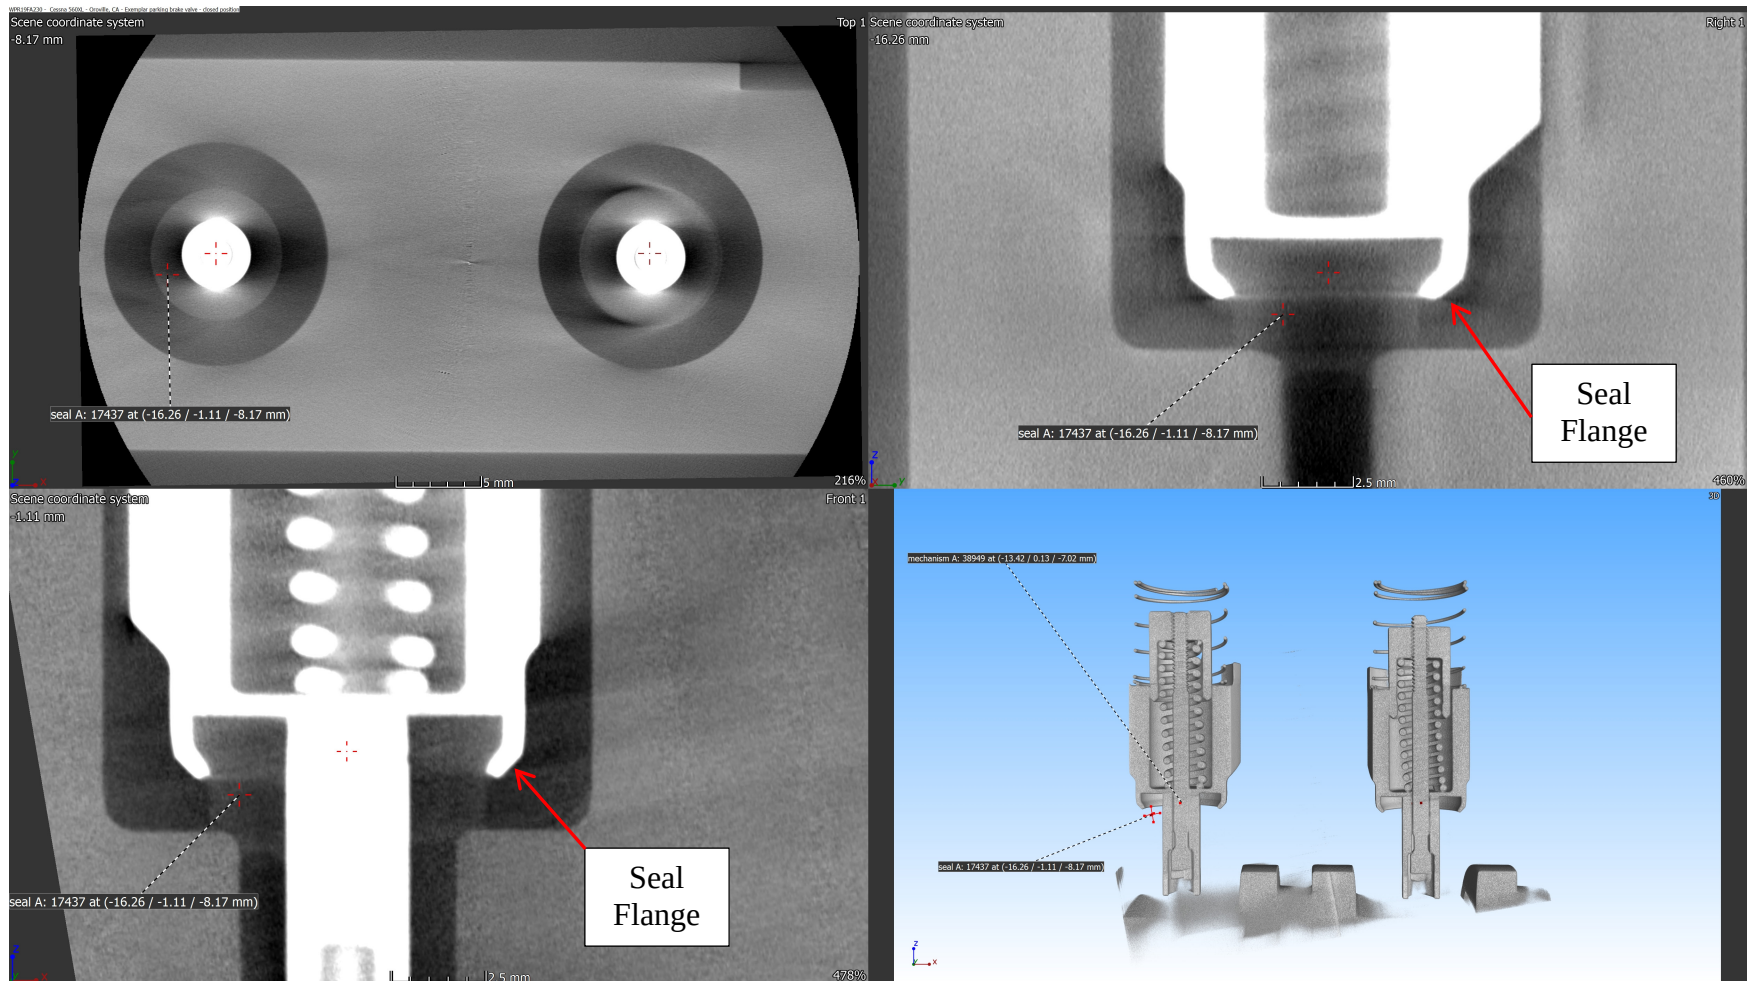
7. For the exemplar valve, indications of the mechanism seals were visible. The seals appeared to be seated in the seal flanges;
8. For the exemplar valve, the mechanism seals appeared to be sealed against the valve housing when the valve was in the closed position. The mechanism seals appeared to have a gap between the seal and the valve housing when the valve was in the open position;

Figure 13  
Exemplar parking brake valve – target CT - closed position - mechanism A – seal
