**NATIONAL TRANSPORTATION SAFETY BOARD**

**Computed Tomography Specialist's Factual Report**

WPR19FA230

Location: Oroville Municipal Airport (OVE), Oroville, California  
Date: August 21, 2019  
Time: 1132 Pacific daylight time  
Airplane: Cessna 560XL airplane, N91GY

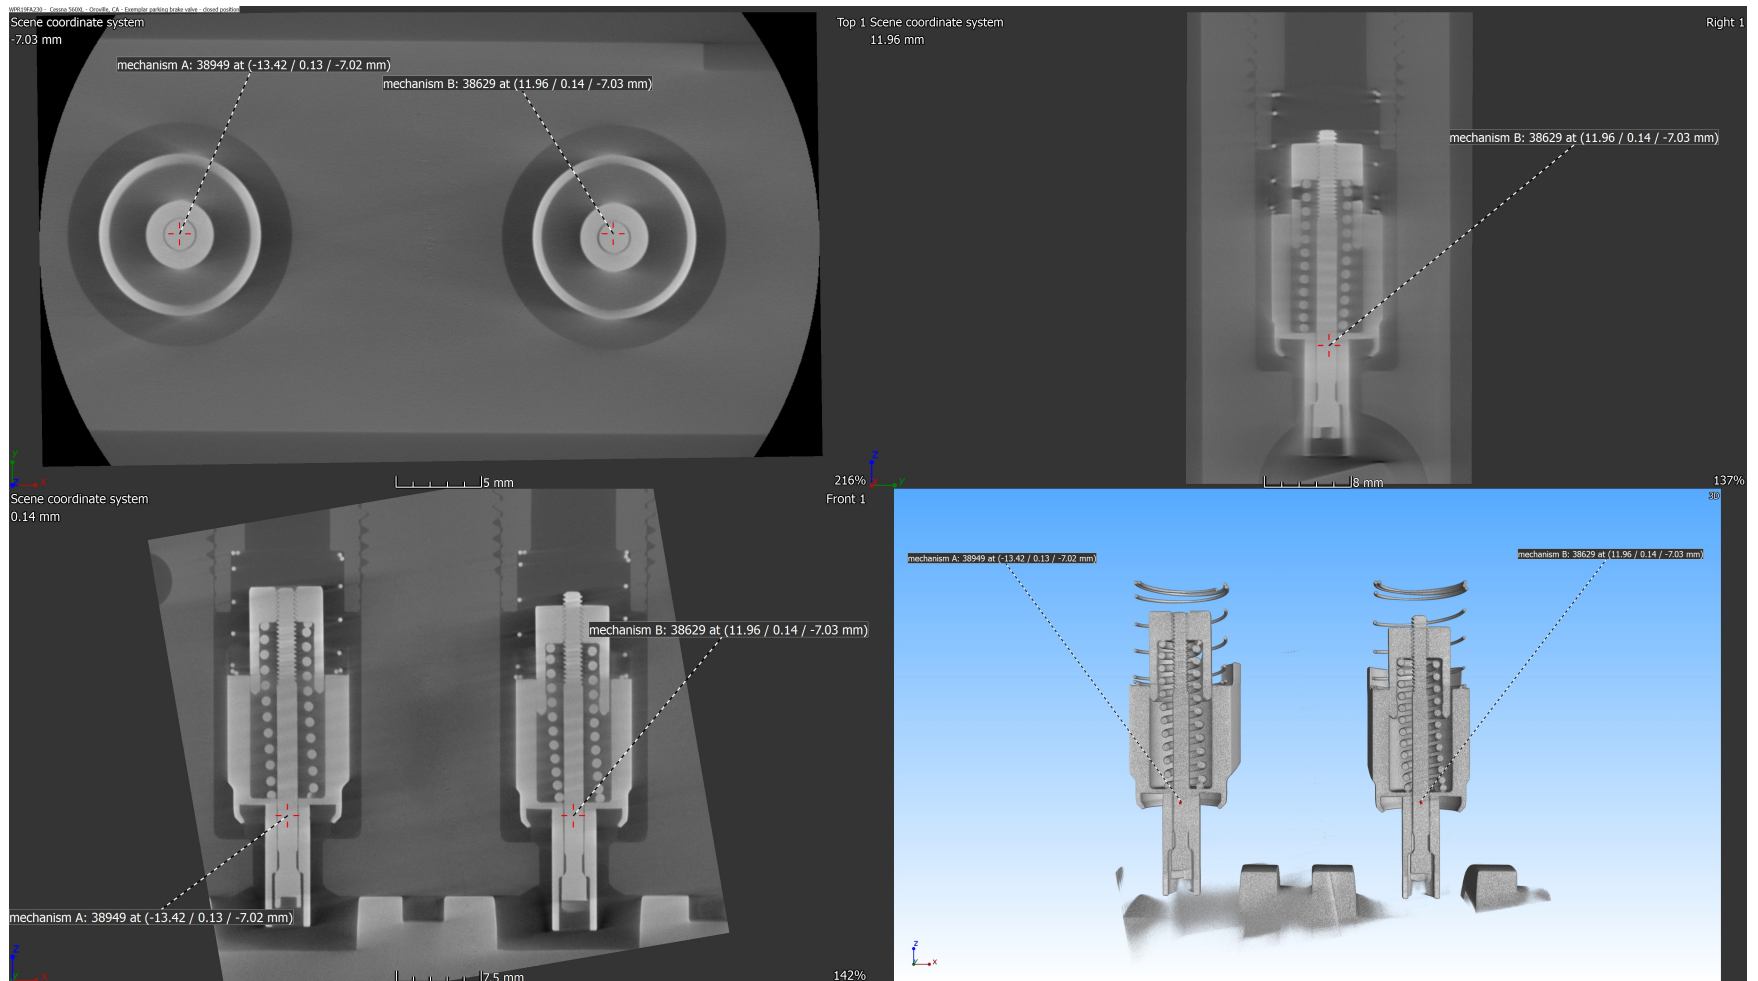
Figure 14  
Exemplar parking brake valve – target CT - closed position - mechanism B

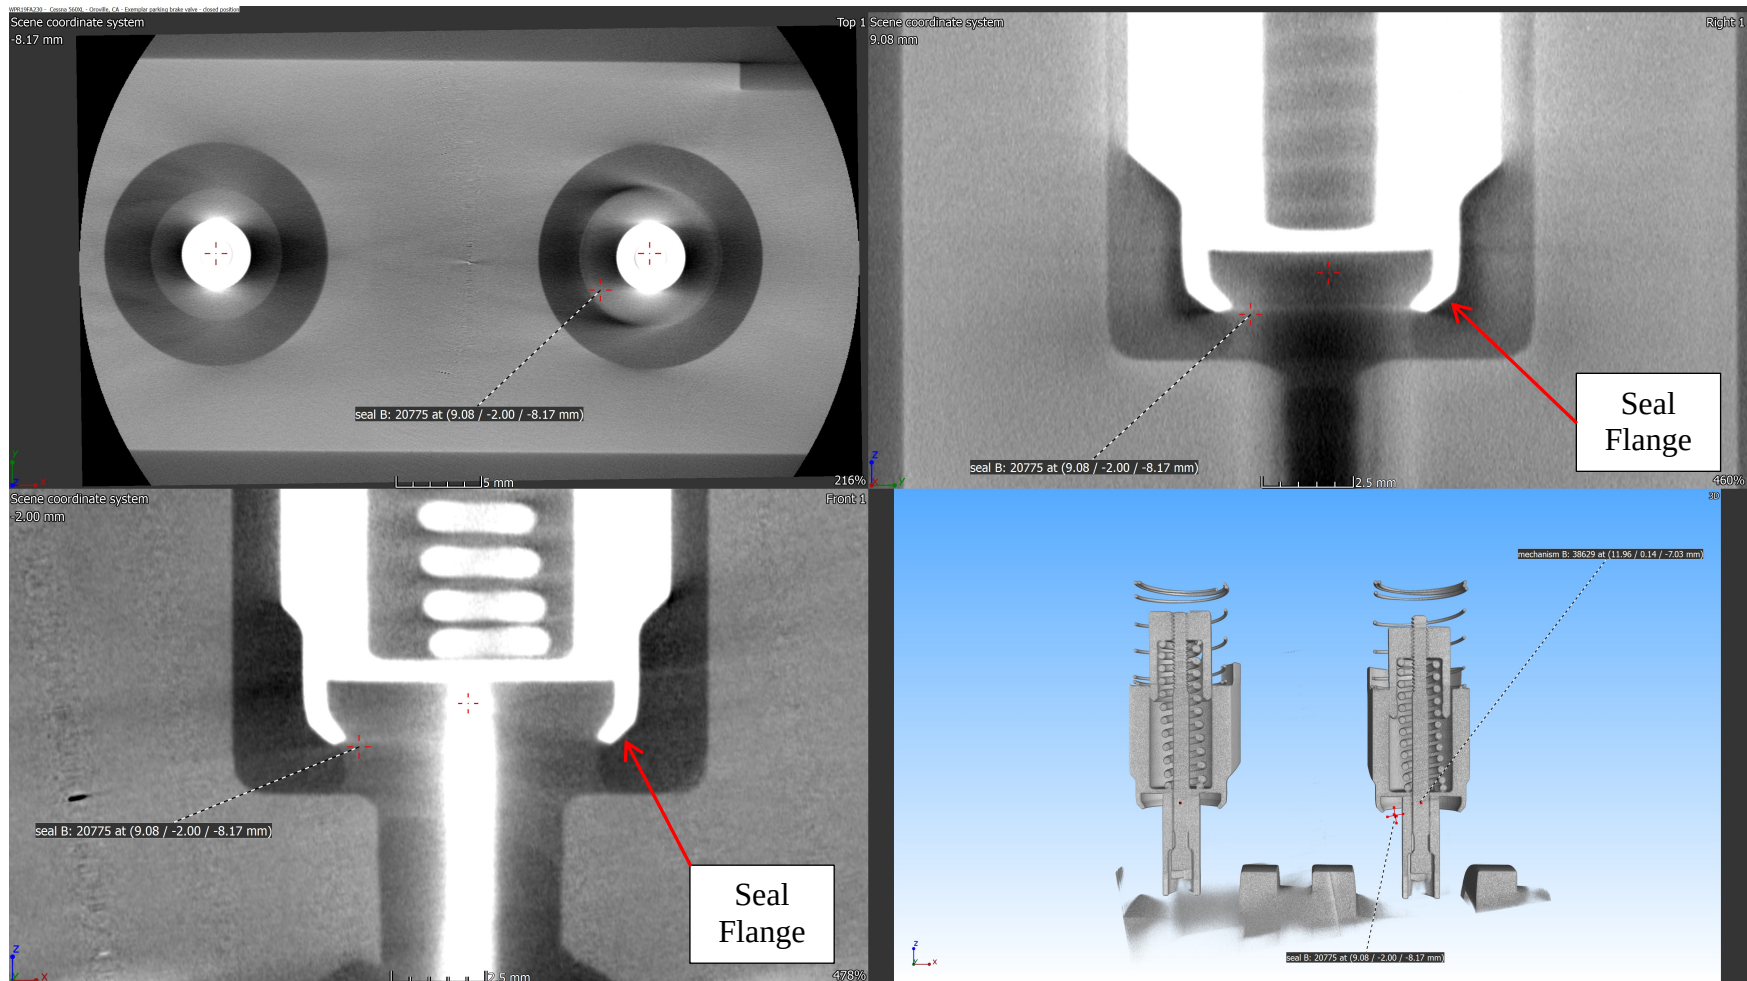
7. For the exemplar valve, indications of the mechanism seals were visible. The seals appeared to be seated in the seal flanges;
8. For the exemplar valve, the mechanism seals appeared to be sealed against the valve housing when the valve was in the closed position. The mechanism seals appeared to have a gap between the seal and the valve housing when the valve was in the open position;

Figure 15  
Exemplar parking brake valve – target CT - closed position - mechanism B – seal

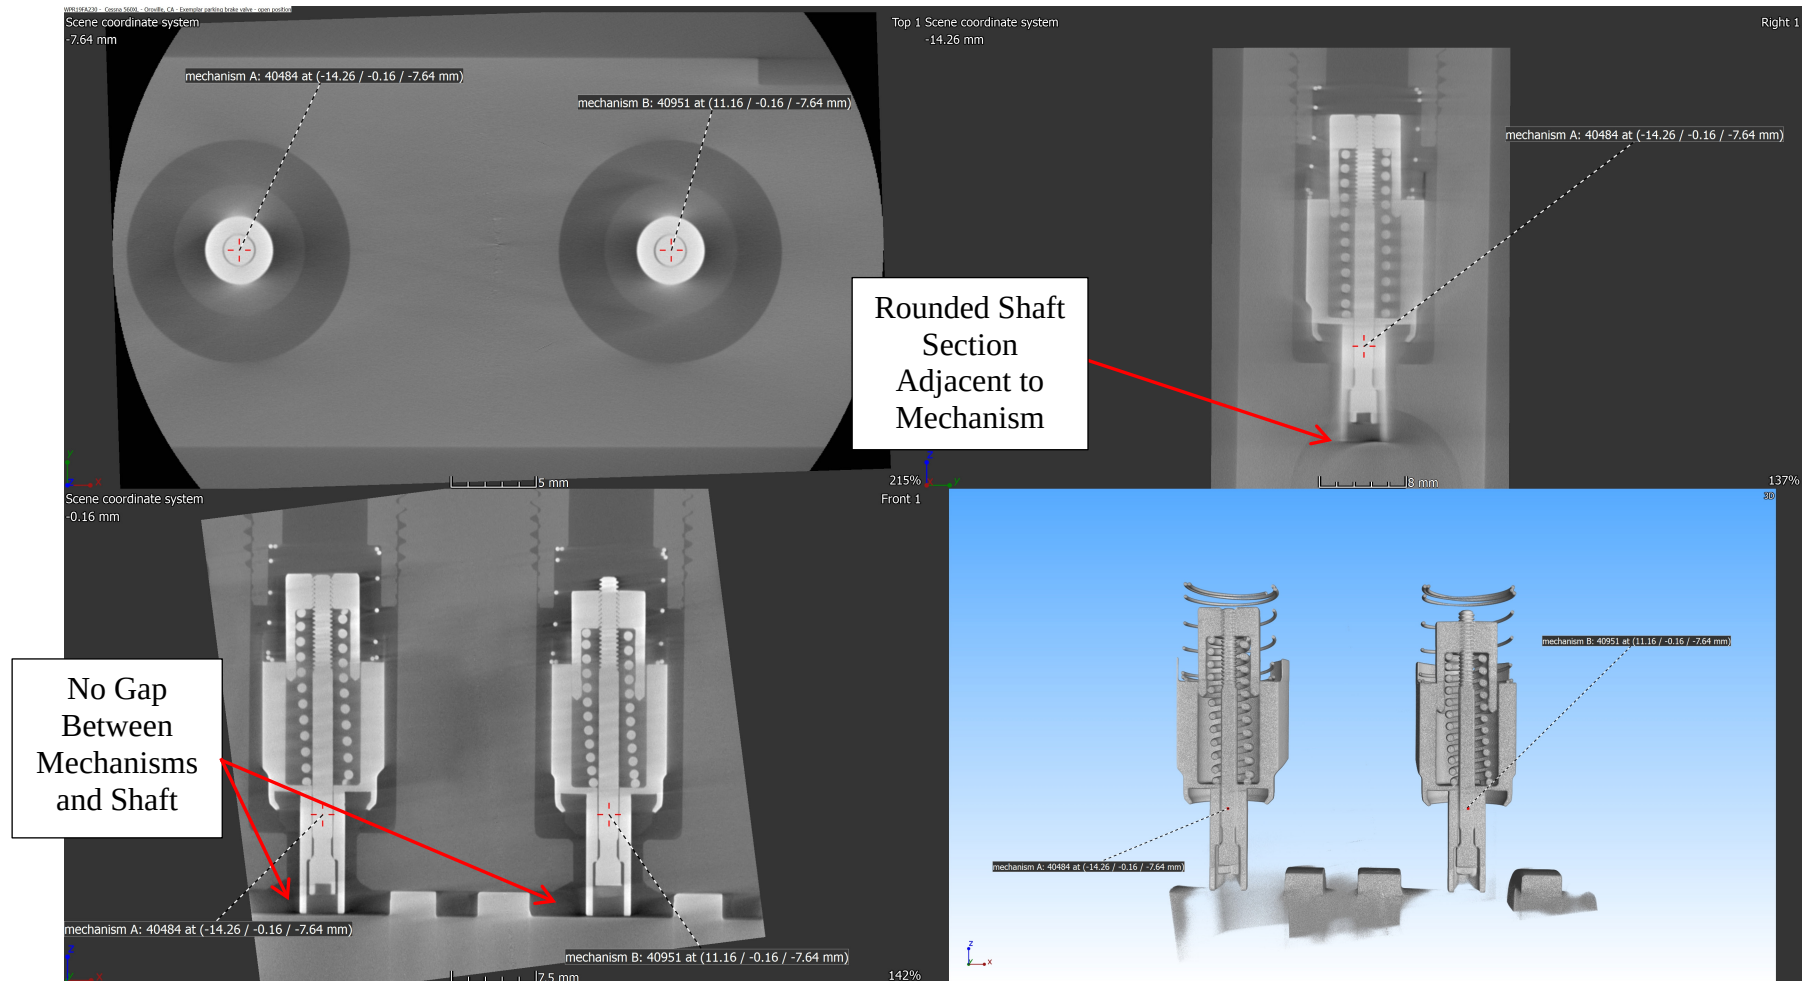
Figure 16  
Exemplar parking brake valve – target CT - open position - mechanism A

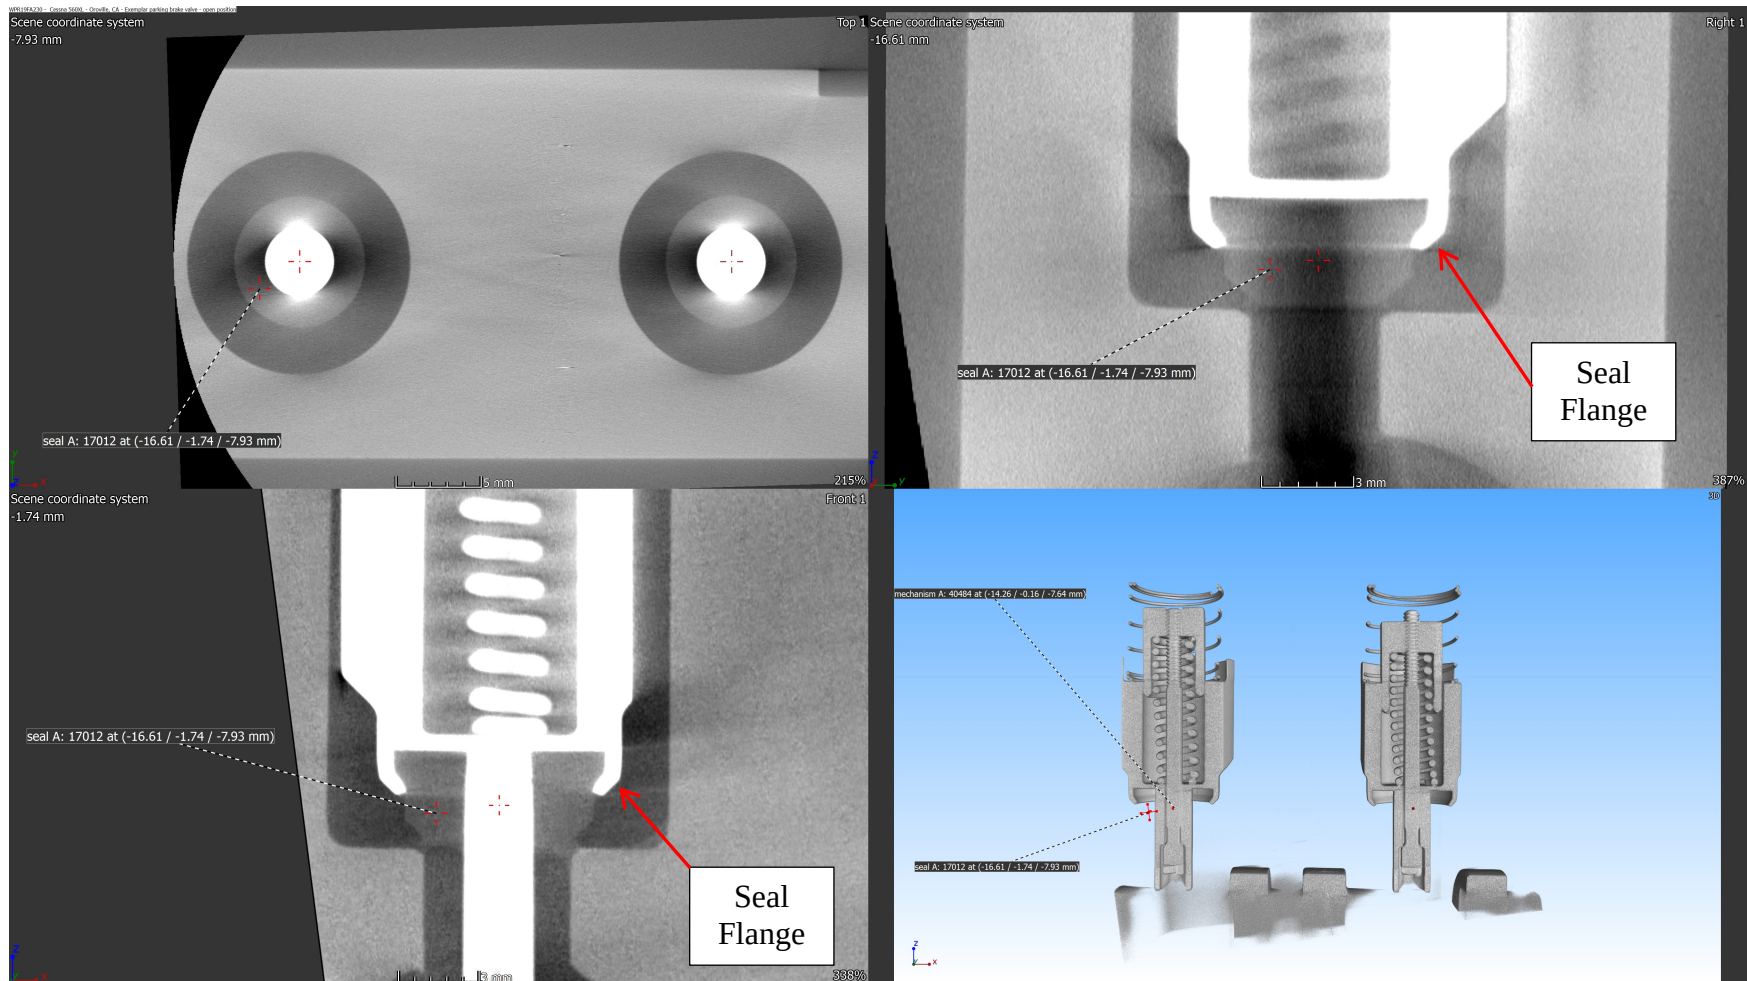
Figure 17  
Exemplar parking brake valve – target CT - open position - mechanism A – seal

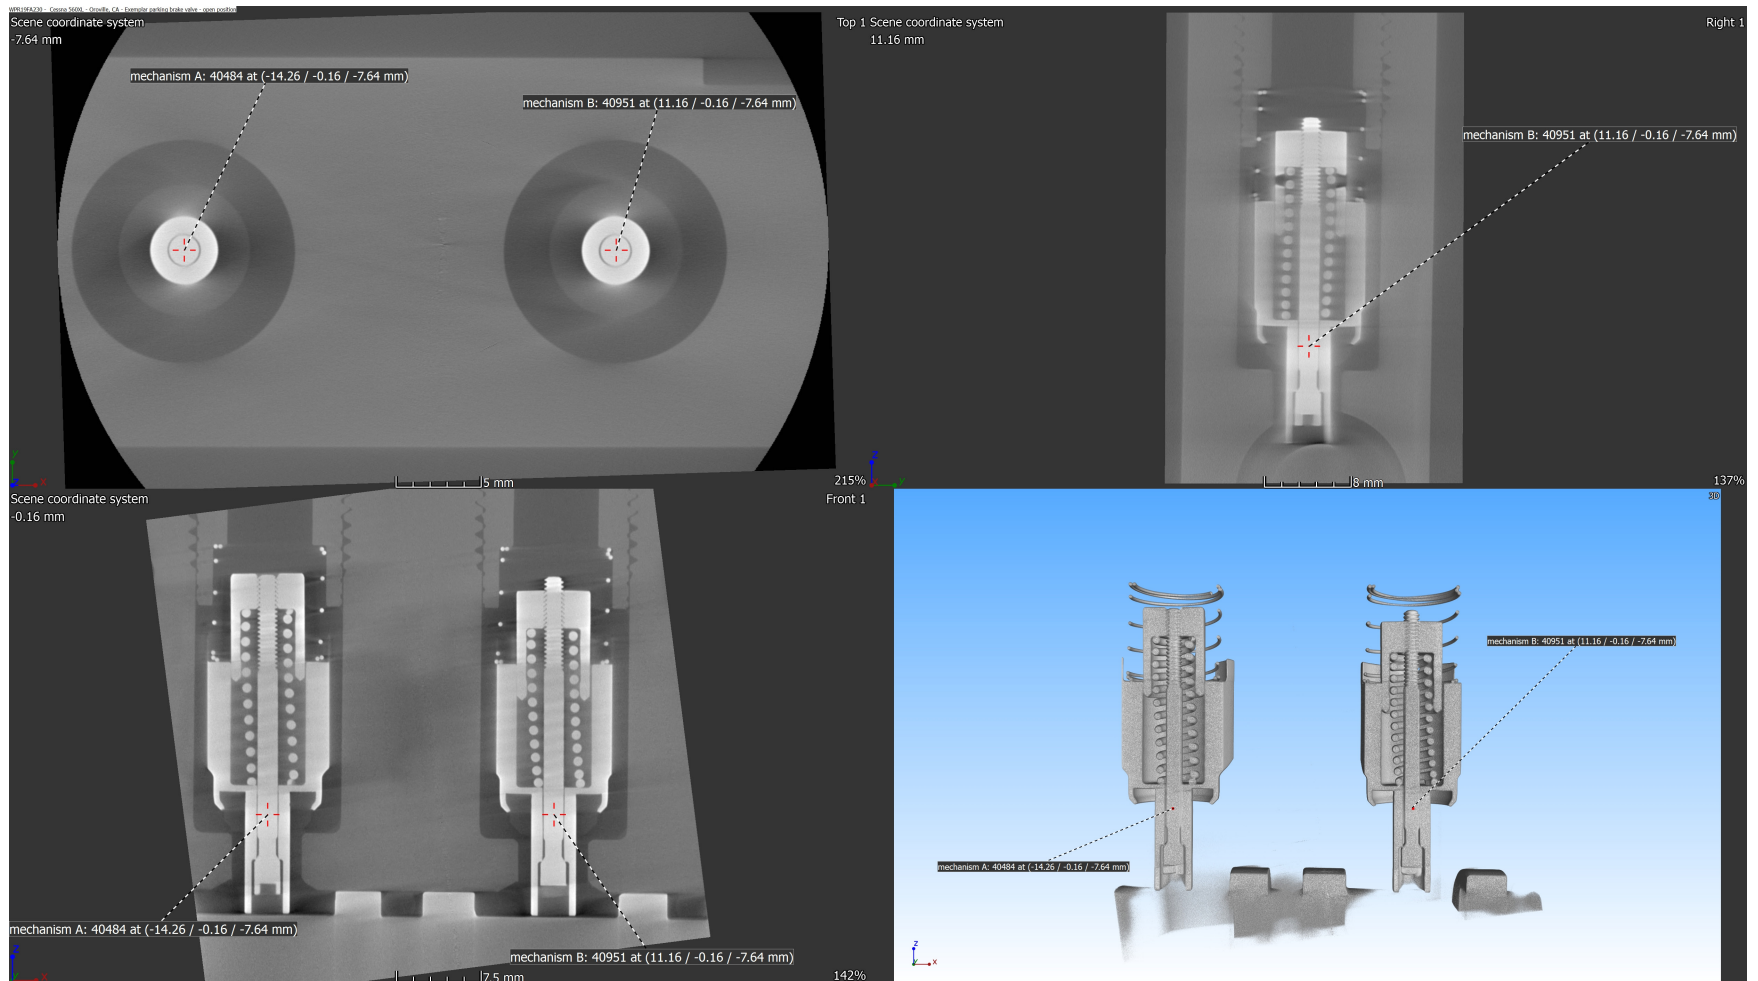
Figure 18  
Exemplar parking brake valve – target CT - open position - mechanism B

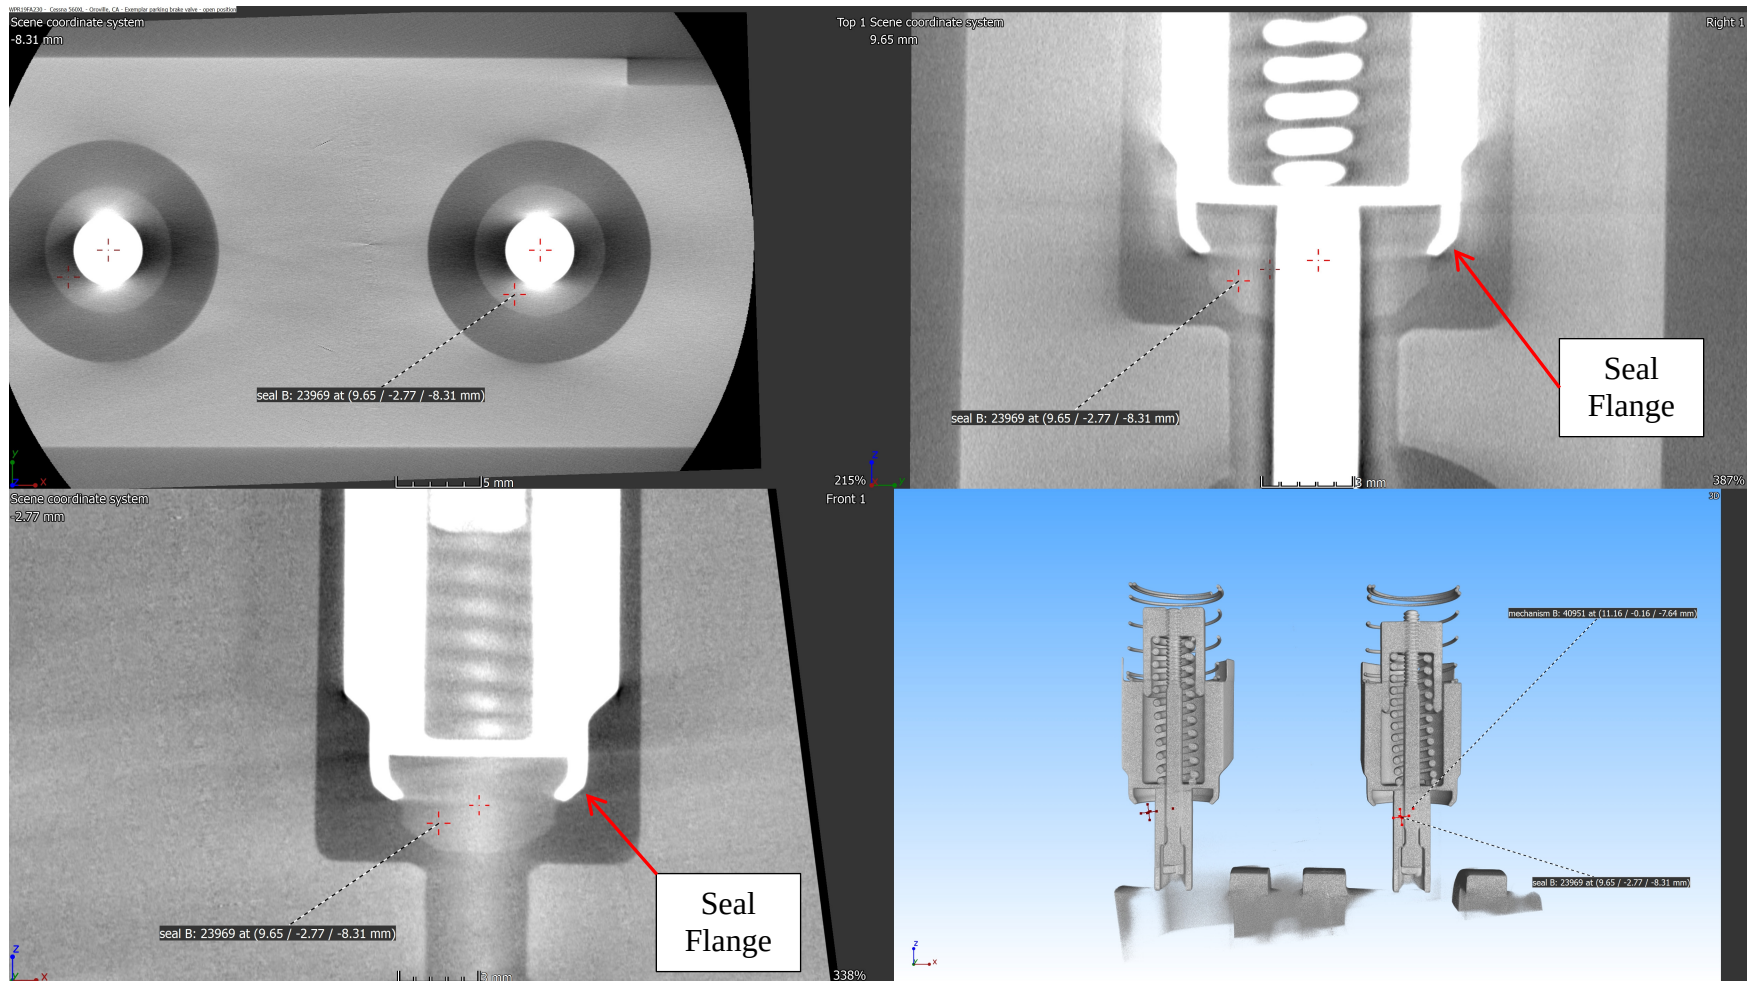
Figure 19  
Exemplar parking brake valve – target CT - open position - mechanism B – seal
