## **National Transportation Safety Board**

### **Group Chairman's Factual Report**

## **OPERATIONAL FACTORS**

WPR19FA230

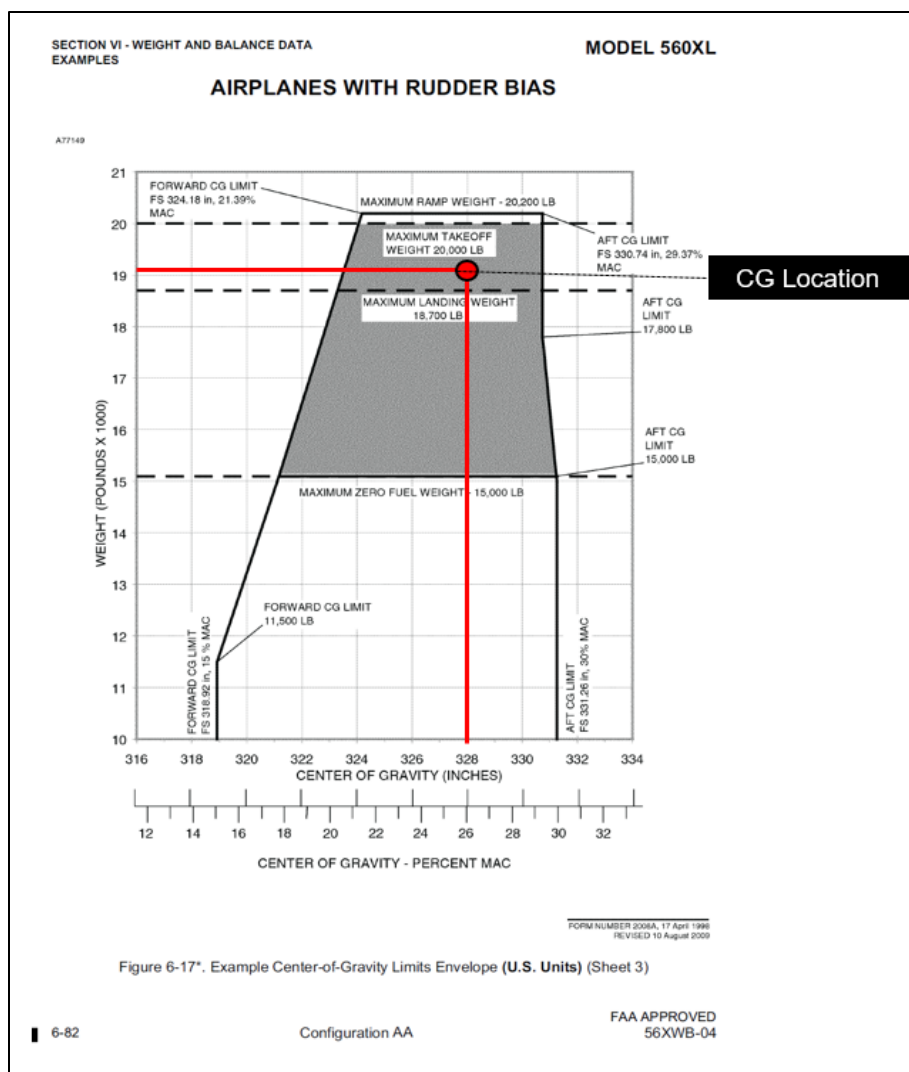
**Figure 3: Center of Gravity Location Utilizing Actual Weights for all Occupants and Baggage**

The recreation of weight and balance utilizing the actual reported weights for all passengers and baggage resulted in the airplane being 142 lbs. over the maximum zero fuel weight limitation of 15,000 lbs. The takeoff weight was 19,112 lbs., which was under the maximum takeoff weight of 20,000 lbs., and according to the AFM center of gravity envelope, the airplane was within the limits.

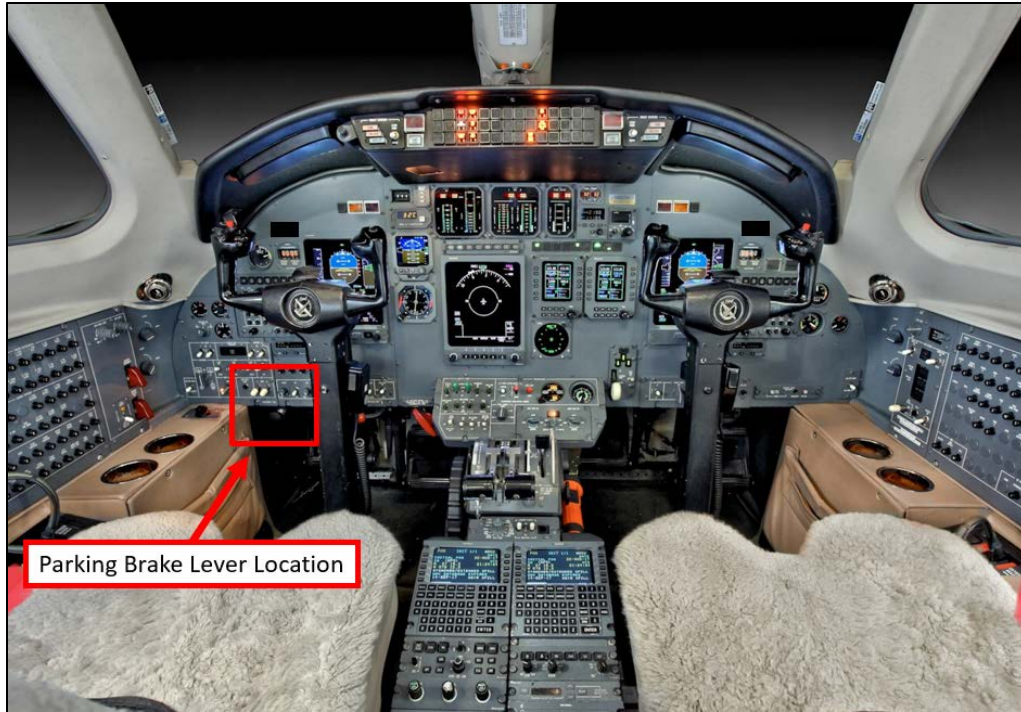
**Figure 8: Overview of exemplar cockpit and location of parking brake lever**

Review of the airplane operating manual, flight manual and normal checklist procedures manual found that there was no guidance on how a pilot may achieve maximum brake pressure (stopping power) through the use of the parking brake as it relates to the toe brake pressure required, prior to manipulating the parking brake lever.

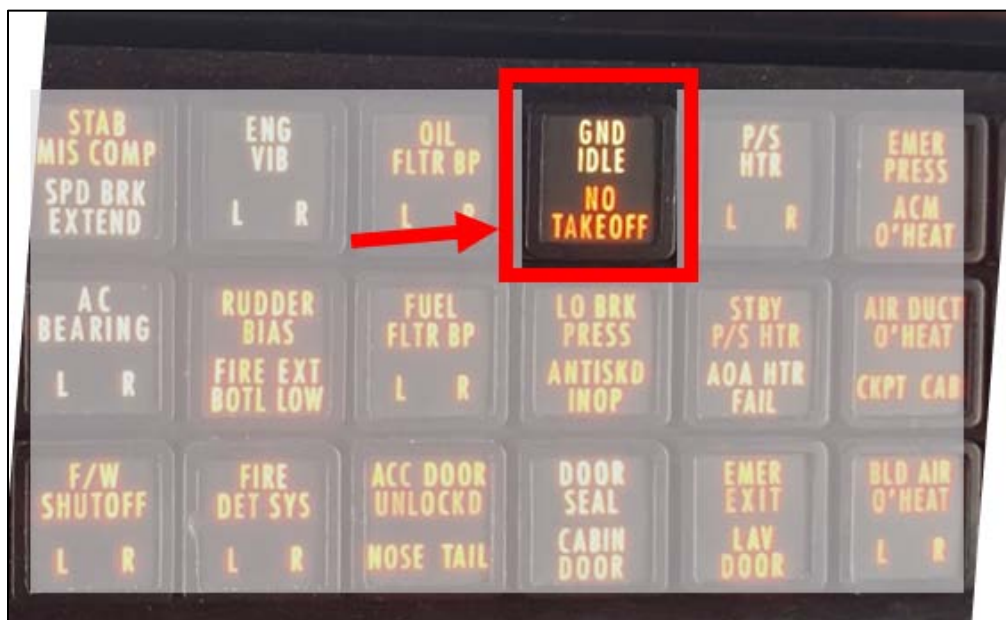
**Figure 14: Exemplar No Takeoff Annunciator**

According to the CVR Factual Report, about one minute and 30 seconds prior to takeoff, the flight crew discussed a no takeoff annunciator illuminated in the cockpit and that the autopilot had engaged. The flight crew discussed that an iPad (EFB) had accidentally shifted and engaged the autopilot. Subsequently, a sound consistent with the autopilot being disconnected was heard.

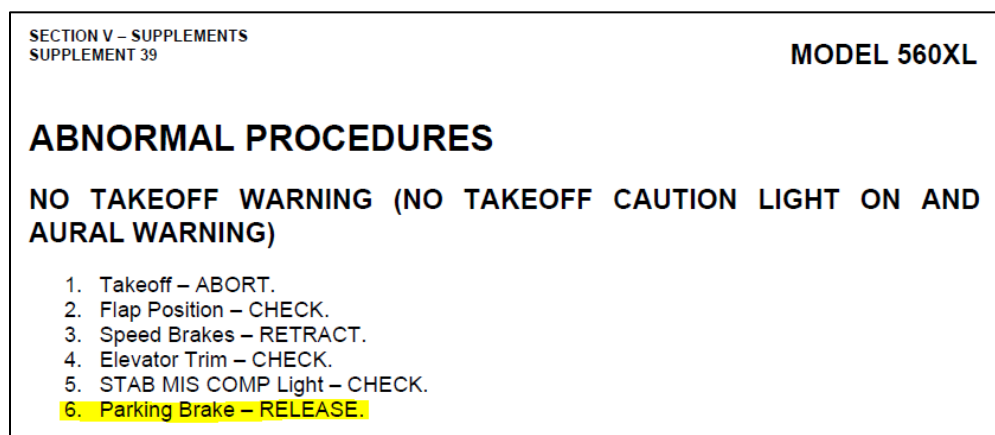
**Figure 15: AFM Supplement 39, No Takeoff Warning Procedures**

A review of Supplement 39 revealed that the no takeoff warning conditions and procedures included the parking brake.

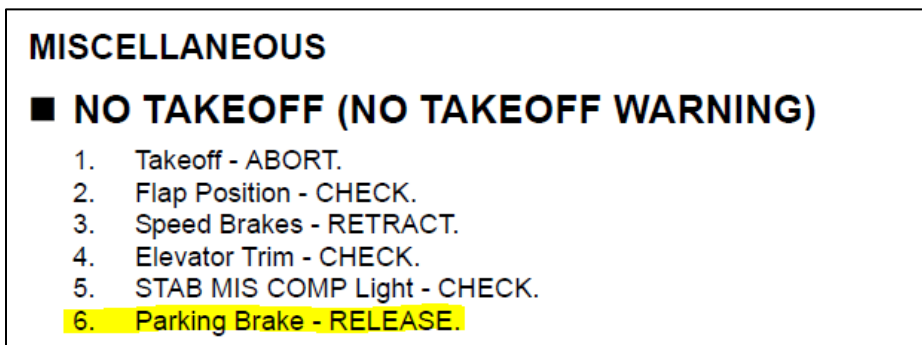
**Figure 16: AFM Supplement 57, No Takeoff Warning Procedures**

A review of Supplement 57 revealed that the no takeoff warning conditions and procedures included the parking brake.

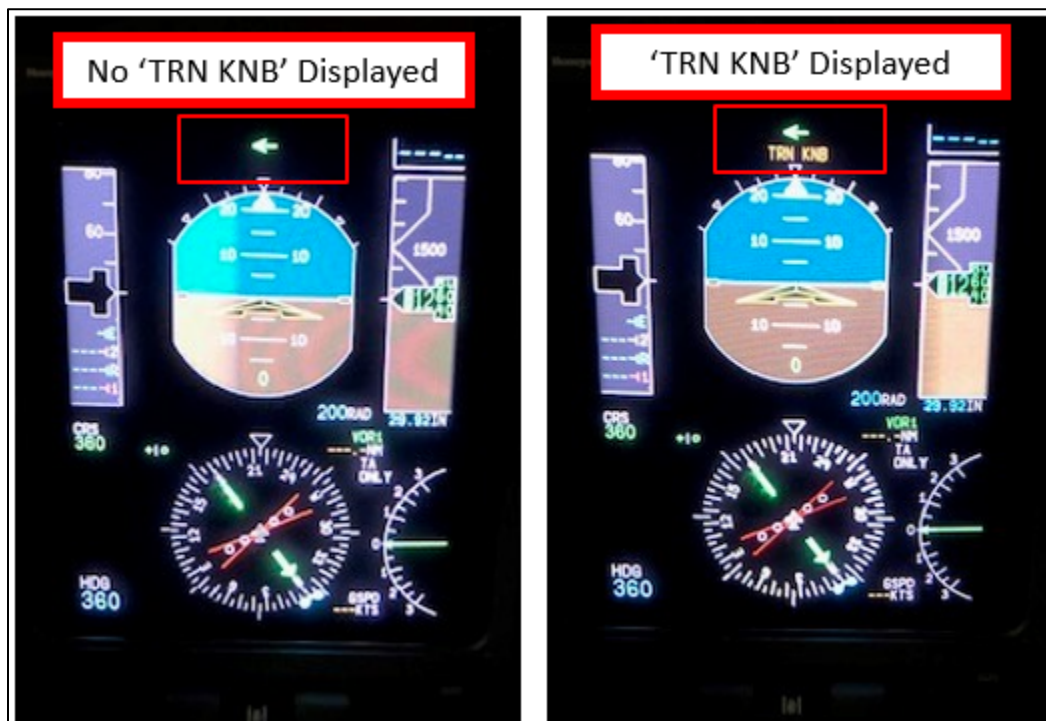
Figure 18: Exemplar Turn Knob Annunciator Message

According to the CVR Factual Report, about 30 seconds prior to the application of takeoff thrust, the flight crew discussed a turn knob annunciator that had illuminated in the cockpit. The SIC discussed that he did not know the meaning of the message and asked whether the PIC wanted to

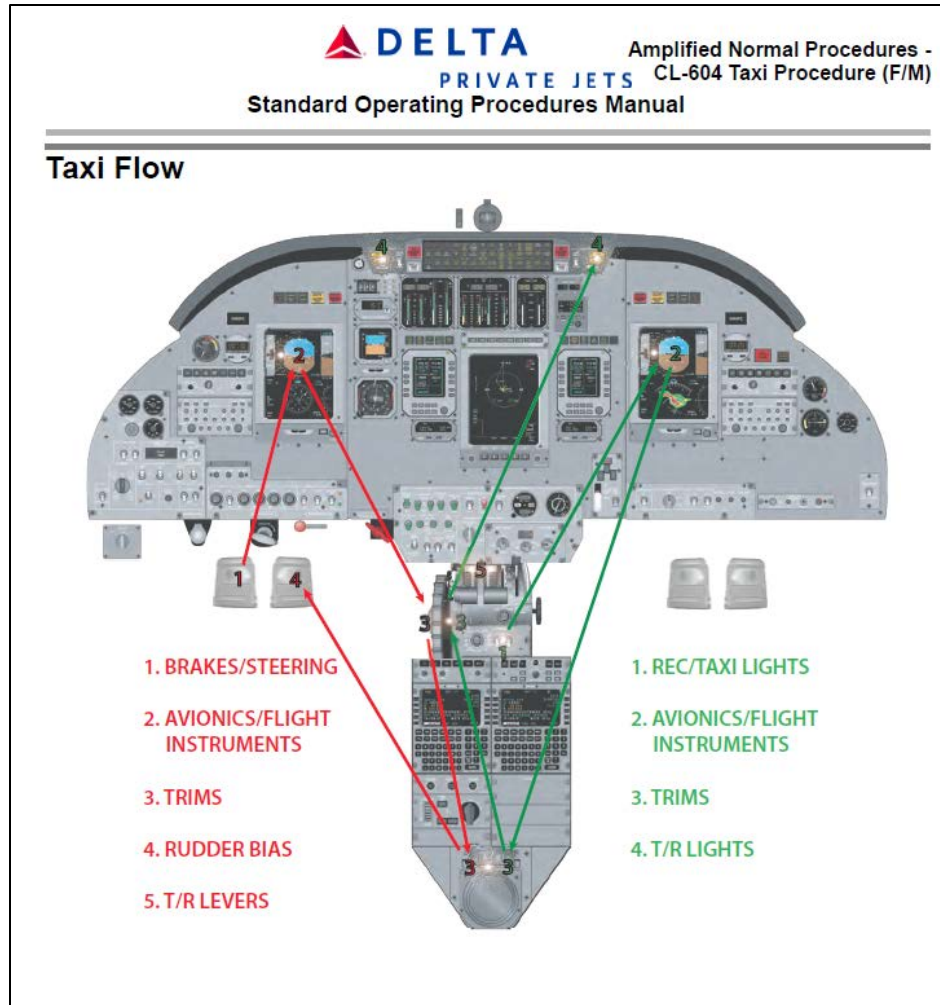
**Figure 22: The Taxi Flow Checklist**

Figure 22 denotes the taxi checklist flow as provided in the DPJ CE-560XL SOP’s. In reference to brakes in the taxi flow, the number one icon was labeled on the toe pedal brakes, rather than the parking brake.
