----- **SYSTEMS GROUP CHAIRMAN'S FACTUAL REPORT** -----

**1 ACCIDENT:**

Location: Oroville, California  
Date: August 21, 2019  
Time: About 1132 LCL  
Aircraft: Cessna Citation 560XL  
Serial Number: 560-5314  
Registration: N91GY

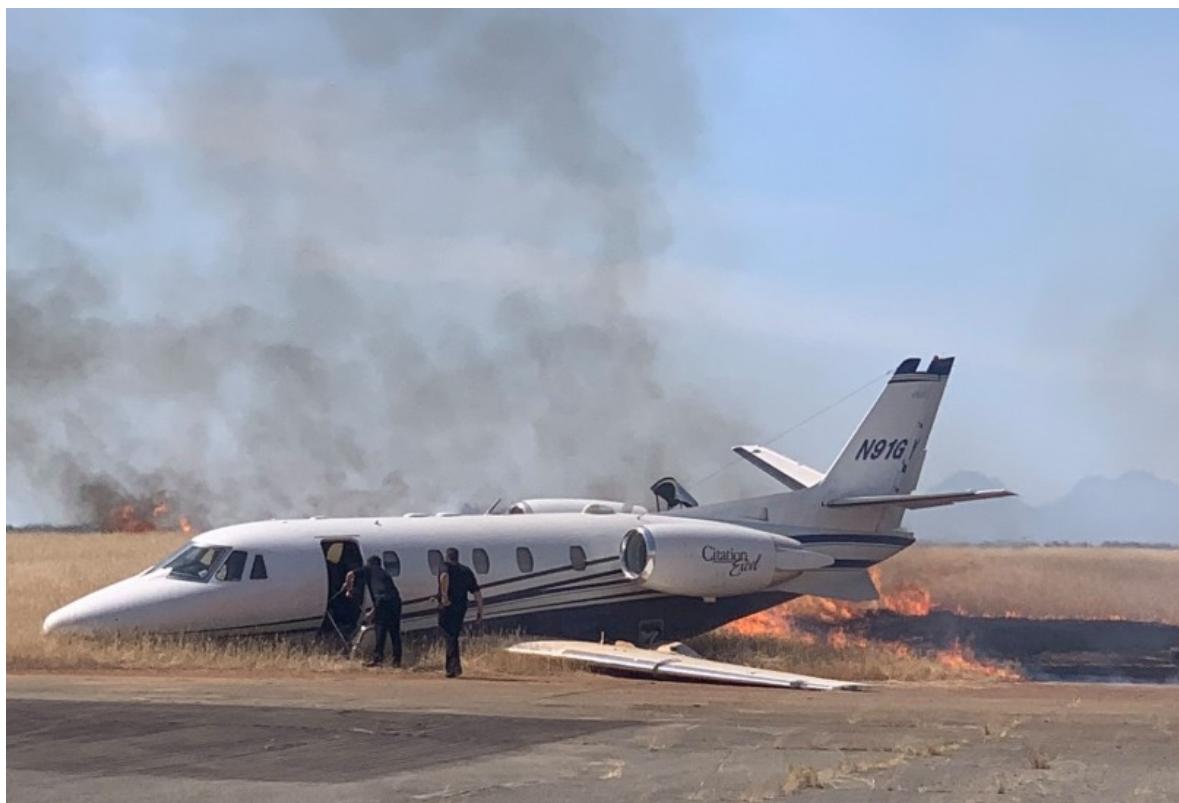
During the runway excursion, the aircraft ignited a brush fire, ref Figure 1. After the crew and passengers exited the aircraft, the brush fire spread and consumed a majority of the aircraft, ref Figure 2.

Figure 1 – Photograph of aircraft just after accident (Source: social media)

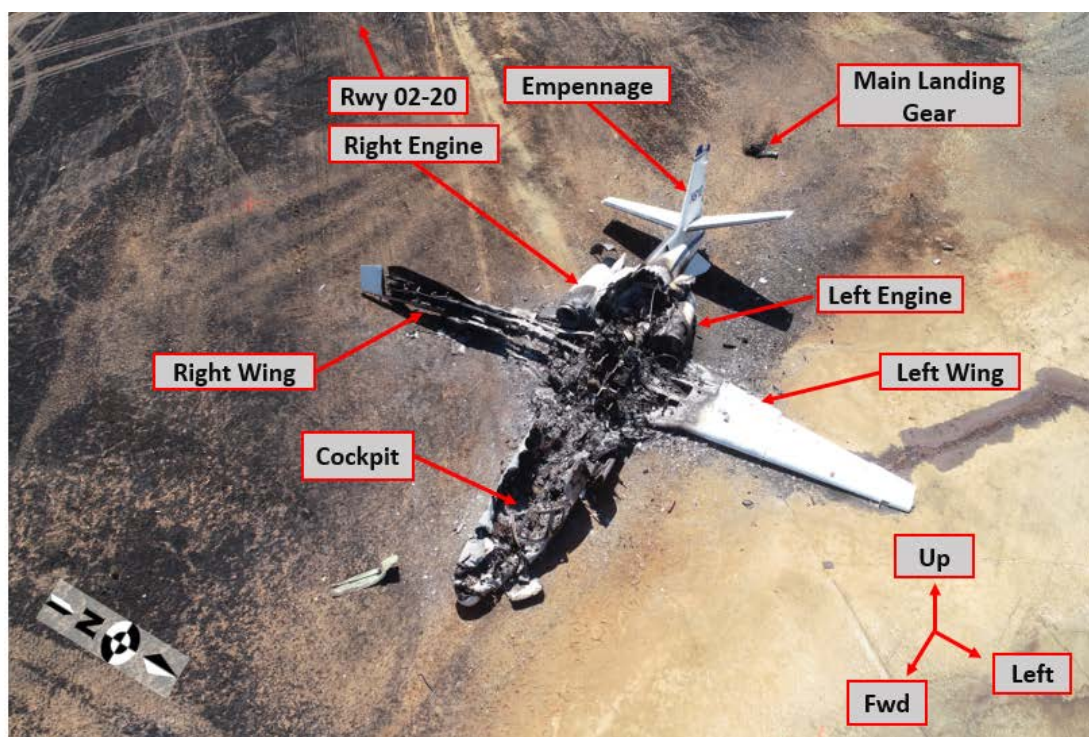
Figure 2 - Photograph of aircraft after brush fire extinguished

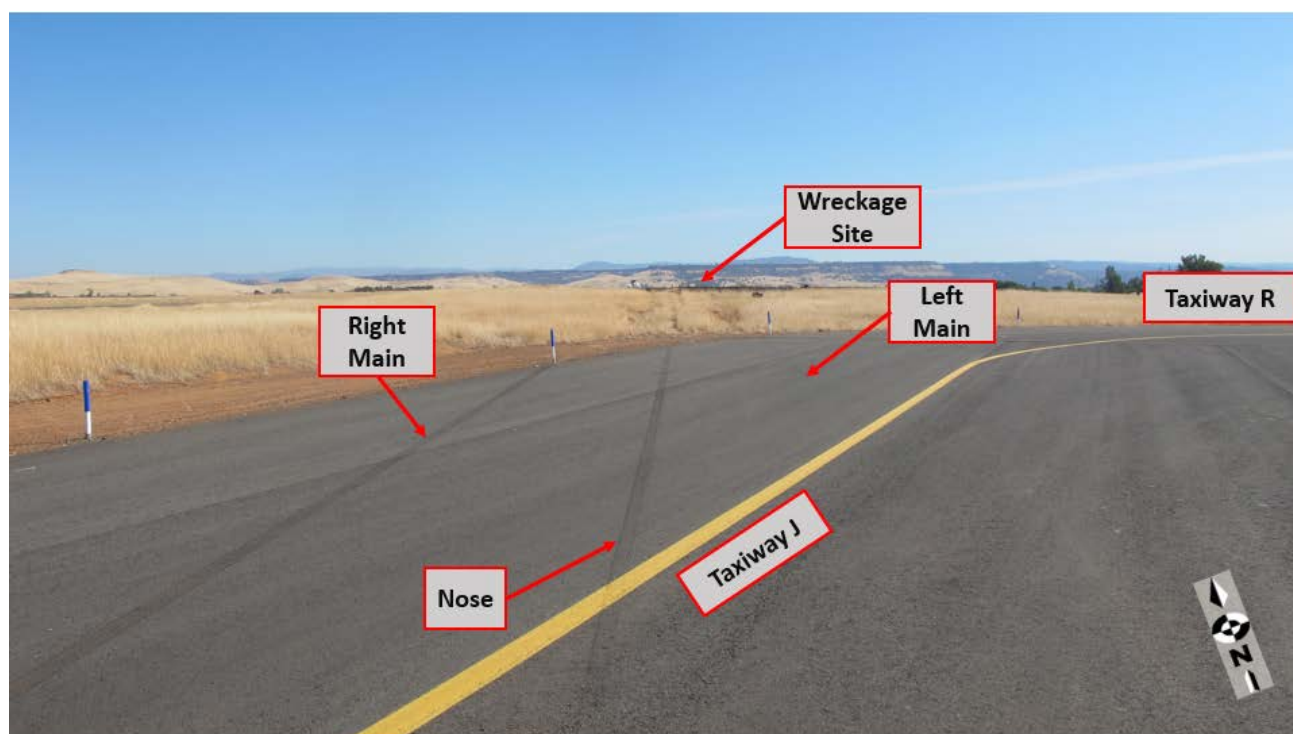
Figure 4 - Tire marks on taxiway (area 2)

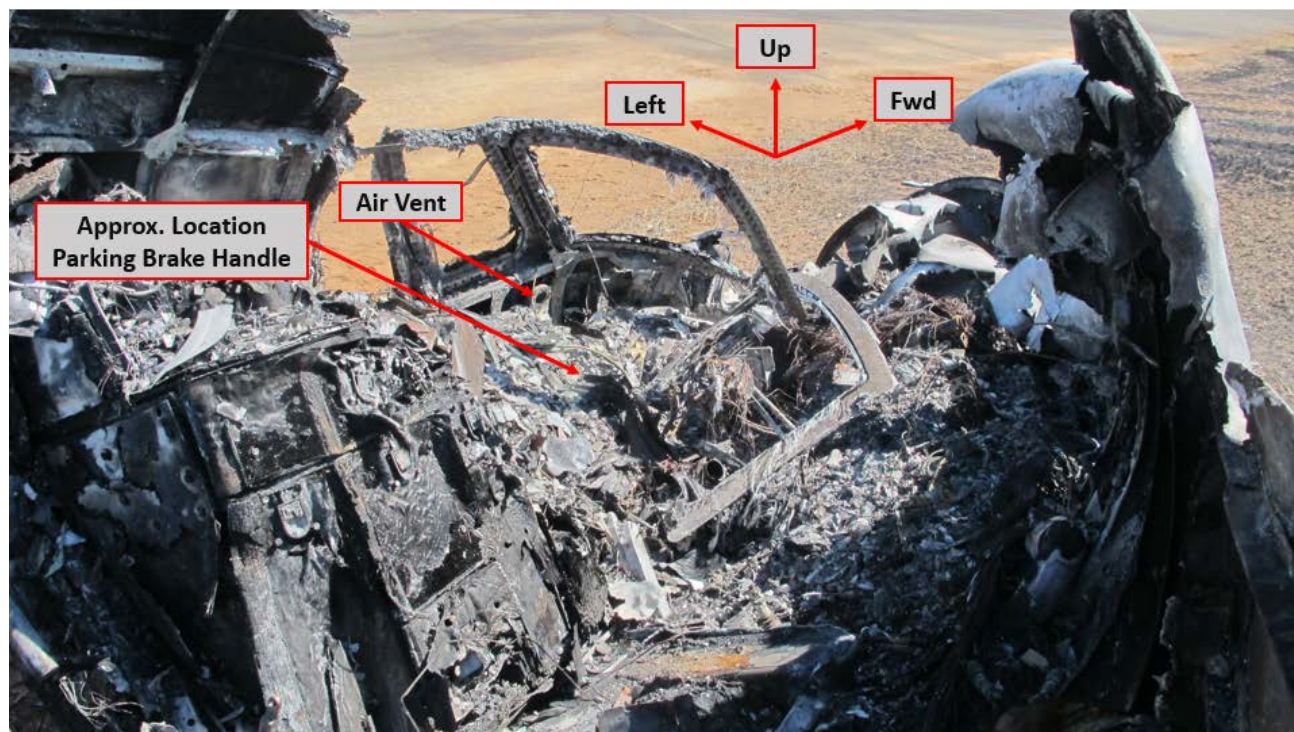
The cockpit area was heavily damaged by the post-crash fire, Figure 8. Most avionics components were burned beyond recognition and unidentifiable.

Figure 8 - View of Aircraft Cockpit

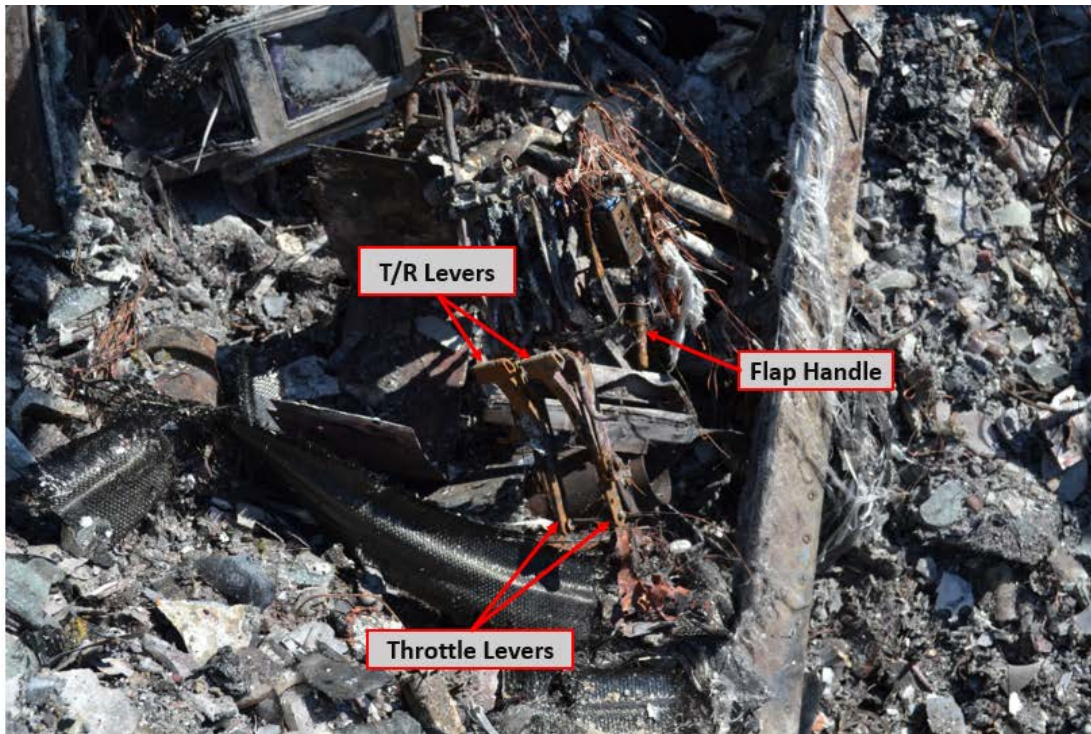
The throttle quadrant/flap handle/pitch trim was identified in the wreckage, Figure 9. The throttle positions were at the idle stops. The thrust reverser levers were in the stowed position. The flap handle position could not be determined.

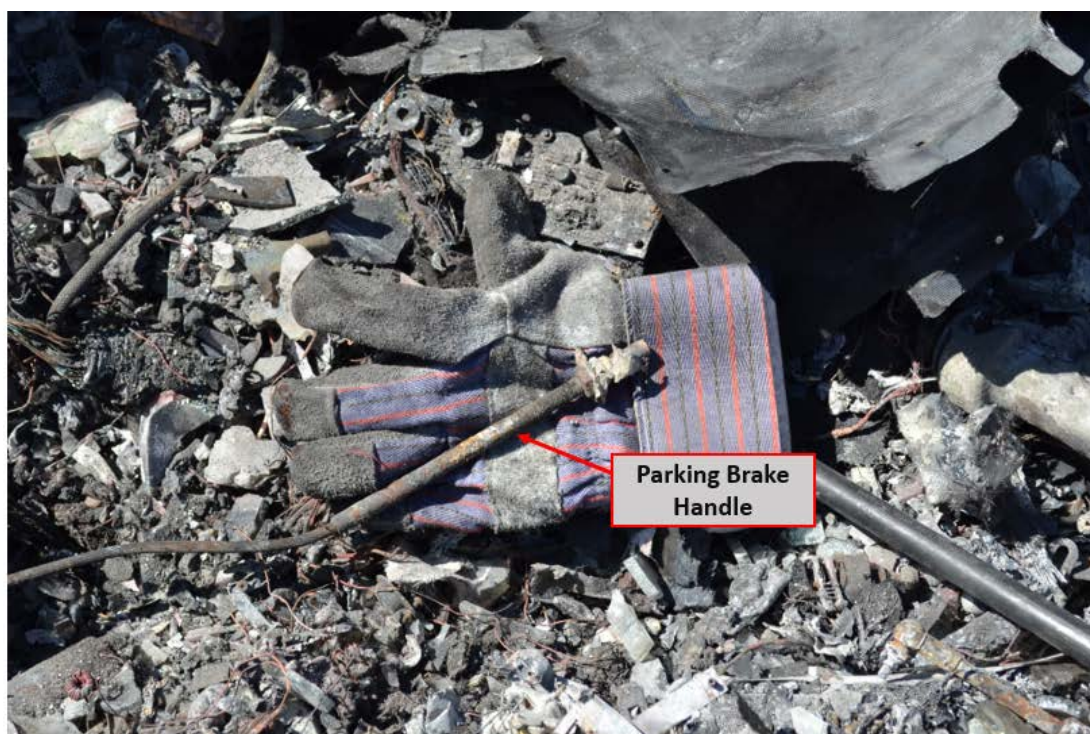
The parking brake cable and handle was located in the wreckage, Figure 10. The parking brake plastic knob was not present. The cockpit end of the parking brake cable/handle was found in a position consistent with the "OFF" position. The cable was traced from the handle to the parking brake valve and was continuous. After the parking brake valve was disconnected, an attempt was made to actuate the cable from the cockpit. The cable could not be actuated due to unknown obstructions/interference within the cable run. The obstructions/interference could not be determined on scene.

**Figure 10 - Parking brake handle (glove added for picture) (DSC\_0012.jpg)**

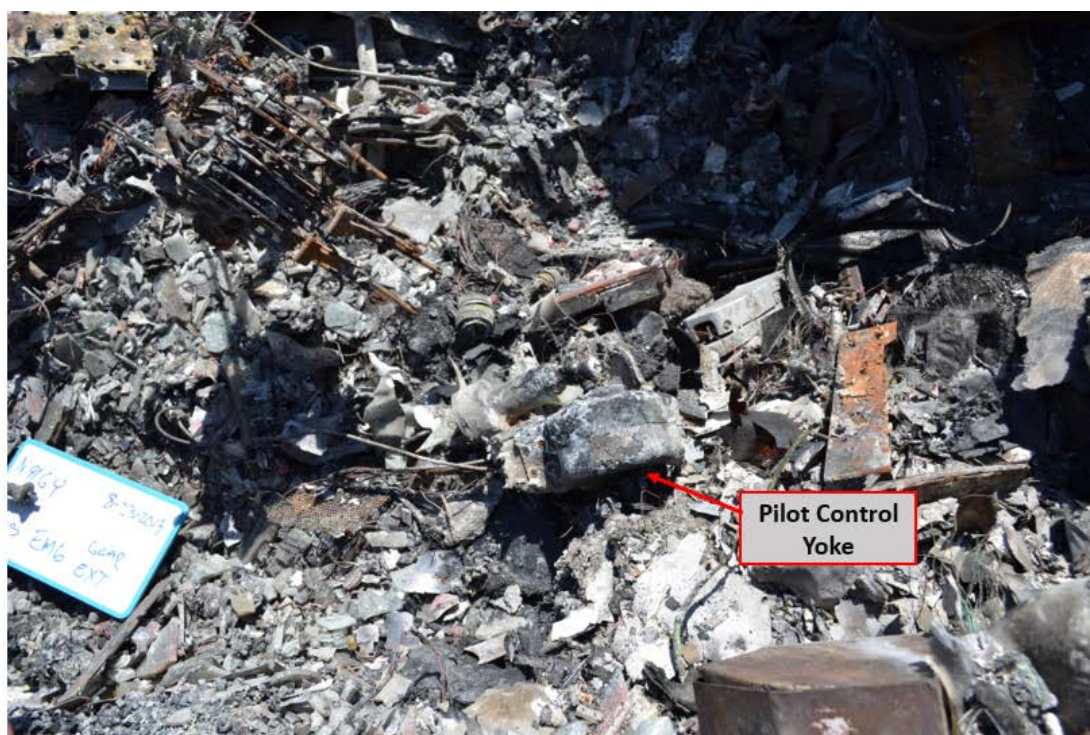
Components of the pilot, Figure 11, and copilots, Figure 12, control column were located in the wreckage but were extensively fire damaged and could not be manipulated.

**Figure 11 - Pilot control yoke components**

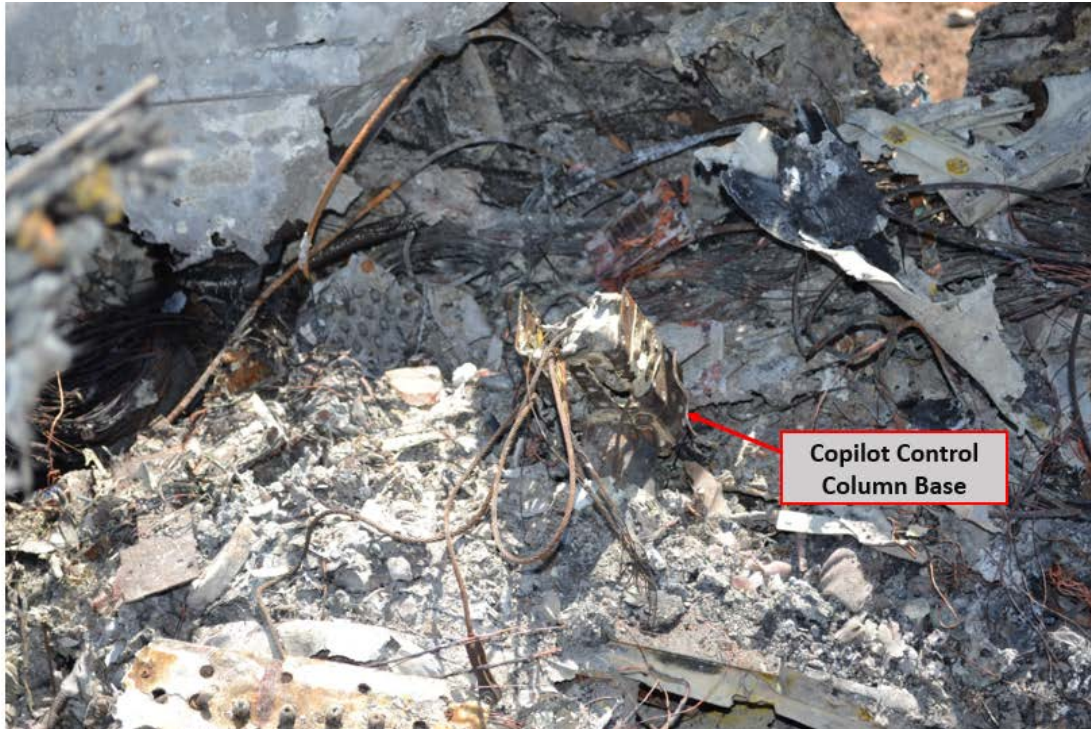
**Figure 12 – Copilot control column base**

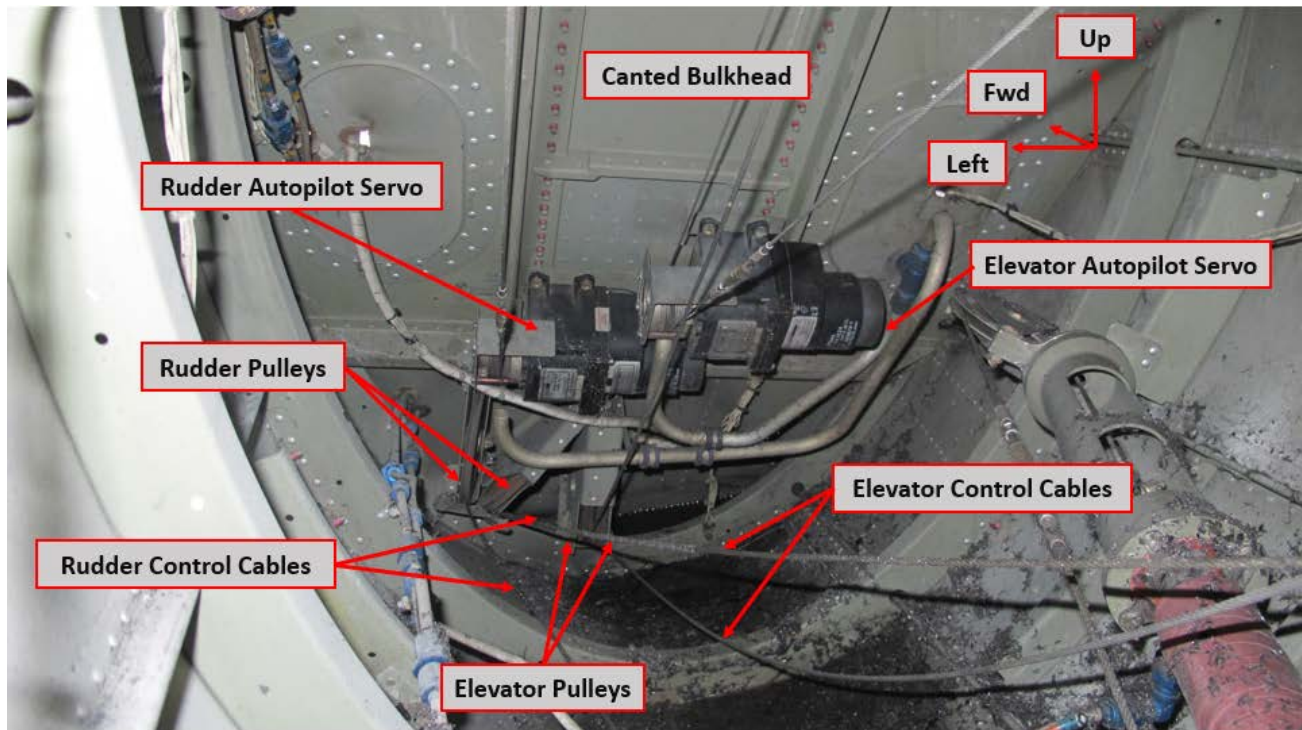
**Figure 13 - View of aft side of canted bulkhead showing rudder and elevator controls**

Visual identification of the elevator cables from the rear spar to the forward bell crank could be obtained in multiple areas along the fuselage. The cables could not be actuated in the center wing portion of the aircraft. Additional visual inspection and control continuity of the cables in the area of the canted bulkhead were completed, Figure 13.

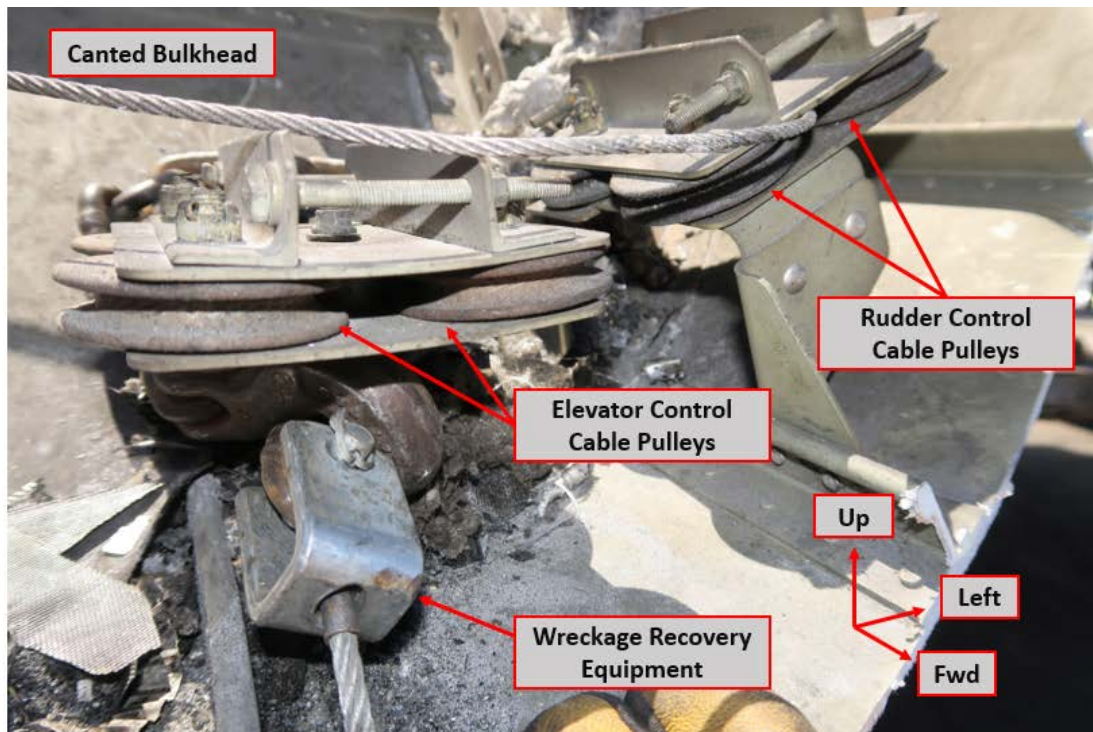
Initial movement of the elevator by hand was impeded just past elevator neutral in a trailing edge up direction. The elevator could move to the full trailing edge down stop. The elevator movement was impeded by the elevator cables. The elevator autopilot servo control cables were removed from the elevator bell crank with no change to the elevator travel. The elevator control cables were marked prior to cutting and removal from the aircraft. After all the elevator cables were removed, the elevator could be moved freely by hand to both the trailing edge up and down stop. Inspection of the elevator cable indicated a fouling condition at the pulleys at the base of the forward side of the canted bulkhead with the elevator turnbuckle. During the aircraft recovery, the rear fuselage was cut to allow access to the pulleys on the forward side of the canted bulkhead, Figure 14. No signs of a fouling condition were present, however loose debris was present in the area surrounding the elevator and rudder pulleys.

**Figure 14 - Elevator pulleys at lower canted bulkhead.**

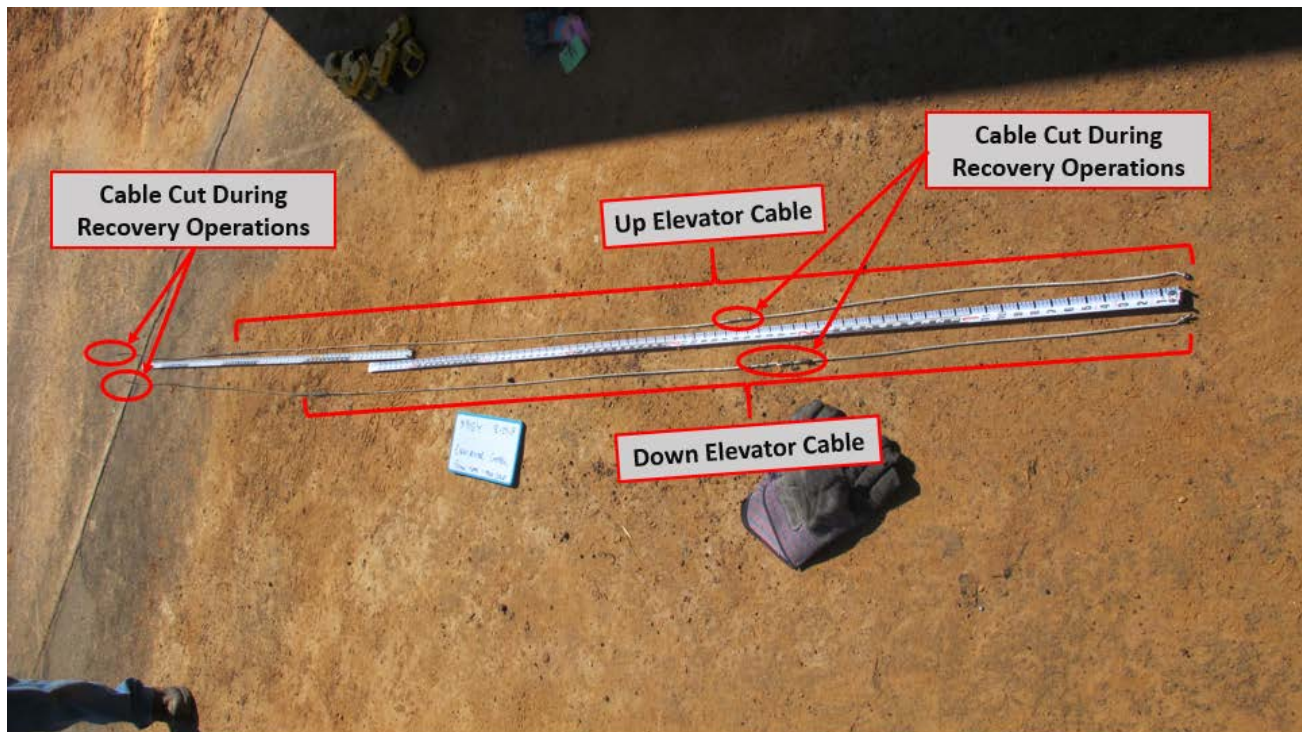
**Figure 15 - Aircraft elevator cables after removal from aircraft**

The elevator cables were removed from the aircraft to take measurements from the cable ends to the turnbuckles and compared to the aircraft manufacturing drawings, Figure 15. For the up elevator cable, the distance between the cable stop and the turnbuckle was measured to be 113 inches and the manufacturer drawing measurement is 113.3 inches. For the down elevator cable the distance between the cable stop and the turnbuckle was measured to be 90 inches and the manufacturer drawing measurement is 90.35 inches.

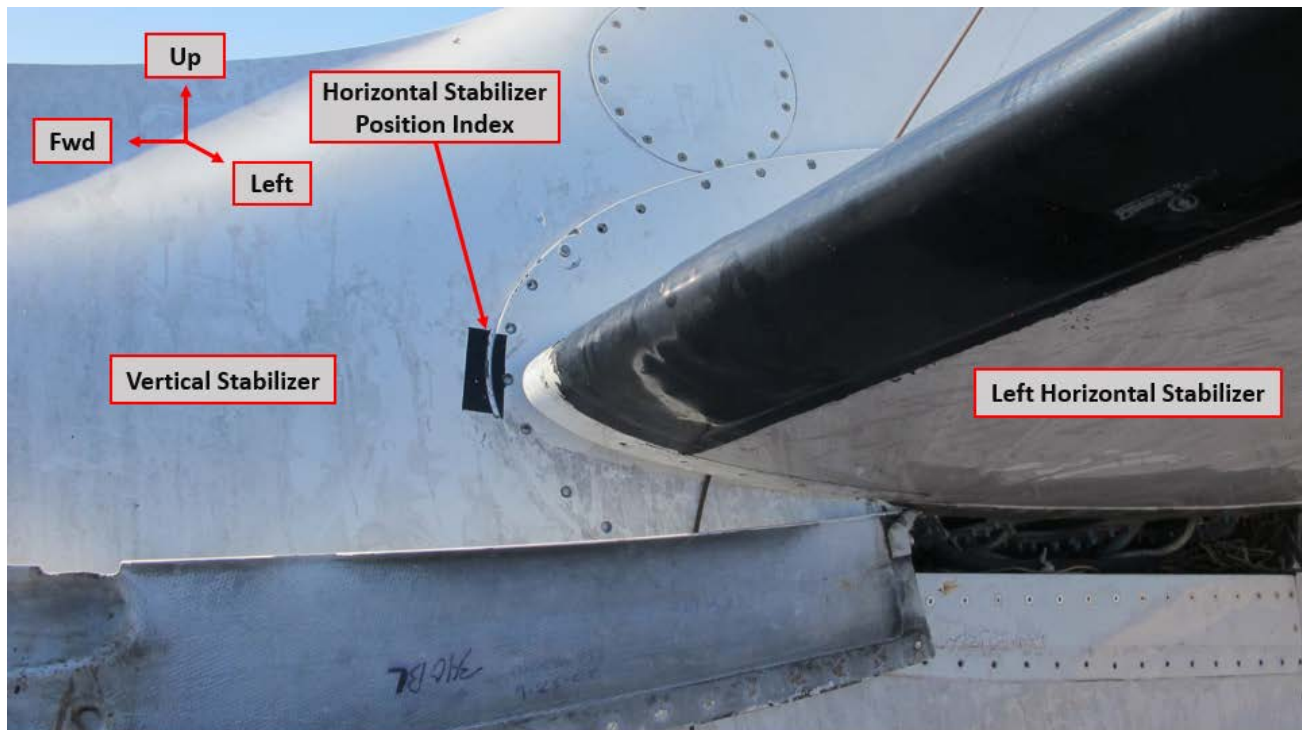
**Figure 16 - Horizontal stabilizer position marking in take-off/landing setting**

The horizontal stabilizer was in the take-off/landing setting. This was confirmed by visual examination of the horizontal stabilizer actuator position and the external marking, Figure 16.

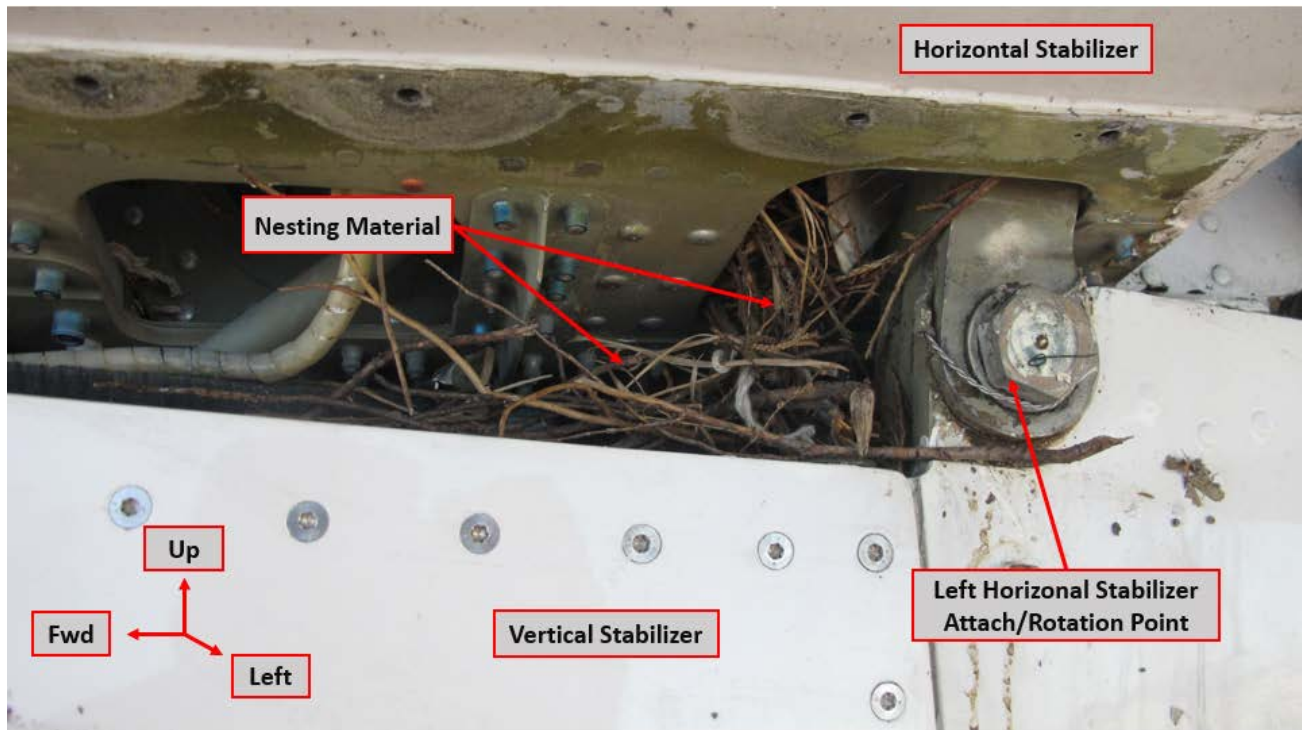
The fairing was removed to inspect the horizontal stabilizer actuator and attach fittings. Nesting material was found in the area of the aft rotation mount, Figure 17. The nesting material was not in contact with any components that would have obstructed movement of the horizontal stabilizer or elevator system.

Figure 17 - Nesting material at aft rotation point.

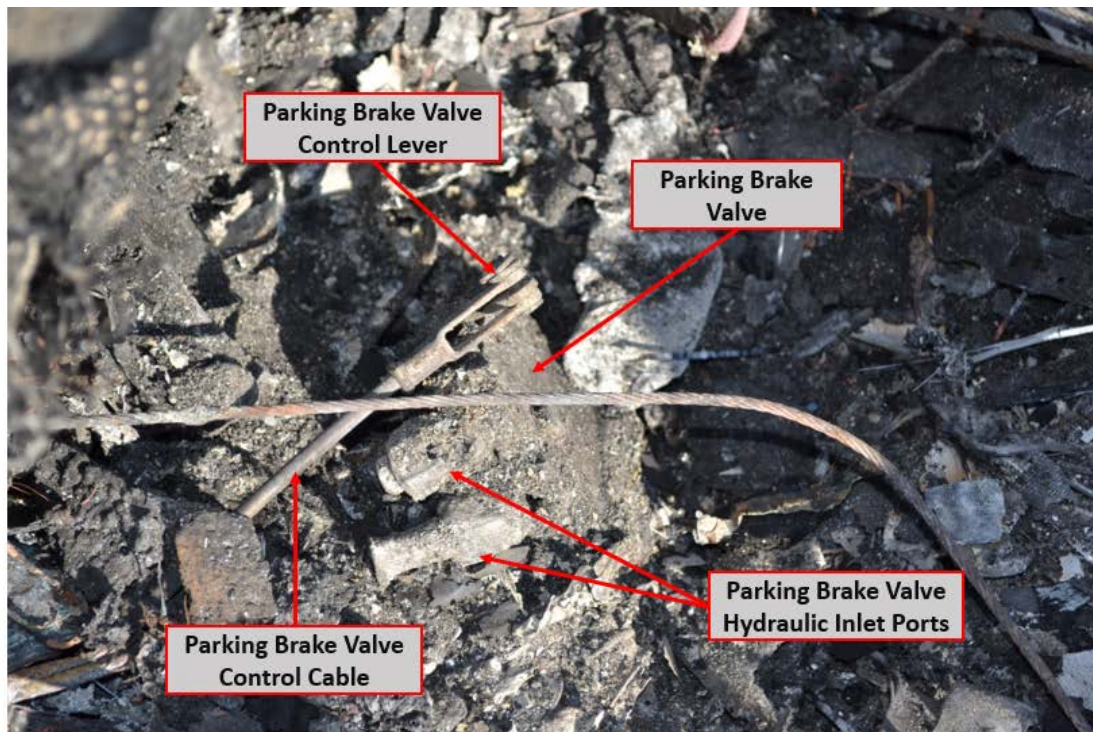
Figure 18 - Parking Brake Valve as found

The parking brake handle information is contained in the cockpit section of the notes. The parking brake valve was located loose in the wreckage and was damaged by fire. The parking brake control cable was attached to the valve and all attaching hardware was present. The cable was removed from the valve, without disturbing the valve lever position. Based on a visual inspection of the lever position, the brake valve was in the “ON” position. No part identification or data plate could be found on the component.

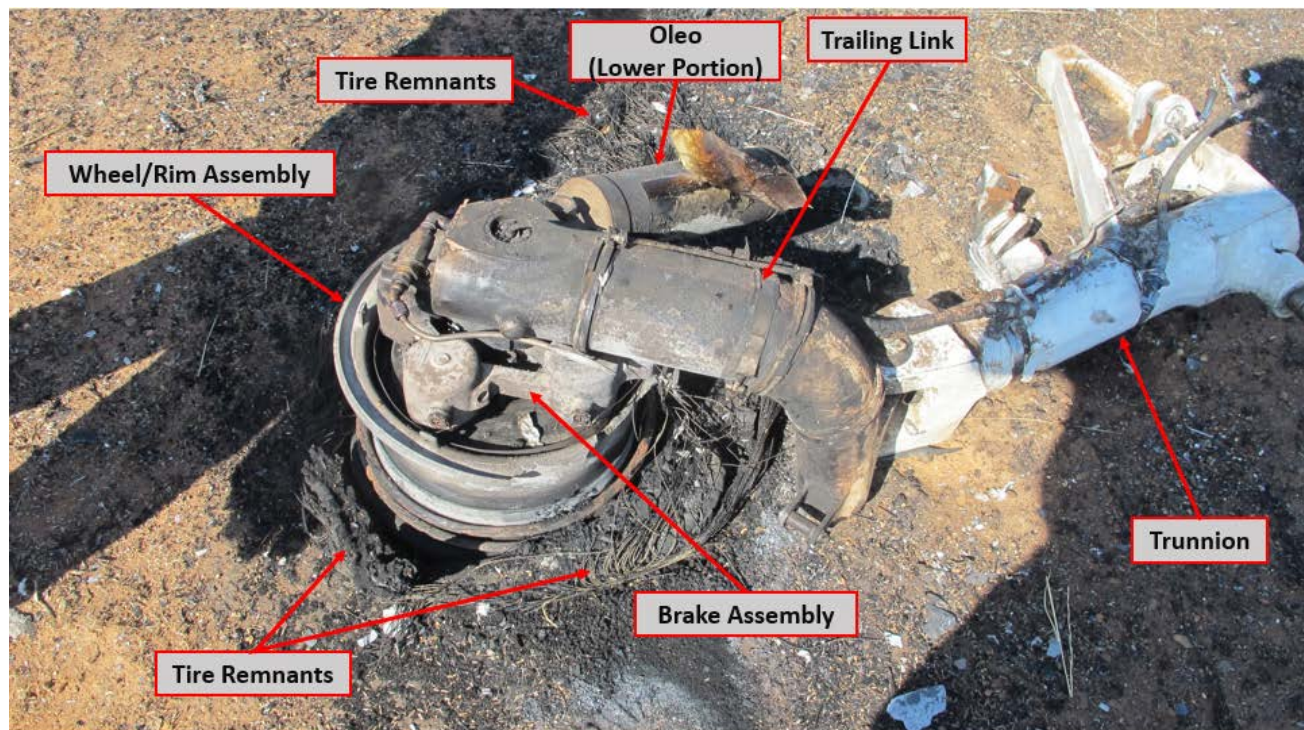
The LH main landing gear oleo was breeched with only the lower portion remaining on the trailing link assembly, Figure 26. The main wheel assembly rim was damaged. Pieces of the rim were found early in the wreckage path. The brake pistons were extended approximately 1 inch. Based on the brake wear indicators, the brakes were within serviceable limits. The tire fill valve and fuse plug were not present on the wheel assembly, Figure 27.

Figure 26 - LH Main landing gear showing brake assembly

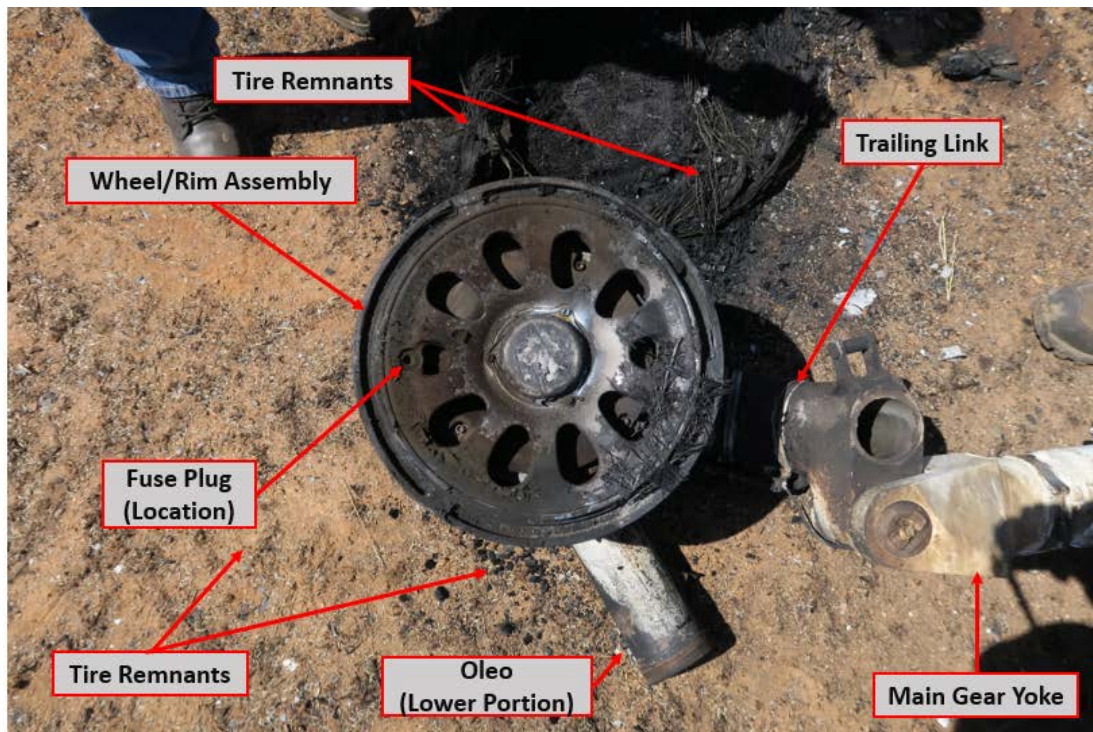
**Figure 27 - LH Main Wheel Assembly showing missing fuse plug and valve**

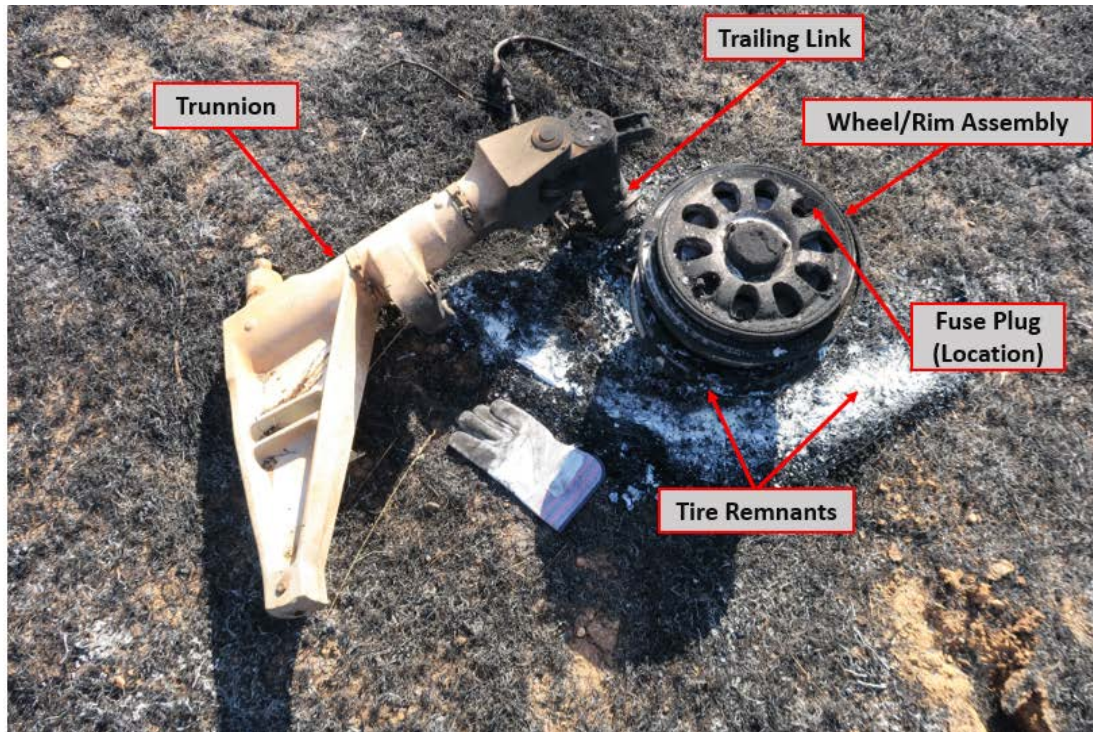
The RH main landing gear oleo was breeched and separated from the trailing link and trunnion. Based on the brake wear indicators, the brakes were within serviceable limits. The brake pistons were extended to the wheel assembly. The tire fill valve and fuse plug were present on the wheel assembly. The fuse plug appeared to be intact and not activated, Figure 28.

**Figure 28 - RH Main landing gear showing brake assembly**
