## **NATIONAL TRANSPORTATION SAFETY BOARD**

# **ON SCENE OBSERVATIONS**

**WPR19FA235**

Location: Big Spring, Texas  
Date: August 23, 2019  
Aircraft: Meyers Midget 0100, Registration N881MM, Serial #3035395  
NTSB IIC: Samantha Link

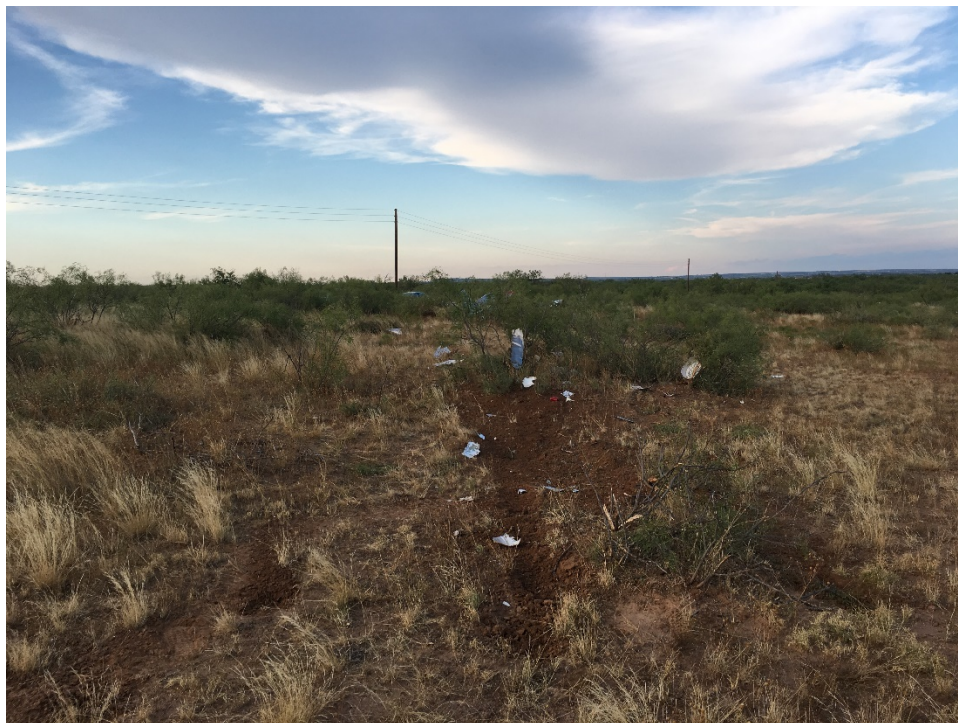
Figure 1: First Identified Point of Contact

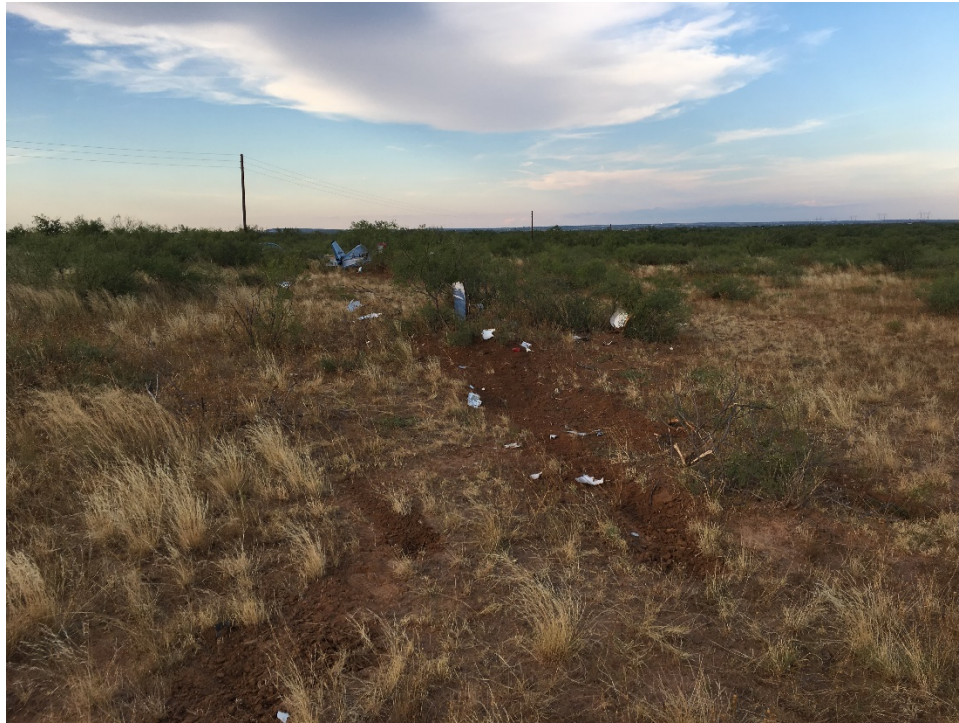
**Figure 2: Most of Debris Path**

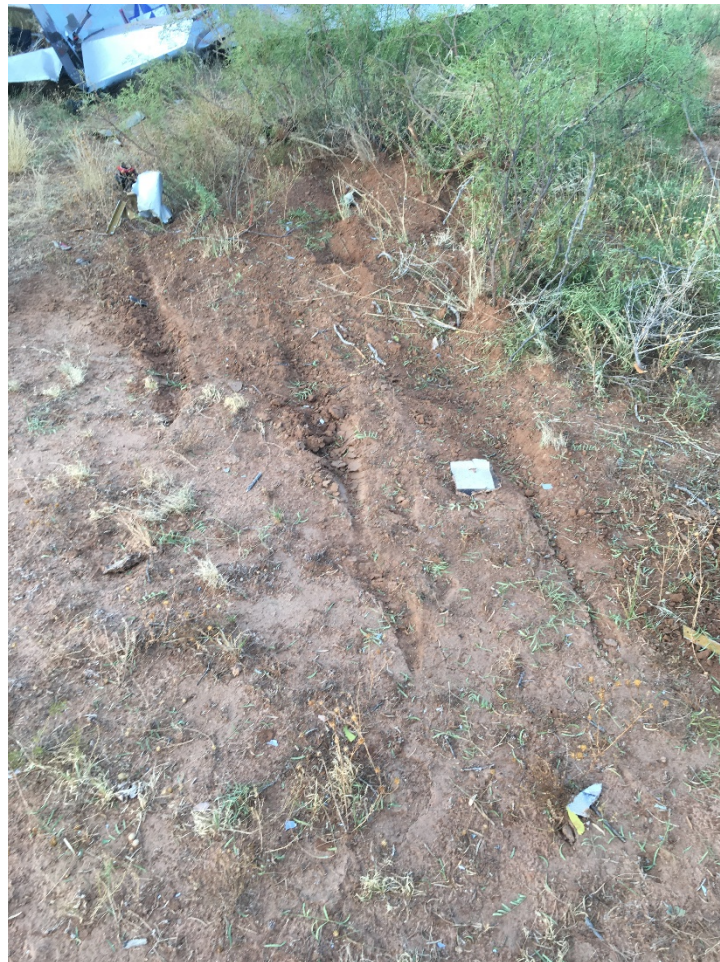
**Figure 3: Slash Marks in the Dirt**

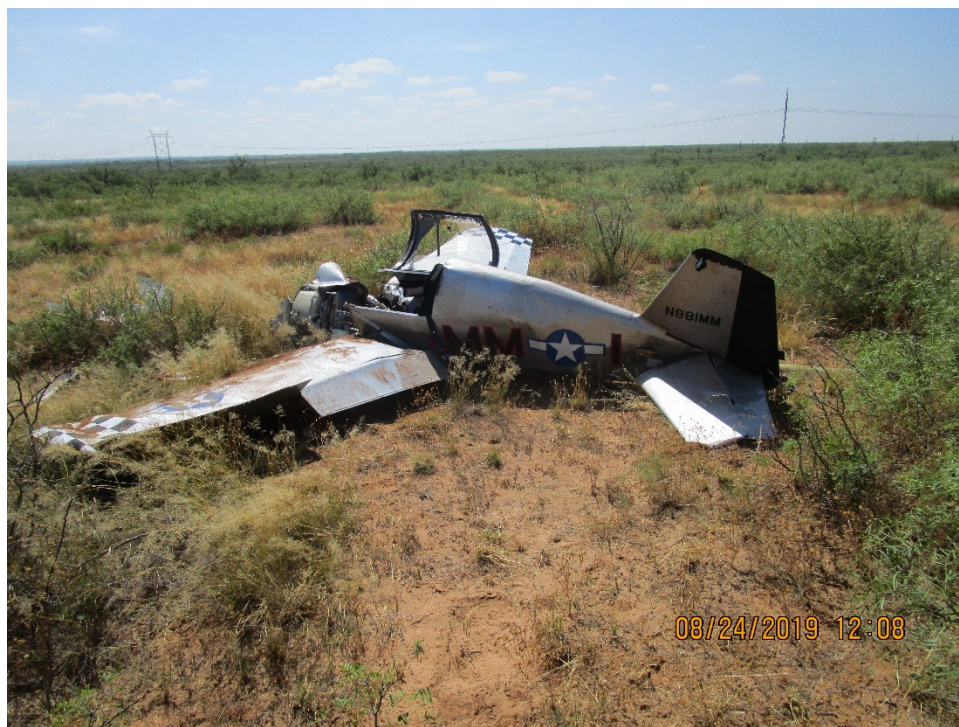
The last piece of the debris path was the main wreckage. The airplane came to rest mostly whole and on its belly. The front fuselage exhibited heavy impact related damage. The engine was mostly fracture separated from the firewall and came to rest nose down and angled toward the right. The lower cowling was fracture separated and in front of the engine. No obvious anomalies were observed with the engine. The wood propeller blades were fractured at the blade root. When the propeller hub was manipulated by hand the engine rotated freely. The #3 cylinder rocker cover was fractured; the rocker arms were exposed and consistent with normal operation. The fuel cap remained secured to the fuel tank, but the fuel tank was breached. Vegetation below the tank exhibited damage consistent with fuel contamination. The instrument panel was whole and mostly

Figure 4: Main Wreckage

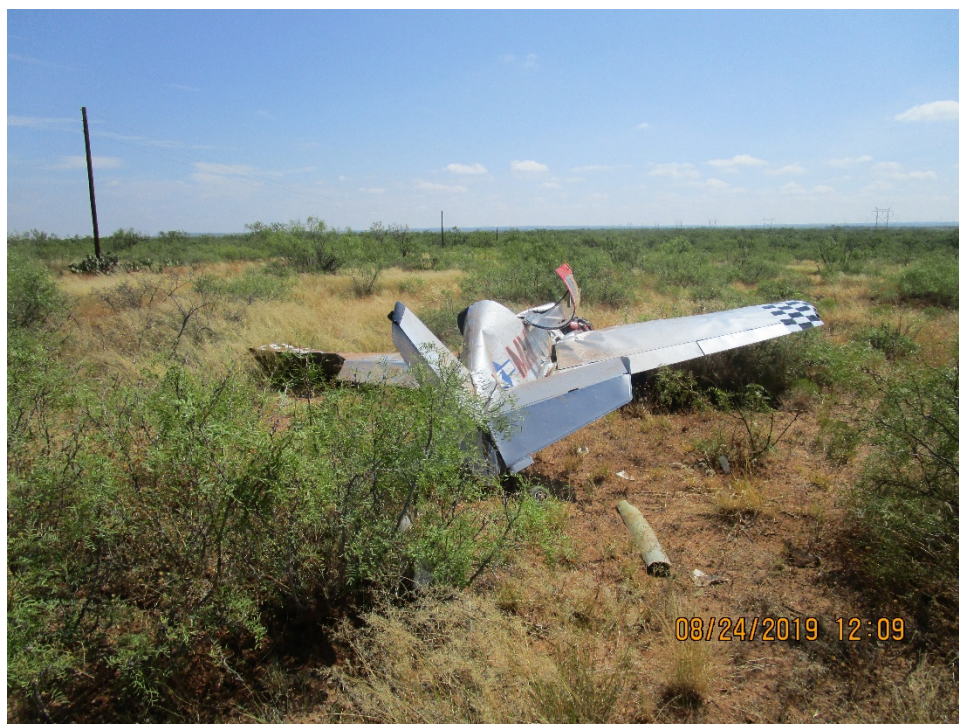
Figure 5: Empennage looking Forward

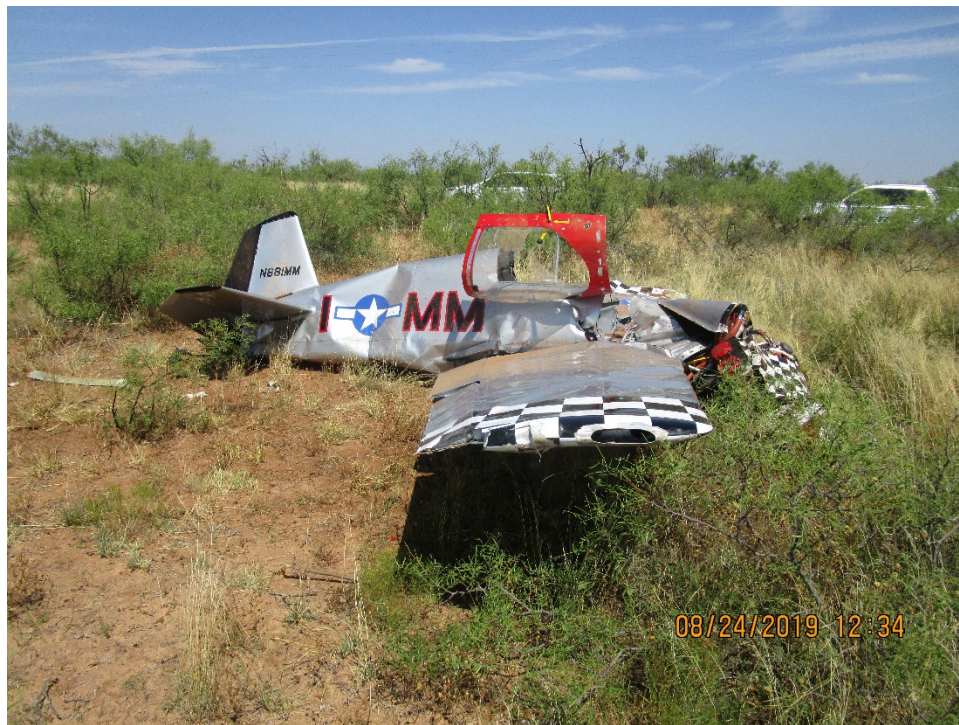
Figure 6: Right Side of Main Wreckage

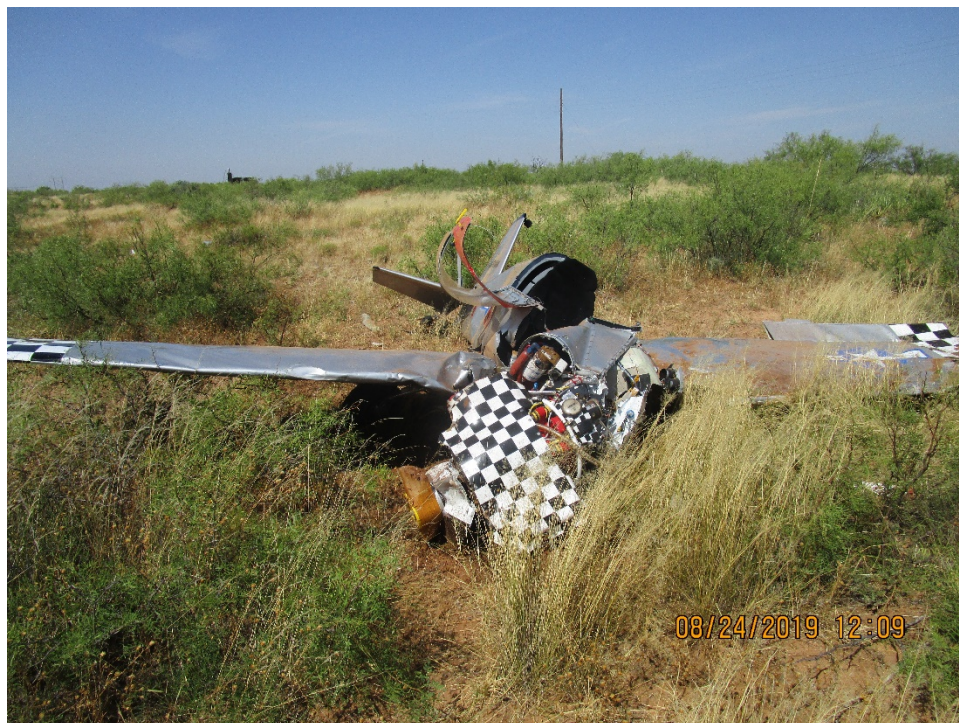
Figure 7: Front of Main Wreckage

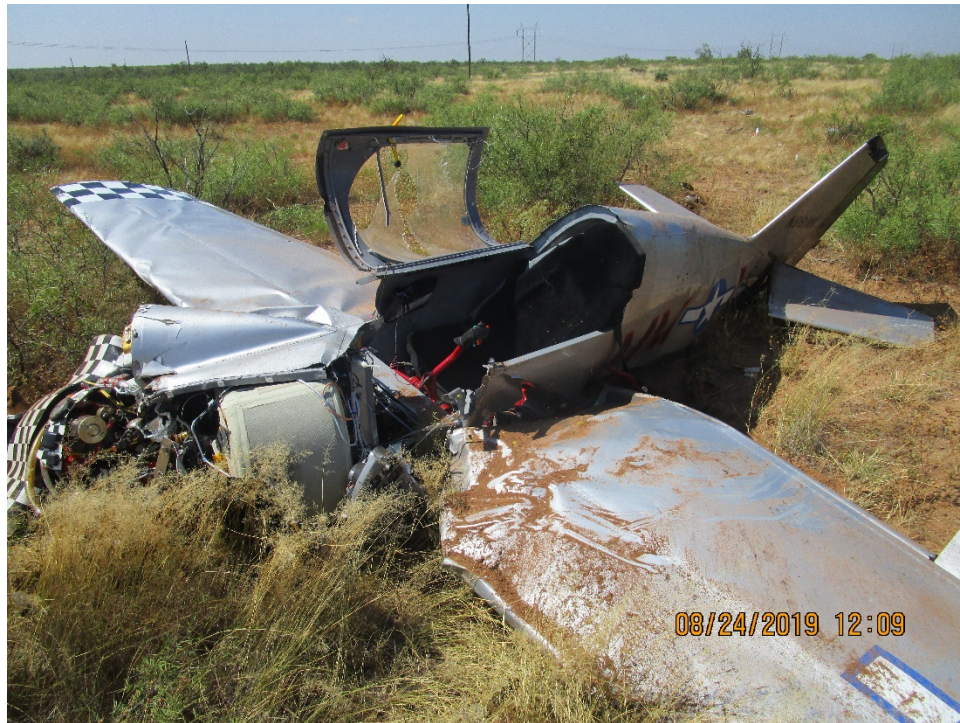
Figure 8: Forward left side of Main Wreckage

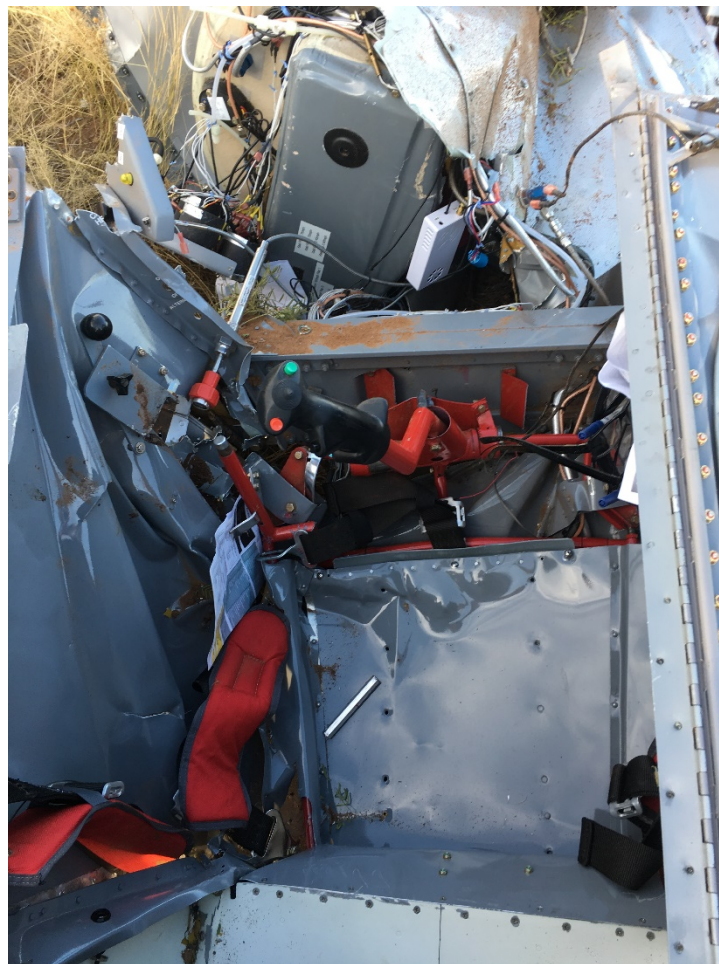
detached from the airframe. The pilot seat area was mostly intact; the surrounding fuselage exhibited 45-degree upward crushing but was otherwise mostly whole. The mount for the control stick was fracture separated from the airframe, but the controls remained attached. Control continuity was established to both ailerons; there was a fracture in the tubing at the left-wing route consistent with overload. Flight controls to the empennage were also established and remained intact.

Figure 9: Cockpit Area and Control Stick

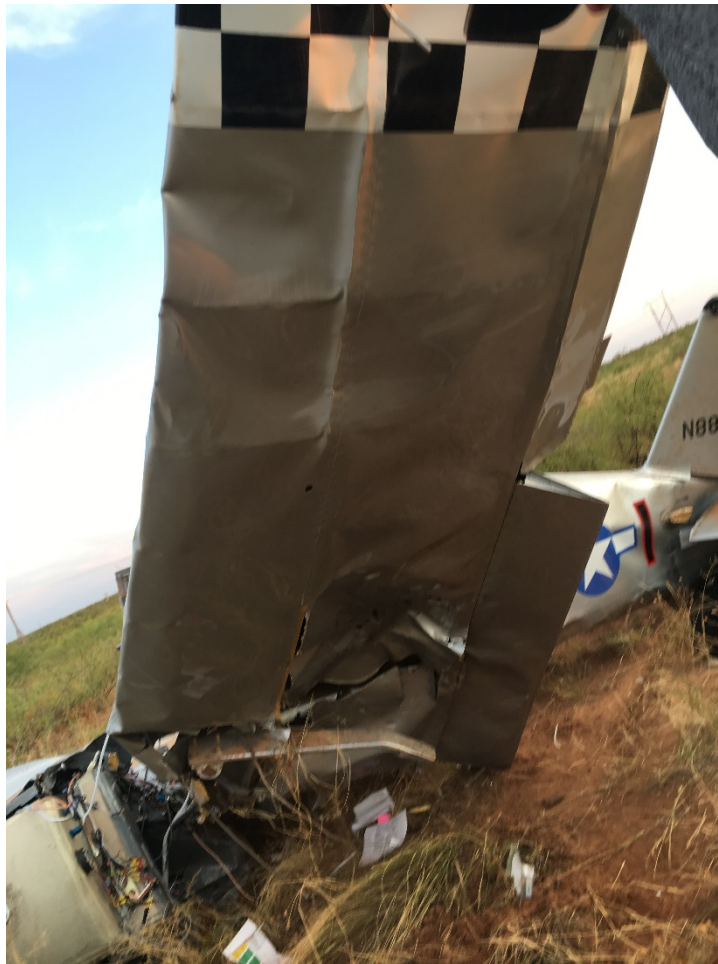
The left wing was mostly separated from the fuselage; the wing was wrinkled throughout at about a 45-degree angle from outboard to inboard. The inboard and outboard leading edges were crushed aft. The main landing gear was bent aft and a large dent consistent with the wheel was observed in the underside of the wing. The left landing gear tire was found fracture separated and underneath the right wing. The aft fuselage exhibited crush and wrinkle damage. The forward attachment point of the left horizontal was fracture separated at the wing route, and it was bent aft. The left elevator was crushed back and in towards the rudder. Damage to the left elevator control surface restricted flight control movement by hand, however, control continuity was established visually. The vertical was mostly undamaged; the rudder remained mostly intact and remained secured to its attachment points. When manipulated by hand the rudder moved freely, however, movement was limited due to impact damage. The right horizontal and elevator were mostly intact and undamaged. The tailwheel remained attached to the airframe. The right side of the aft fuselage exhibited a very large dent. The right wing exhibited wrinkle damaged throughout. The inboard wing root was crushed aft and the right wingtip was fracture separated. The right landing gear was bent aft, and the right wheel came to rest against the underwing skin.

**Figure 10: Underside of Left Wing**

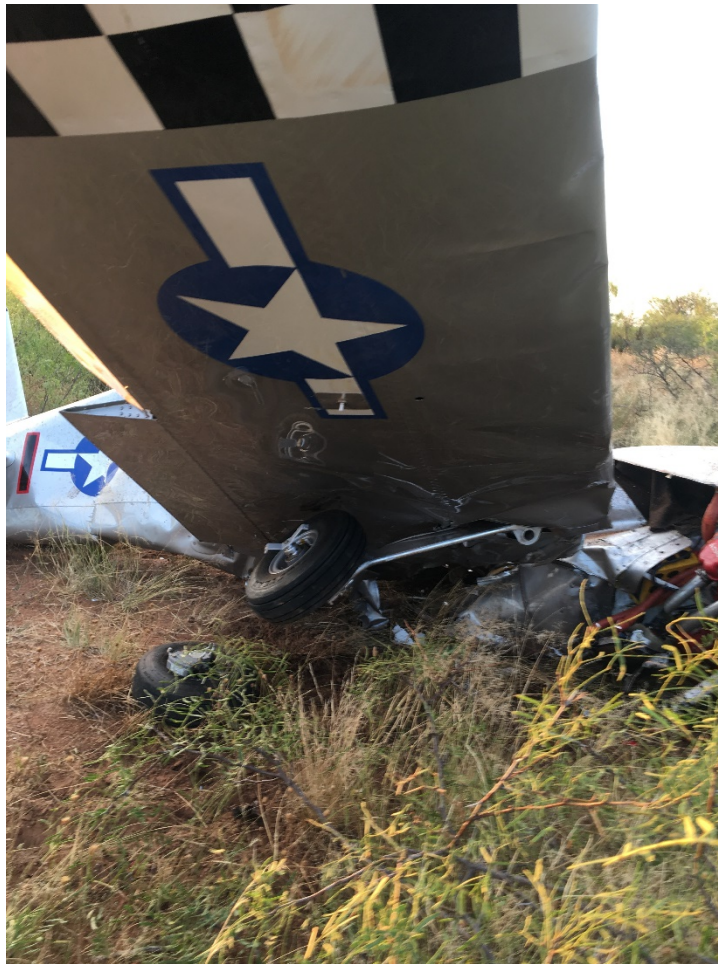
Figure 11: Underside of Right Wing

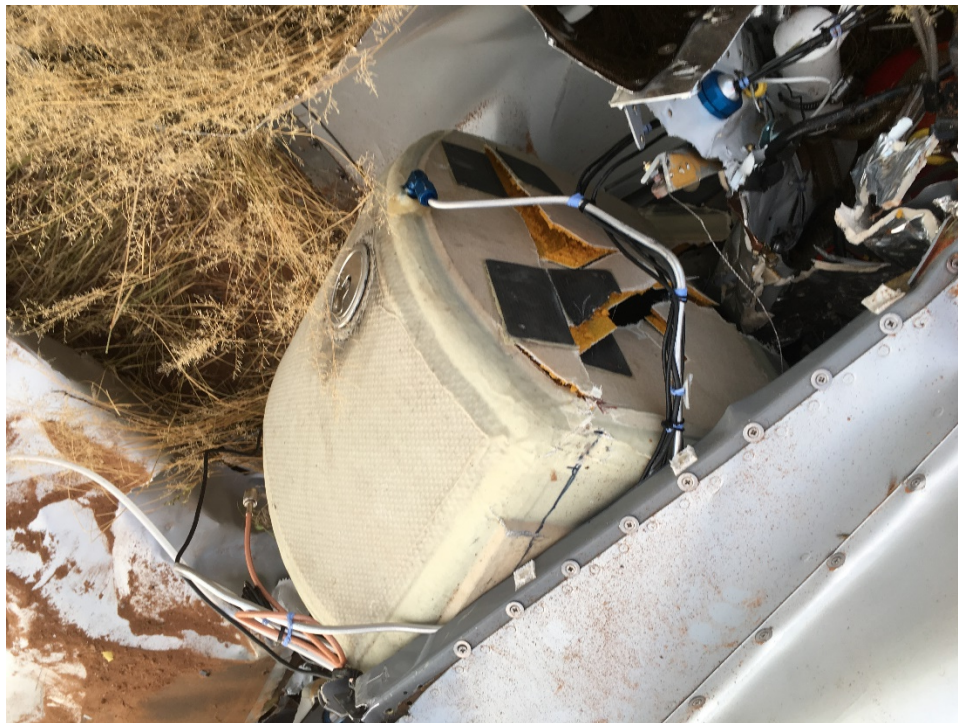
Figure 12: Fuel Tank

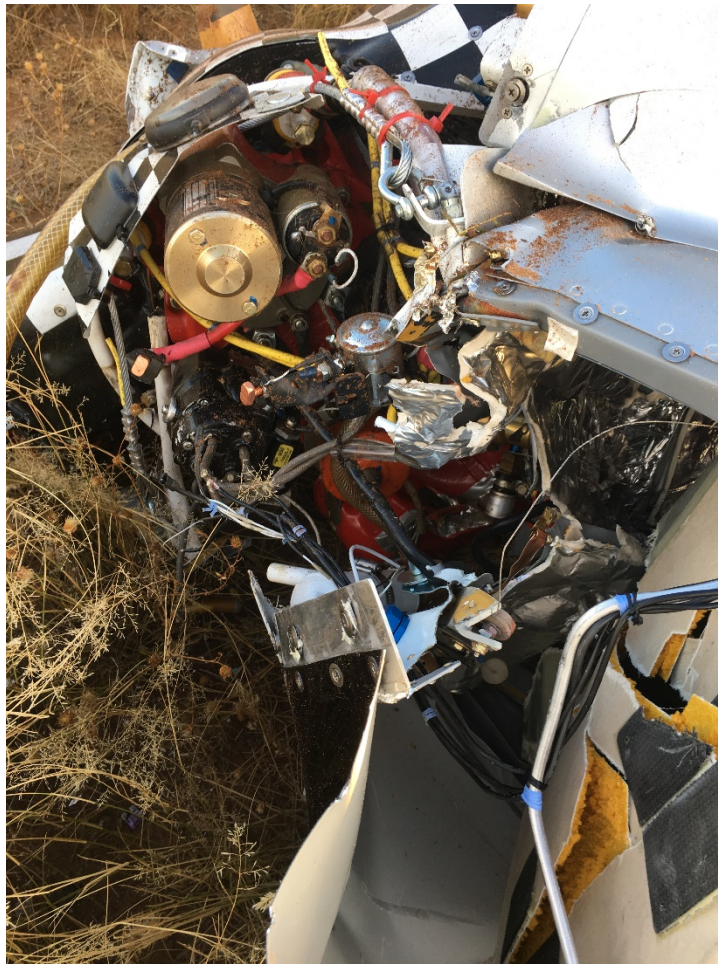
Figure 13: Accessory Section of Engine

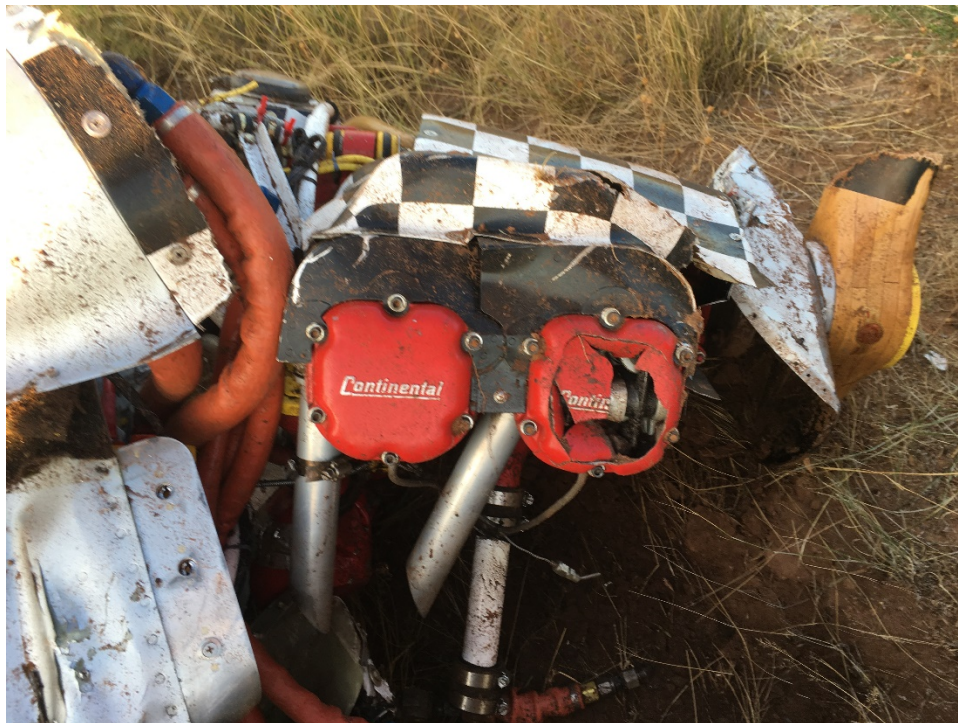
Figure 14: Right Side of Engine

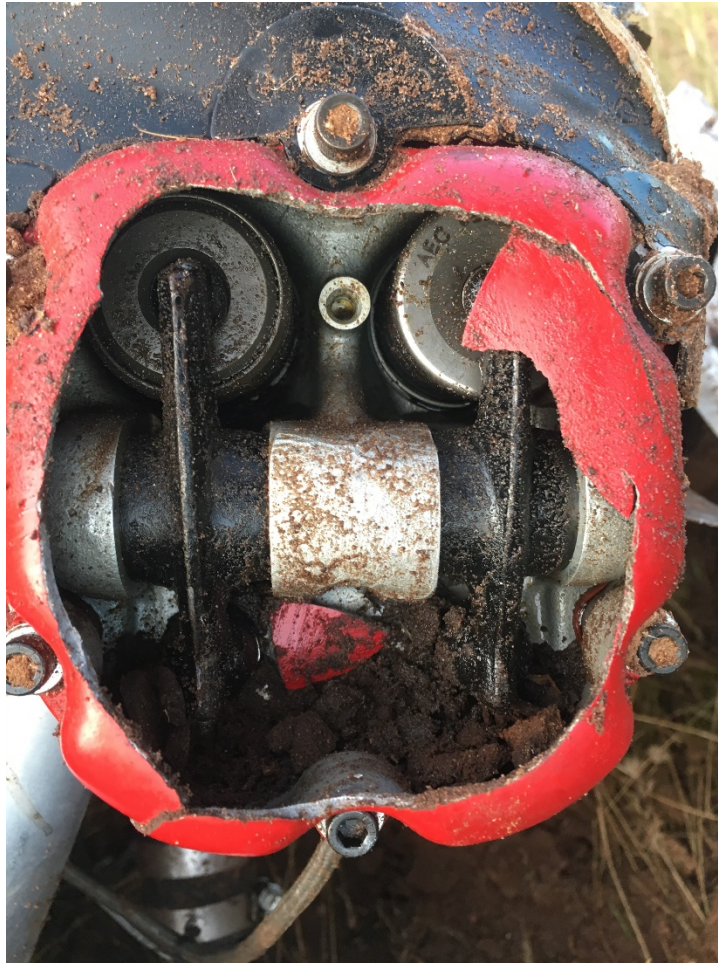
Figure 15: #3 Cylinder Valves

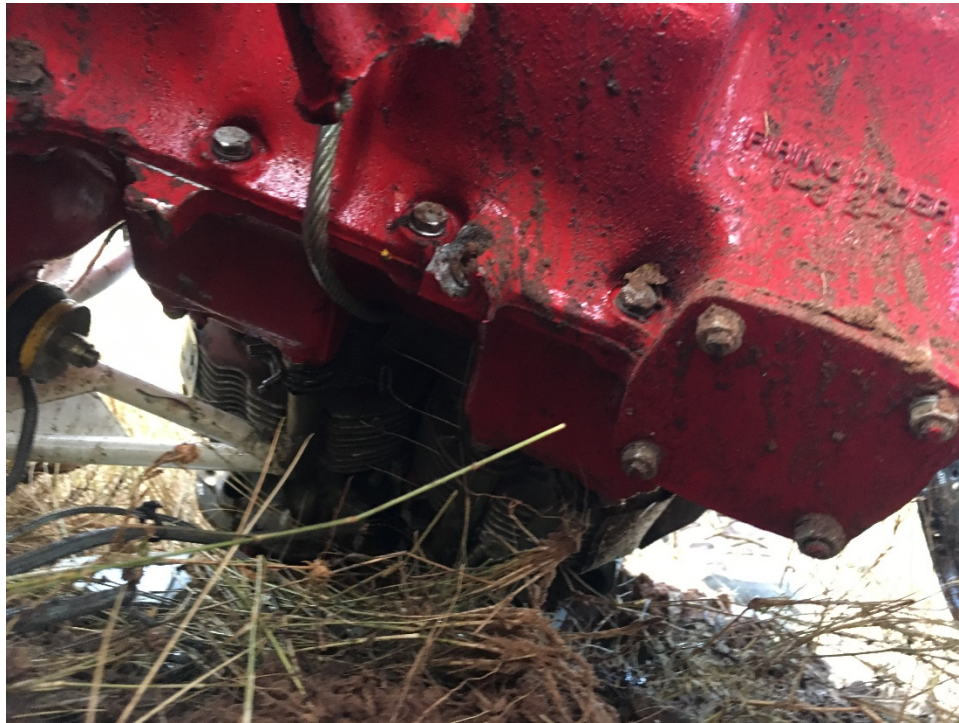
Figure 16: Underside of Engine

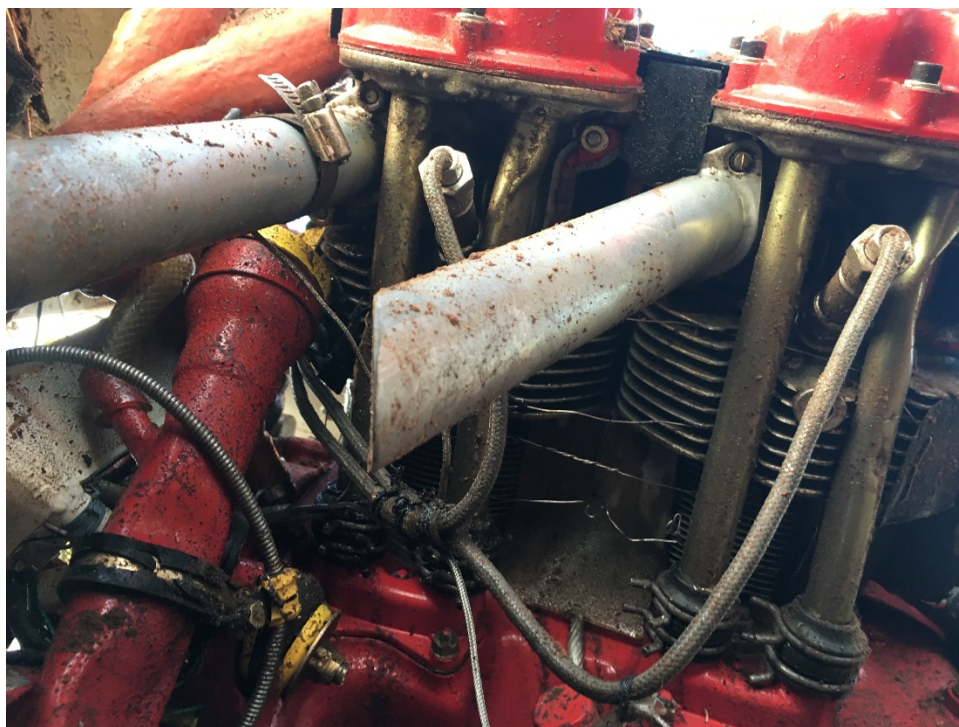
Figure 17: Underneath Right Side Cylinders

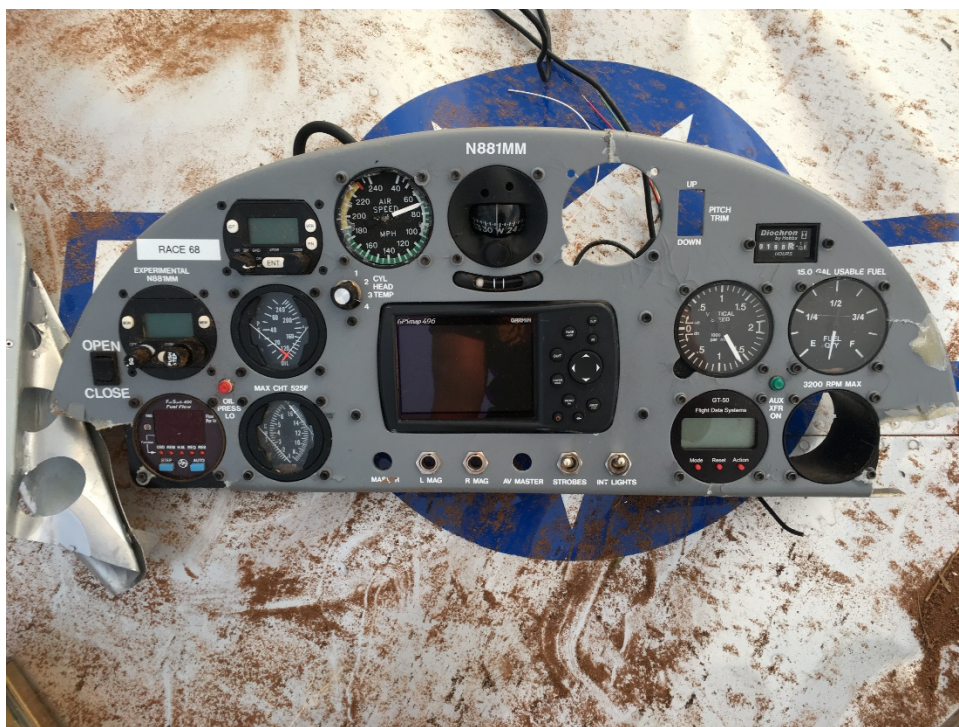
Figure 18: Instrument Panel

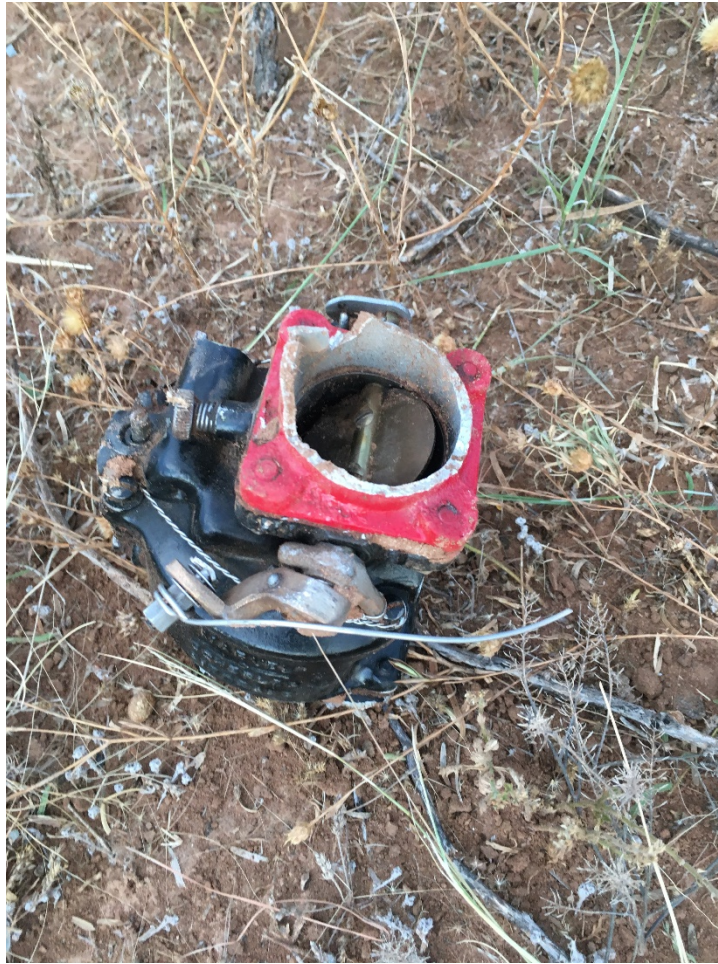
Figure 19: Carburetor
