## **NATIONAL TRANSPORTATION SAFETY BOARD**

# **ENGINE EXAMINATION**

**WPR19FA235**

Location: Air Salvage of Dallas (ASOD)  
Date: March 4, 2021  
Aircraft: Meyers Midget Mustang  
NTSB IIC: Samantha Link

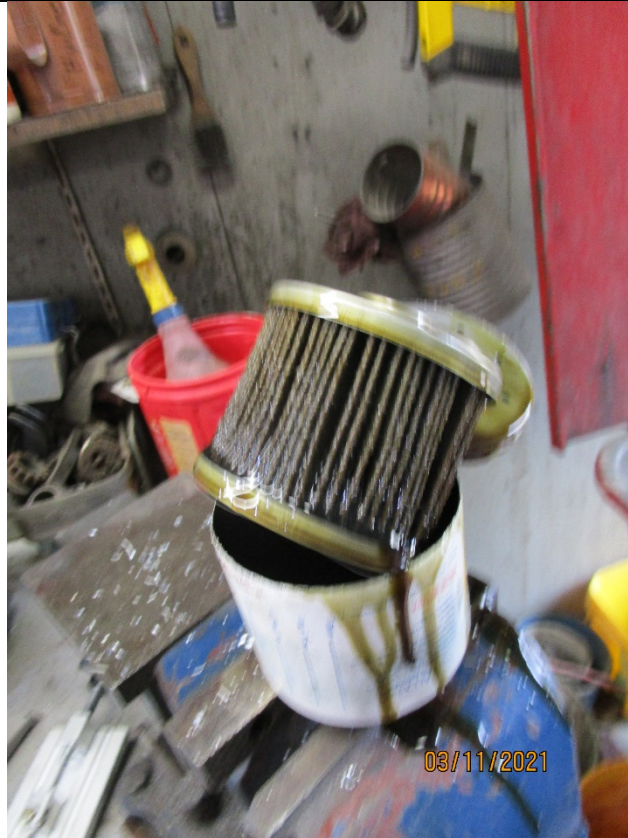
Remote mounted oil filter was cut open and the filter element examined; the element was absent metal contamination.

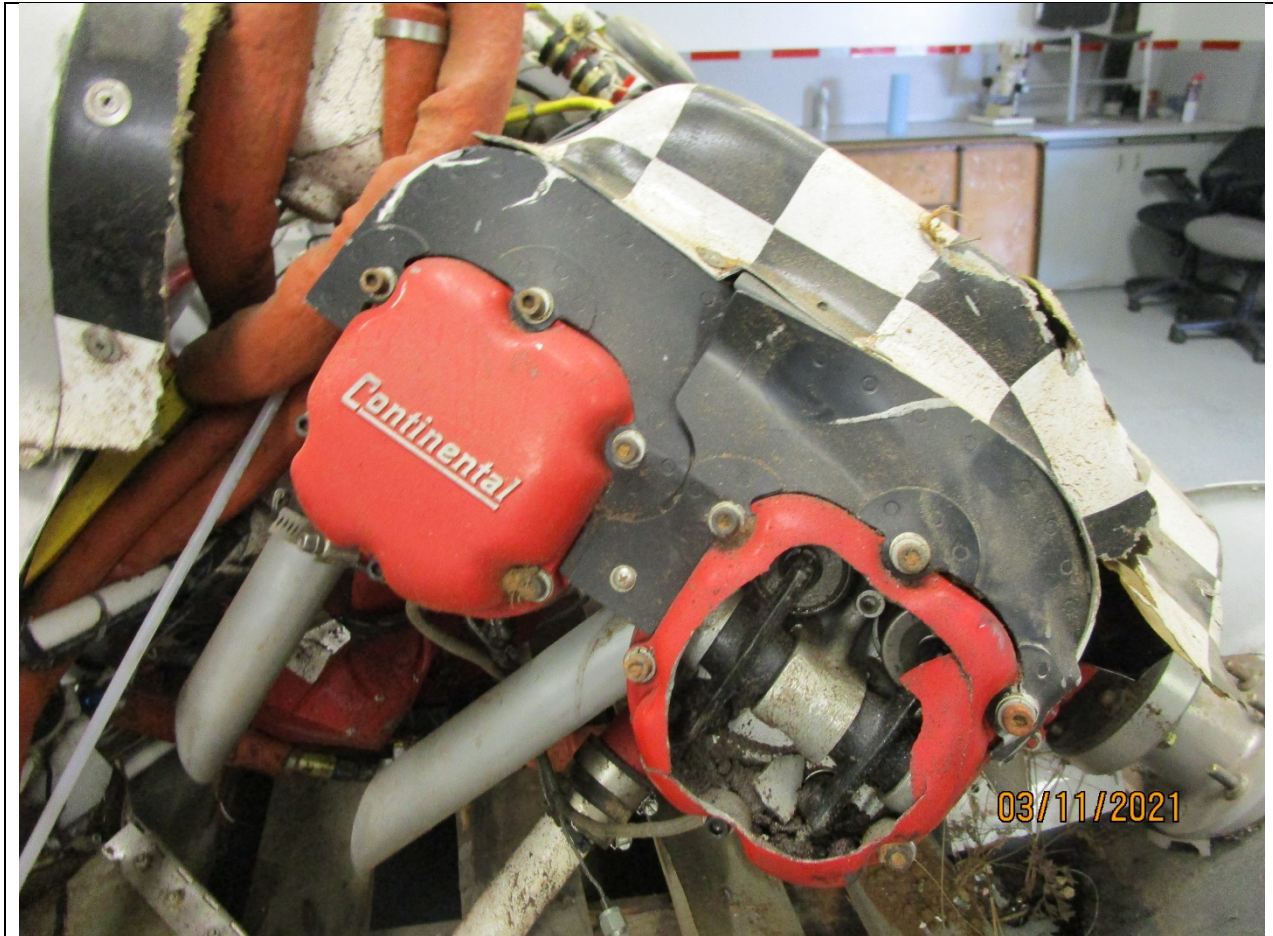
Right side of engine, note damage to the valve cover.

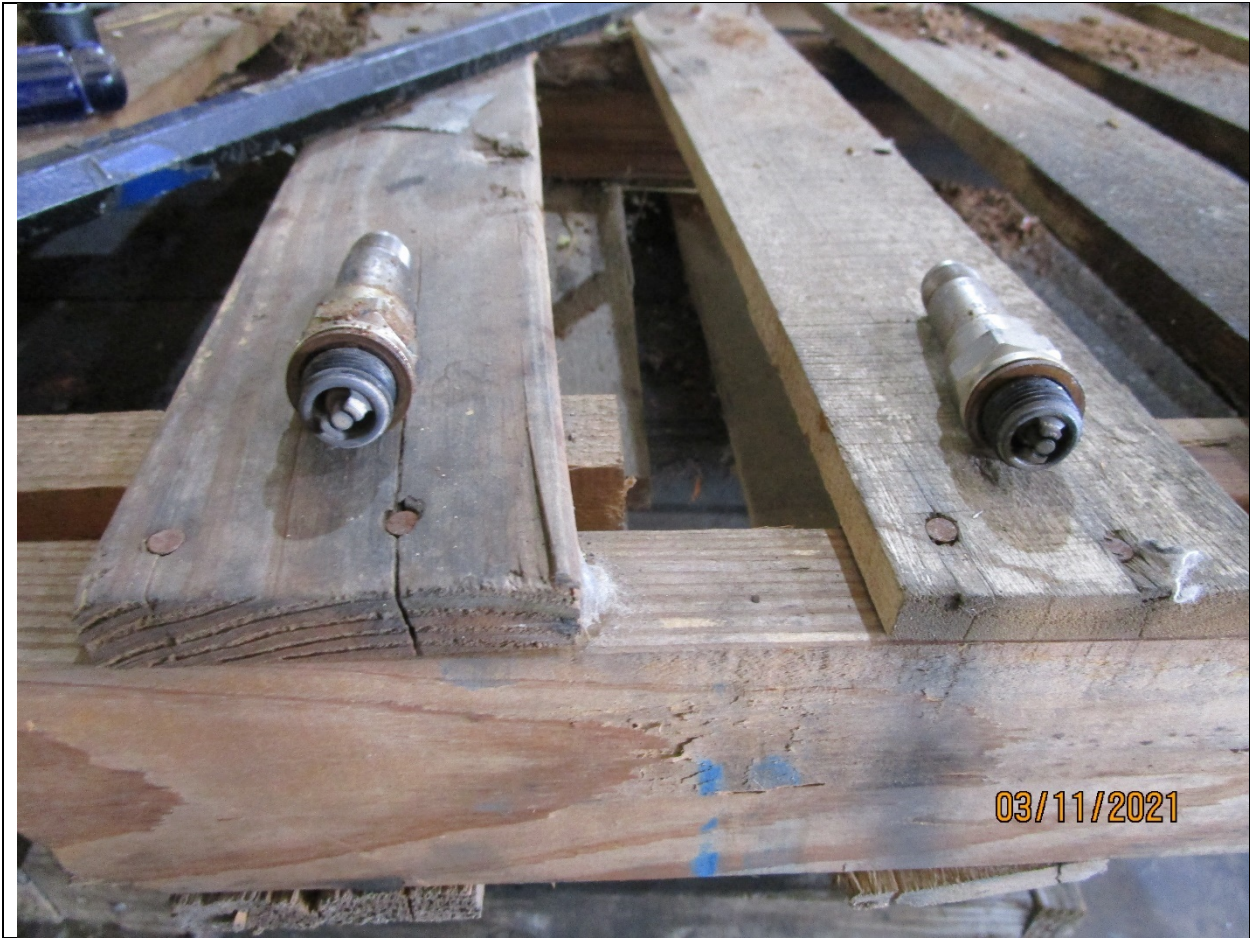
Sparkplugs exhibited normal wear and deposits

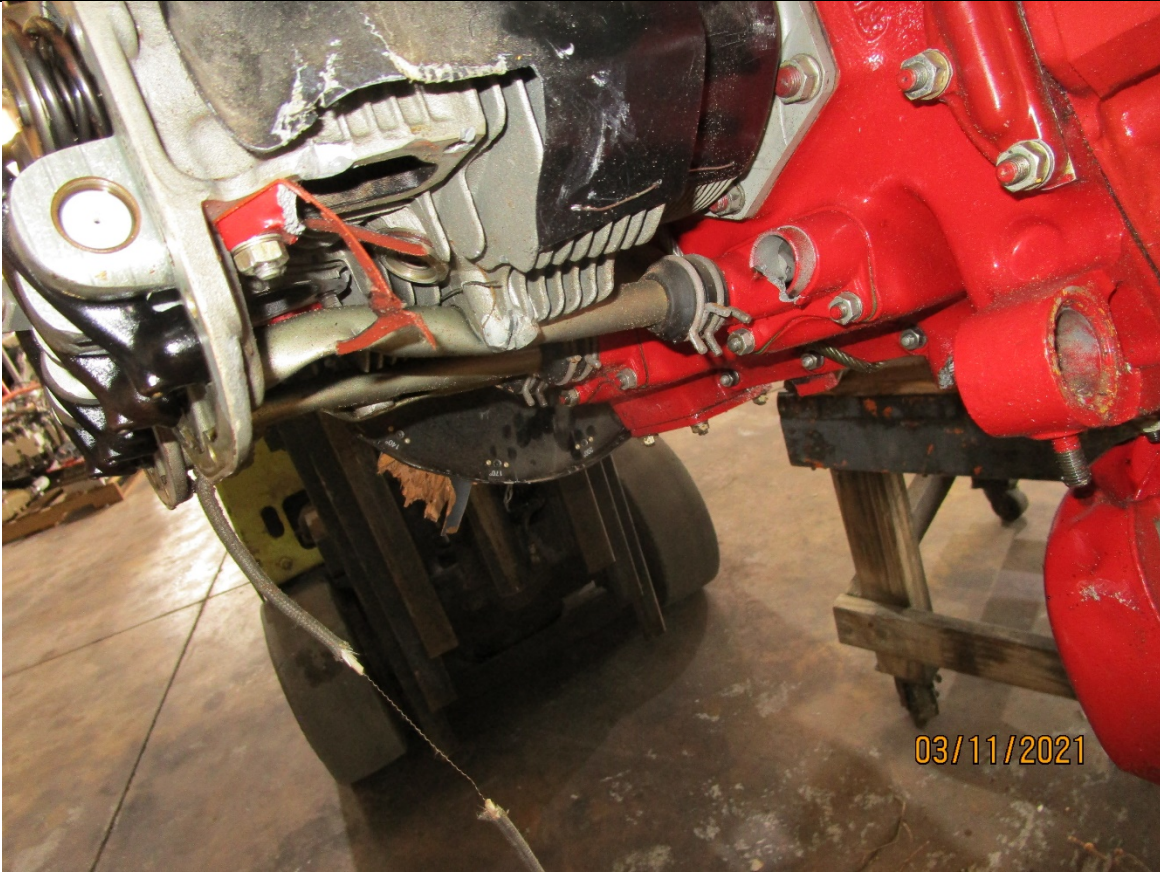
A preliminary inspection of the engine noted that the two left cylinder's pushrod tubes were damaged or missing. The oil sump was partly crushed had been punctured, the carburetor was broken from the case, and the case was absent any holes or obvious pre-impact abnormalities.

Missing pushrod and tube, the left front cylinder also has a mangled pushrod/tube

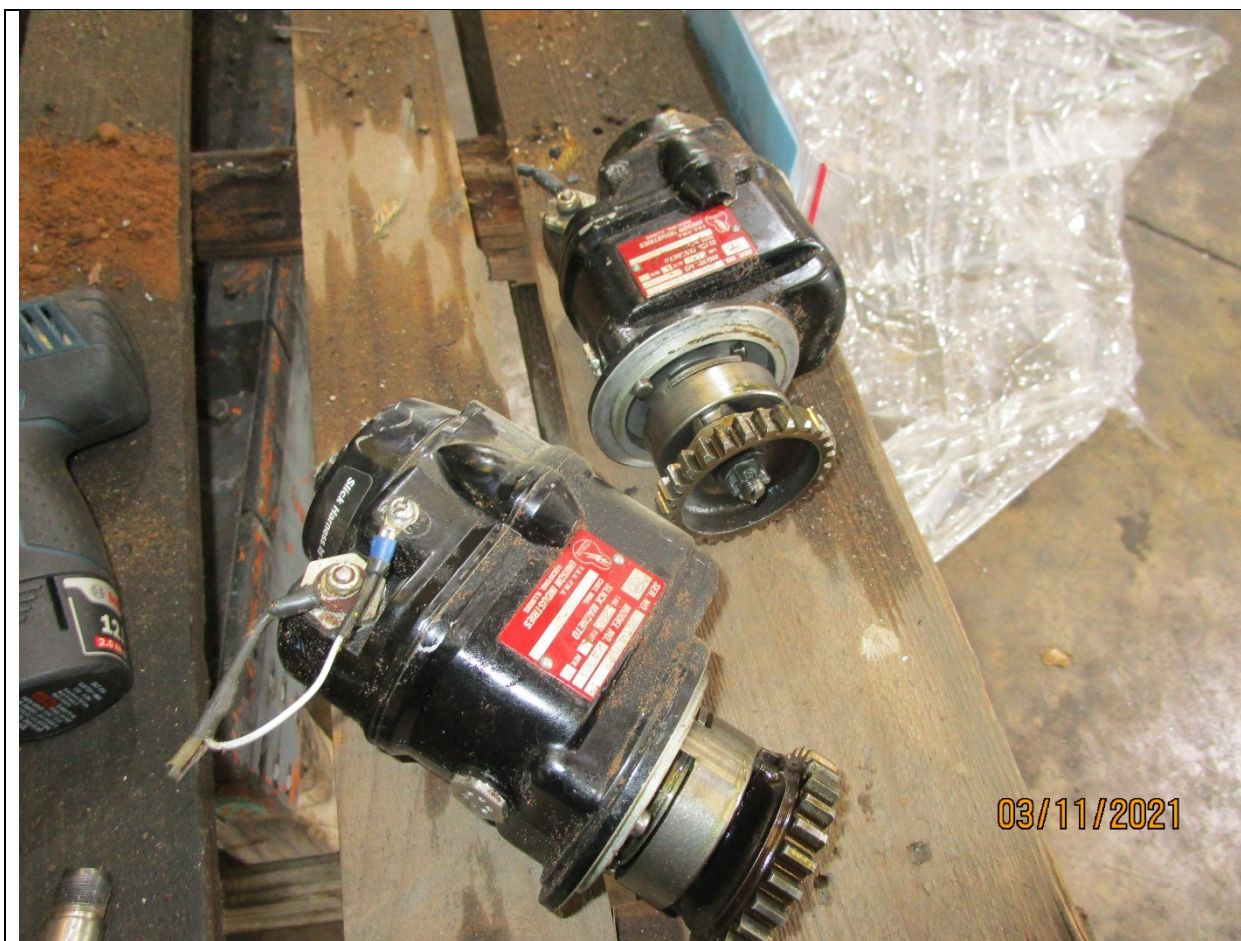
A drill motor was attached to each magneto; both magnetos produced spark on each terminal

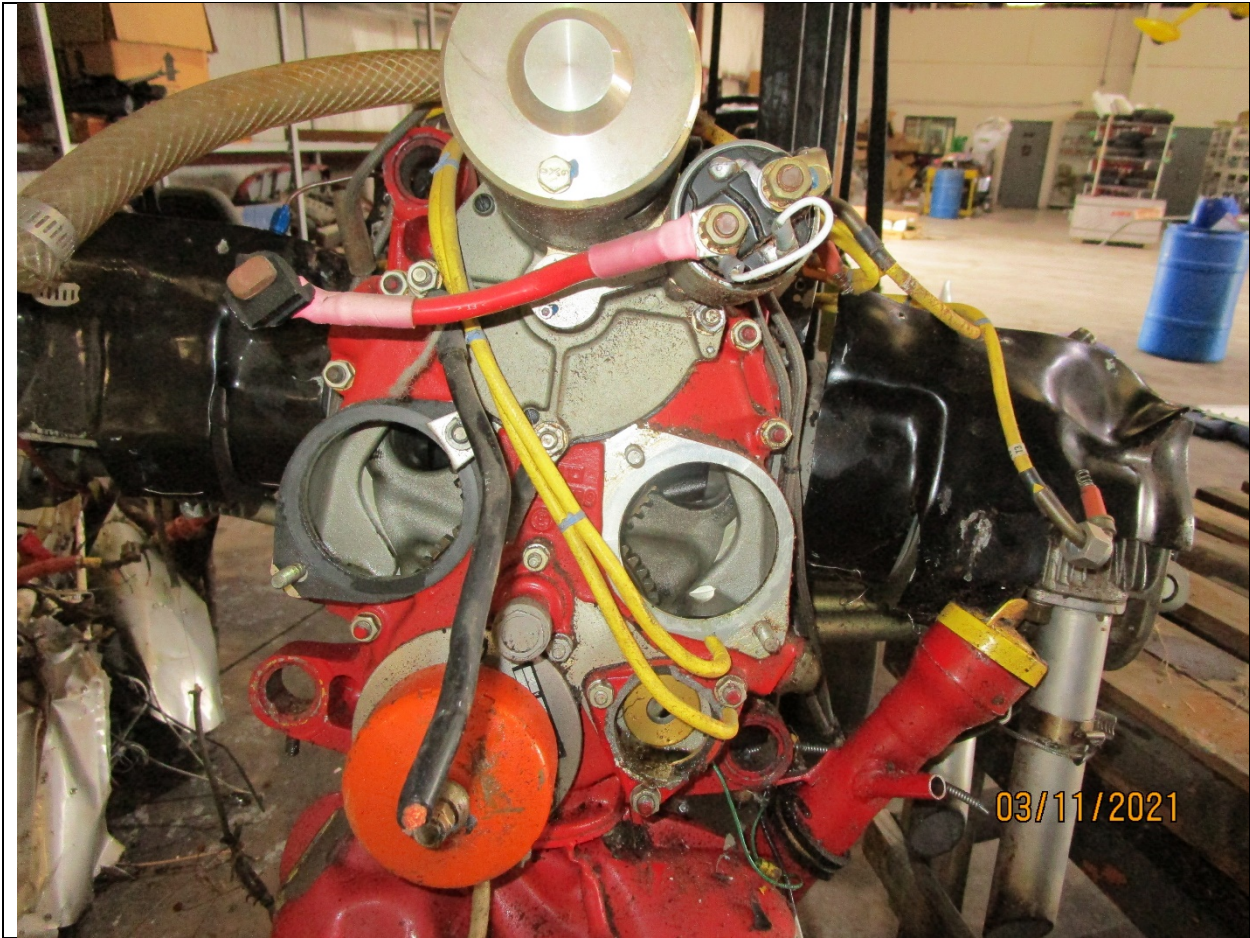
When the crankshaft was turned by hand, continuity thru the valve train and accessory section was noted.

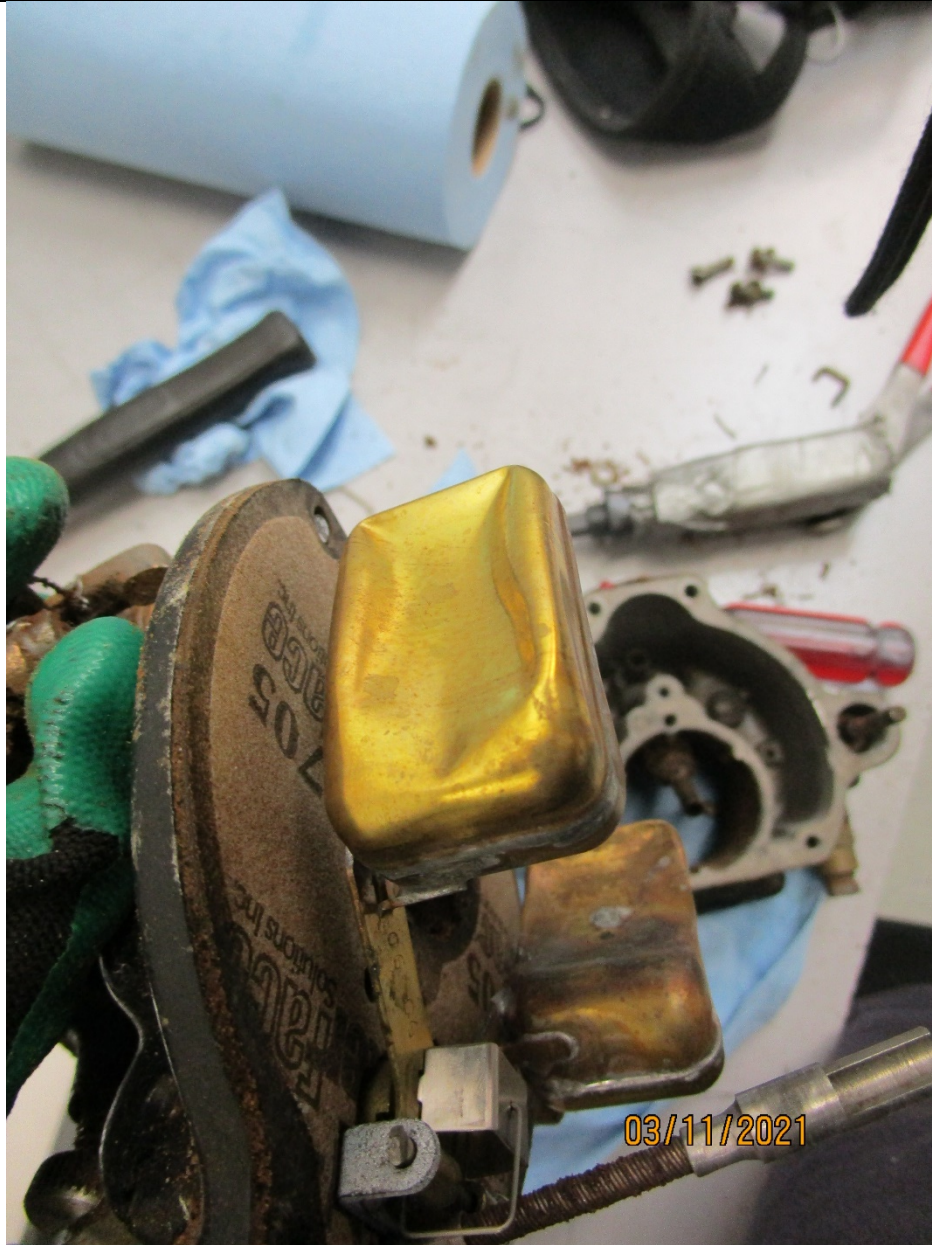
- The engine was equipped with a remote mounted spin-on oil filter, the filter was absent an installation date/engine time. The oil filter canister was cut open and the filter element inspected.
- The carburetor was recovered from a bag that contained miscellaneous airplane pieces
  - The bowl was dry and clear of contaminants, both metal floats were partly "crushed"

Carburetor was disassembled, both floats appeared to be “crushed”

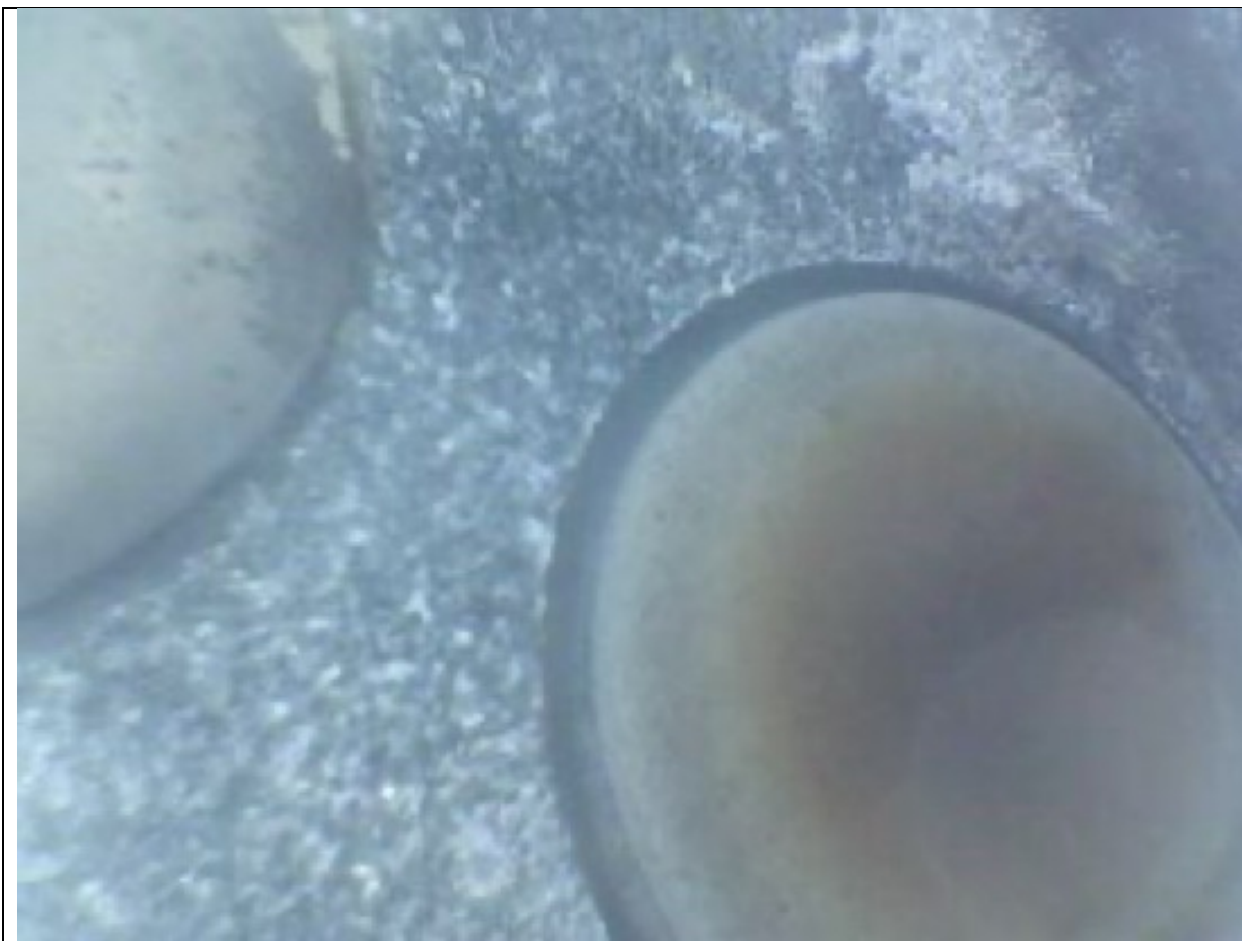
Borescope of the cylinders, showing intake and exhaust valves.
