## **NATIONAL TRANSPORTATION SAFETY BOARD**

# **AIRFRAME AND ENGINE EXAMINATION**

**WPR19FA241**

Aircraft: Glaser-Dirks DG 300 / N300GG

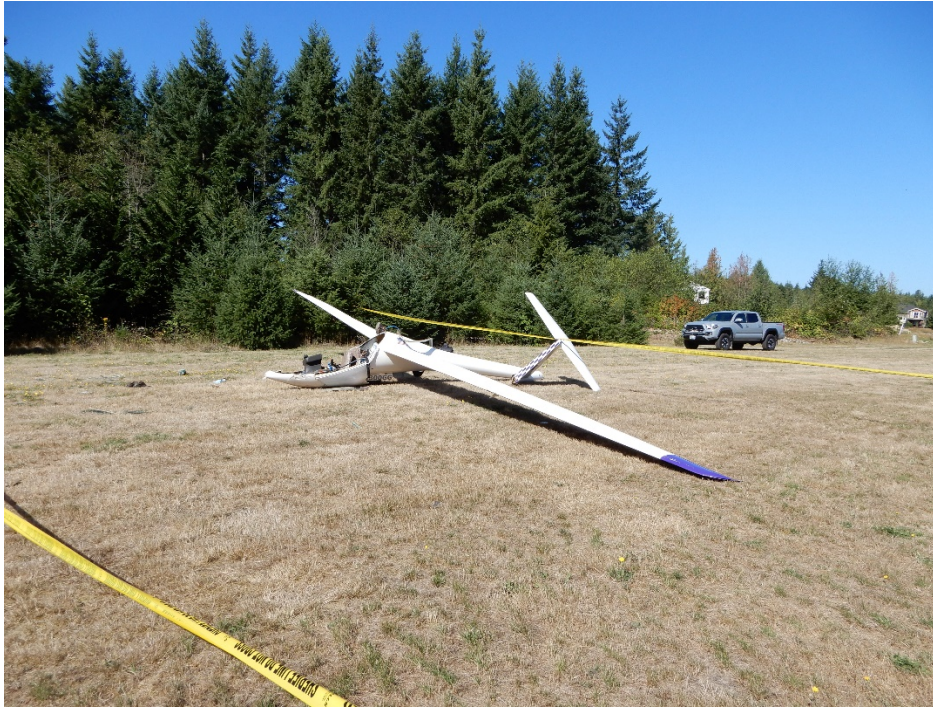
Photo 1. N300GG, left-side view

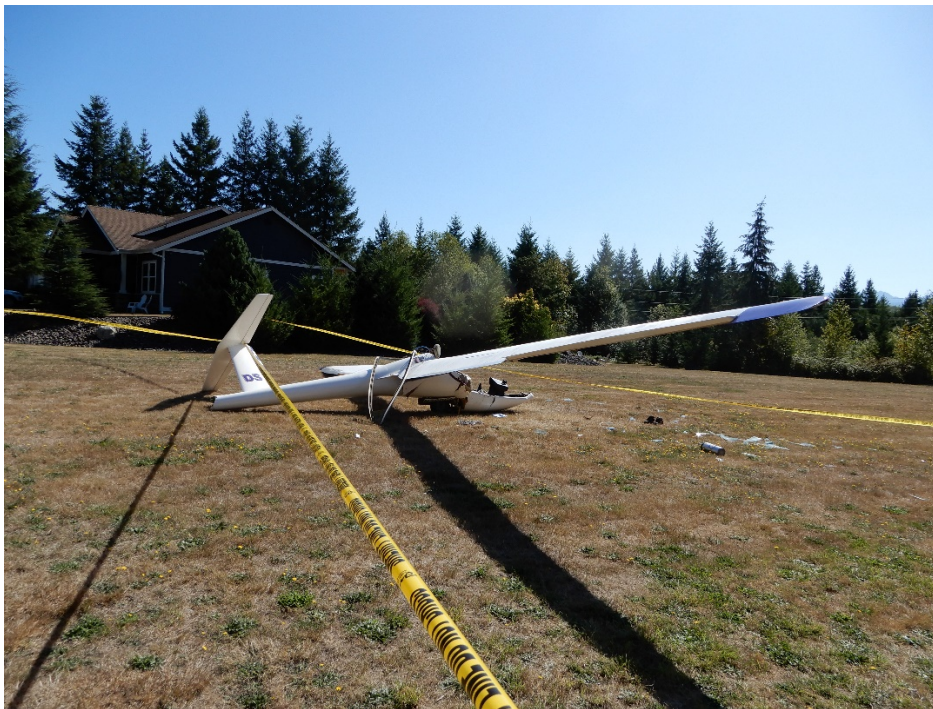
Right Wing. The right wing was partially separated at the root. The forward pin was discovered out of the receptacle. The wing was found elevated above and resting on the pin. The root trailing edge was split open from the root to about 60 inches outboard. The underneath portion of the wing root was displaced down. A large tear of the composite material, about twelve inches long was found on the underside of the wing about ten inches from the root. The remaining underside displayed some tears and creases in the composite skin. The tip of the wing was damaged consistent with contact with the ground. The leading edges, from the tip to about 20 inches inboard was split open at the leading edge and multiple purple paint chips were observed on the ground. Some grass was found wedged in between the composite material. Extensive cracks were observed along the upper portion of the wing tip. The wing tip wheel had separated from the underside of the wing. The aileron was jammed into the wing nearest the wing tip. The wing portion near the inboard corner of the aileron was found fractured with cracks radiating out in a 45° angle. A ground scar with portions of purple paint chips and the wing tip wheel was found near the right-wing tip. The aileron did not move freely. The right spoiler was found in the retracted position and moved freely up and down when the right wing was removed from the fuselage.

Photo 2. N300GG, right-side view.

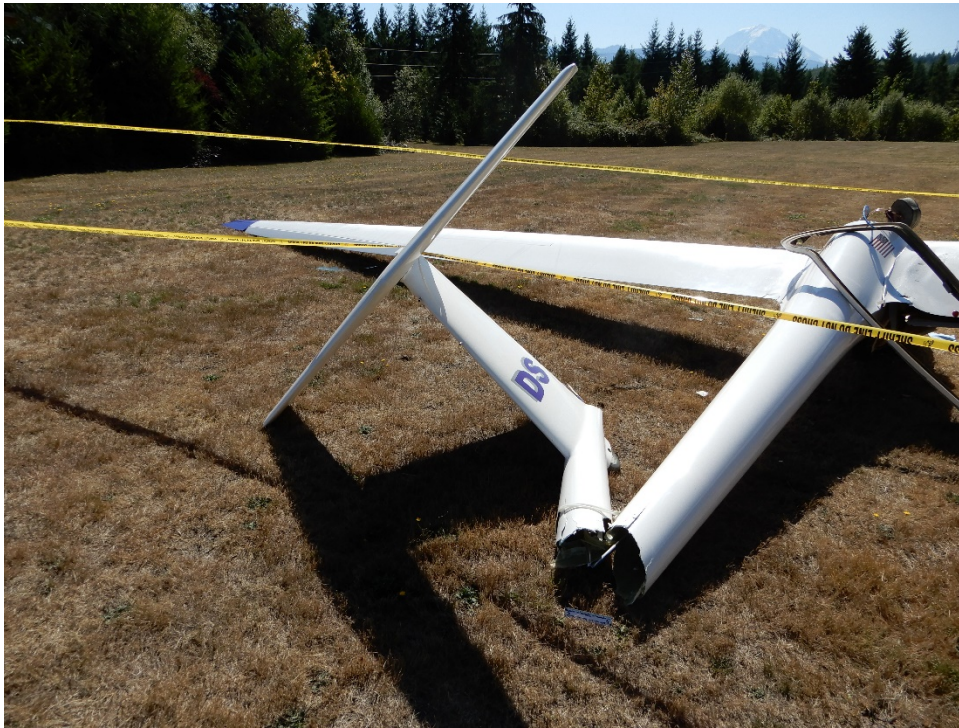
The aft fuselage was found fractured and the entire empennage was separated from the aft fuselage at about 36 inches from the end of the aft fuselage. The empennage remained attached to the aft fuselage via tubing. The elevator remained attached to the top of the vertical fin and moved freely to the limits. The rudder remained attached to the vertical fin at the hinges and moved freely to the limits.

Photo 3. View of the empennage

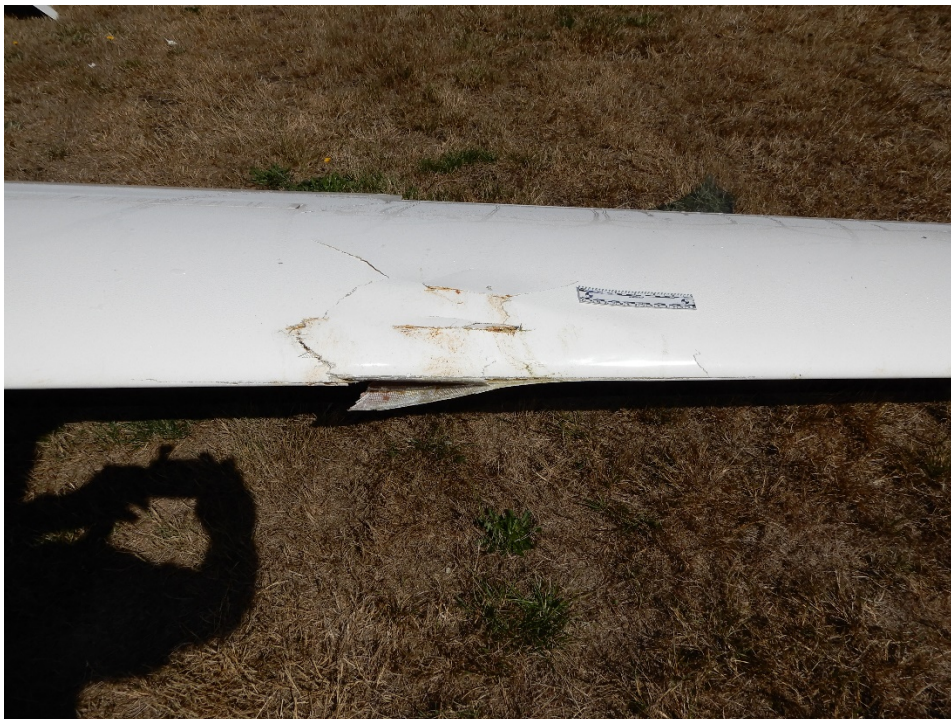
Left Wing. The left wing remained attached to the fuselage. Small cracks were noted at the wing root at the trailing edge. Some cracks in the composite material were observed on the top of the wing near the inboard edge of the aileron. The aileron remained attached to the wing at the hinges and was displaced downward. The aileron moved freely by hand manipulation. The tip of the wing displayed cracks at the leading edge, and upper surface. The leading edge forward of the aileron and near the tip of the wing, displayed cracks and wrinkling of the upper surface, and extending inboard. The left-wing tip wheel separated from the underside of the wing. The leading edge displayed a damaged area, with multiple large cracks in the composite material, with brown matter consistent with tree bark and green pine needles wedged into the composite material. The underside of the wing displayed delamination, brown matter, and trapped pine needles in the cracks of the composite material in this area. The left spoiler was found in the retracted position and moved freely after the wing was removed from the fuselage. The wing appeared normal inboard of the damaged leading-edge area to the wing root.

Photo 4. Left wing showing cracks in composite material along with brown colored deposit and pine needles trapped in cracks.

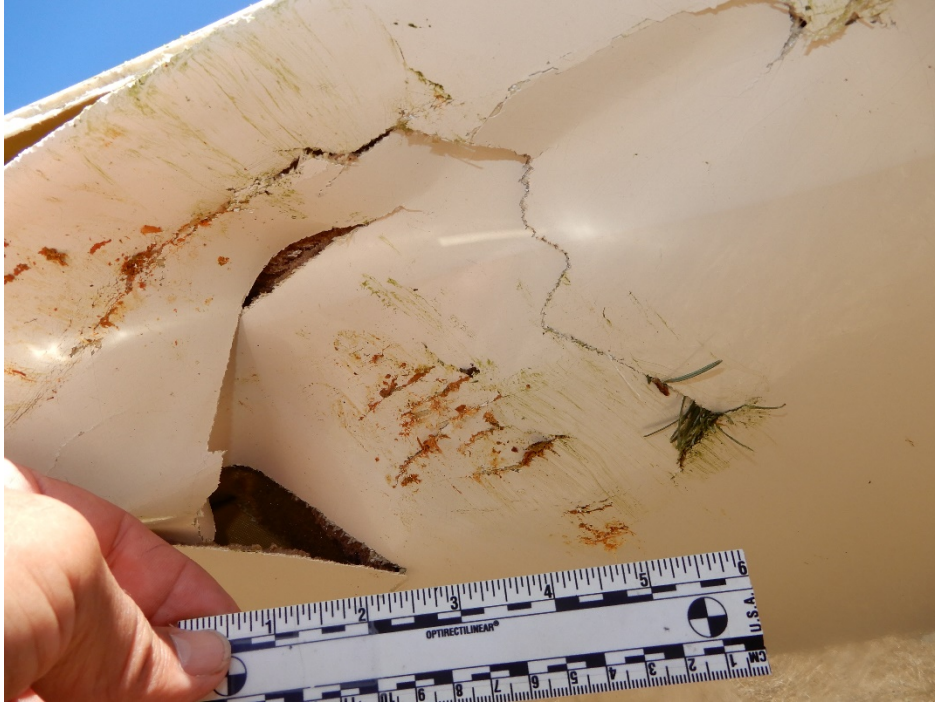
Photo 5. Underside of left wing, showing cracks in composite material, brown colored deposit and pine needles trapped in cracks.

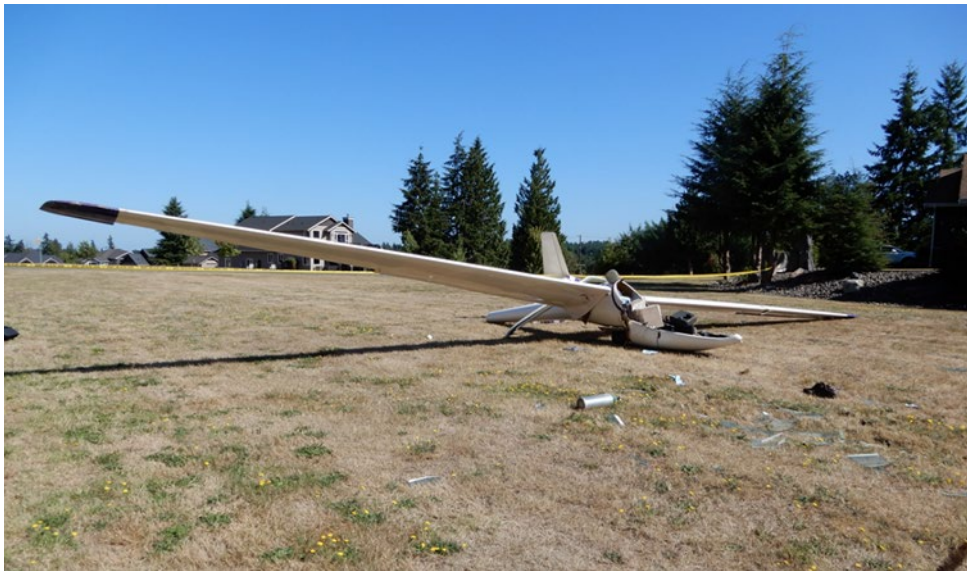
Photo 6. Showing N300GG, with the debris field in the foreground.
