## **NATIONAL TRANSPORTATION SAFETY BOARD**

# **AIRFRAME AND ENGINE EXAMINATION**

**WPR19FA246**

Aircraft: Beech BE-33 Debonair / N9529Y

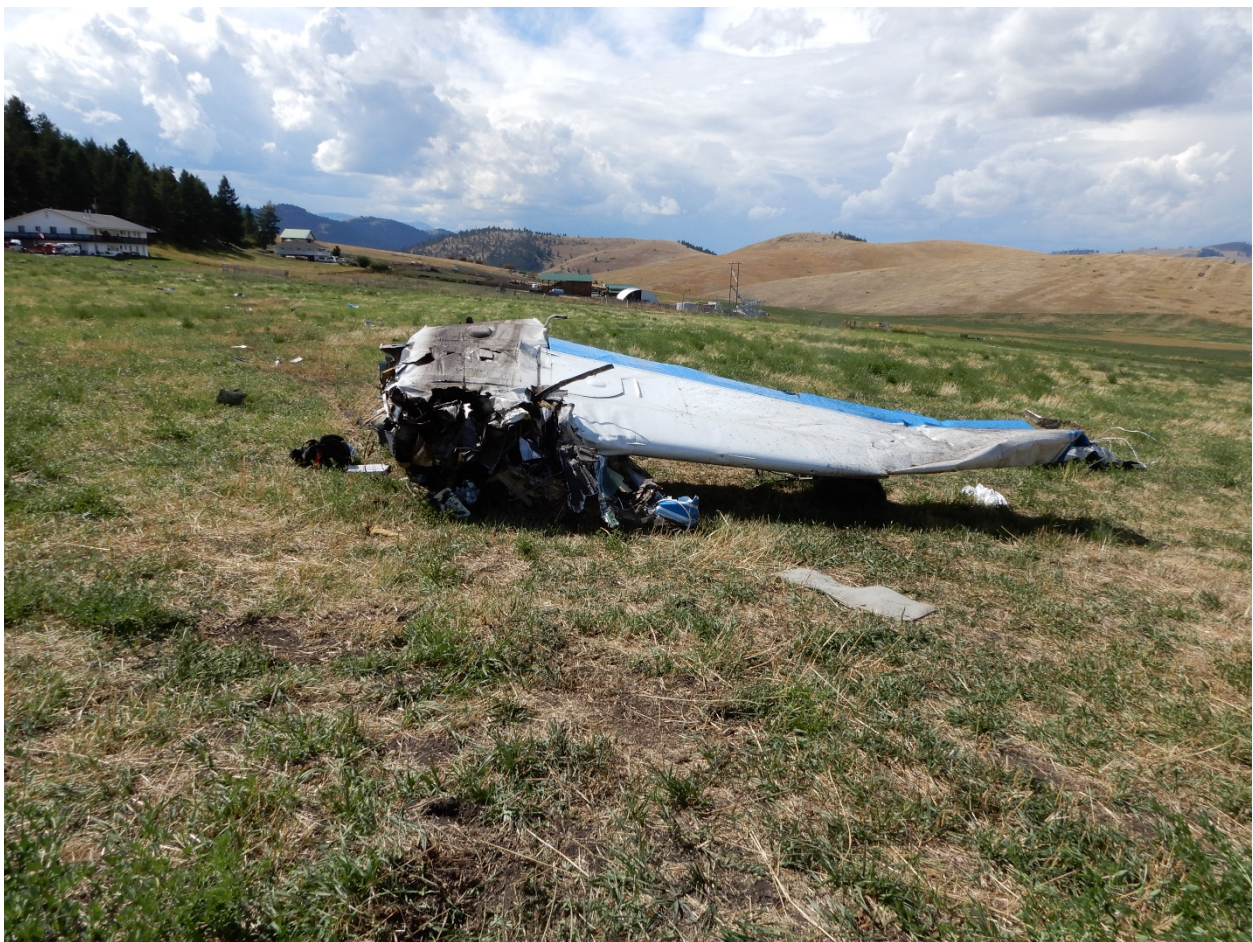
The airplane came to rest inverted in a flat hay field. The belly of the airplane displayed dents and tears and oil streaks throughout the bottom of the airplane. The airplane was flipped over during the examination.

Photo 1. N9529Y, as found after the accident.

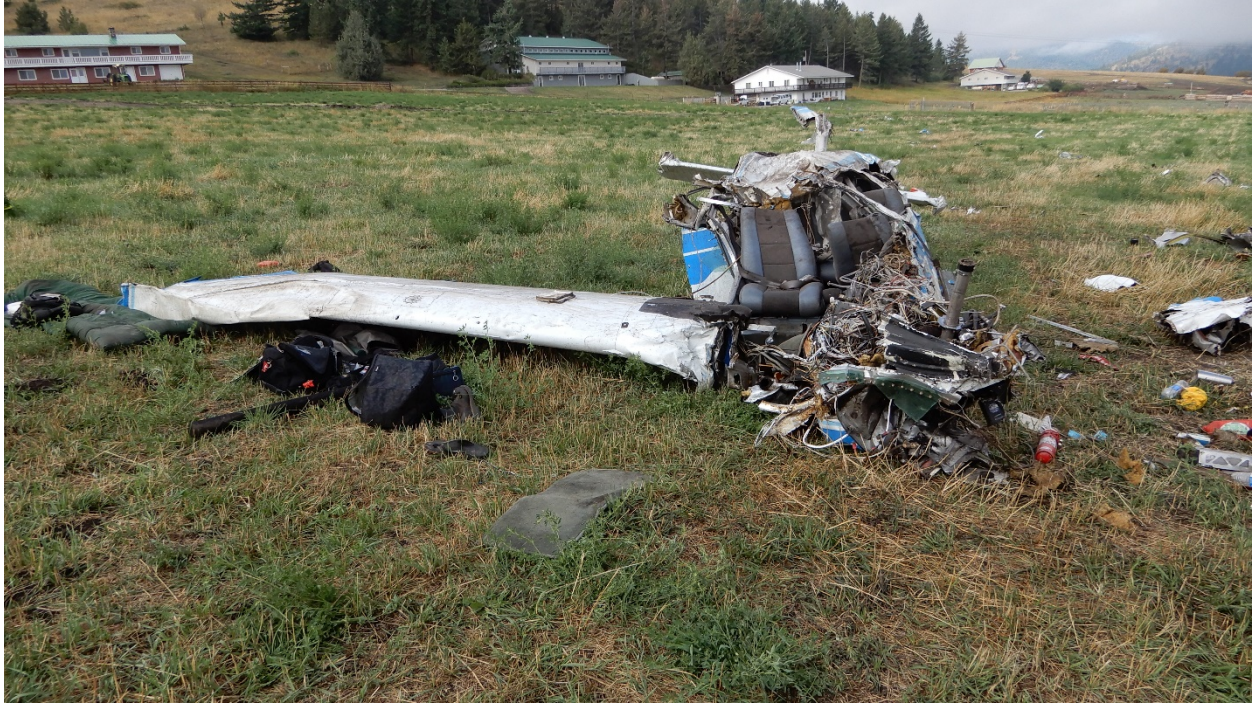
Photo 2. N9529Y, front view after the airplane was turned right-side up.

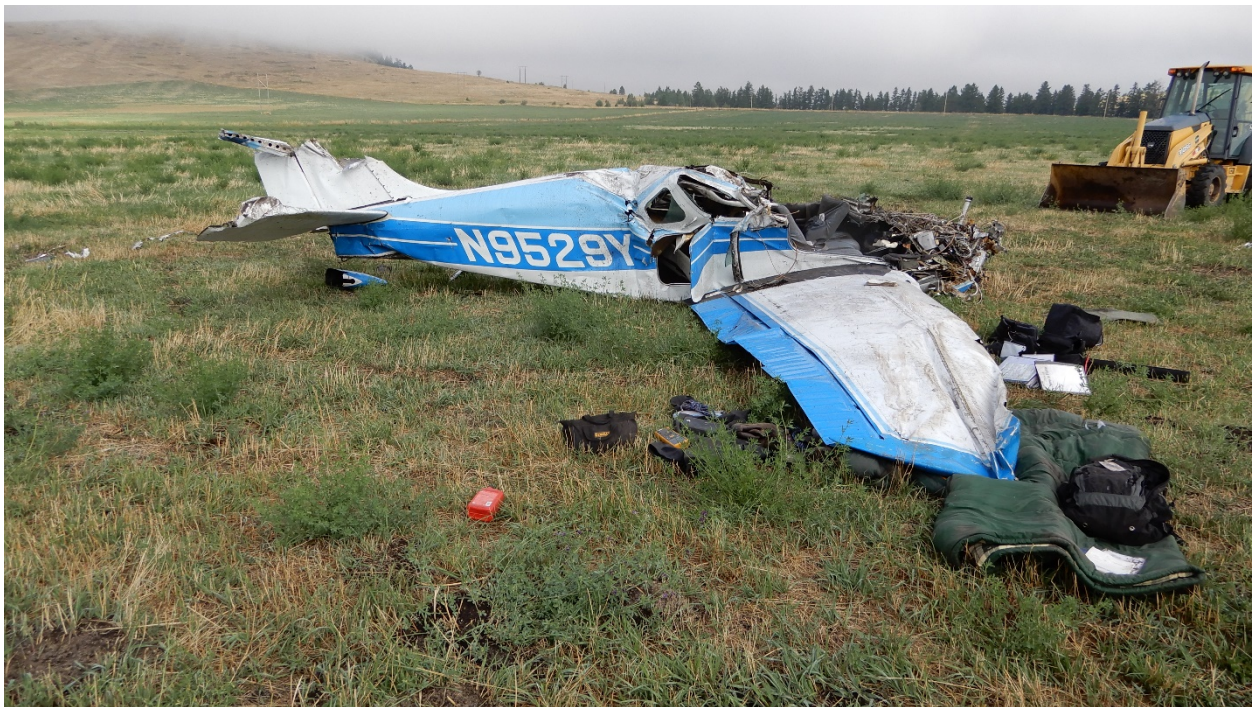
Fuselage Right Side. The forward half of the cabin, the portion above the front seats, and the right door had separated from the fuselage exposing the inner cabin area. Fragments of the window supports remained attached to the right side. The right wing remained attached to the fuselage at the root. The outboard wing tip to about 30 inches inboard, was bent aft and downwards. The right aileron remained attached to the wing at the hinges and displayed damage throughout its span. The aileron appeared to be in a neutral position. The right flap remained attached to the wing at the hinges and displayed damage throughout its span. The flap was found in the up position. The right fuel cap was found secured in the port. The rubber seal was soft and pliable. Residual fuel found in the tank tested negative for water.

The right-side access door remained attached to the fuselage at the hinge and was found open. The fuselage was buckled inwards just aft of the rear window. The buckling continued upwards to the top of the rear portion of the cabin. The aft fuselage displayed dents and wrinkles back to the empennage.

Photo 3. N9529Y, right-side view.

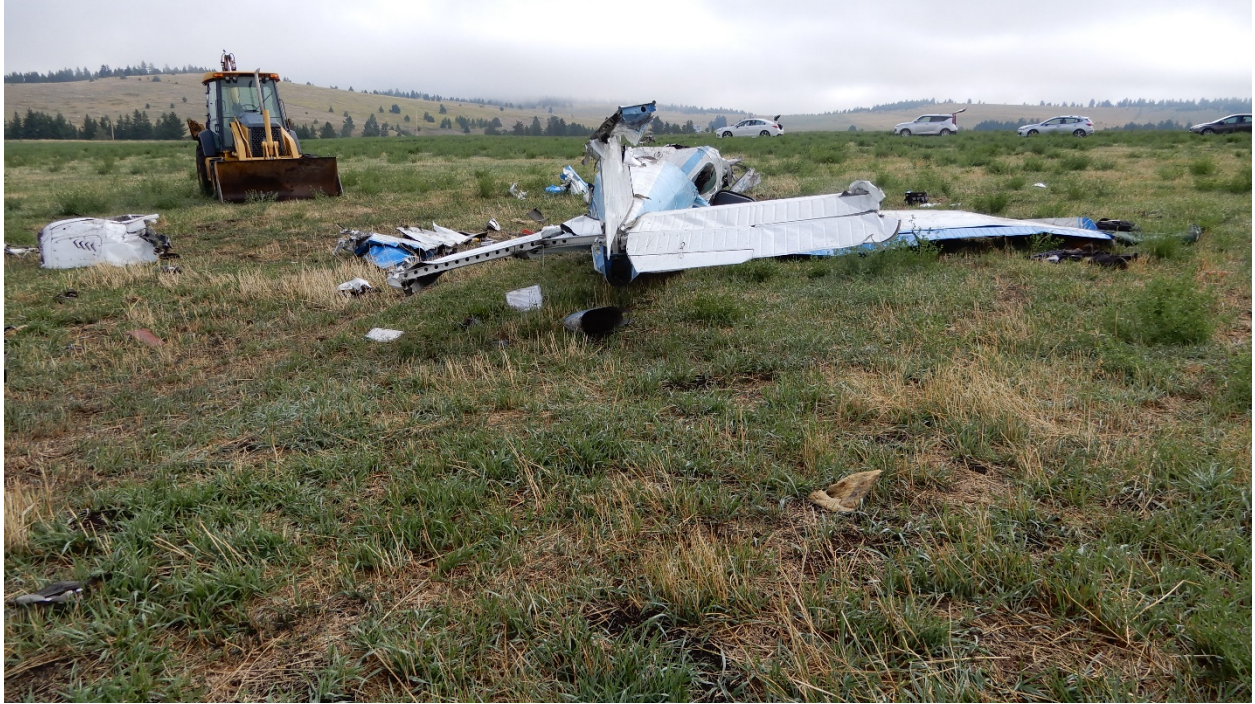
Empennage. The right horizontal elevator remained attached to the fuselage at its mount and displayed damage at the tip, with wrinkling and dents along the span. The right elevator displayed damage at the outer tip. The counterweight was separated and found in the debris field. The right trim tab remained attached to the elevator and appeared in a neutral position. The vertical fin remained attached to the fuselage. A portion, from the root to about 18 inches up, had separated and found near the power lines. The lower half of the rudder remained attached to the fuselage. The left horizontal elevator remained attached to the fuselage. The left horizontal stabilizer displayed damage at the tip and aft bending with wrinkling and tearing of the sheet metal on the top side near the root. The left elevator had separated from the horizontal stabilizer at the hinges.

Photo 4. N9529Y, rear view.

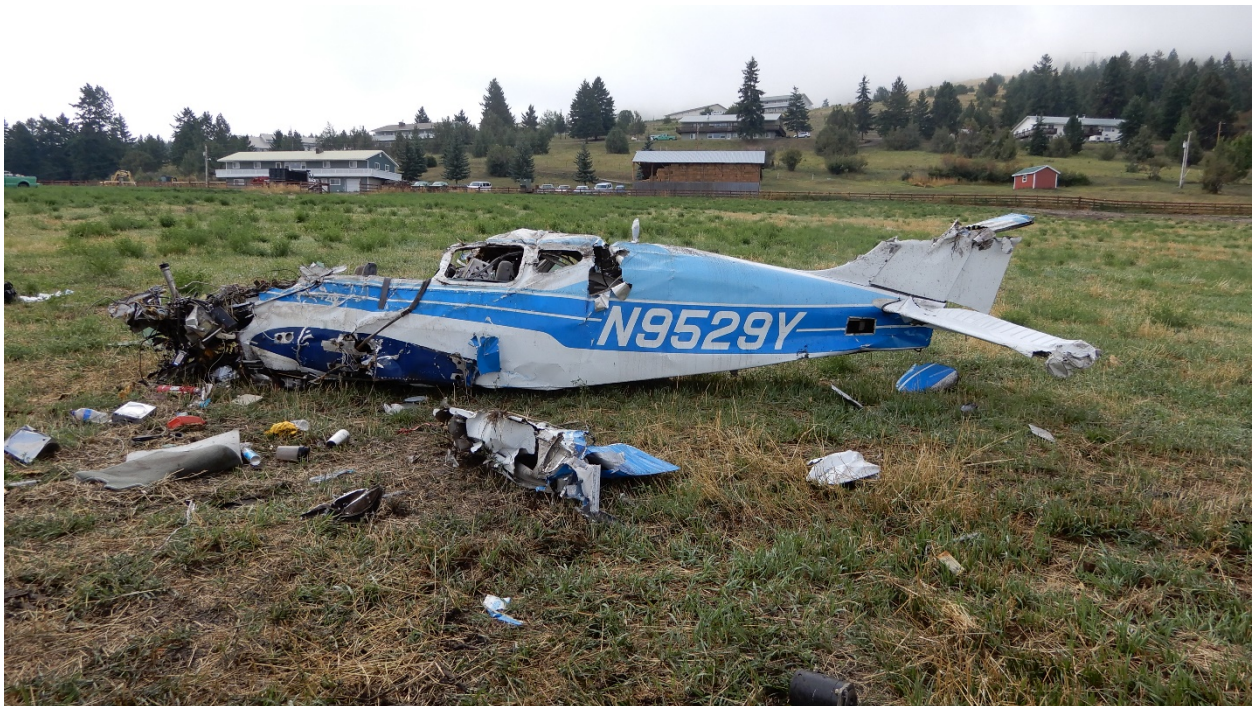
Fuselage Left Side. The left-aft fuselage displayed wrinkling and buckling forward to the rear-passenger window. Aft of the rear passenger window was a tear in the sheet metal that exposed the aft storage area.

Photo 5. N9529Y, left-side view.

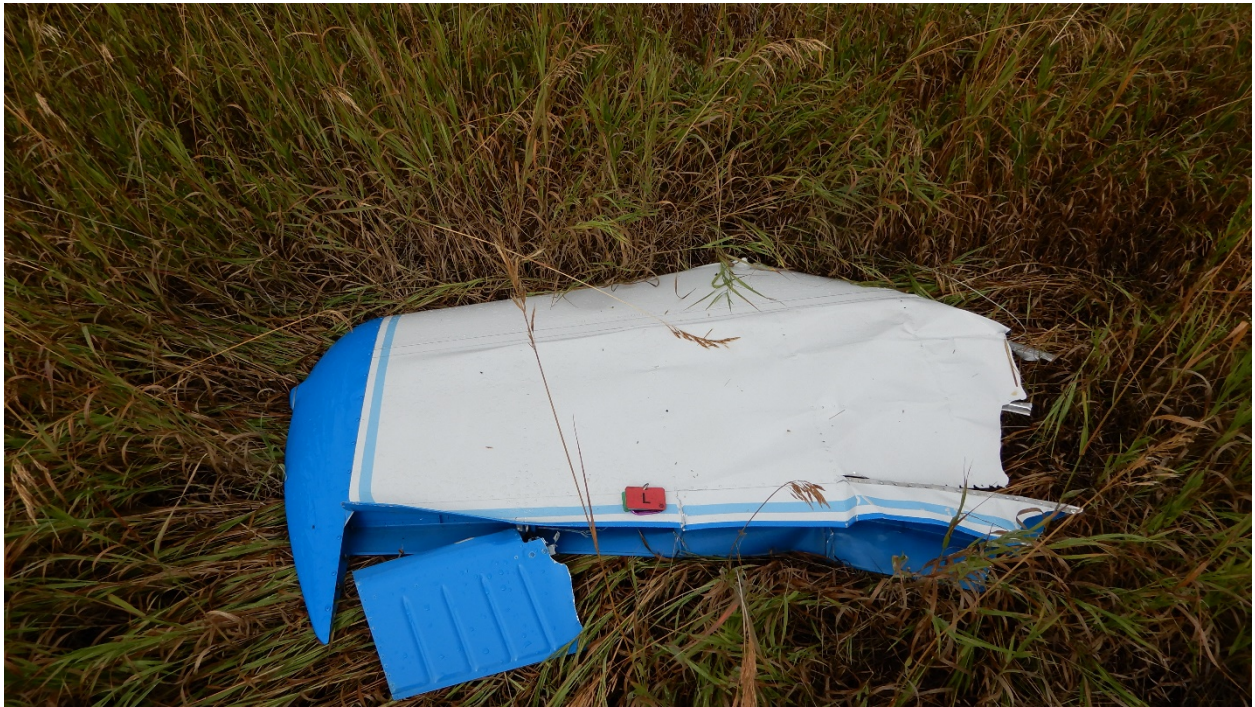
The entire left wing separated from the fuselage. The outboard 4 feet of the left wing separated from the wing and was found in the vicinity of the power lines, about 800 ft away. The separated portion of the wing displayed striations consistent with the size and diameter of power

transmission lines found nearby. The remaining section of left wing was found near the fuselage. The left aileron separated and was located near the outer portion of the wing near the power lines. A small portion of the aileron remained attached to the wing at the outer hinge. The left cabin area of the fuselage was crushed downward. The windscreen and left window separated.

Photo 6. Left outboard section of wing and aileron.

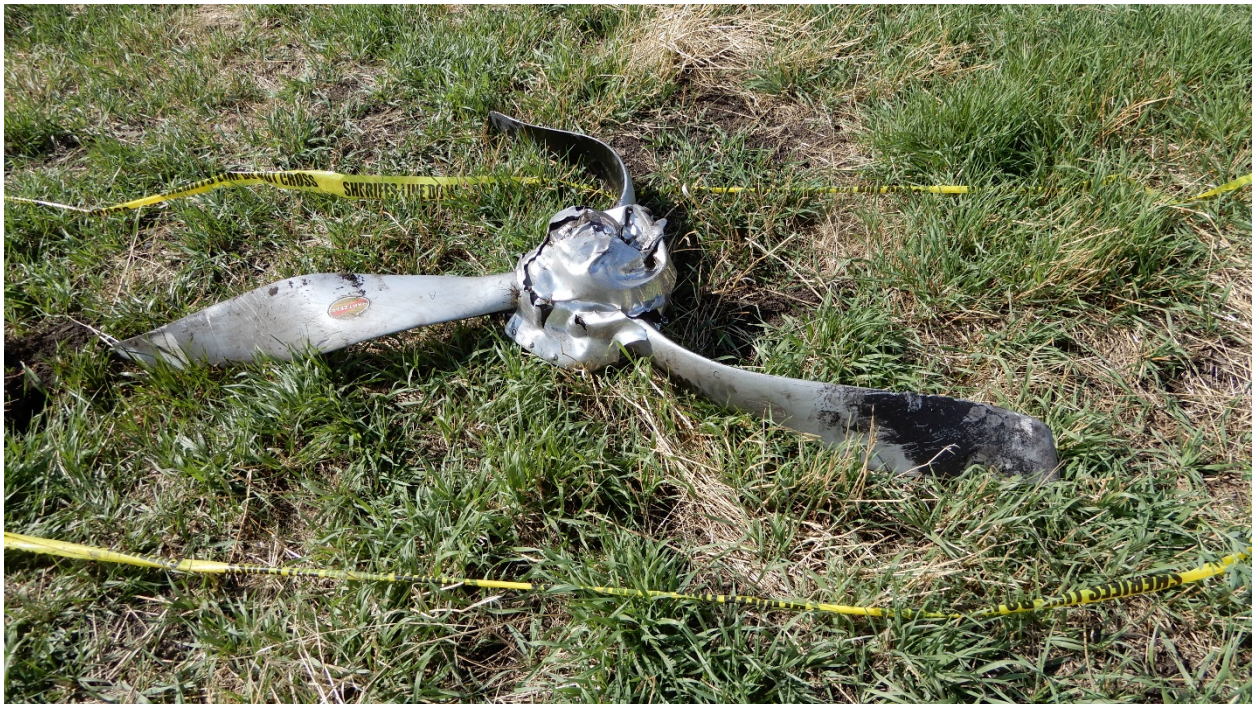
The three-blade propeller separated from the engine and was located about 50 feet from the fuselage. All propeller blades displayed S-bending and twisting, along with gouges and scratches and throughout the span of the blades. The spinner was crushed to the propeller hub.

Photo 7. Propeller, hub, and spinner.

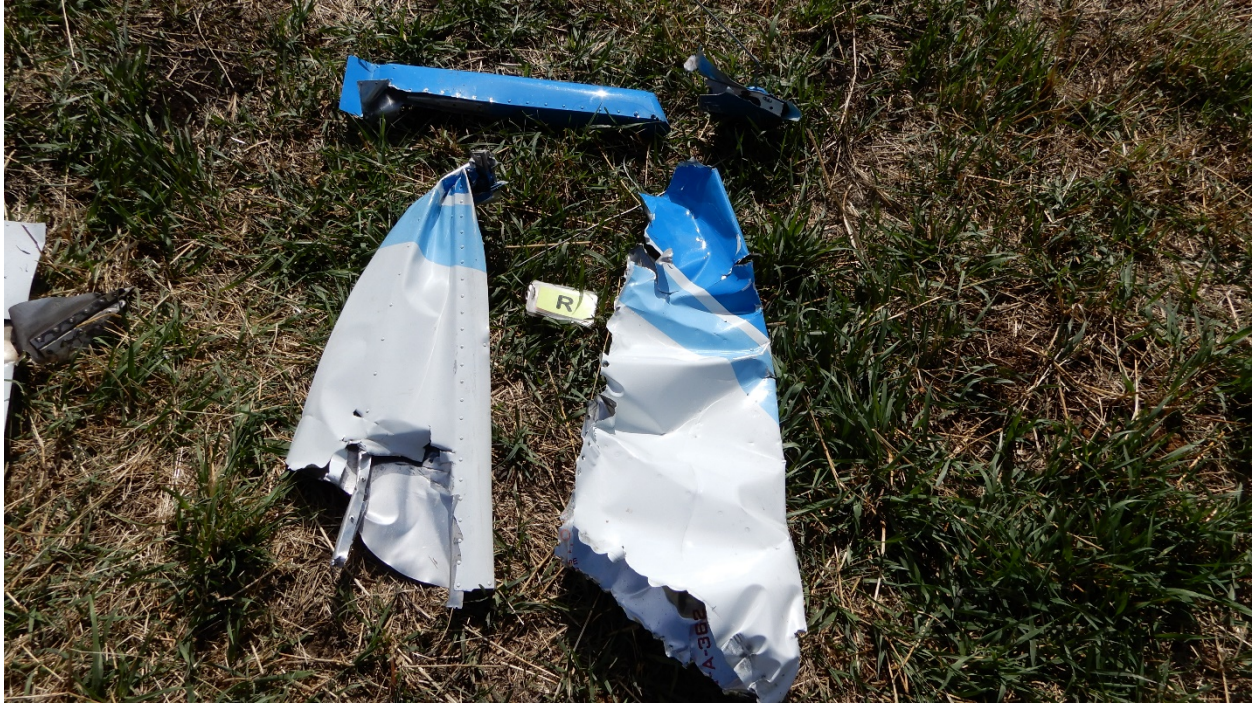
Photo 8. Portions of the Vertical stabilizer, rudder, and cap.

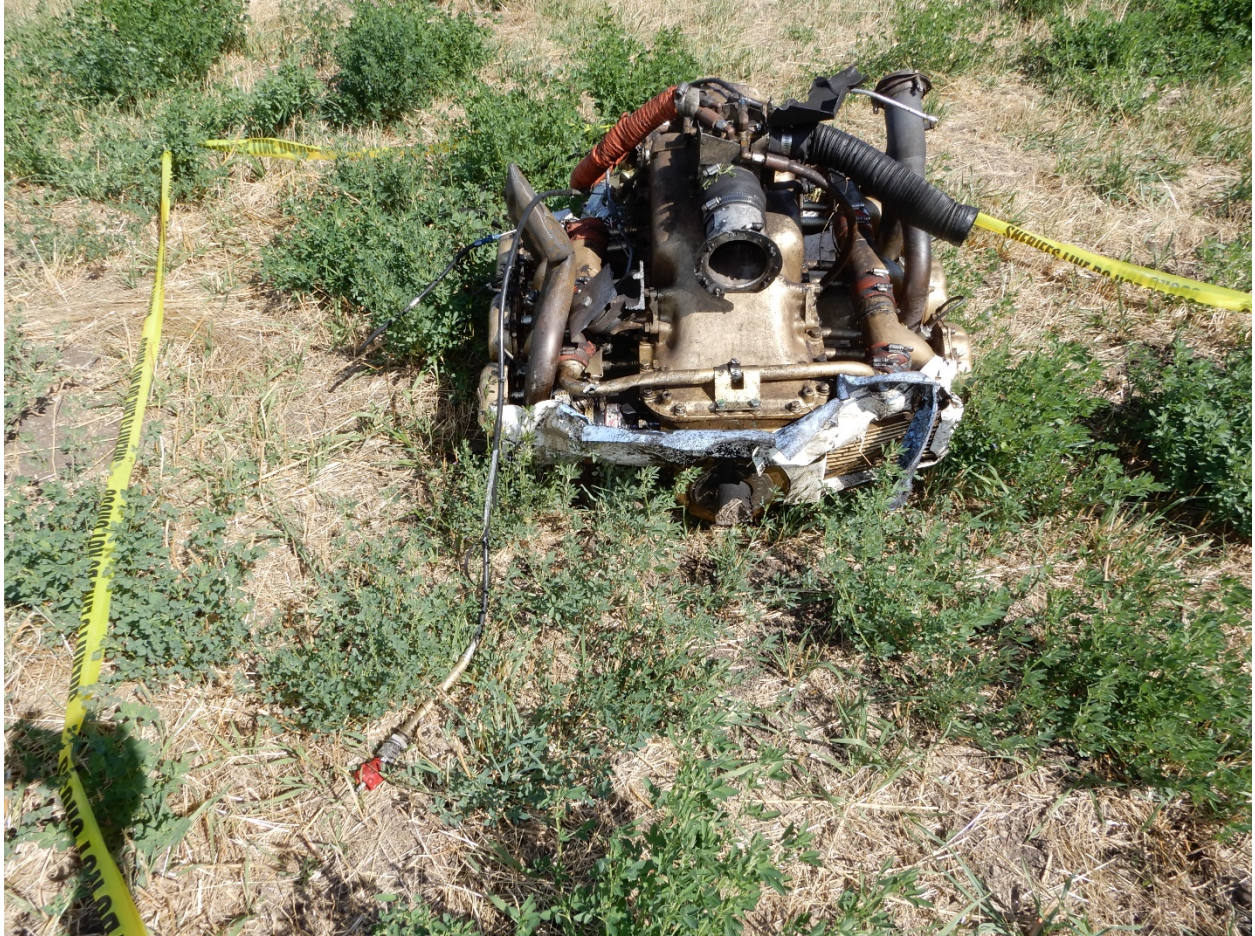
The engine, model IO-470-N (1) Serial number: 096522-R, separated from the fuselage at the firewall and was located about 50 feet ahead of the fuselage, fight side up. The six cylinders remained attached to the engine block. The left magneto remained attached to the engine at its mount. The right magneto had partially separated from its mount. Both magnetos produced spark when rotated by hand.

Photo 9. Engine As found, upside down, front view.

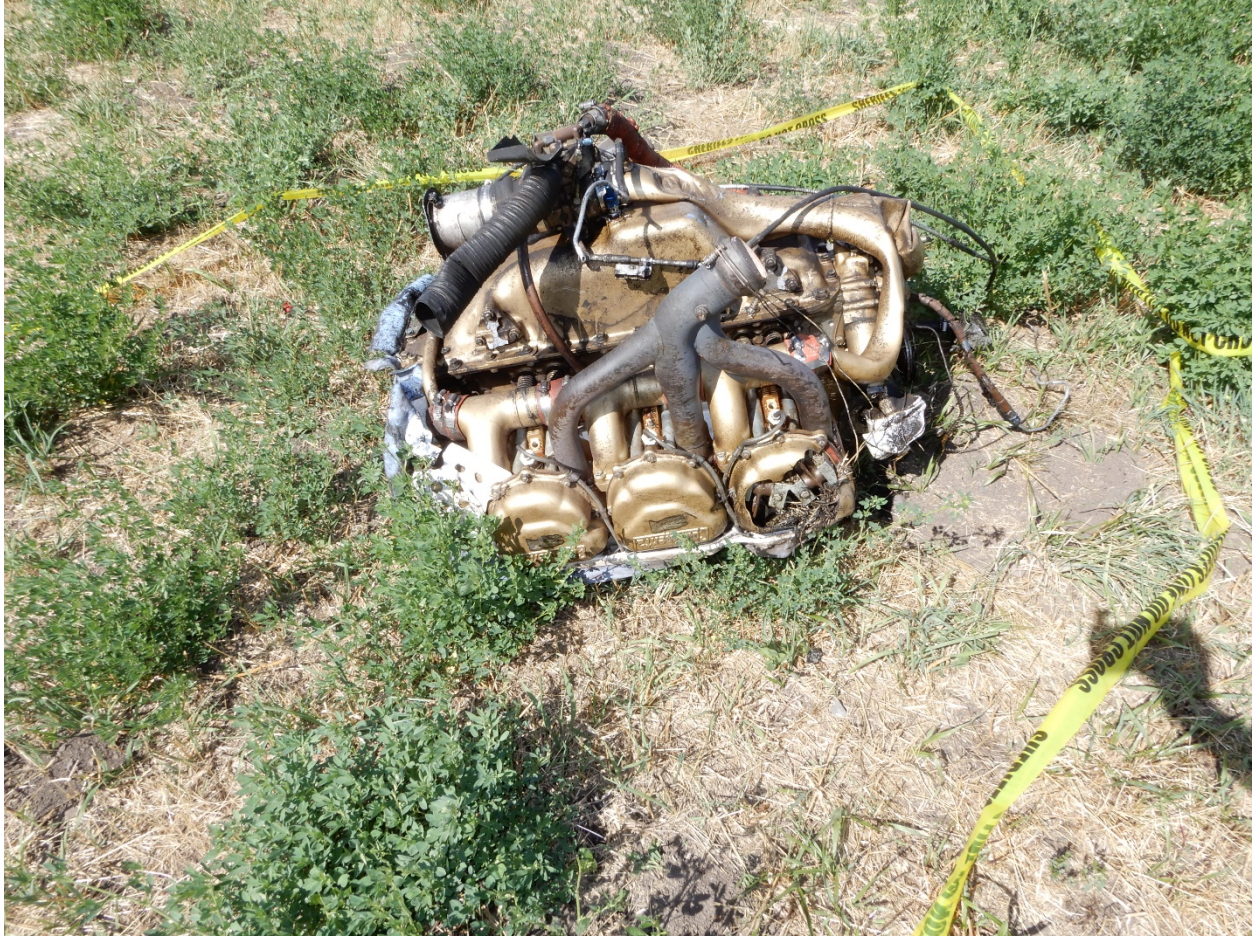
Photo 10. Engine, upside down, right-side view.

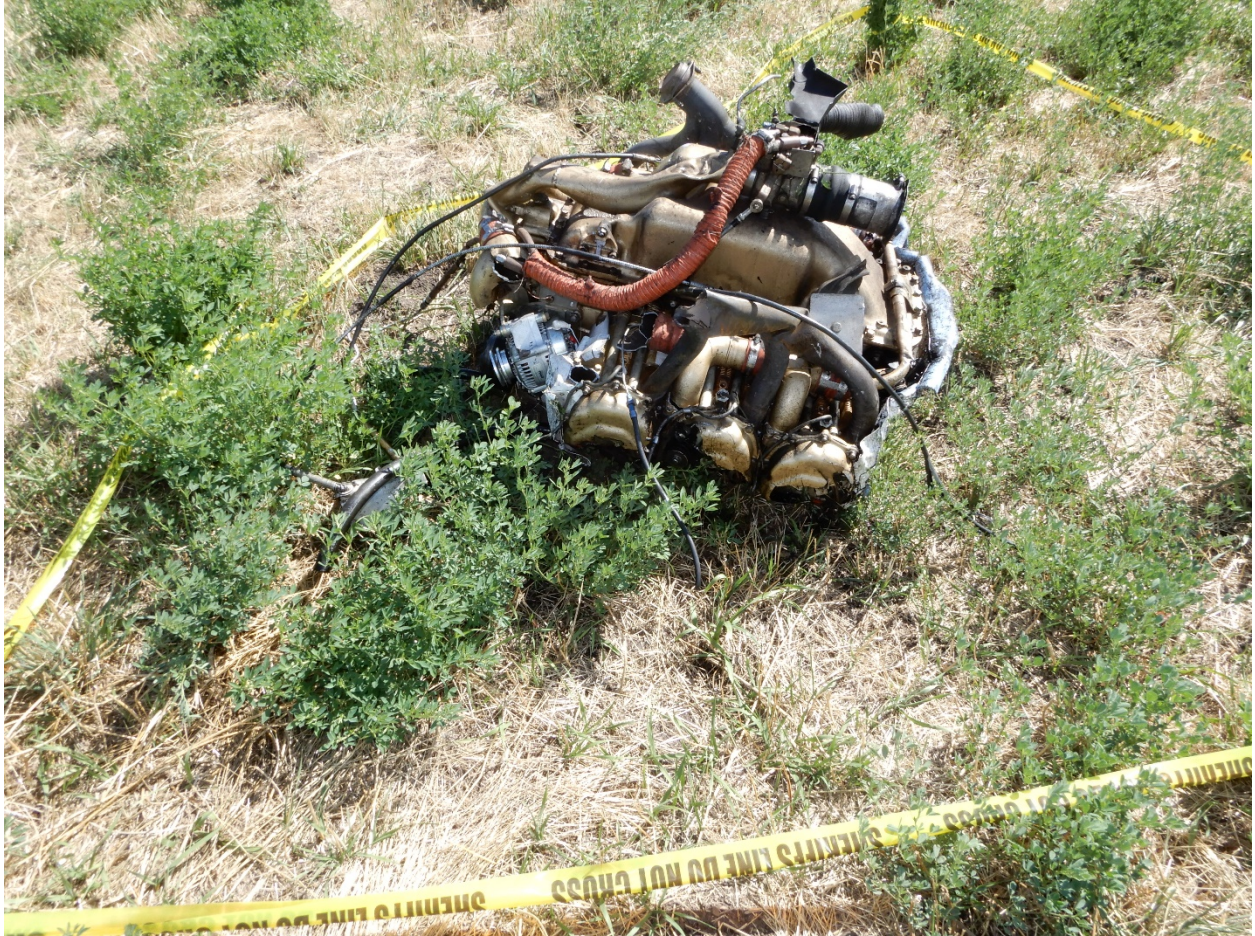
The left-side three cylinders (2, 4, and 6) had damage that exposed the rocker arms and valve springs of each cylinder. The spark plug leads were separated from the sparkplugs on the left side. Borescope examination of the cylinders was normal.

Photo 11. Engine, upside down, left view.

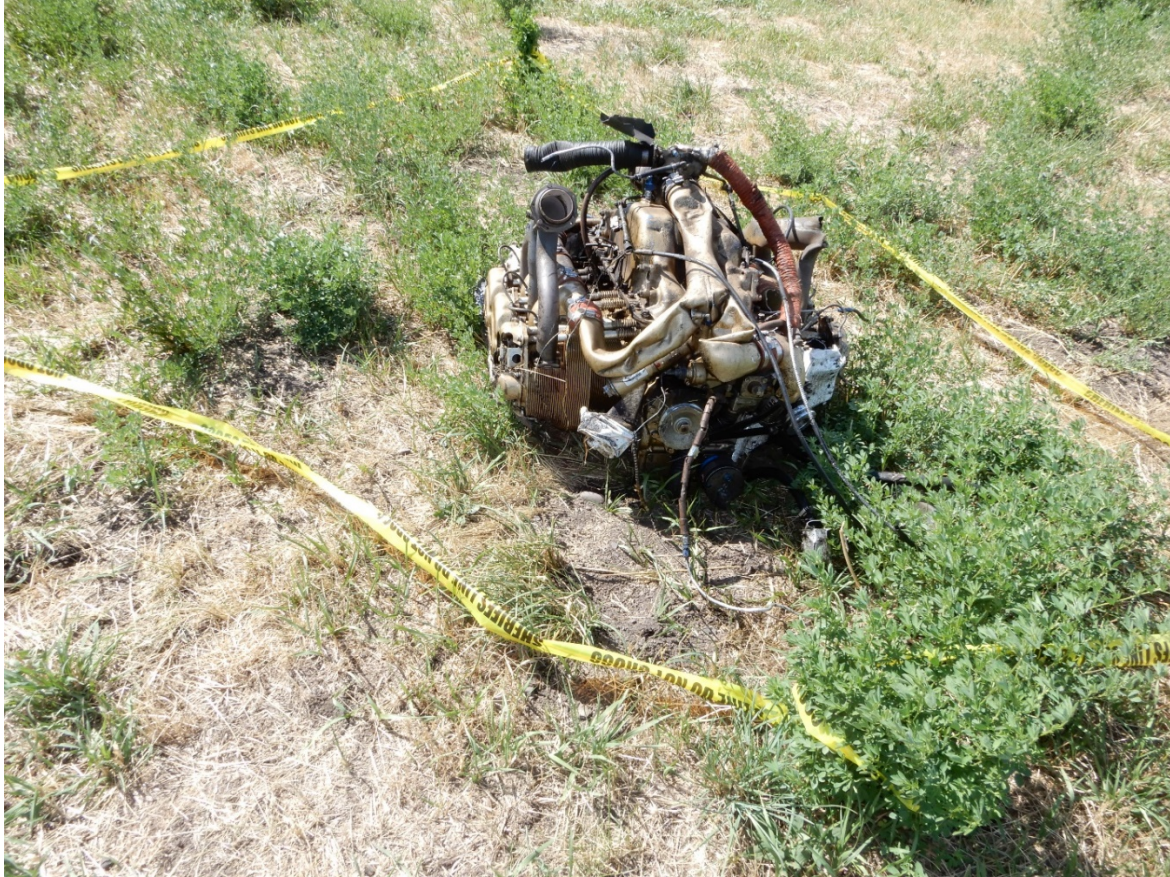
Photo 12. Engine, upside down, rear view.
