## **NATIONAL TRANSPORTATION SAFETY BOARD**

### **ONSITE EXAMINATION NOTES**

**WPR19FA250**

Location: Henefer, UT  
Date: September 4, 2019  
Aircraft: N94262  
NTSB IIC: Albert Nixon

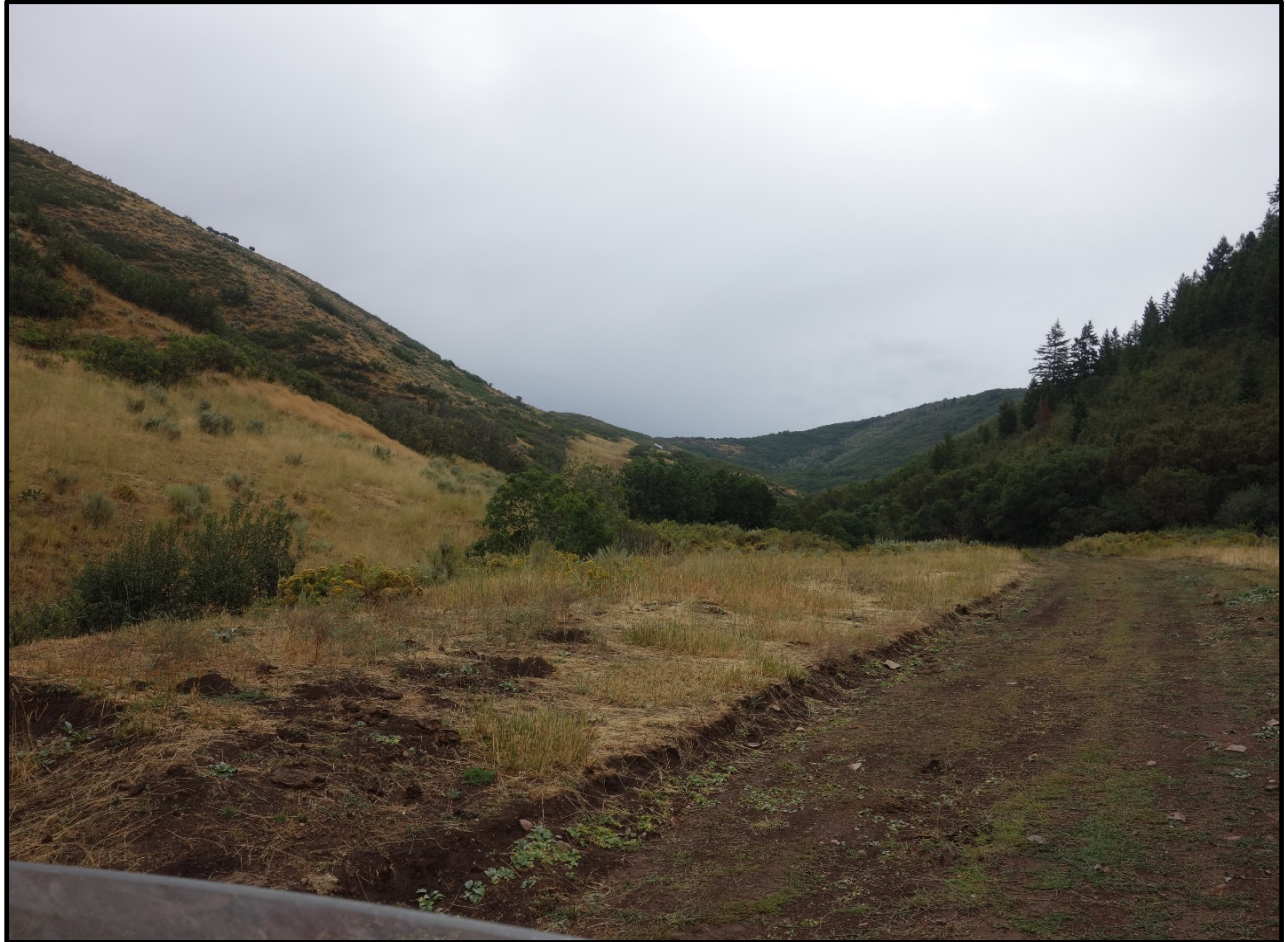
Examination of the accident site revealed that the white and blue colored airplane impacted terrain about 150 ft below the top of a ridgeline. All major components of the airplane were contained within the main wreckage site. About 30 ft before where the main wreckage came to rest, a large disturbance in the ground was observed. The disturbance measured about 22 ft long by 9 ft wide. Small fragments of the airplane, and propeller blade tips were found in the disturbance. The wings were partially attached and angled towards the ground about 45°.

**Figure 1: Airplane wreckage as viewed driving into the canyon.**

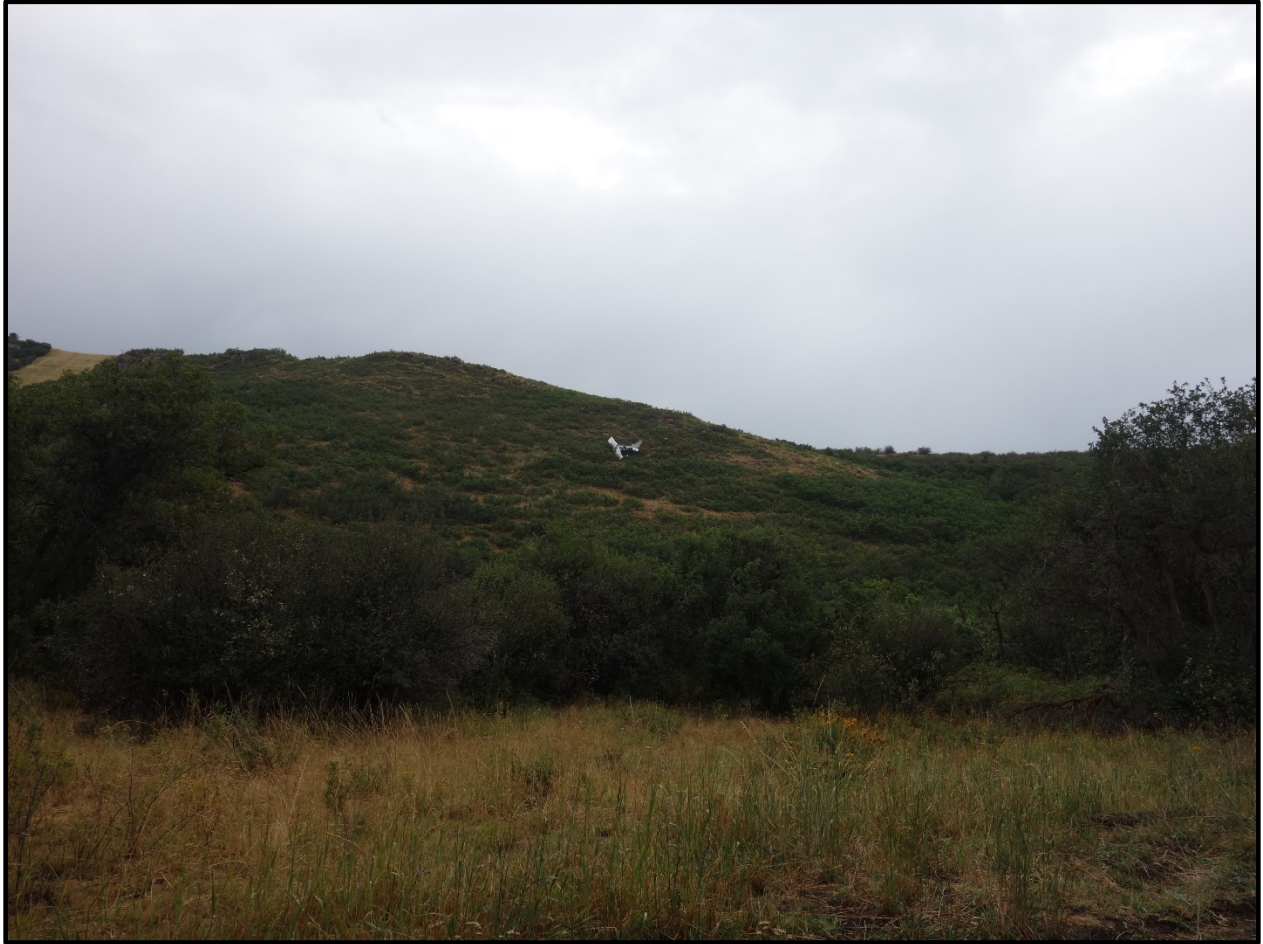
Figure 2: Airplane wreckage as viewed from the left side.

The left wing sustained substantial leading-edge damage on the entire span, with substantial crushing damage observed on the outboard 2 ft. The left flap and aileron were still attached. The left aileron was bent upwards about the inboard 1/3. The left flap appeared to be retracted. The left main gear was extended outward consistent with impact damage. The left fuel tank was breached. The fuel cap was secured in place and the seal in good condition.

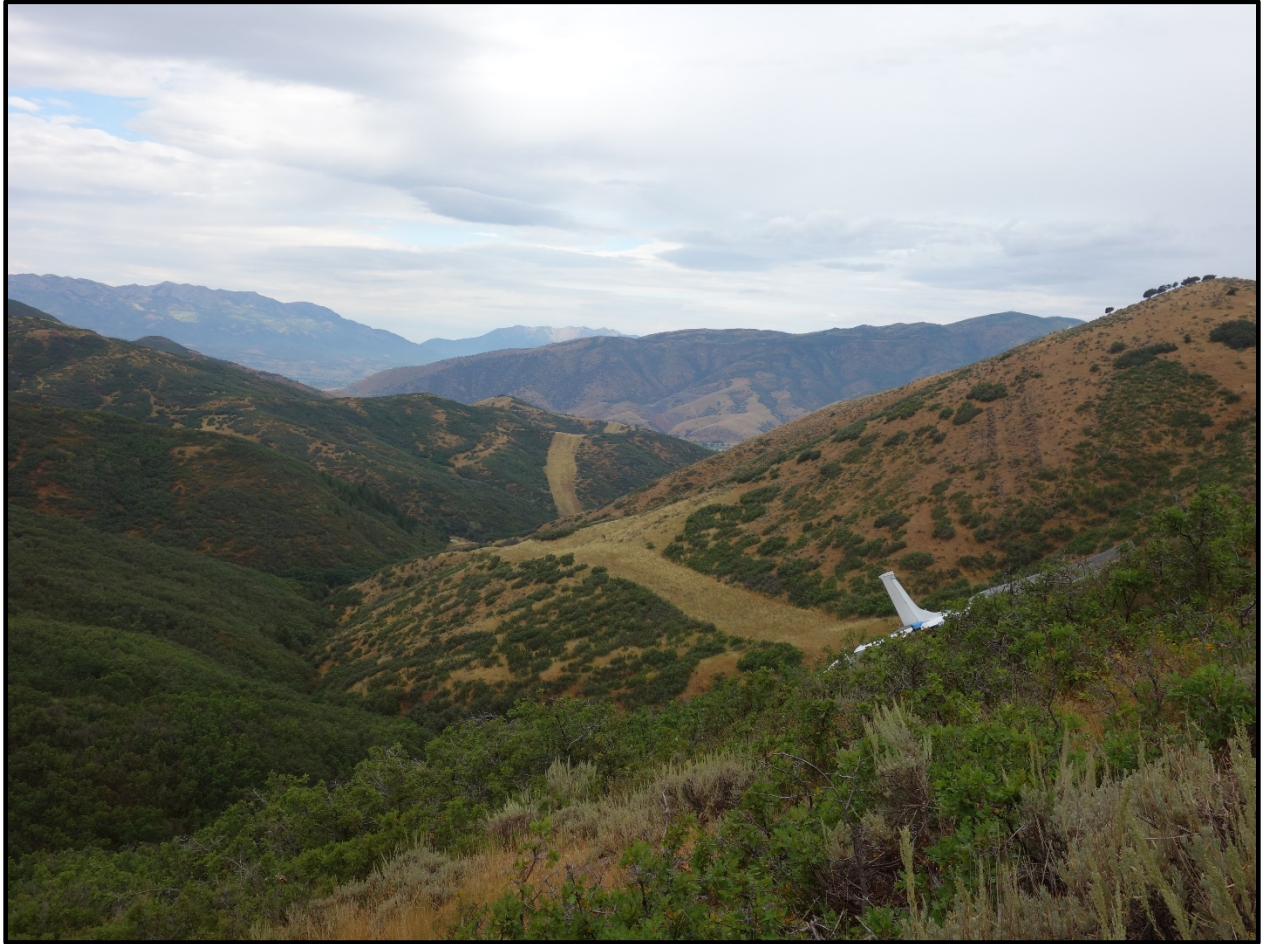
**Figure 3: Airplane wreckage as viewed from the rear.**

The empennage remained attached to the fuselage and was relatively intact. Flight control continuity was unable to be established due to the impact damage and the precarious position of how the airplane was situated on the mountain slope. The vertical stabilizer and rudder were attached to their respective attachment points. The left and right horizontal stabilizers and left elevator were attached and were relatively intact. The right elevator counterweight was partially attached and bent downwards. The elevator trim was observed in about the neutral position.
