## **NATIONAL TRANSPORTATION SAFETY BOARD**

# **AIRFRAME AND ENGINE EXAMINATION**

**WPR19FA250**

Location: Henefer, UT  
Date: September 4, 2019  
Aircraft: Registration Number: N94262, Cessna C210L  
NTSB IIC: Albert Nixon

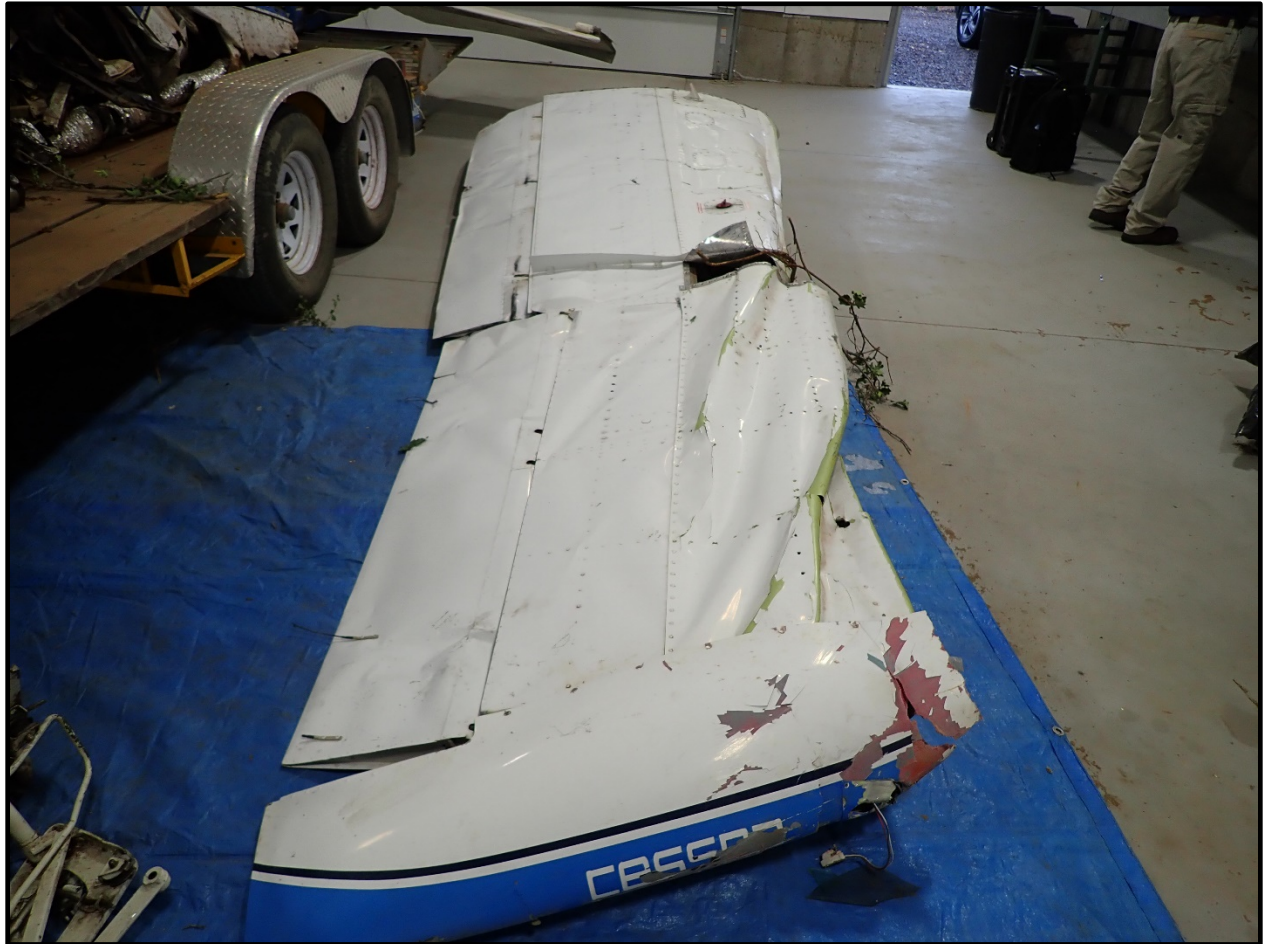
Figure 1: Right wing as viewed from the right side.

Flight control continuity was established from the ailerons to the wing root. In addition, aileron continuity was established from the cabin to the cockpit controls. Rudder and elevator continuity were established to the flight controls.

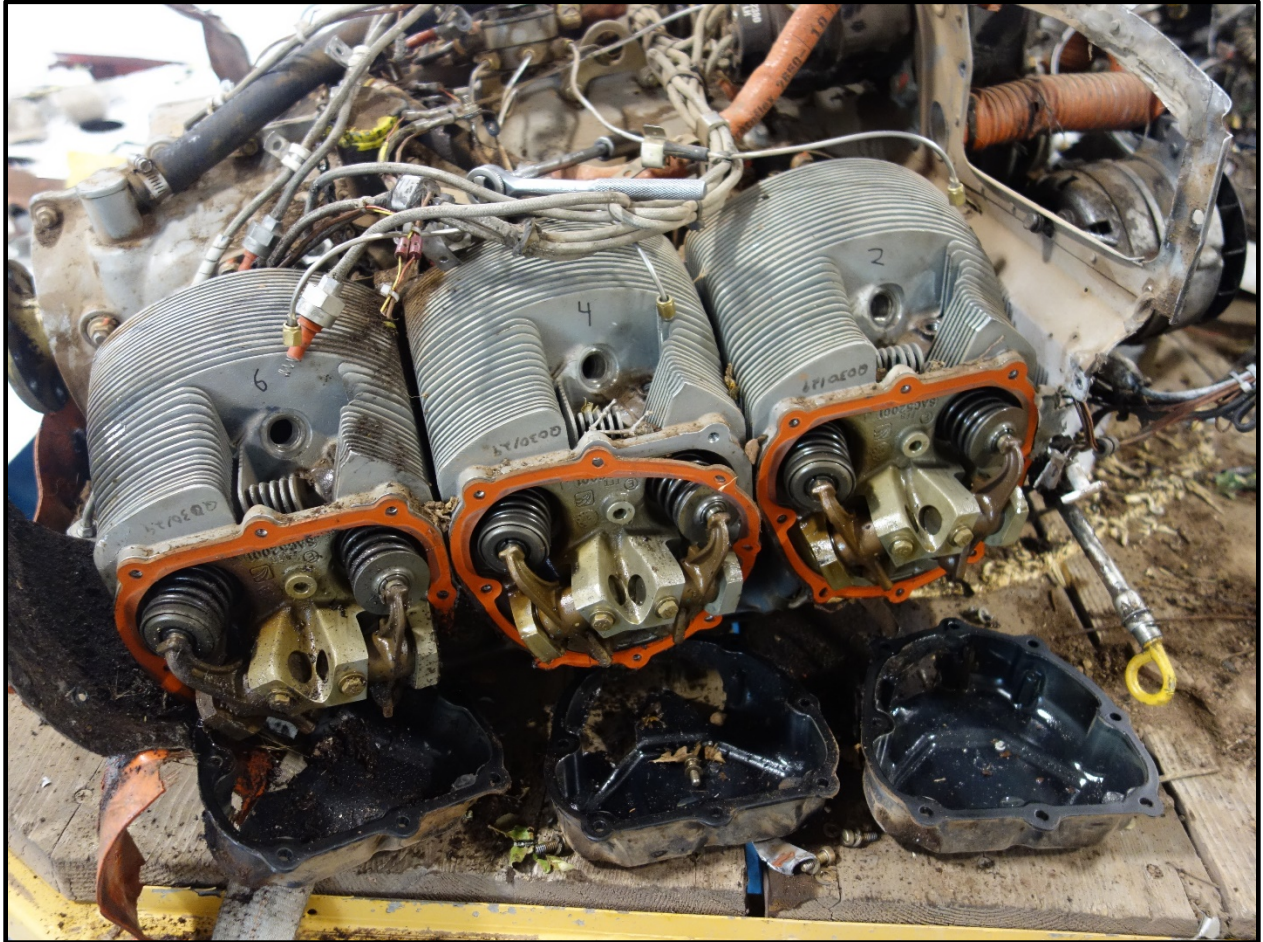
Examination of the Continental IO-520FcL engine, revealed that the engine sustained impact damage on the bottom side, rear, and left rocker cover. All the engine mounts were fractured. The crankcase sustained impact on the front. All rocker covers were removed, and examination revealed that all intake and exhaust rocker arms, shafts, and valve springs, were intact with no anomalies observed. The crankshaft was able to be rotated by hand and rotational continuity was established throughout the engine and valve train all cylinders. All cylinders displayed appropriate compression and suction. Spark was observed on all the ignition leads during the rotation. The top spark plugs were removed, and the spark plugs electrodes exhibited “grey color and normal wear” signatures when compared to the Champion Check-A-Plug comparison chart.

A borescope inspection of the cylinders revealed evidence of normal operational conditions. However, the nos. 4 and 5 cylinders had a semi-circular impression on the piston face consistent with a valve strike. The no. 4 cylinder had combustion deposits in the indentation that was consistent with engine operation since the strike. The no. 5 cylinder had no significant combustion deposits in the indentation. No obstruction to valve movement was observed and the valve moved normally.

Figure 2: Engine as viewed from the left side.
