## Air Safety Investigations Aircraft Incident/Accident Technical Report

| Aircraft Incident/<br>Accident Information | Year: 1977 | Make: Beechcraft | Model: C24R |
| | Serial number: MC-487 | | Registration: N24030 |
| Location: Henderson, NV | | Date: 09-07-19 | Time: 1950 PDT |

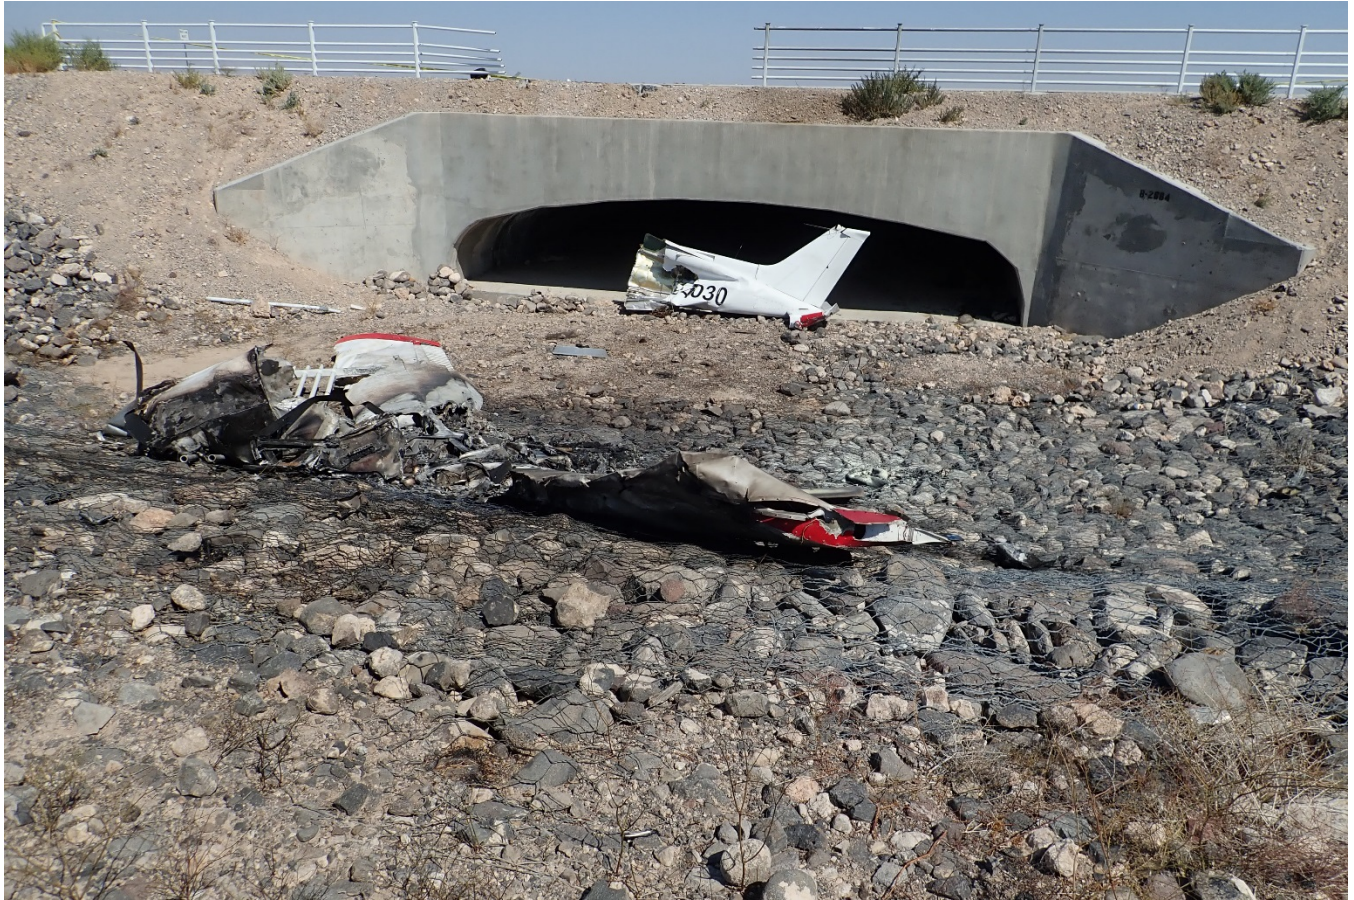
The aircraft impacted a divided highway in a right-wing-low attitude, then slid through a steel boundary fence before coming to rest in a culvert next to a road. The empennage separated during the impact sequence. A post-impact fire consumed the cabin and inboard wings.

Wreckage overview, ASI-19-CI-018

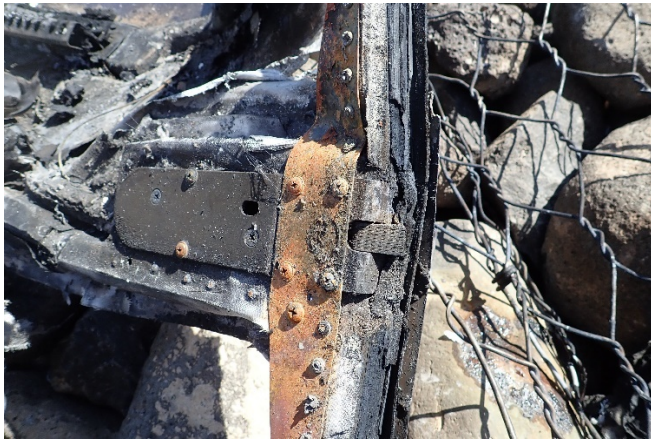
Left cabin door latch, ASI-19-CI-074

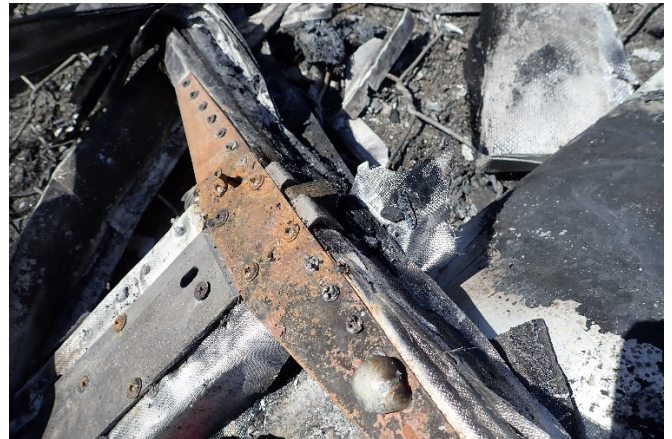
Right cabin door latch, ASI-19-CI-077

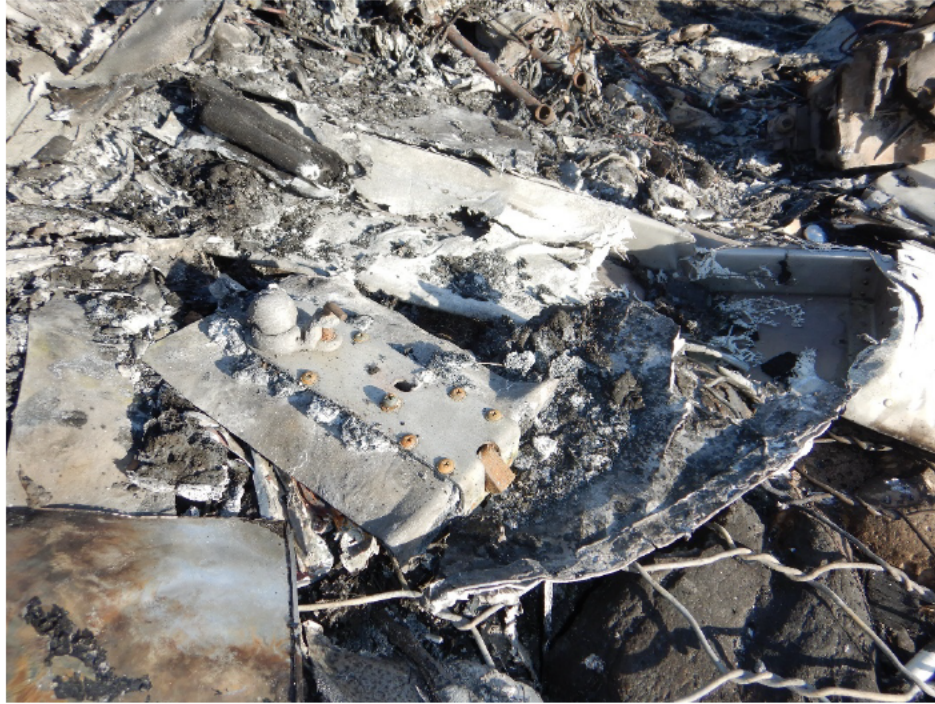
Baggage door latch, NTSB photo

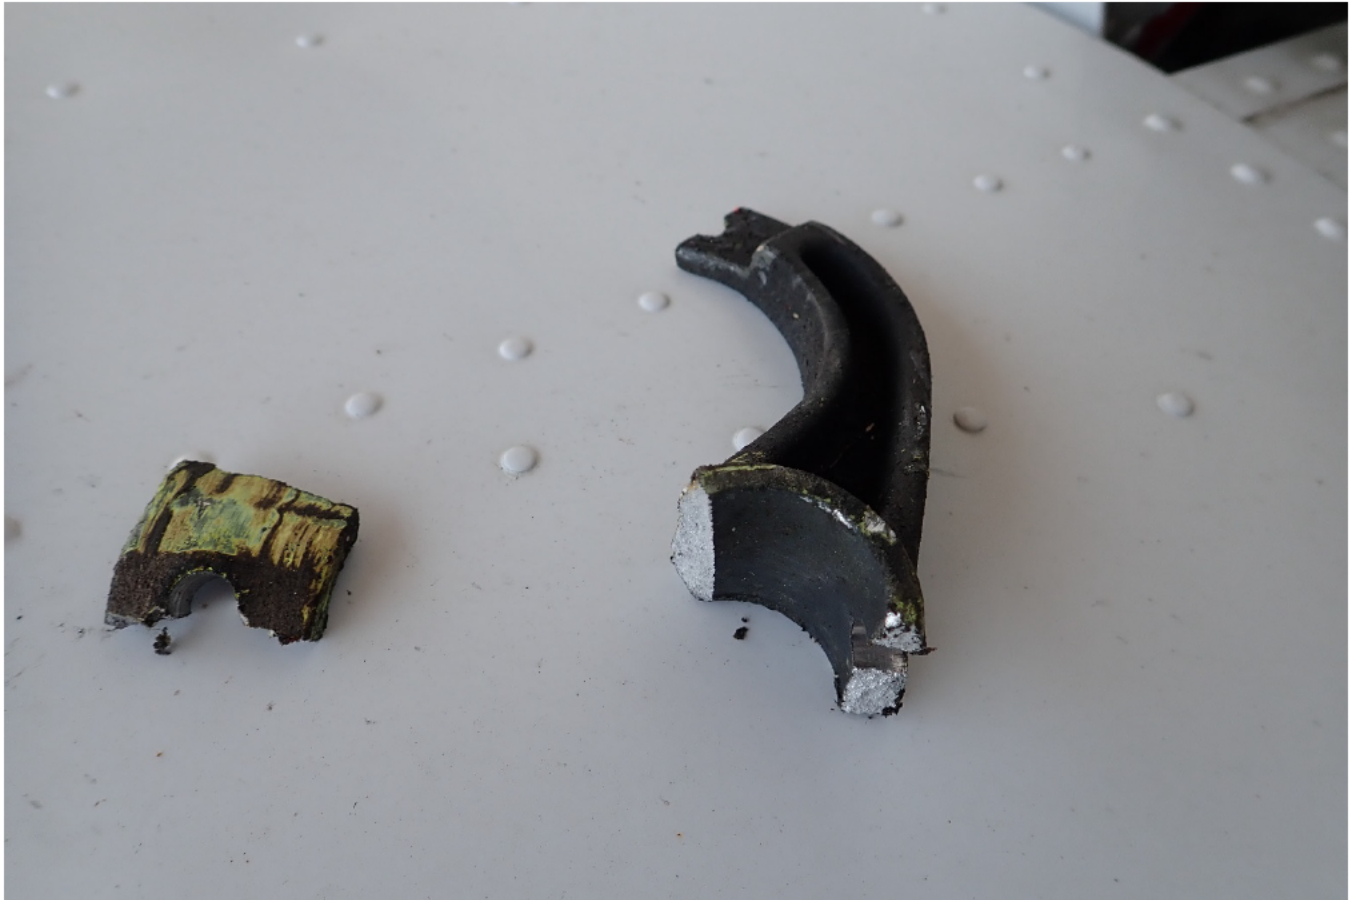
Control cable continuity was established from the ailerons and stabilator to the control column. The stabilator and trim cables were separated in tensile overload. The rudder bellcrank fractured and continuity was established from the cable attachment points to the cockpit.

Rudder bellcrank, ASI-19-CI-030

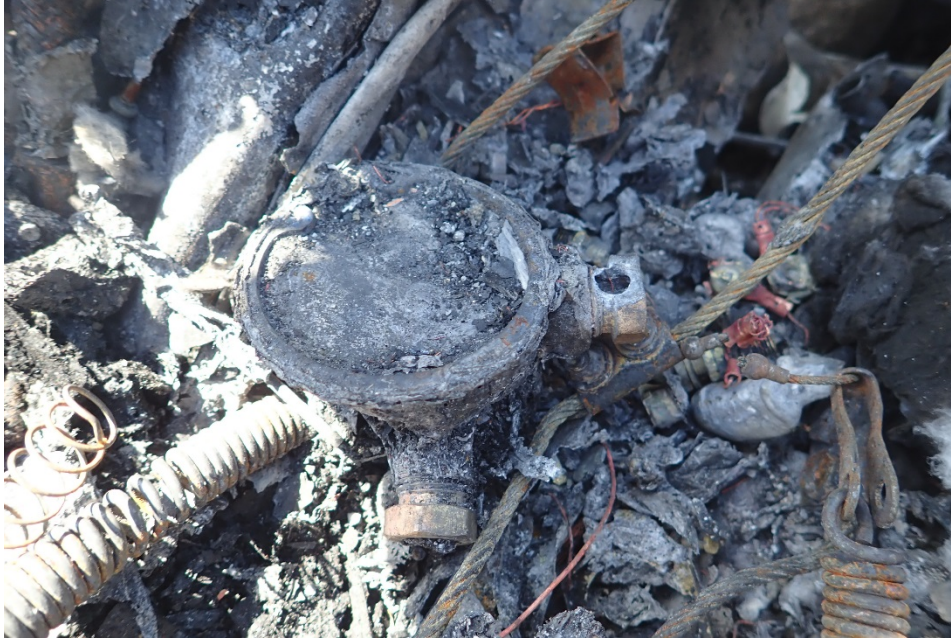
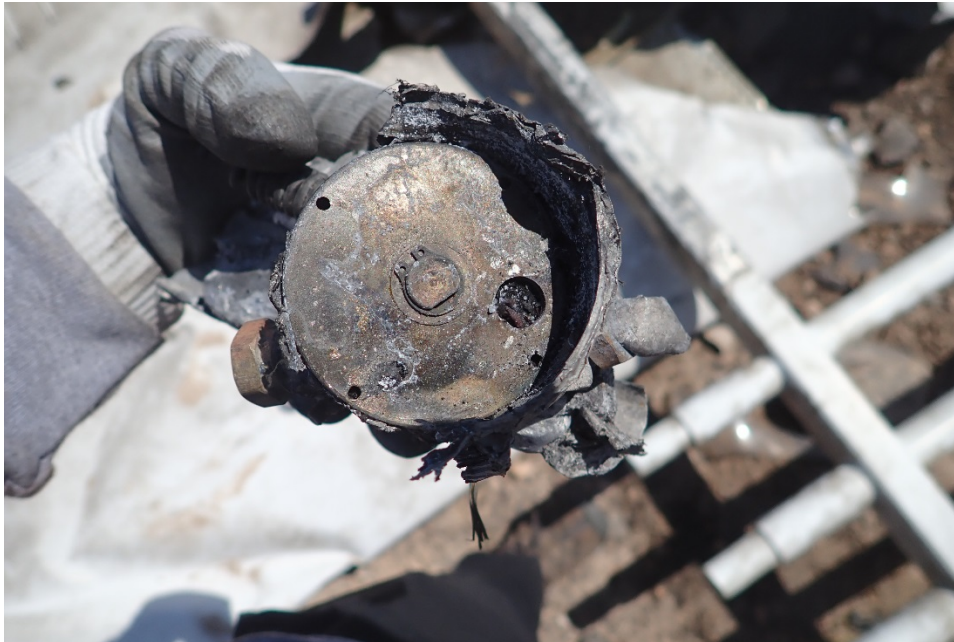
The fuel strainer bowl contained soot. The fuel selector handle was destroyed in the post-impact fire.

Fuel selector valve, ASI-19-CI-058

Fuel selector valve, ASI-19-CI-063

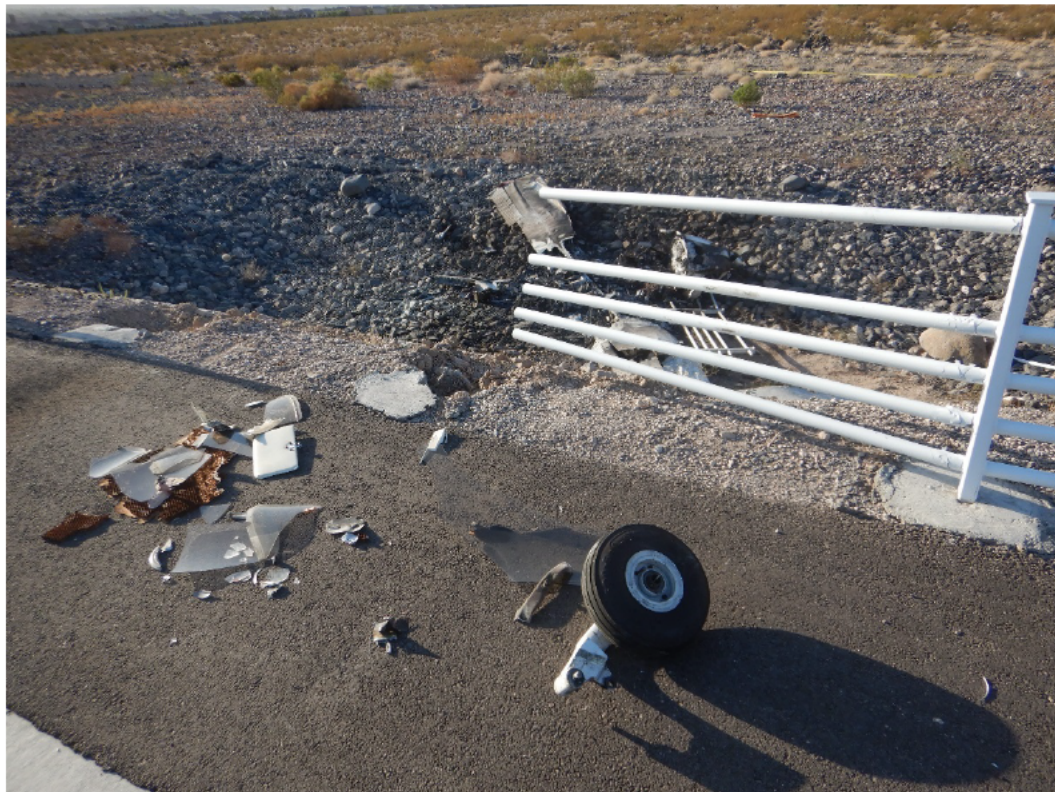
NTSB photo

The wheel of the nose landing gear separated during the impact sequence and the strut position was undetermined.

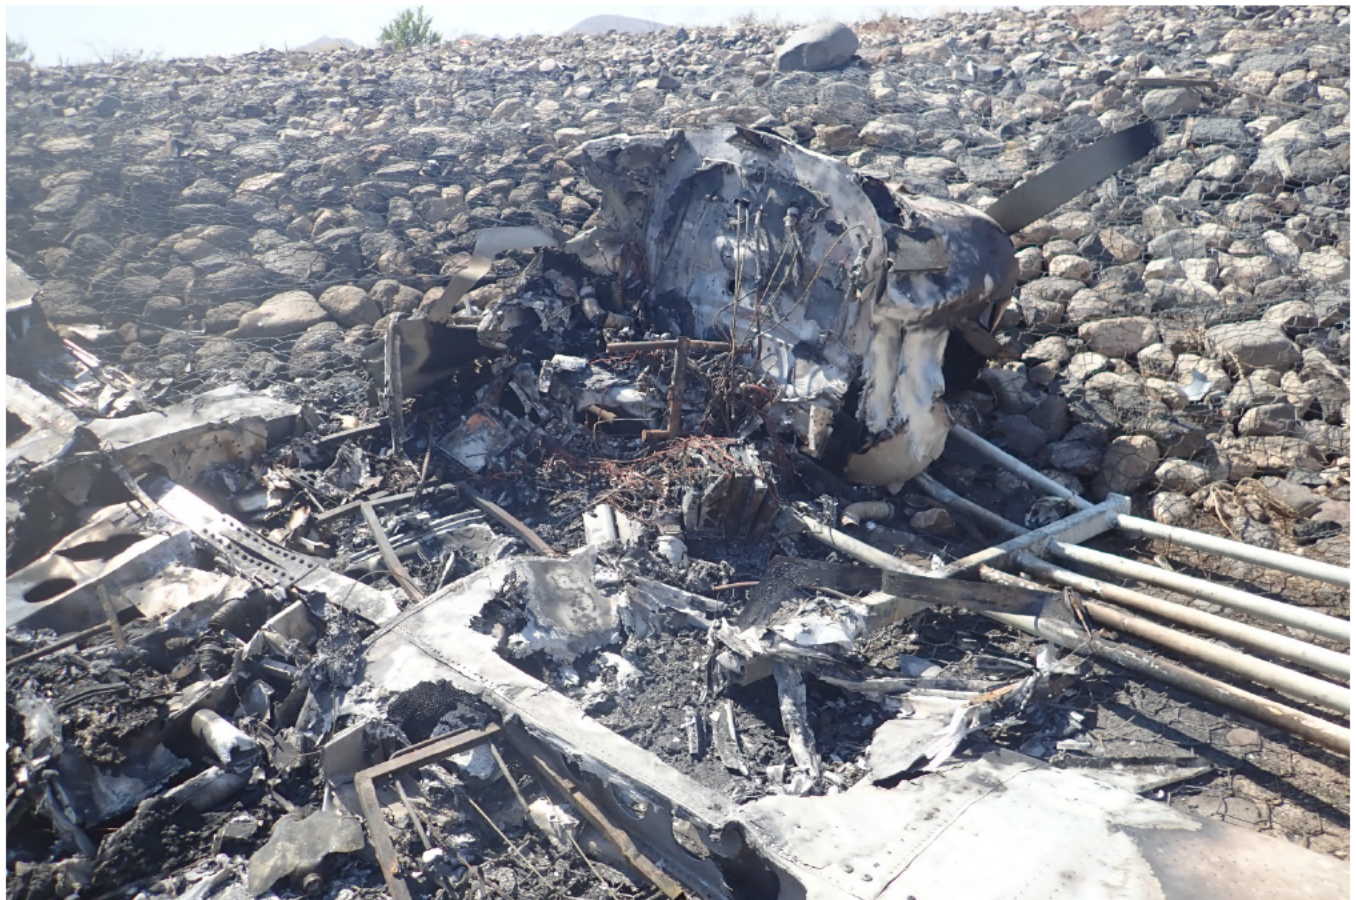
The seats were destroyed in the post-impact fire. Several restraint buckles were in the wreckage.

Cabin and cockpit area, ASI-19-CI-038

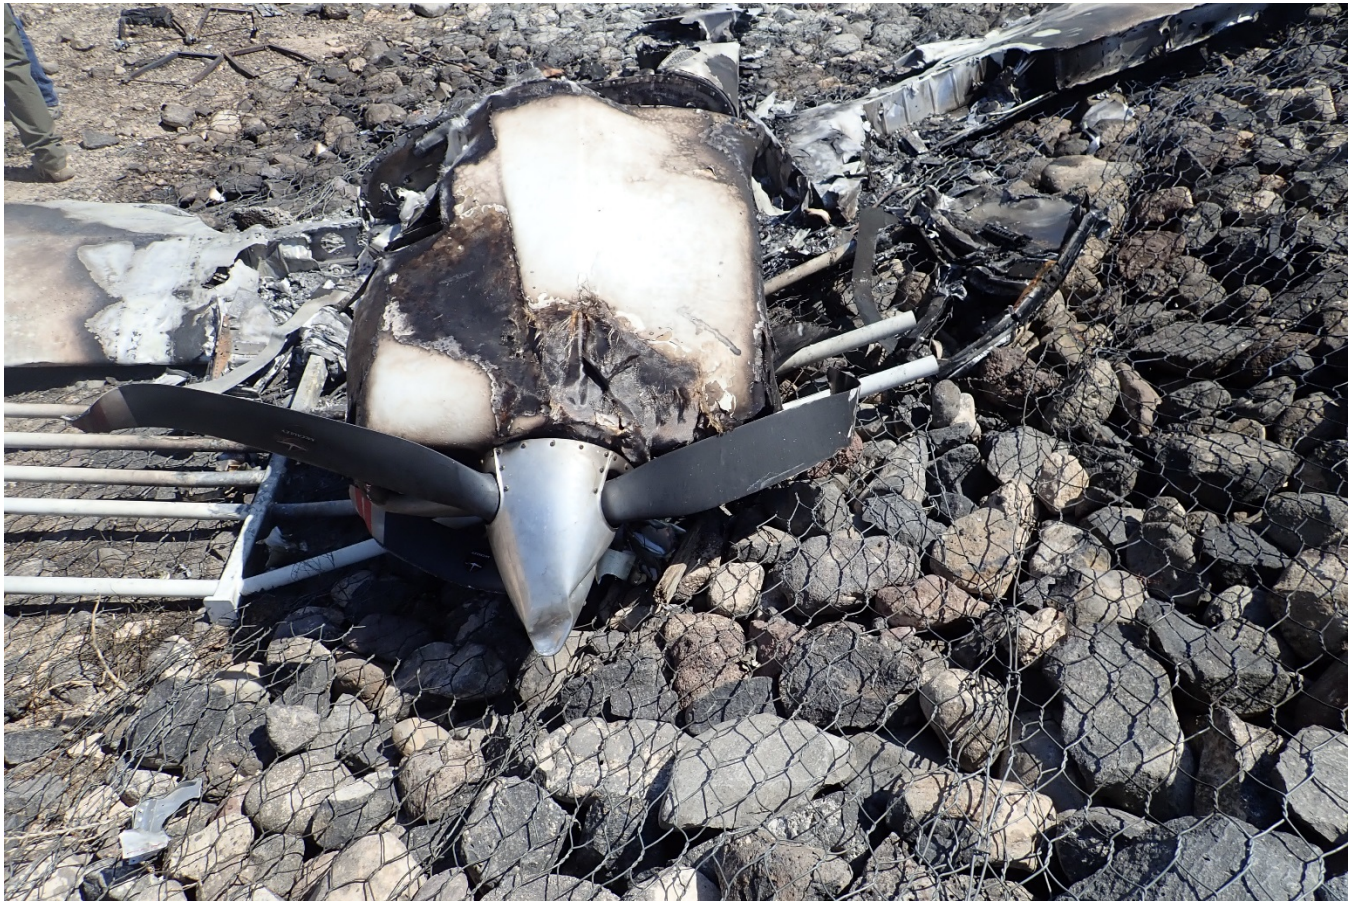
All three propeller blades exhibited leading edge gouging, S-bending and significant material loss at the tips. Each blade was loose in the hub. Propeller strikes were observed on the road past the initial impact point.

Propeller, ASI-19-CI-065

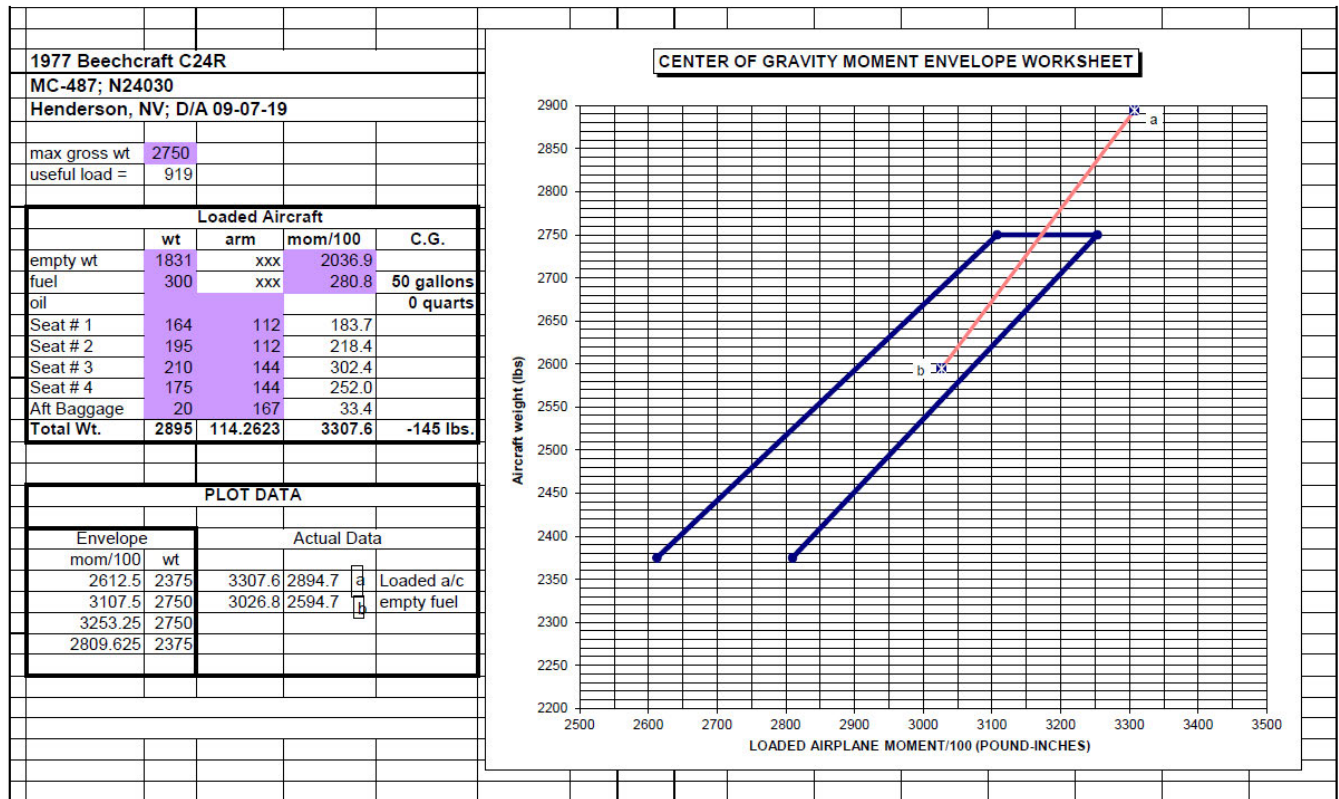
The aircraft was loaded over the max gross takeoff weight and aft of the center of gravity moment envelope for both flights. The following charts depict the calculated weight and balance for the flight attempted at midday with 50 gallons of fuel and the accident flight with 40 gallons of fuel.

Flight 2 – midday, calculated weight and balance

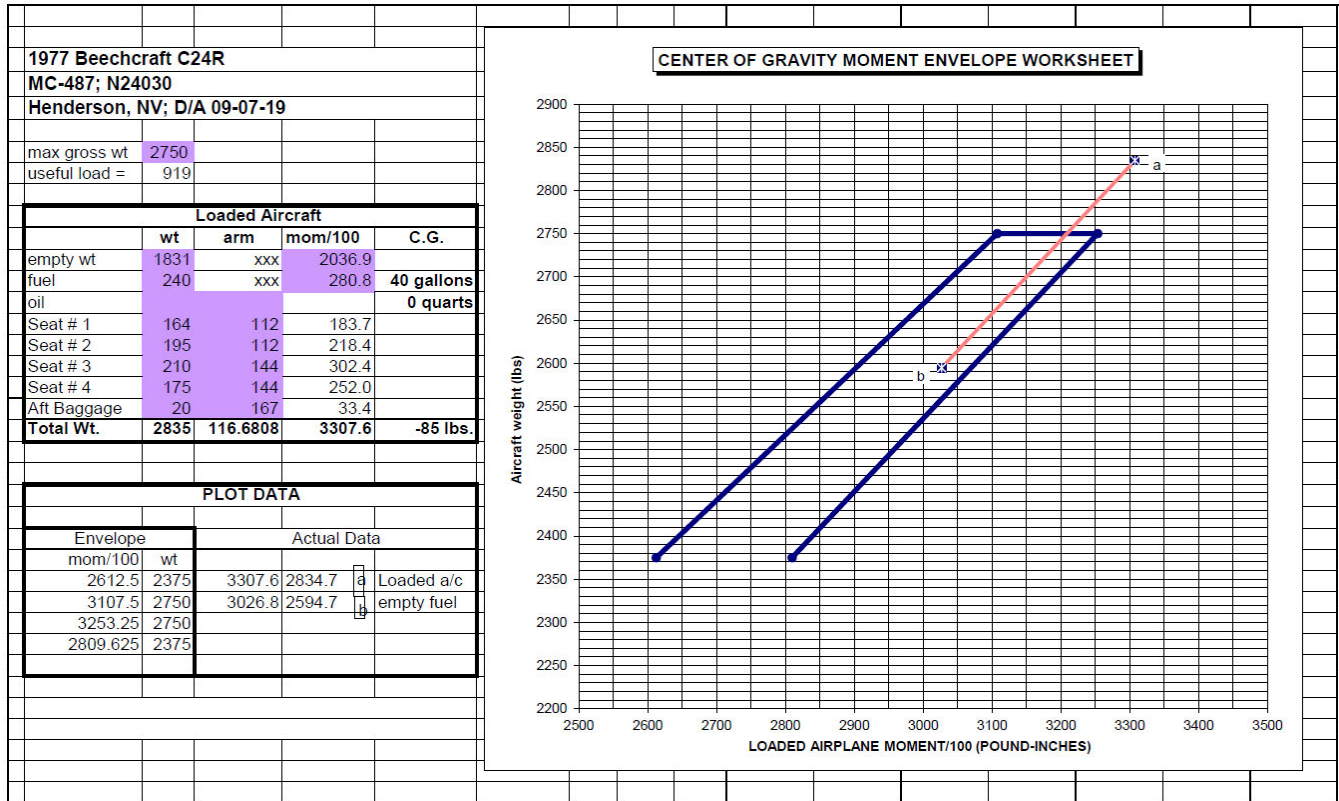
Flight 3 – accident flight, calculated weight and balance
