## **NATIONAL TRANSPORTATION SAFETY BOARD**

# **ACCIDENT SITE EXAMINATION SUMMARY**

**WPR19FA252**

| Aircraft: | N24030, Beech C-24R |

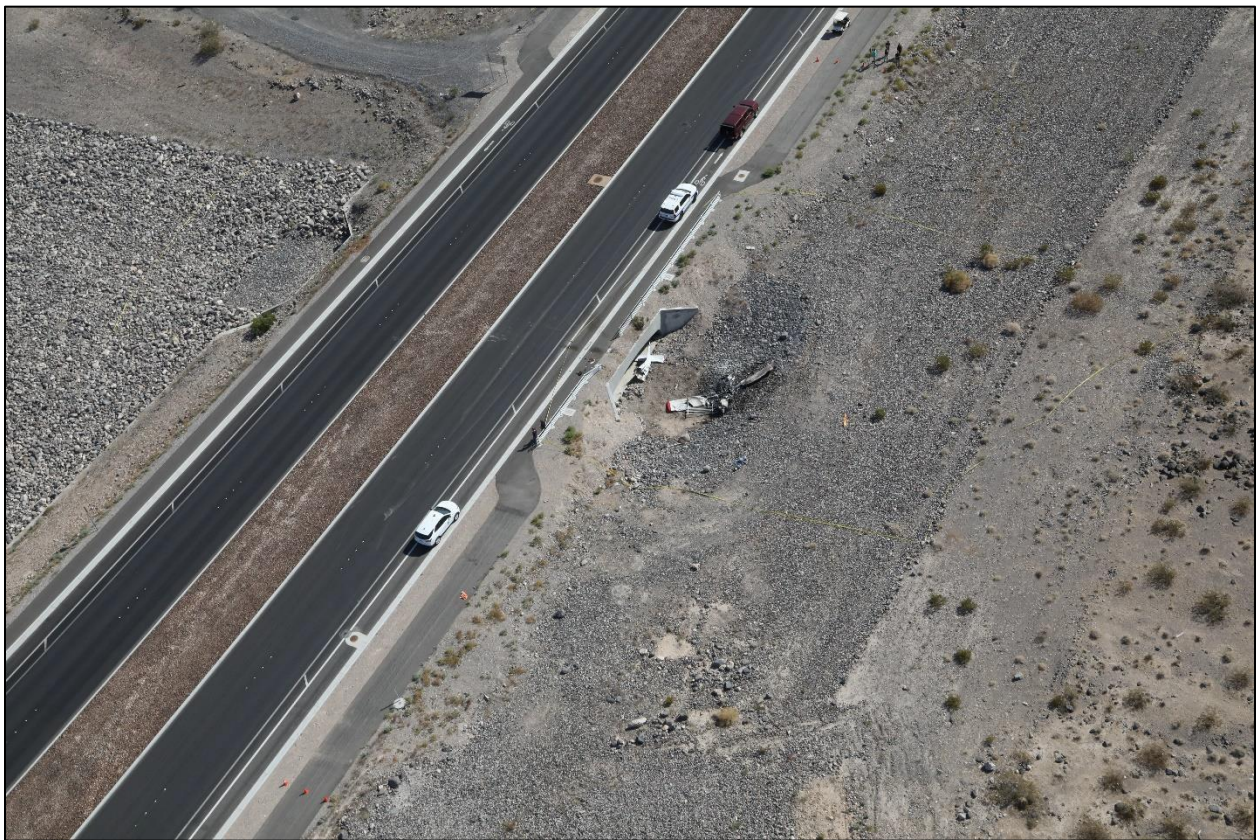
Examination of the accident site revealed that the airplane impacted a divided roadway, slid through a steel barrier fence, and came to rest in a culvert drainage area. The empennage separated from the main wreckage just aft of the baggage door area and was found adjacent to the culvert entrance. The main wreckage was partially consumed by post-impact fire. The cabin area and the wing's inboard sections, including the wing fuel tanks were mostly consumed by post-impact fire. The wreckage was relocated to a secured facility for further examination.

*Figure 1-Accident site, aerial view (Courtesy of the Henderson Police Department)*

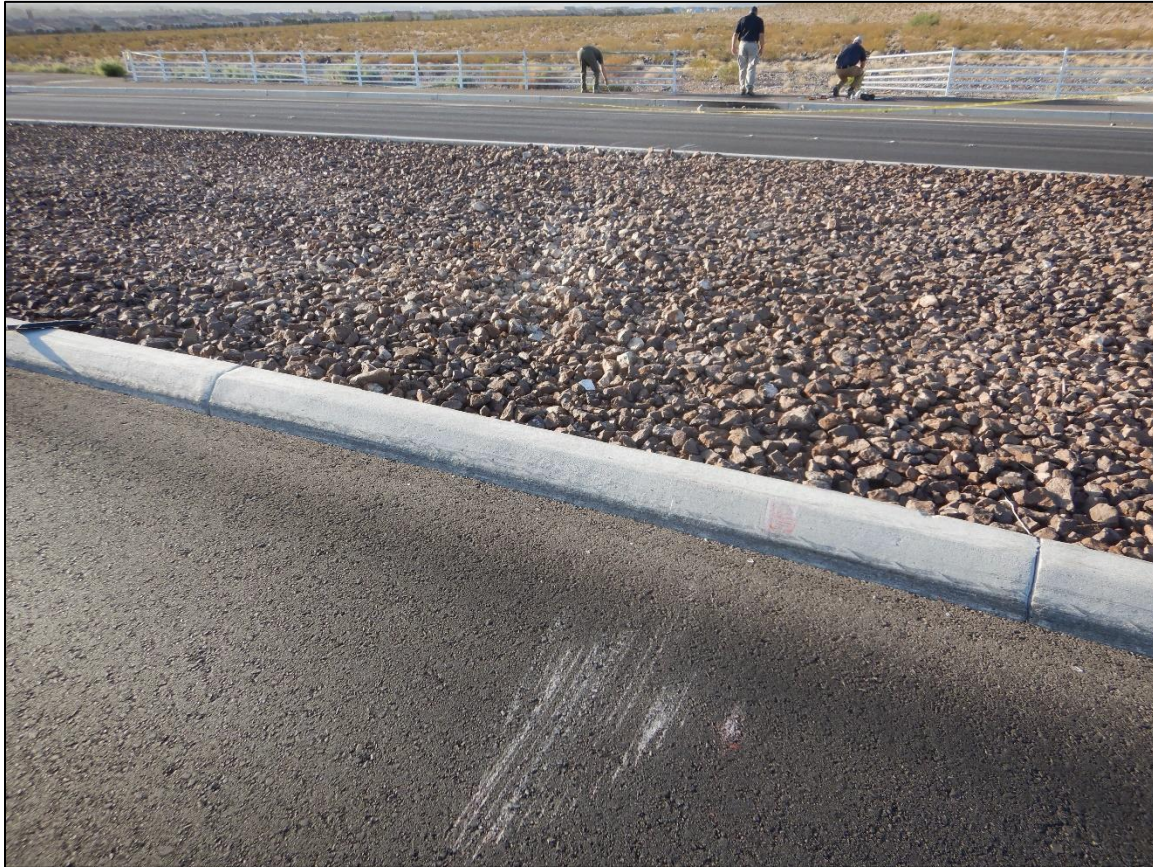
Examination of the accident site revealed that the first identified point of contact (FIPC) was on the westbound side of a divided roadway surface. The rock-filled median had an area of disturbed rock and propeller strike marks were found on the median curb and asphalt of the east bound side of the divided roadway. Two small thin plexiglass pieces were found in the disturbed rock. The impact marks and disturbed rock were consistent with the airplane impacting in a right wing down, nose down attitude. The nose landing gear wheel and a section of the strut were found on the roadway.

*Figure 2-Accident site, first identified point of contact.*

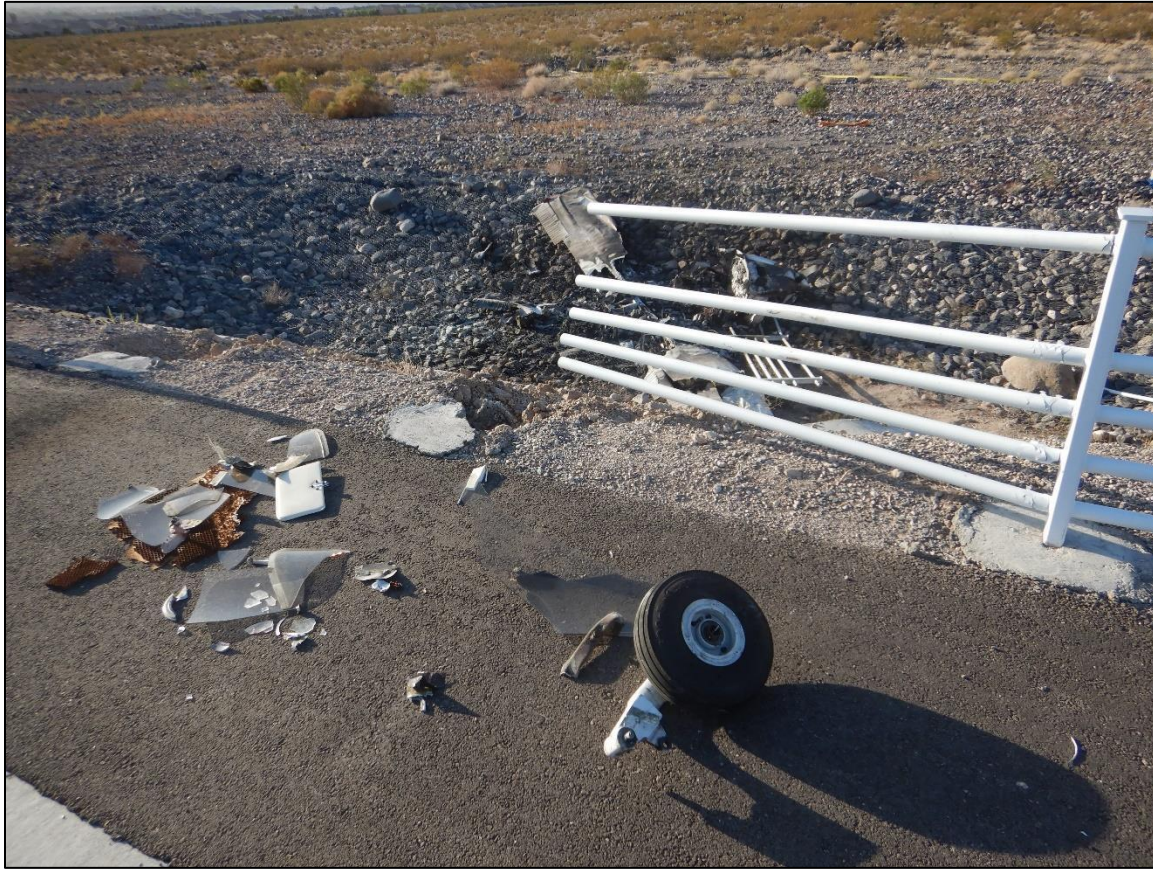
Impact marks suggest that the airplane slid across the east bound side of the divided roadway and impacted a steel barrier fence adjacent to a culvert. A 14 ft section of the steel barrier separated from its ground support and was found with the main wreckage; embedded in the right wing and underneath the engine.

*Figure 3-Accident site, barrier fence and wreckage.*

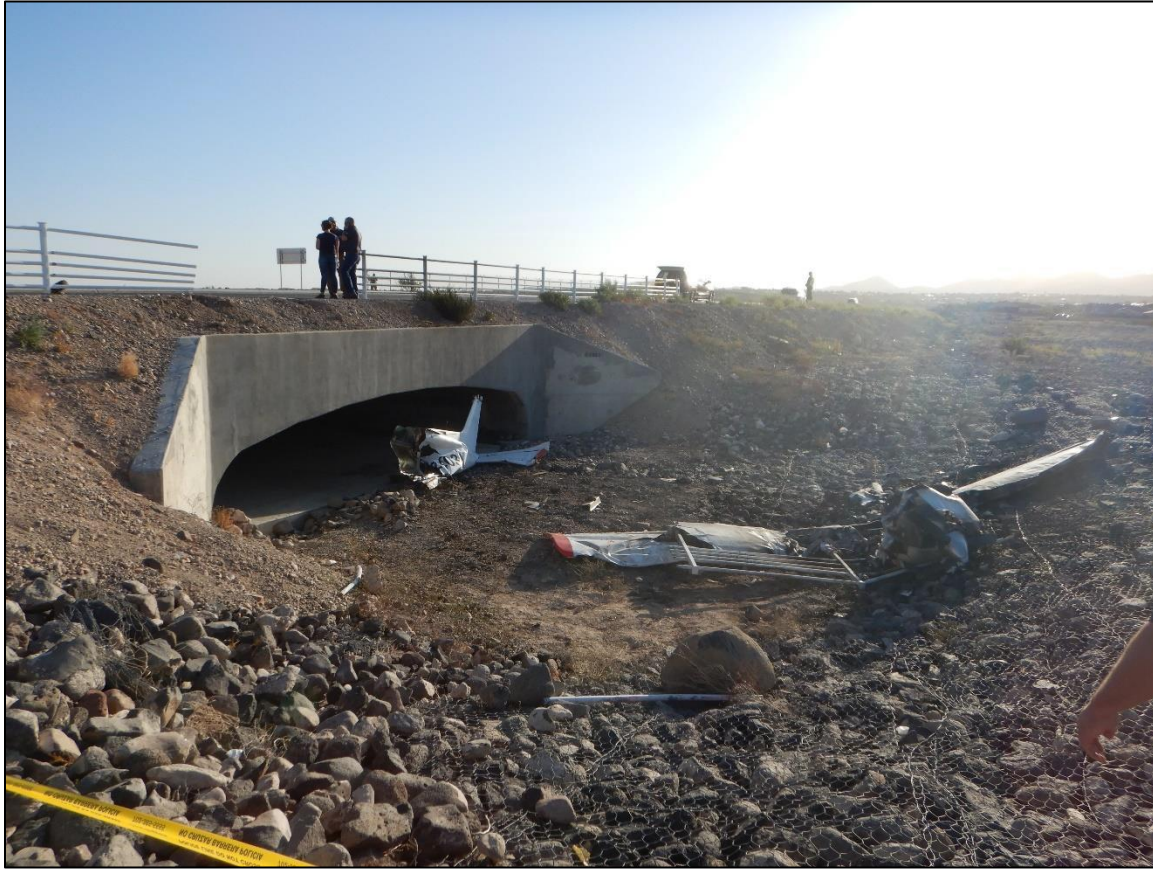
The main wreckage was found in the culvert drainage area about 30 ft across and 10 ft below the south side of the divided roadway. The empennage separated from the main wreckage just aft of the baggage door area during the accident sequence and was found adjacent to the culvert entrance. The empennage had impact damage consistent with impacting the barrier. The main wreckage was partially consumed by post-impact fire.

The wing's inboard sections, including the wing fuel tanks were mostly consumed by post-impact fire. The left wing tip was buckled upwards and the wing's leading edge was crushed from the lower side. The right wing tip was had scrapes on the lower side and the steel barrier vertical beam was embedded past the separated spar, about 4 feet from the tip and at the wing fuel tank position. The right outboard wing was buckled. The cabin area, including the instrument panel was mostly consumed by post-impact fire.

*Figure 4-Accident site, view of the culvert and main wreckage.*

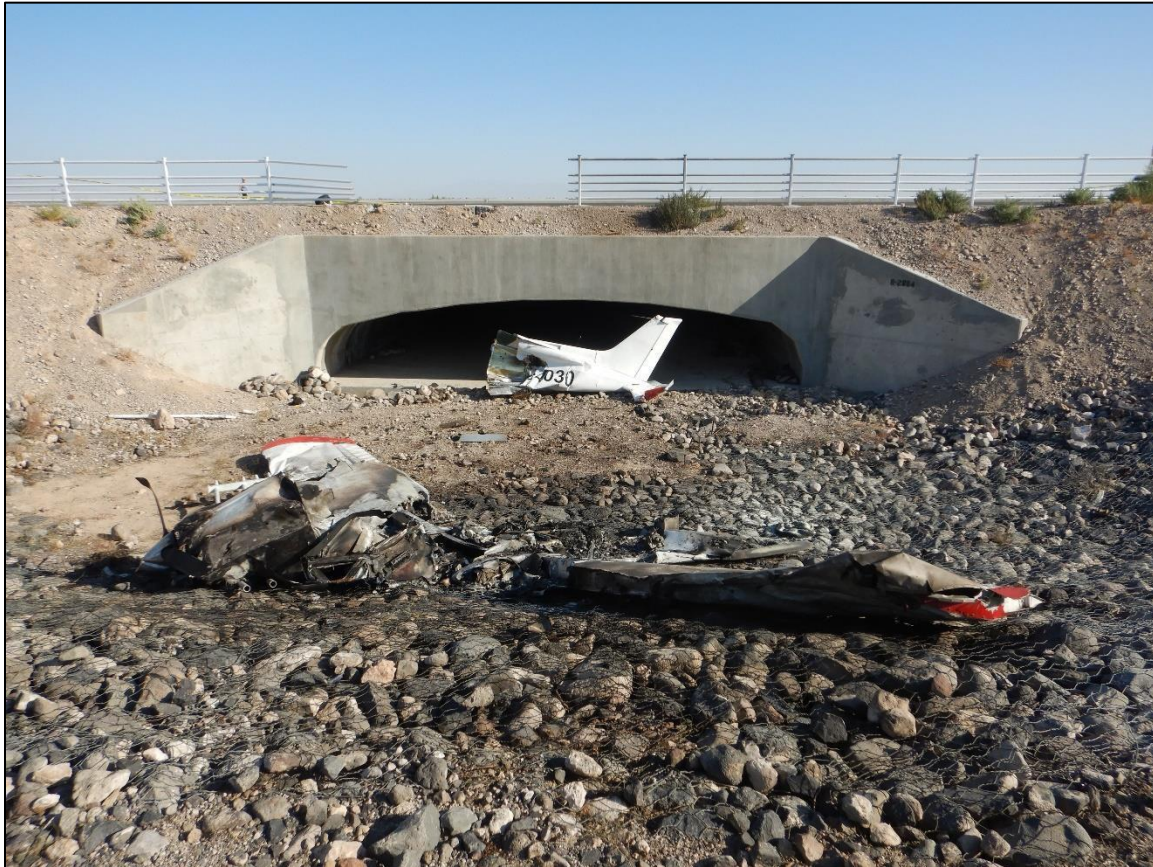
*Figure 5-Accident Site, North View*

All flight controls were accounted for, and flight control continuity was attained. The elevator control cables separated with broom straw signatures near the fuselage separation. The rudder control cables separated at the rudder bellcrank. The rudder bellcrank separated from the rudder. A section of the rudder bellcrank was found in the aft fuselage. The rudder and stabilator control cables had continuity to the forward cabin area. The aileron control cables had continuity to the cabin area.

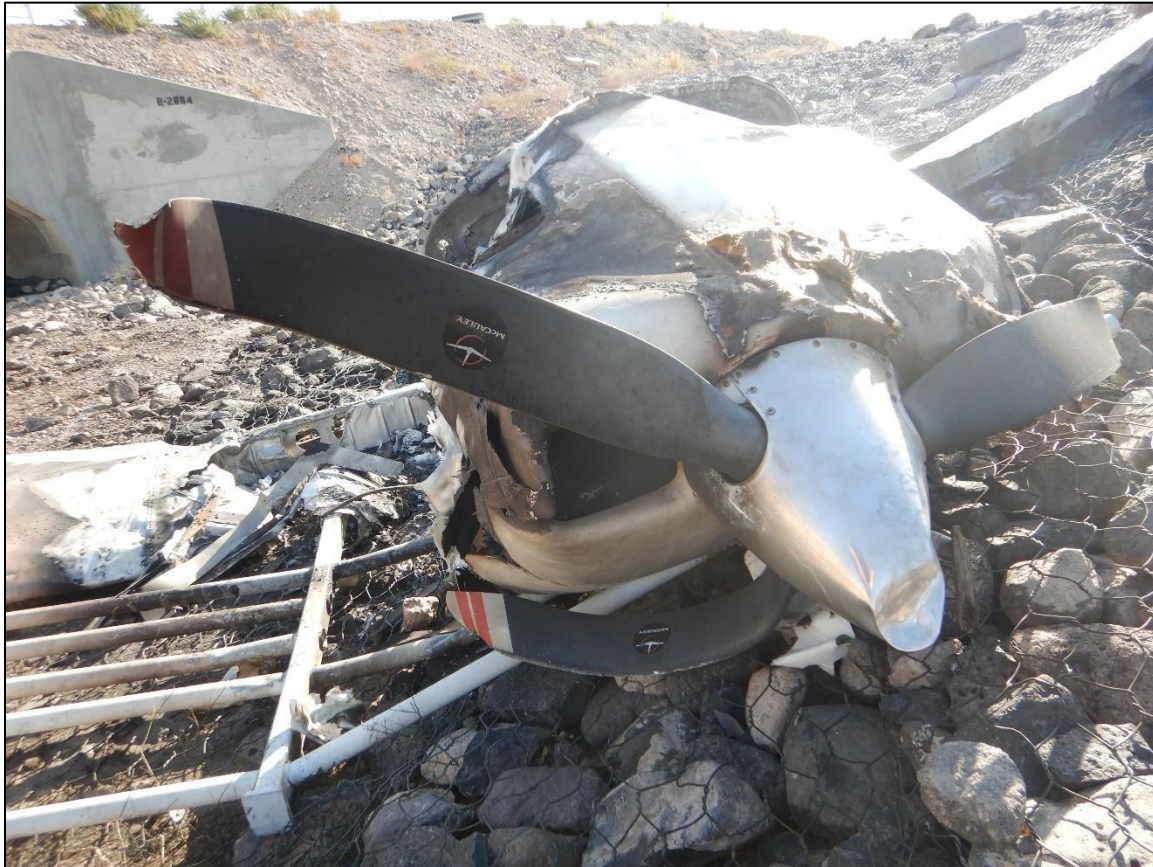
The engine remained attached to the main wreckage. The lower cowling separated revealing the lower side of the engine. The upper cowling remained attached to the engine. The propeller assembly remained attached to the engine and one blade was bent rearward with leading edge scoring and gouging at the tip. The other two blades have S-type bending and missing material from the tips.

*Figure 6-Accident site, engine and propeller assembly.*

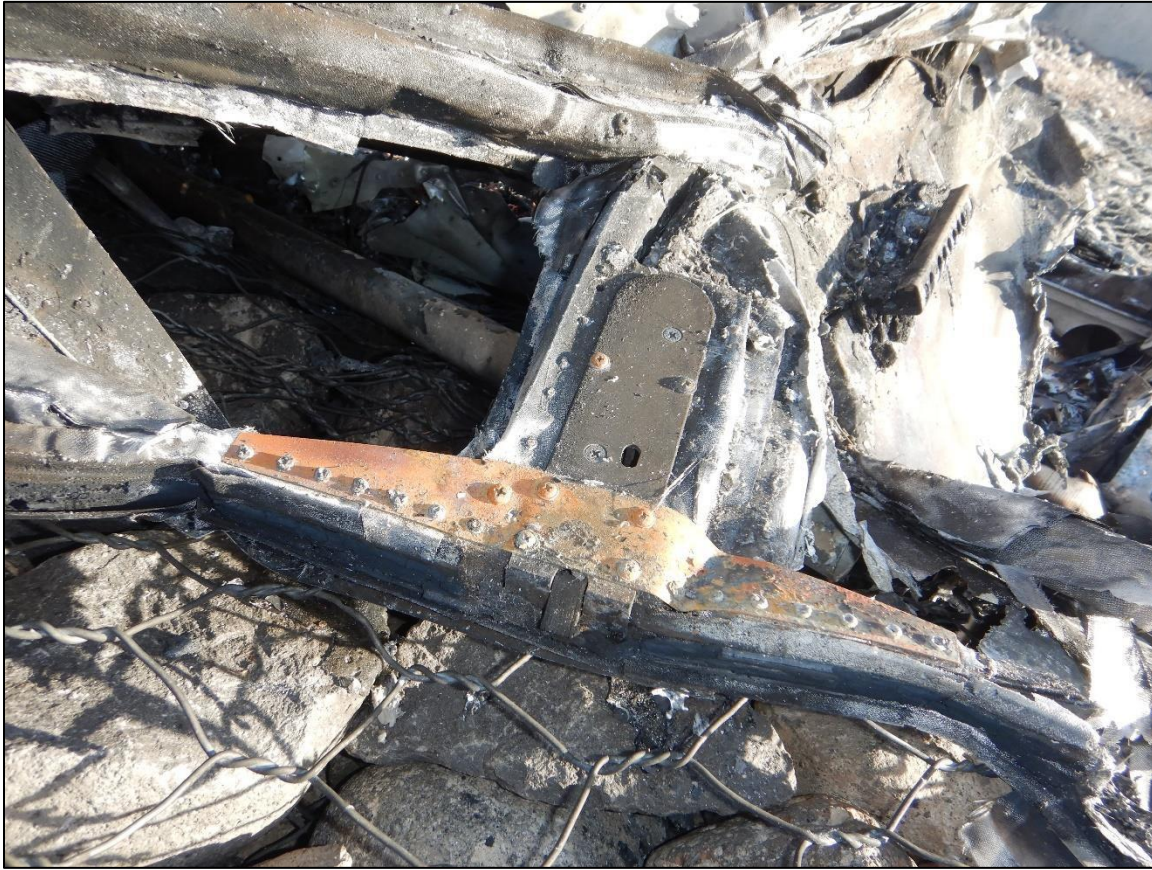
*Figure 7-Left Entry Door Lower Latch*

The two entry doors and baggage door were mostly consumed by post-impact fire. The latch assemblies were identified and were in the engaged (out) position. The latch strike plate was found for the aft baggage door and showed normal signs of wear. The latch strike plates for the two entry doors were not found.

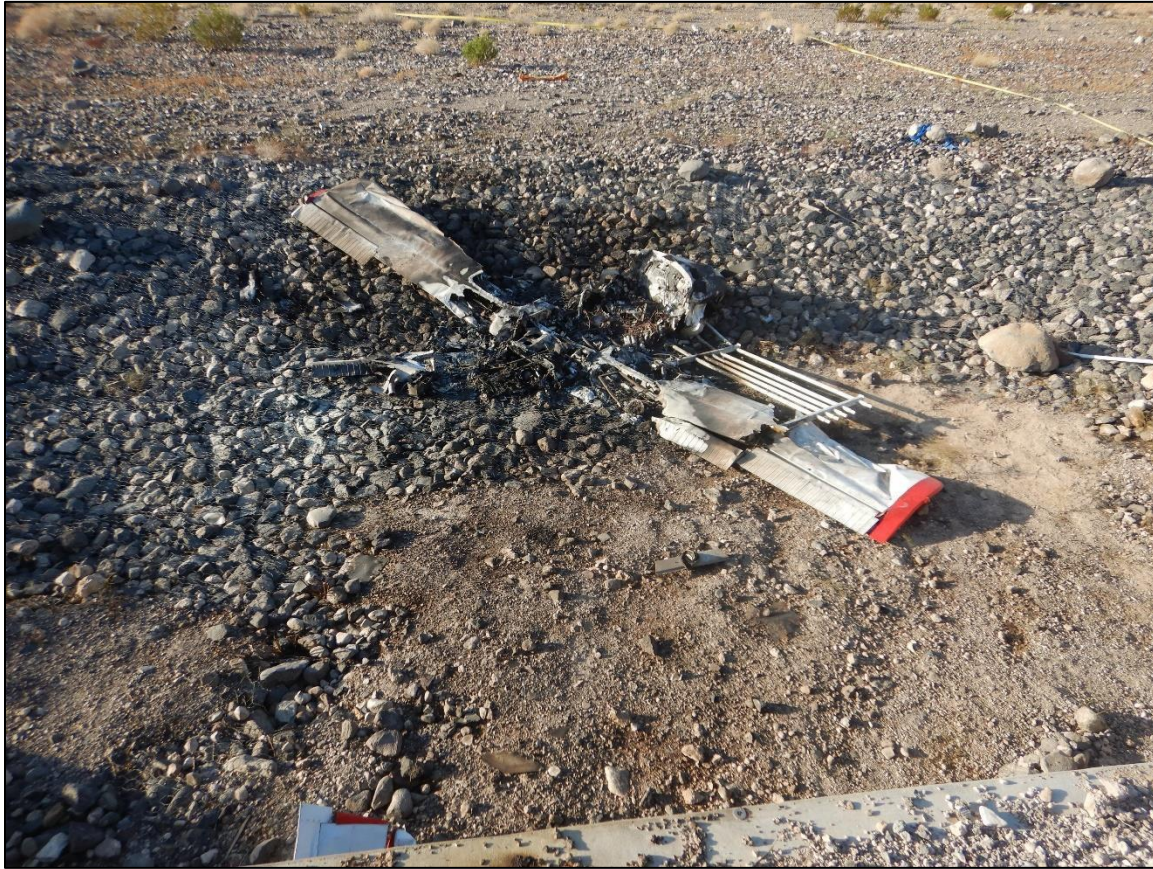
*Figure 8-Main wreckage, view from the road.*
