## **NATIONAL TRANSPORTATION SAFETY BOARD**

### **ONSITE EXAMINATION NOTES**

**WPR19FA262**

Location: Torrance, CA  
Date: September 19, 2019  
Aircraft: N2323Y  
NTSB IIC: Albert Nixon

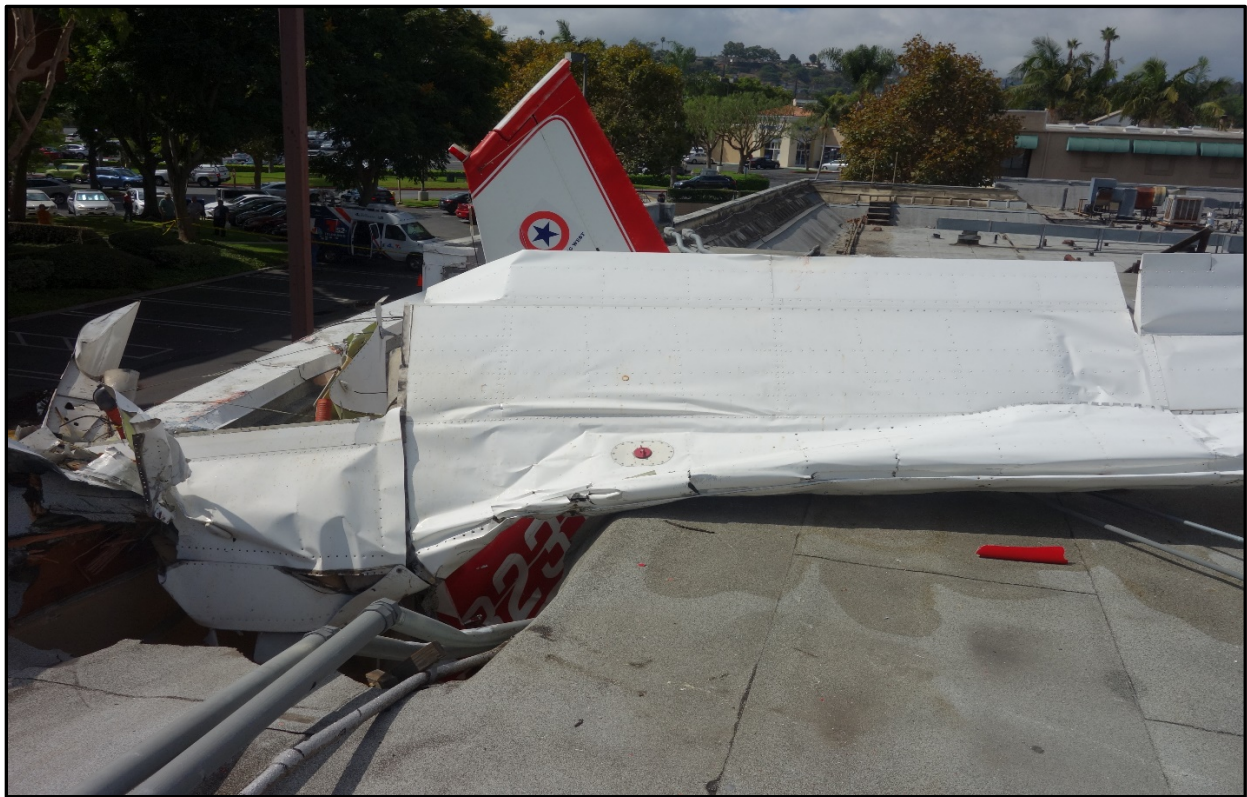
Figure 1: Airplane wreckage as viewed from the left side on the roof.

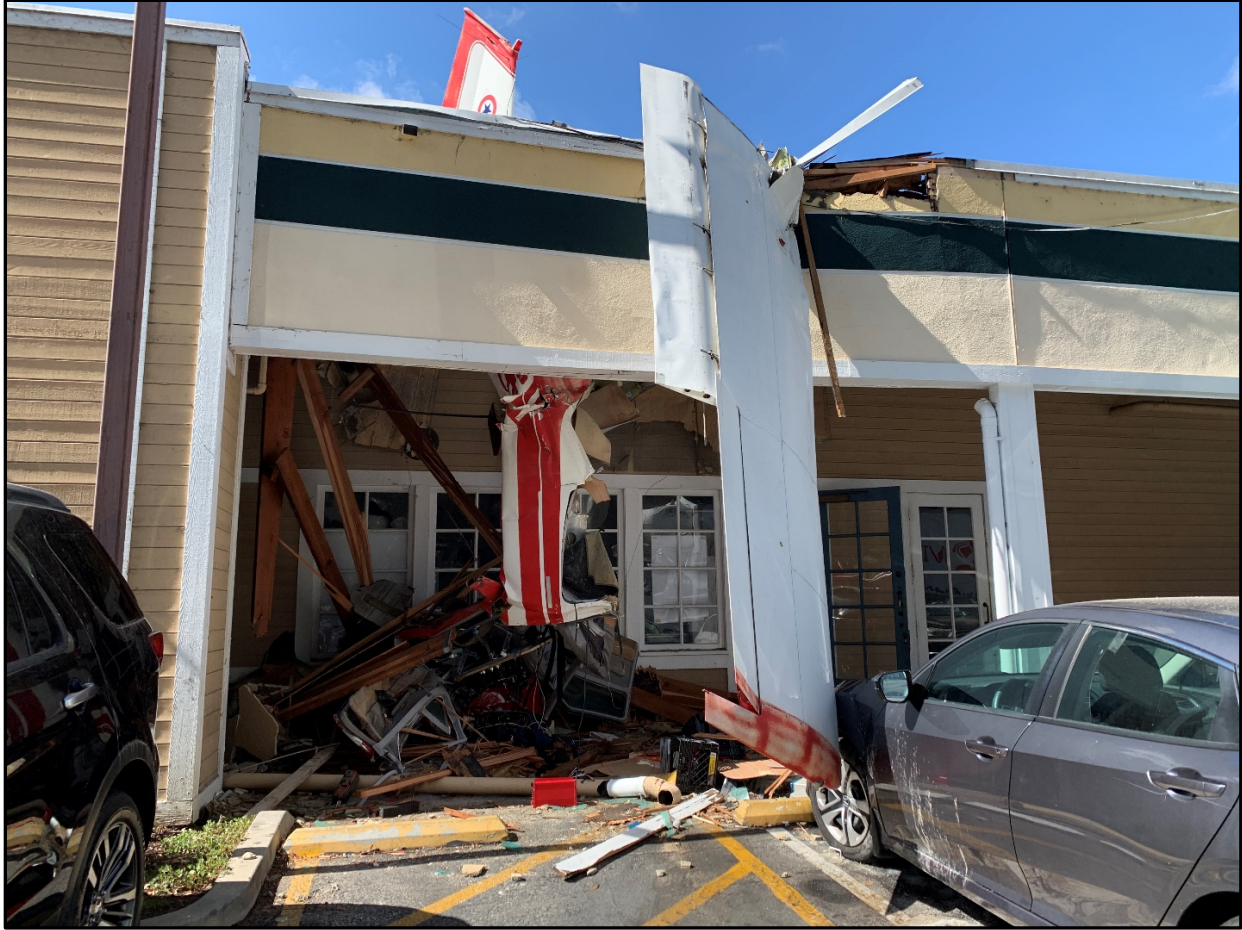
Figure 2: Airplane wreckage as viewed from the ground.
