## **NATIONAL TRANSPORTATION SAFETY BOARD**

# **AIRFRAME AND ENGINE EXAMINATION**

**WPR19FA262**

Location: Torrance, CA  
Date: September 19, 2019  
Aircraft: Registration Number: N2323Y, Cessna 177  
NTSB IIC: Albert Nixon

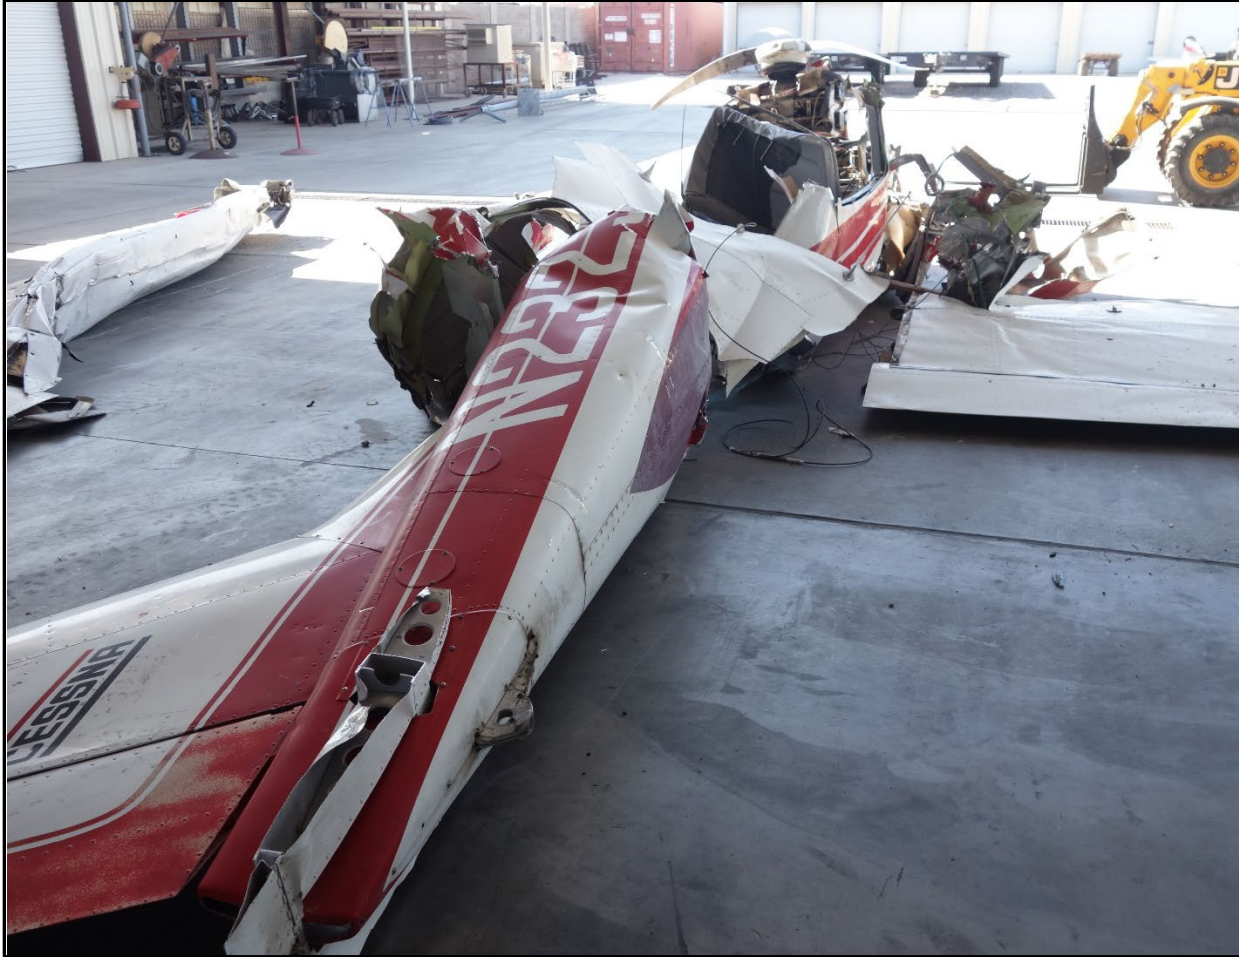
Figure 1: Airplane wreckage prepared for examination as viewed from the rear.

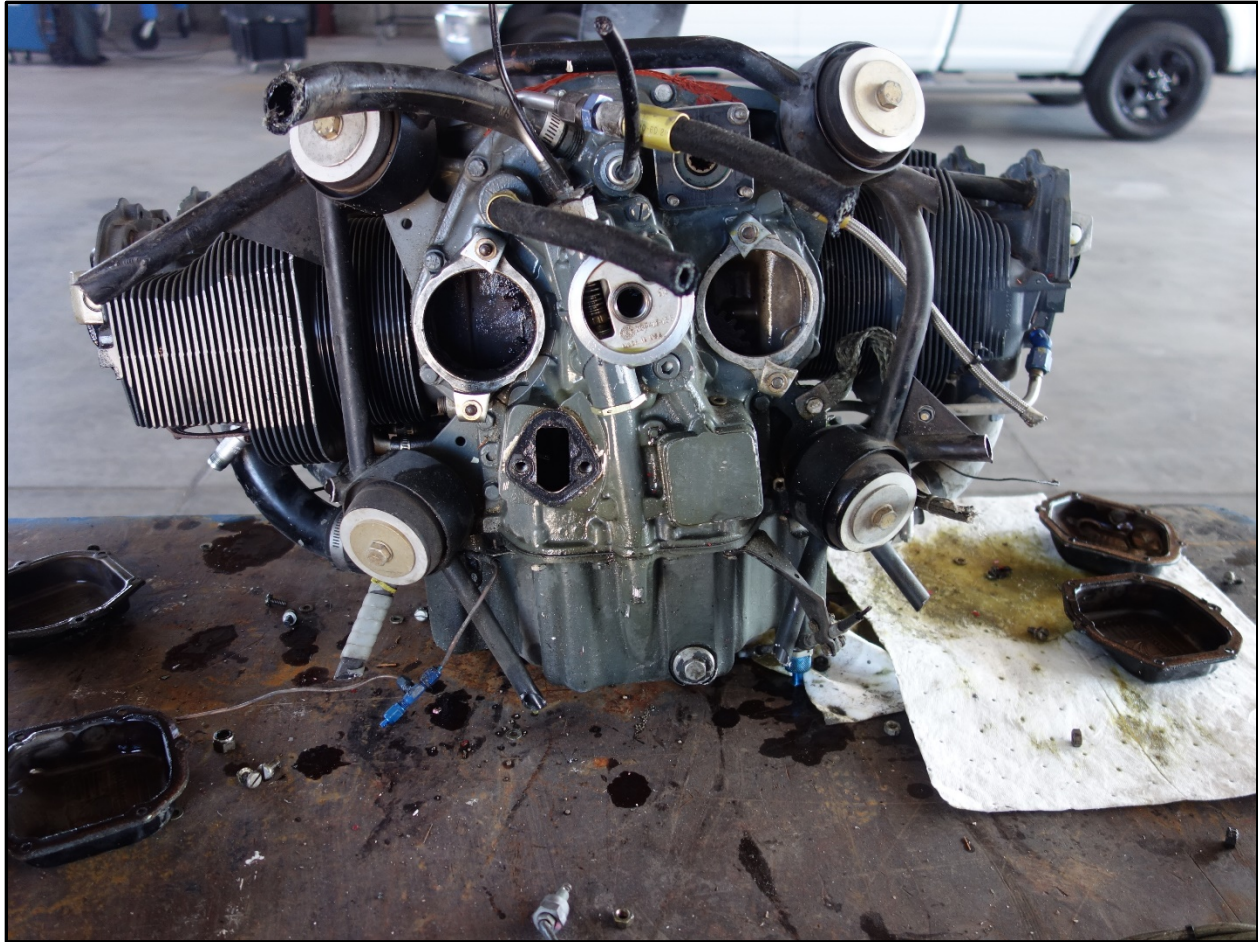
Figure 2: Engine as viewed from the rear.
