## **NATIONAL TRANSPORTATION SAFETY BOARD**

# **ENGINE EXAMINATION**

**WPR19LA010**

Location: Hurricane, UT  
Date: October 21, 2018  
Aircraft: Piper PA-46-350P; N413LL  
NTSB IIC: Elliott Simpson

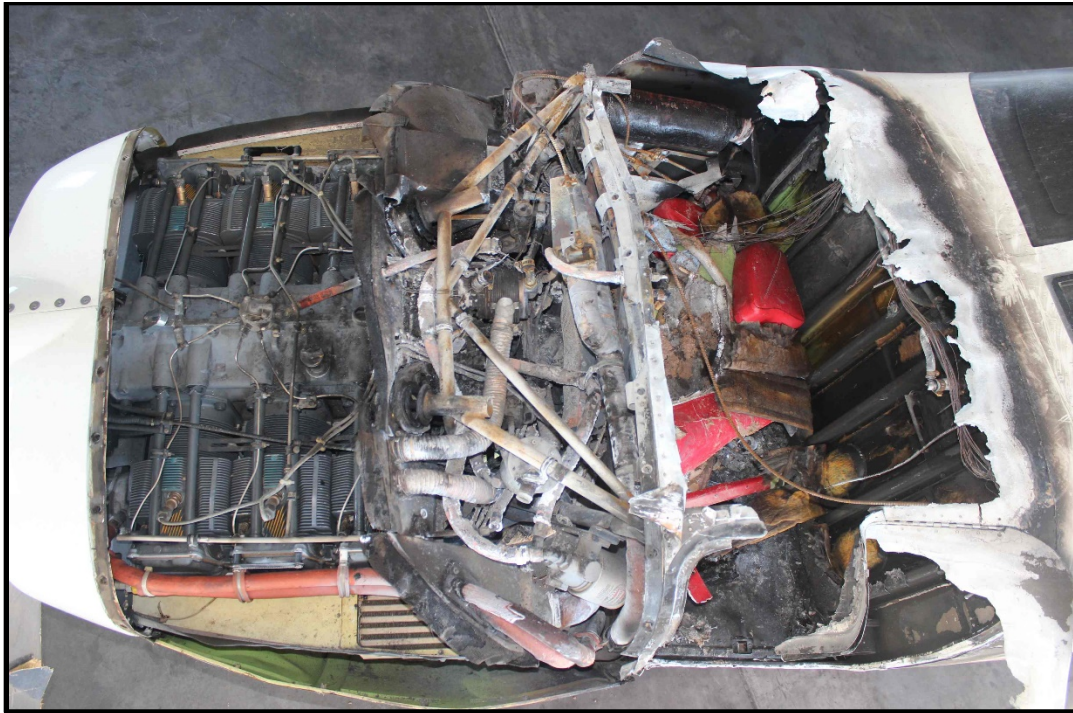
The airplane sustained fire damage to the baggage compartment, and the area between the firewall and the aft engine baffle (Photo 1). Two holes in the fuselage just aft of the firewall and the upper and lower cowling were coated in black soot that trailed aft (Photo 2). All other soot damage appeared to trail in an upwards direction. The nose landing gear remained partially attached, and the wheel had rotated 90° to the left.

**Photo 1 – Fire Damaged Area**

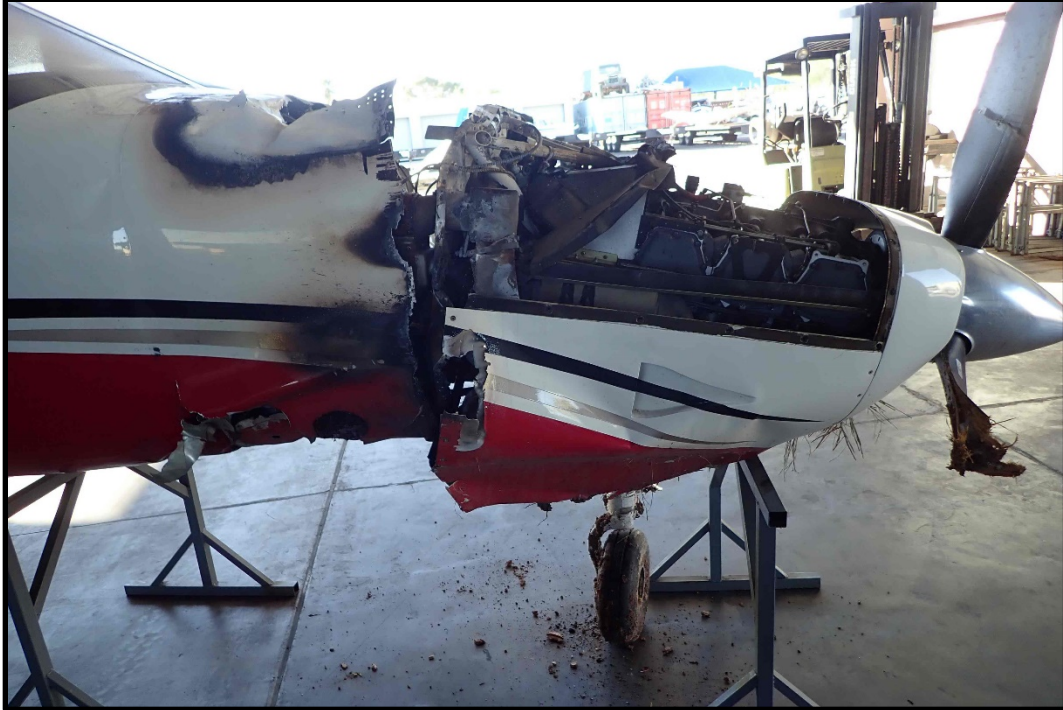
**Photo 2 – Smoke Streaks Aft of Firewall**

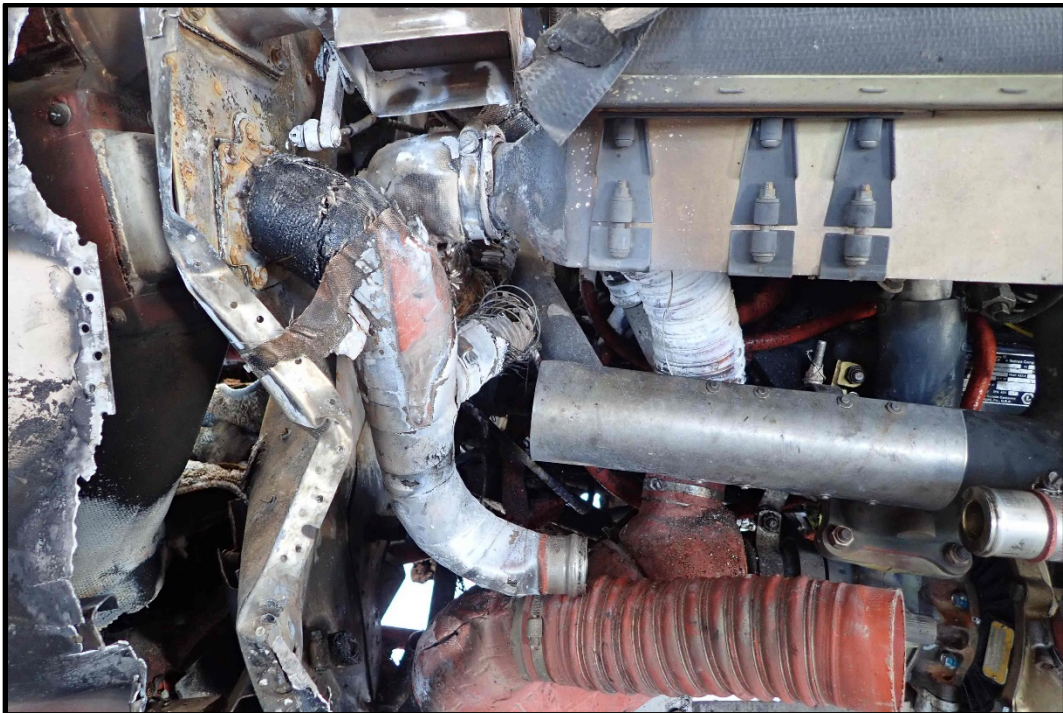
On the right side of the engine, in the area adjacent to the two holes on the right side of the firewall, the cabin climate scats tubes had burnt through to their support wires (Photo 3). The aft end of the right intercooler was located in the same area and sustained similar burn damage (Photo 3).

**Photo 3 – Right Side Aft of Engine Compartment**

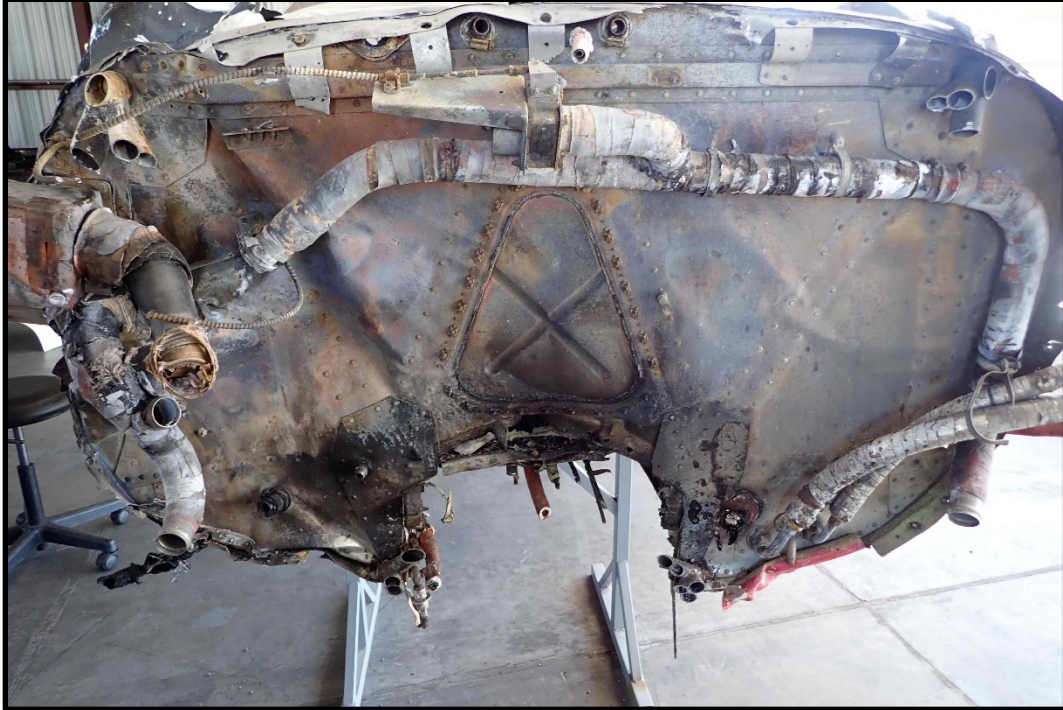
The entire firewall exhibited yellow-blue thermal discoloration to most of its surface, with orange discoloration and crumple damage on the upper right side (Photo 4).

**Photo 4 - Firewall**

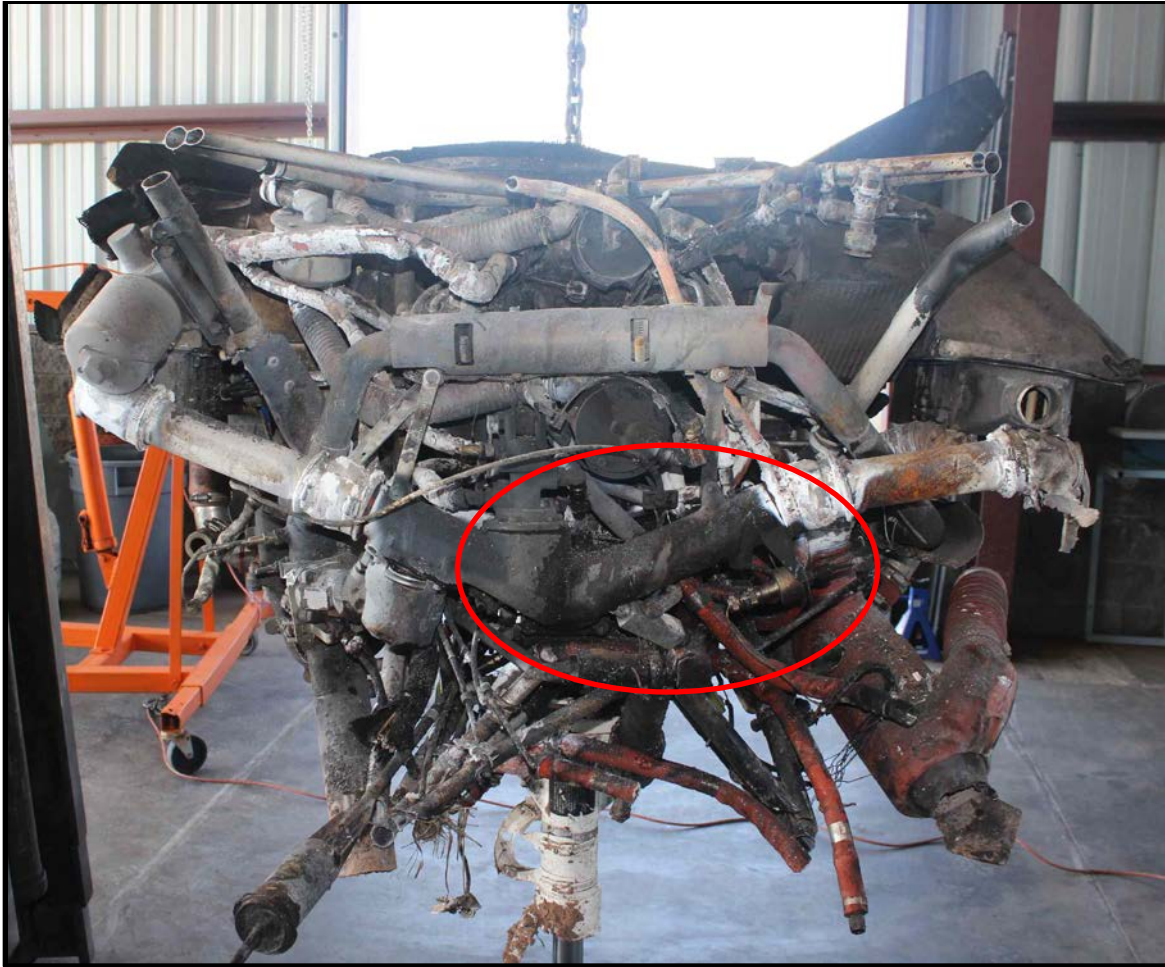
The aft end of the engine along with all accessory and ancillary components sustained varying degrees of thermal damage (Photo 5). The left intercooler air inlet housing pipe and its associated hoses and elbows were intact and charred white. The matching inlet components on the right side exhibited more extensive burn damage, and the inlet housing pipe was orange in color with a lateral flow pattern (Photo 6). The oil pressure sender switch, mounted on the top right engine mount, had sustained thermal damage, separating its plastic cap (Photo 7). The fuel injection servo pipe assembly appeared blackened and coated in oil-like residue on its right side (Photo 5); similar oil residue was found on the engine accessories on the right side below the sender.

**Photo 5 – Accessory Case Side of Engine (Oil Streaks in Red Circle)**

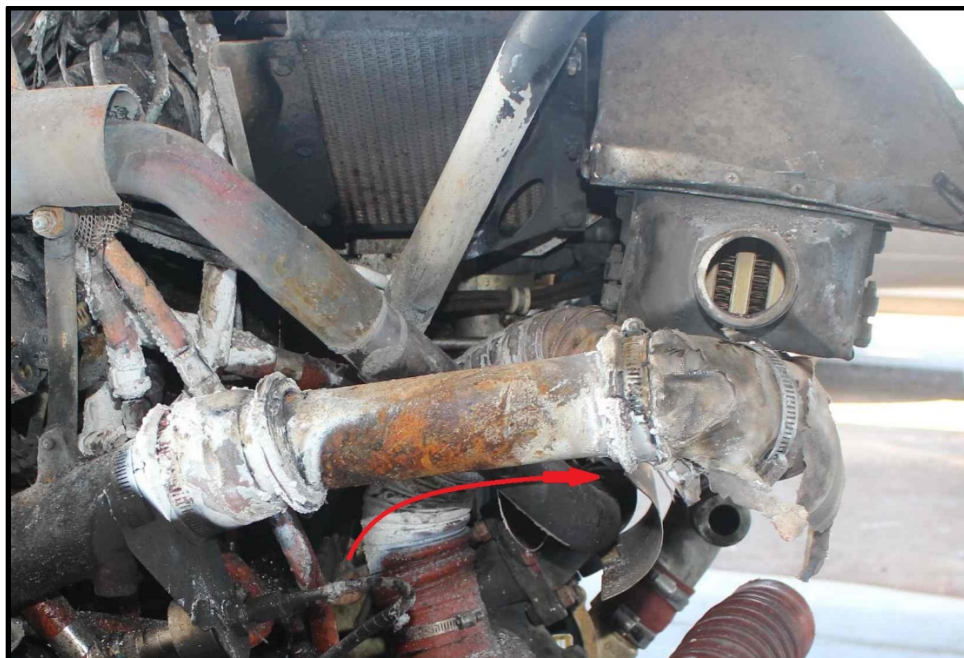
**Photo 6 – Intercooler Inlet Pipe**

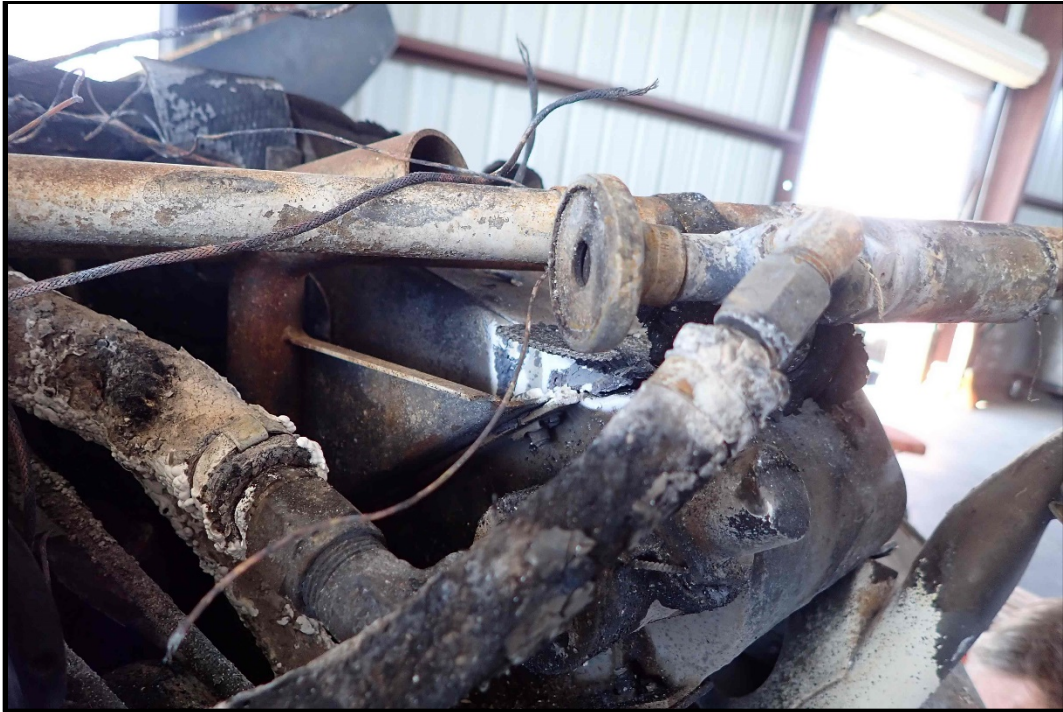
**Photo 7 – Oil Pressure Sender**

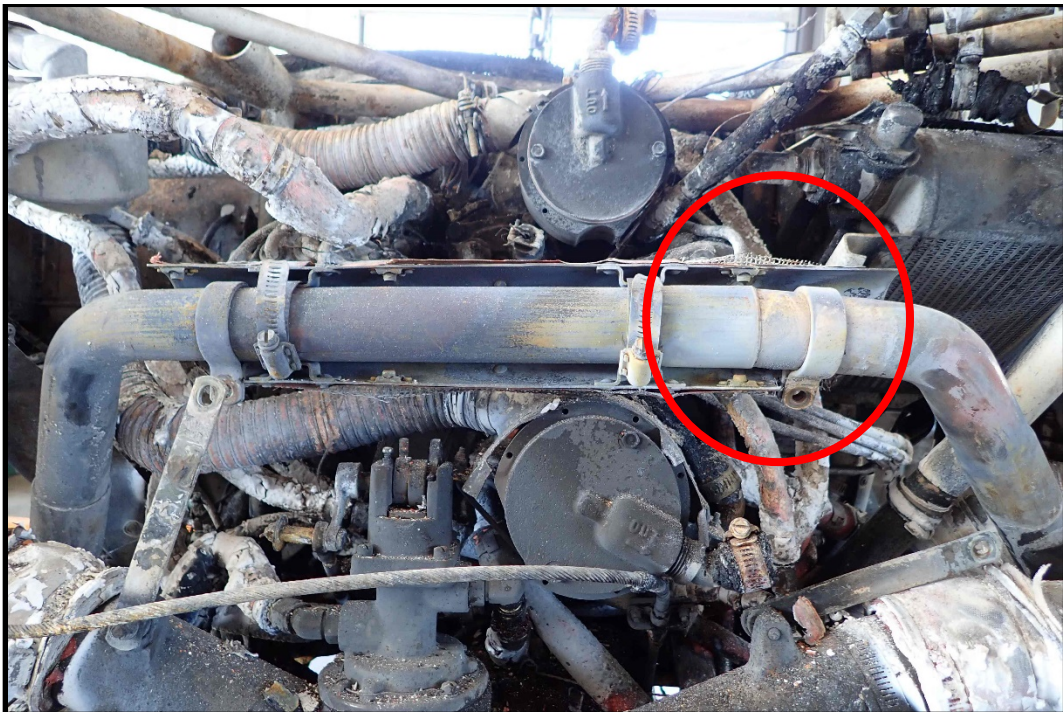
The exhaust crossover pipe heat shield was removed for examination. The intermediate and right exhaust crossover pipes (part numbers: 40B19974, and 40B19975) appeared misaligned at the slip joint (Photo 8, 9). Orange/yellow discoloration was present around the pipes at the joint, and similar discoloration was present on the inner surface of the heat shield adjacent to the joint. The discoloration on the heat shield appeared to show both a swirling form leading to a lateral flow pattern to the right (Photo 9, 10). Lycoming service bulletin 521 indicated that the right pipe should have been engaged at the slip joint with an overlap of at least 3/4-inch (Photo 11). Examination revealed that the right pipe had about 1/16-inch engagement on the forward side (Photo 11, 12) and 3/16-inch engagement on the rear (Photo 13). Prior to disassembly, all of the crossover pipe hardware and support brackets were found to be in-place and secure. The crossover pipe assembly exhibited no evidence of impact damage.

**Photo 8 – Exhaust Crossover Pipes (Area of Misalignment Shown in Red)**

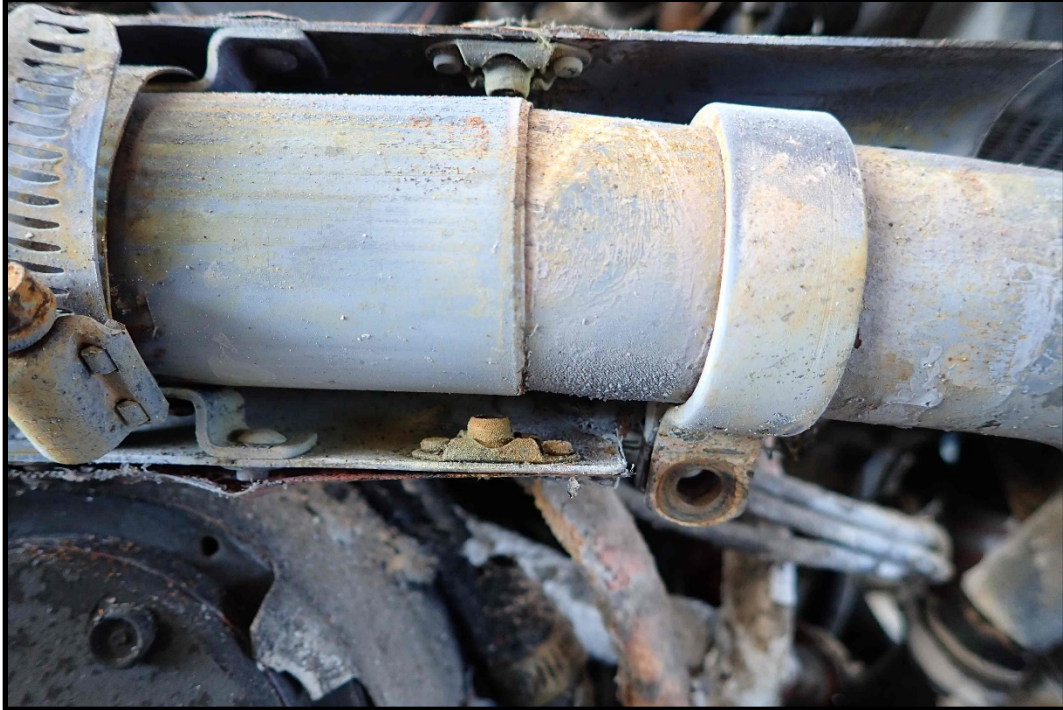
**Photo 9 - Intermediate and Right Exhaust Crossover Pipe Engagement**

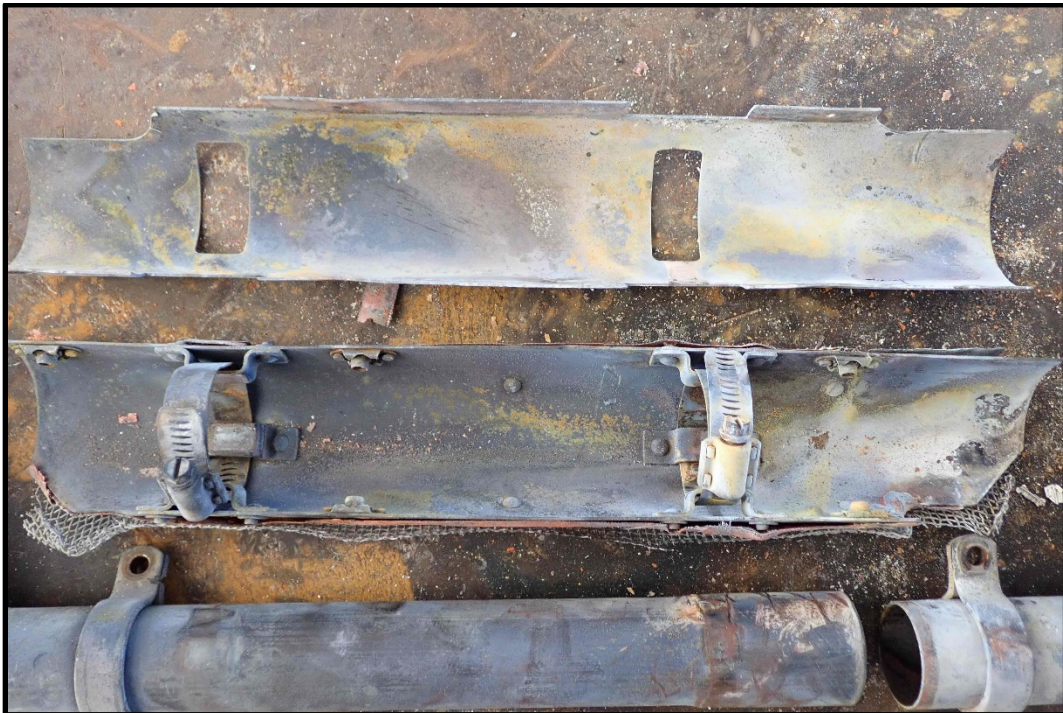
**Photo 20 – Heat Shield**

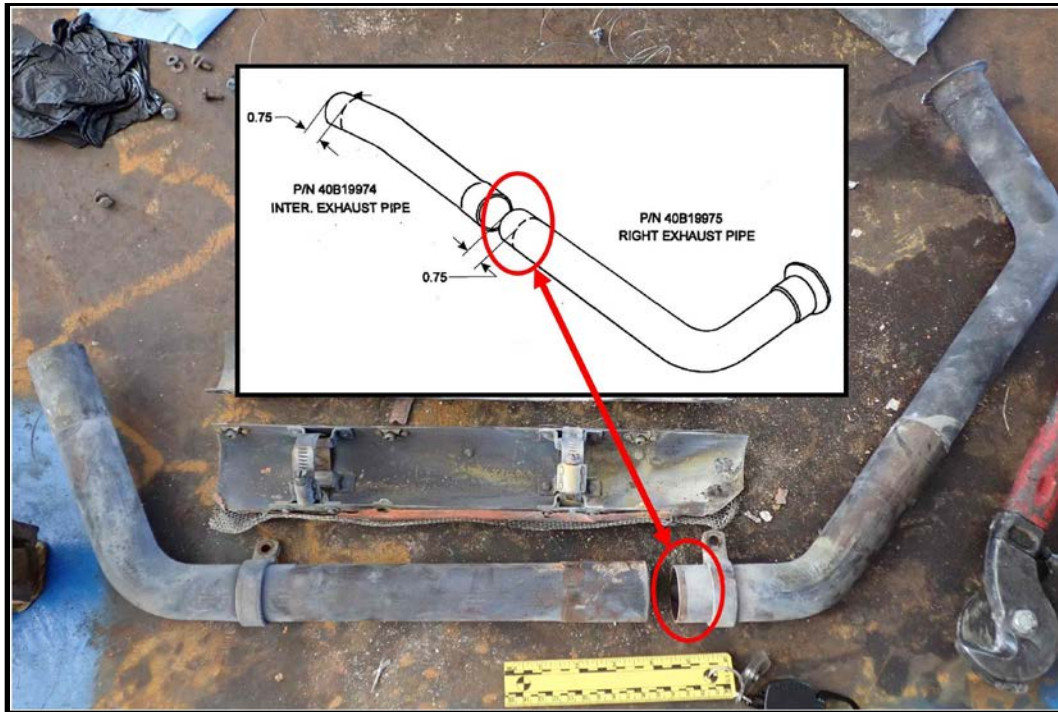
**Photo 31 – Actual Pipe Engagement versus Nominal**

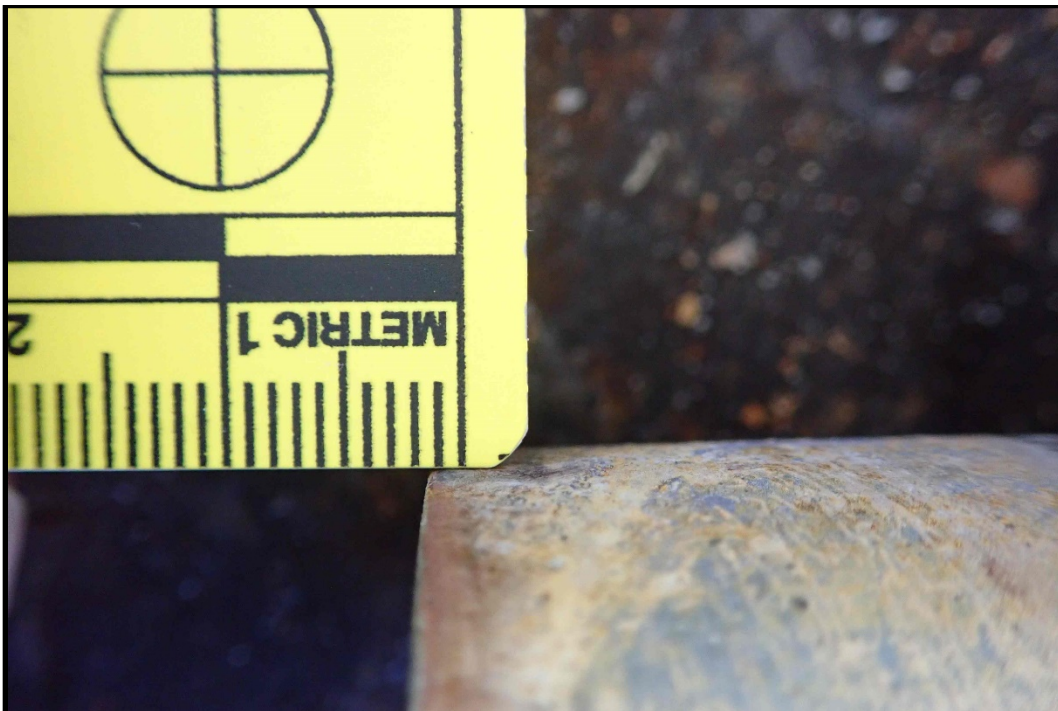
**Photo 42 – Right Crossover Piper Forward Engagement**

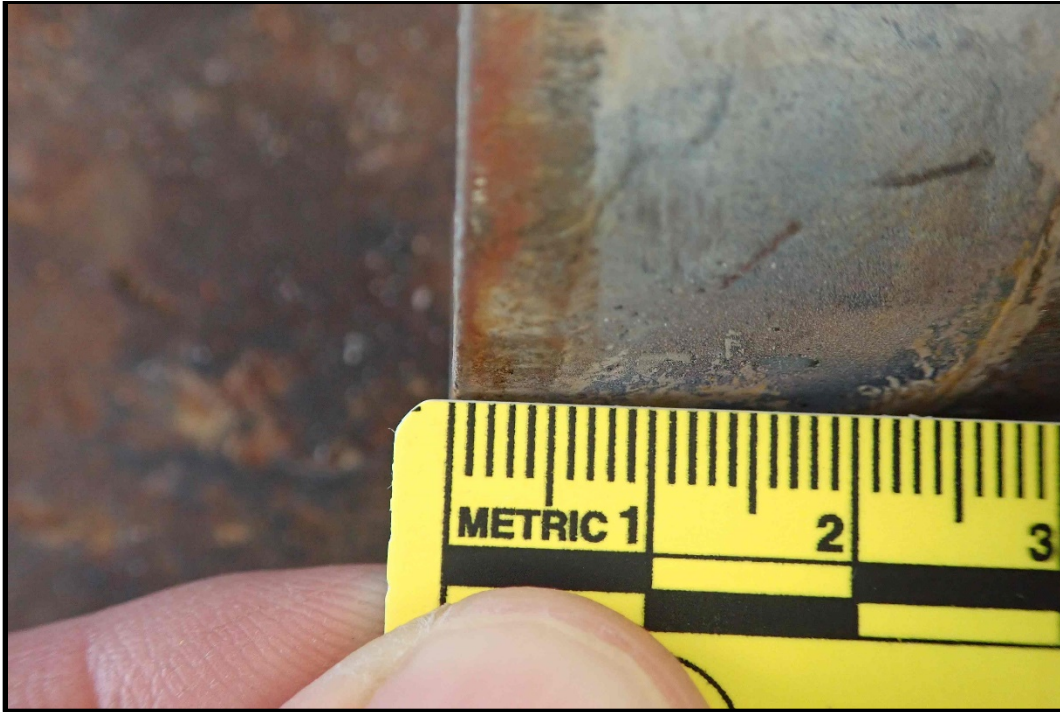
**Photo 53 - Right Crossover Piper Aft Engagement**

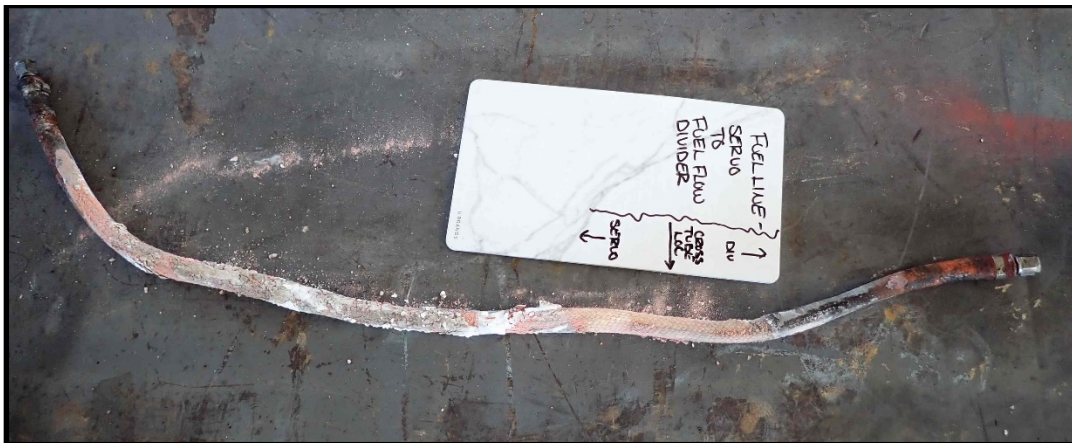
The fuel line which connected the fuel injection servo to the fuel flow divider passed next to the heatshield on the right side. The fire sleeve of the line was charred along most of its length, with more significant thermal damage in the area next to the heatshield; an oil-like substance was also present on the upper end of the line (Photo 14).

**Photo 64 - Fuel Line from Servo to the Flow Divider**

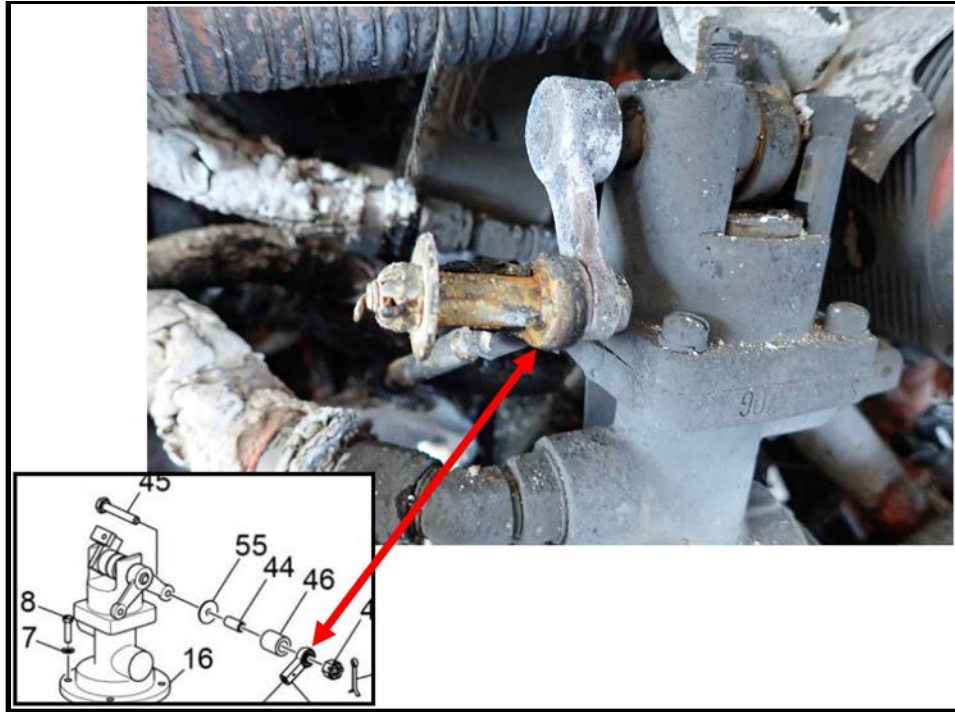
The control linkage joint and washer for the control arm of the absolute pressure controller appeared to have been installed on the wrong side of linkage adapter (spacer) (Photo 15). The linkage remained intact.

**Photo 75 – Absolute Pressure Controller Linkage**
