## **NATIONAL TRANSPORTATION SAFETY BOARD**

### **INITIAL MAGNETO EXAMINATION**

**WPR19LA011**

Location: Indianapolis, IN  
Date: October 21, 2018  
Aircraft: Piper PA-32-300, N2920Q  
NTSB IIC: Maja Smith

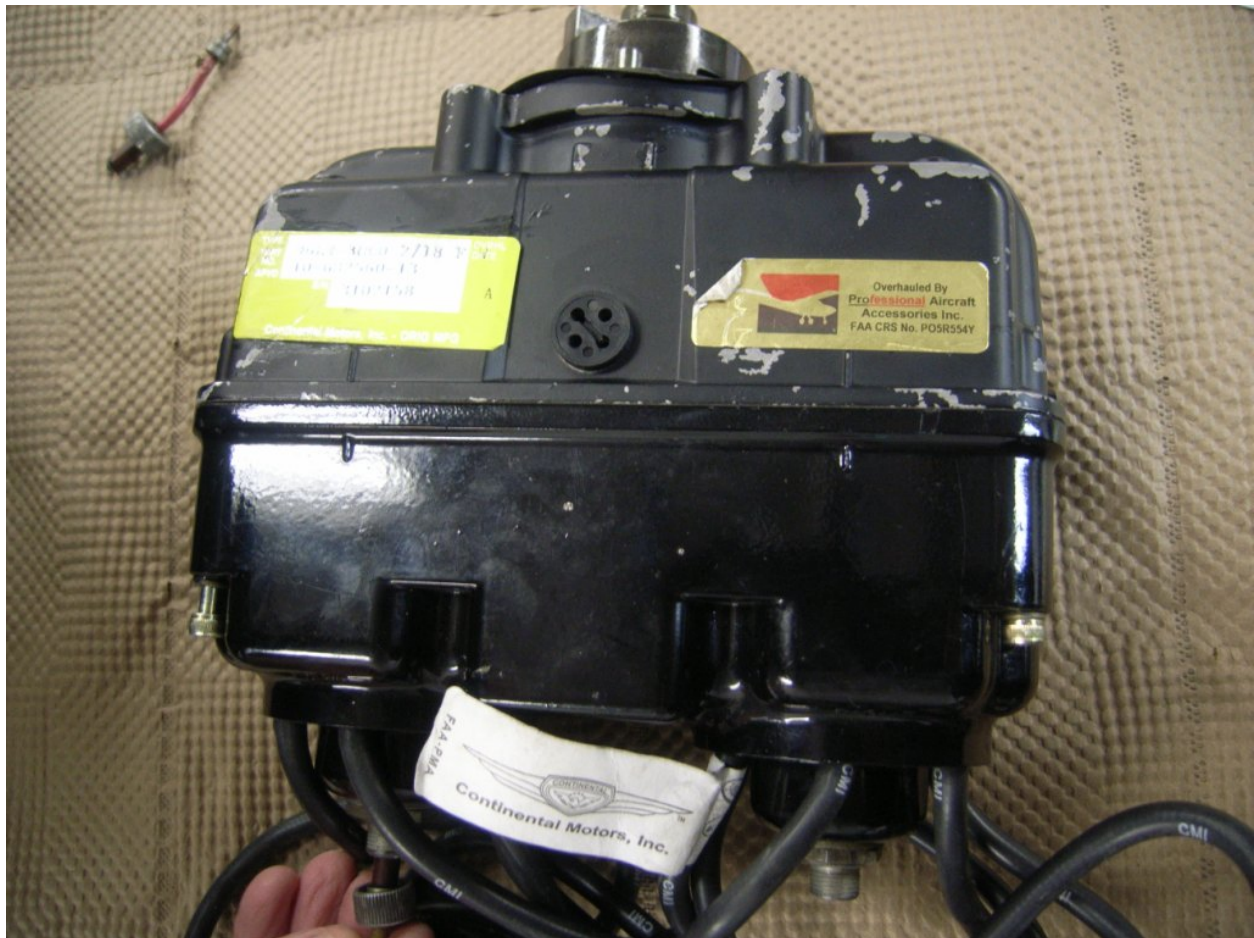
Figure 1 - Magneto Body

- The magneto appeared to be in very good condition
- It bore two placards on the body
  - One was a dataplate-like placard, that CMG personnel determined was not a CMG dataplate
  - The other contained the name and repair station information of a maintenance facility
- There was also a paper tag on one of the ignition leads

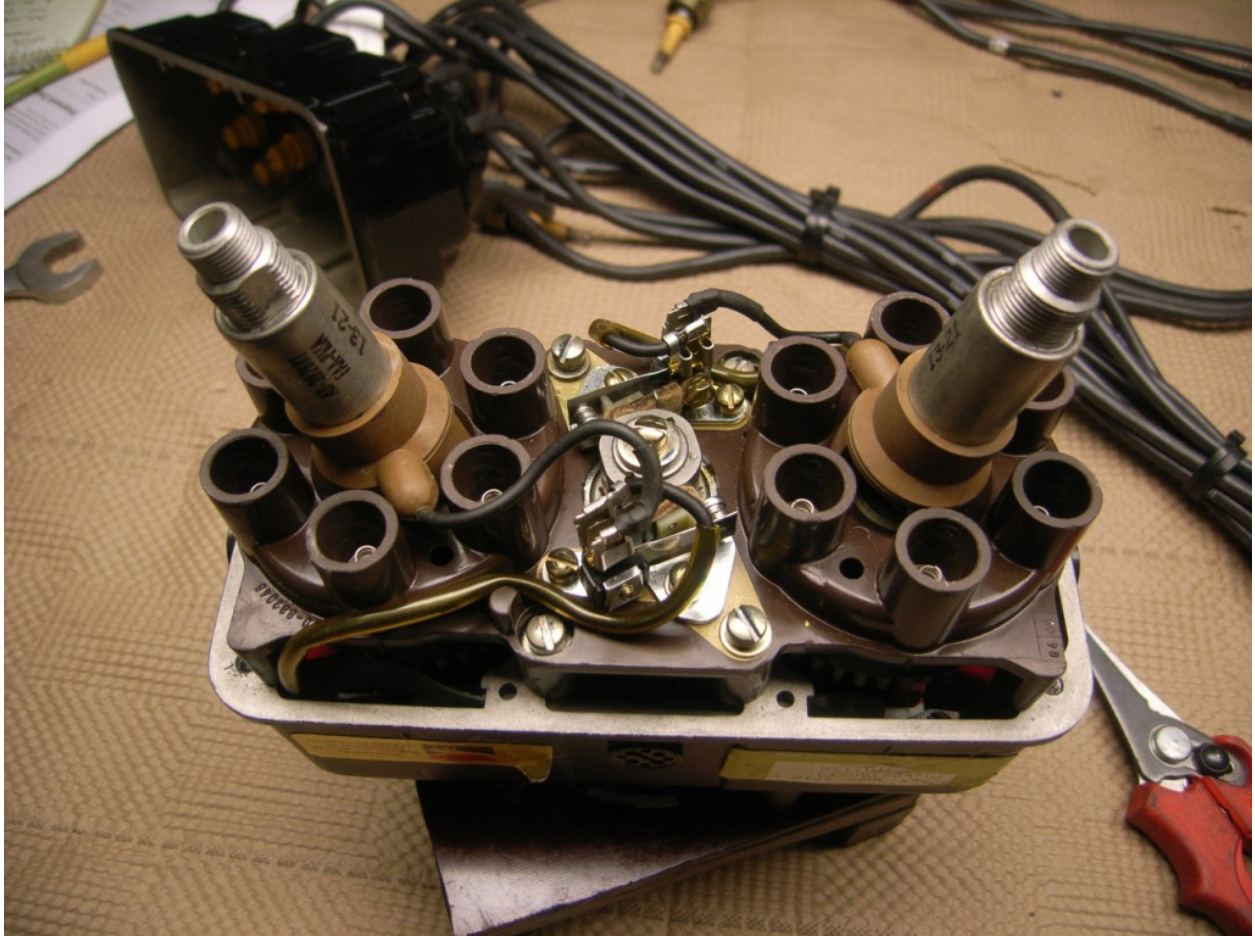
**Figure 5 - Magento with Cover Removed**

The magneto was examined at CMG. All 12 ignition leads were attached and intact. The unit it displayed no external indications of damage or other mechanical deficiencies. The cover was removed, and a visual inspection of the interior components (with no further disassembly) revealed no indications of damage. The unit was reassembled and installed on the test bench device for operational checks.

- After the cover was removed, the magneto drive was rotated slowly by hand
  - The impulse coupling was heard to operate
  - Both sets of contact points opened and closed with rotation
