## **NATIONAL TRANSPORTATION SAFETY BOARD**

### **FOLLOW UP MAGNETO EXAMINATION**

**WPR19LA011**

Location: Indianapolis, IN  
Date: October 21, 2018  
Aircraft: Piper PA-32-300, N2920Q  
NTSB IIC: Maja Smith

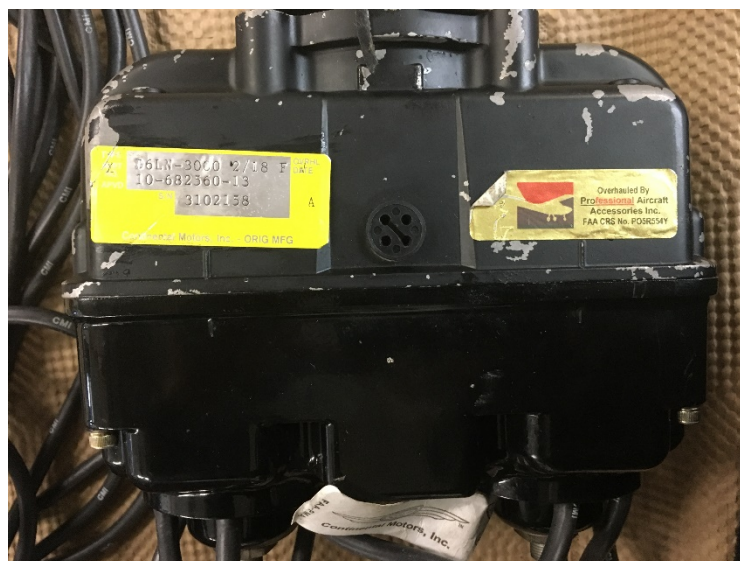
Following the initial magneto testing which resulted in an inability of the magneto to produce any sparks, subsequent examination was conducted with the CMI's magneto specialist. After the initial examination, magneto was reassembled to its initial state.

Figure 1. Magneto body

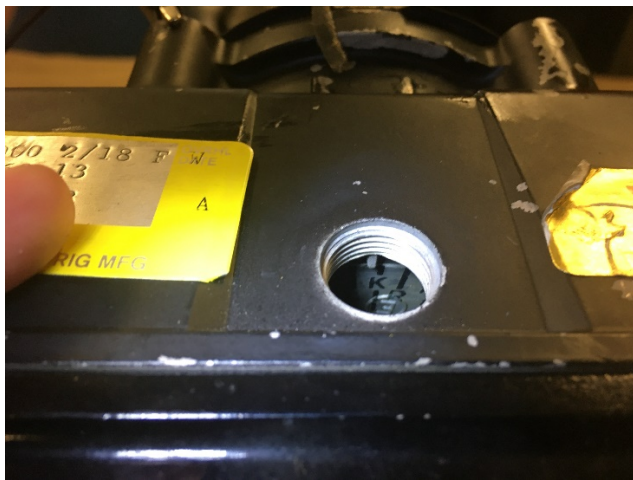
Figure 2a – Impulse coupling at the K mark

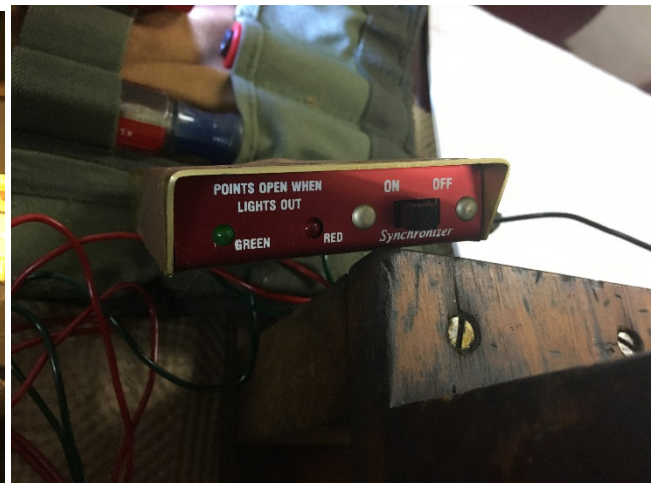
Figure 2b – Timing lights indicate open ports

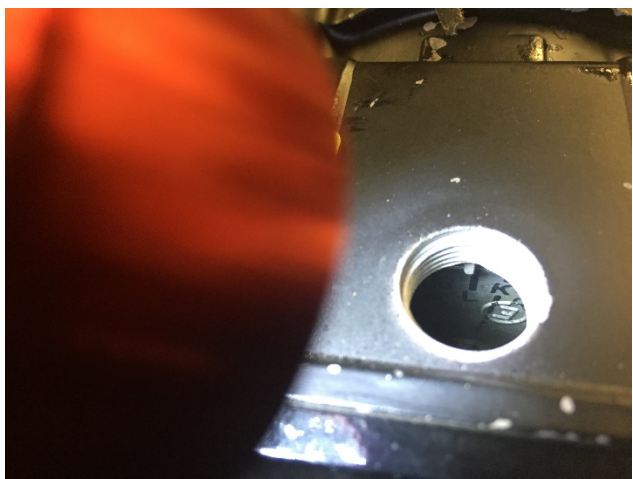
Through the timing hole in the top of the magneto, you can see the ink stencil on the rotor magnet. E-gap in the dual mag is found when the "K" is positioned in the center of the hole and the red painted teeth are visible in timing holes located in each side of the mag housing. The "L" or "R" on either side of "K" is the mark designated for contact point opening, depending on rotation. After the magneto cover was removed, the impulse coupling was rotated by hand and the magneto was tested using the Synchronizer brand timing light. It was observed that, when the impulse coupling was rotated to neutral (K) position, points were open when they should have been closed. When impulse coupling was rotated counterclockwise approximately 8° to the L mark, the timing light indicated that the points were closed when they should have been open.

Figure 3a – Impulse coupling at the L mark

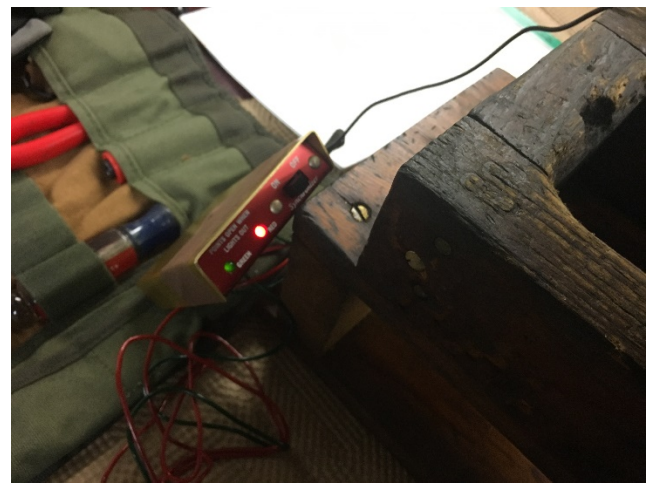
Figure 3b – Timing lights indicate closed ports

Camshaft in the middle showed when in neutral, open points where they should have been closed. When rotated approximately 8 degrees, they should have been opened but they were closed at that position. The amount of cam position displacement was significant; which would result in the magneto's inability to start. The Cam was supposed to be positioned so it forced the points open at

the L mark on the shaft; what we found the points were closed at the L mark .The cam was not positioned in such a way that it would be open at the L mark; that's what caused the loss of power (Cam being out of position caused the magneto not to fire and caused the engine to lose power).

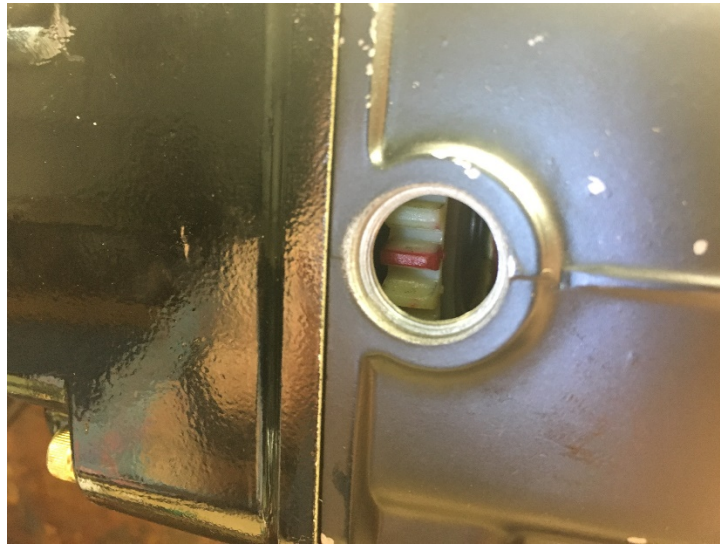
The internal gear timing for the right magneto was observed to be correct; the red line was in the middle of the window which indicated that the points were open.

**Figure 4 – Red mark in the middle of the window indicates open points**

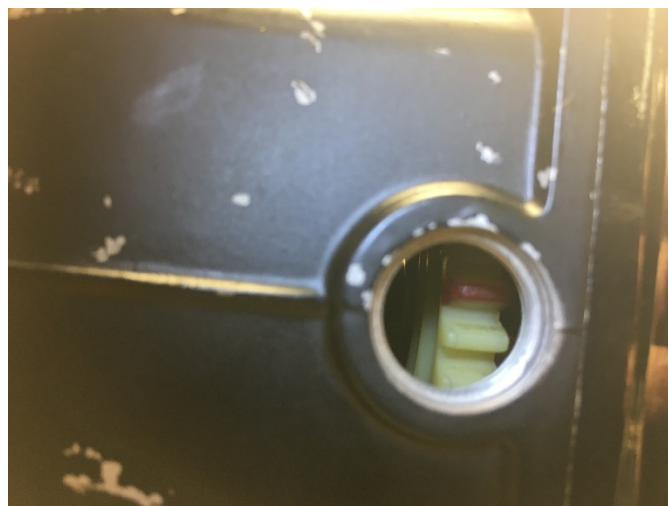
The internal gear timing for the left magneto was observed to be correct; the red line was in the middle of the window which indicated that the points were open.

**Figure 4 – Red mark in the middle of the window indicates open points**

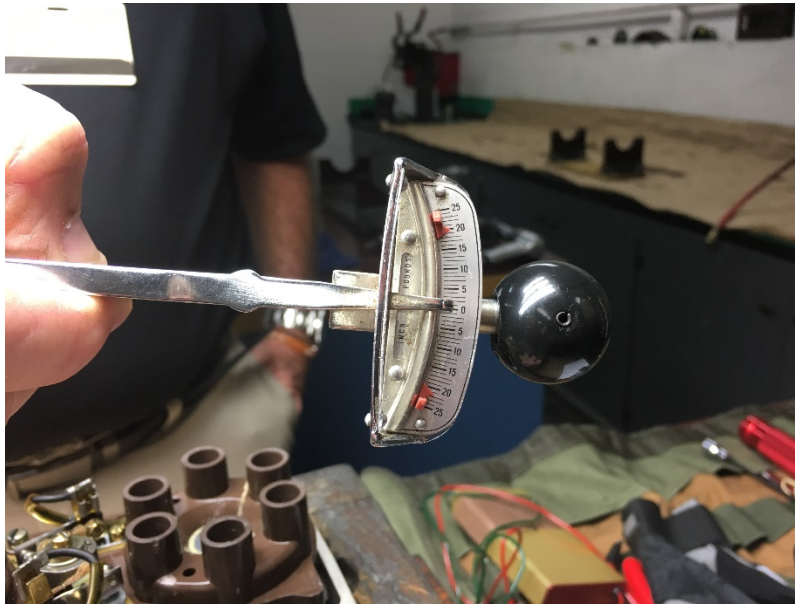
The next step was to measure the torque needed to lose or tighten the retaining screw located on the top of the camshaft. According to the specification, the screw should be tightened between 21 to 25 pounds per inch with allowable error of 1. The retaining screw measured 20 pounds per inch when tightened.

**Figure 5- - Tightened screw at 20 lbs per in**

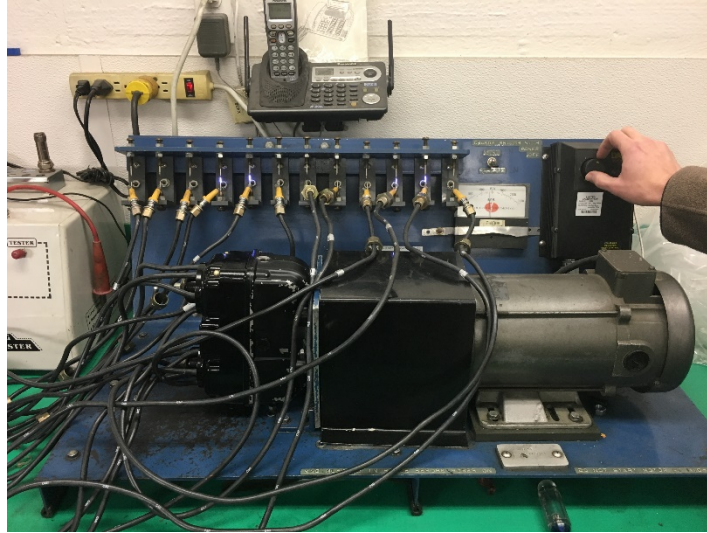
The magneto was then assembled again to it specifications, tested and it produced sparks on all leads.

**Figure 6 – Magneto testing**
