## **NATIONAL TRANSPORTATION SAFETY BOARD**

### **Engine Exam Notes**

**WPR19LA014**

4 Aircraft: NORTH AMERICAN, SNJ-5, Registration Number: N7969C, Serial #: 43974

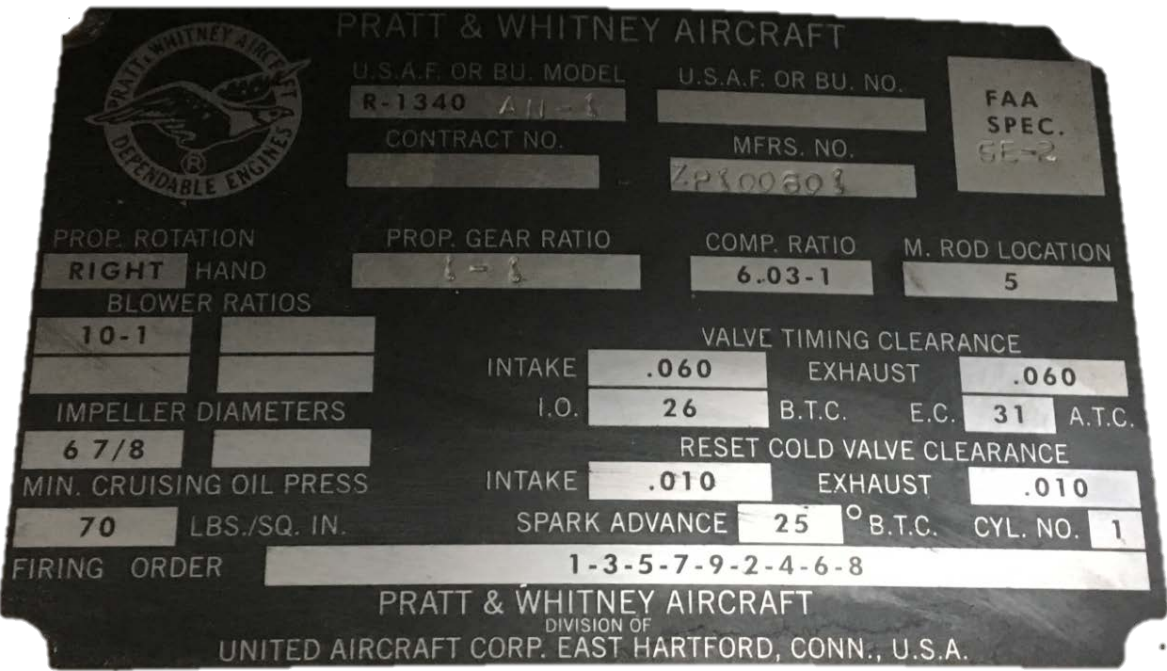
11    **Figure 1: View of data plate. Master Rod Location No.5 cylinder.**

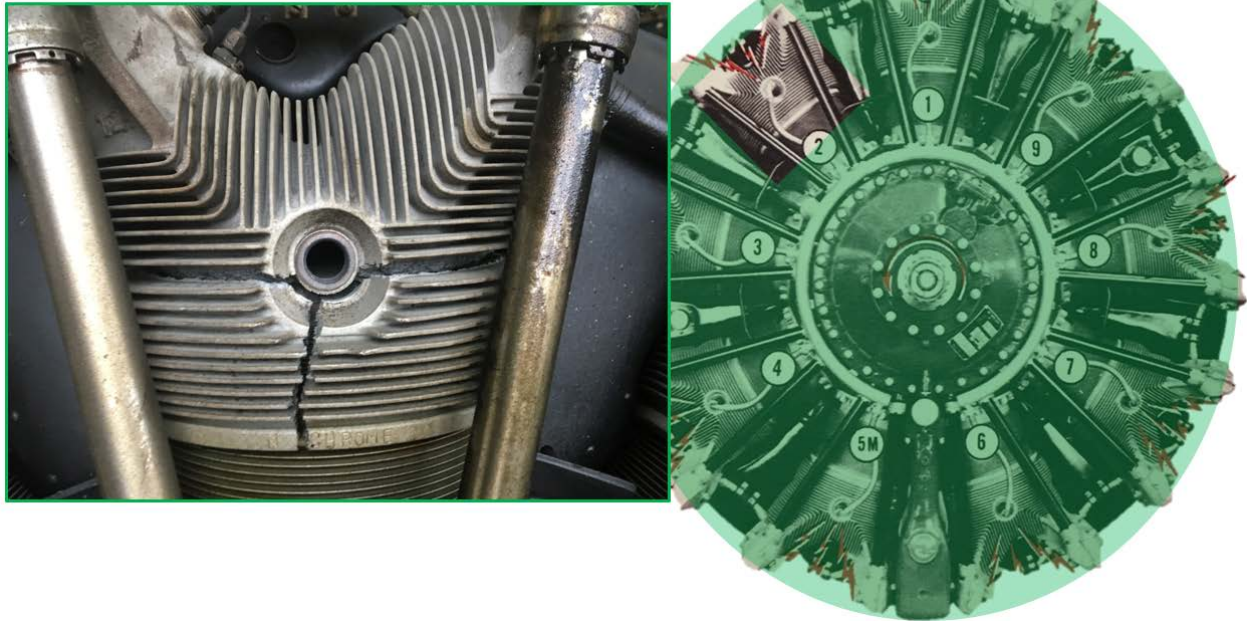
20 The cylinders are constructed of steel and aluminum. Cylinder No. 2 was cracked between the  
21 10<sup>th</sup> and 11<sup>th</sup> (From Bottom of Head) cylinder head cooling fin. Another crack on No. 2 ran down  
22 from the sparkplug to the base of the head.

24 **Figure 4: View of cracked No 2. cylinder head.**

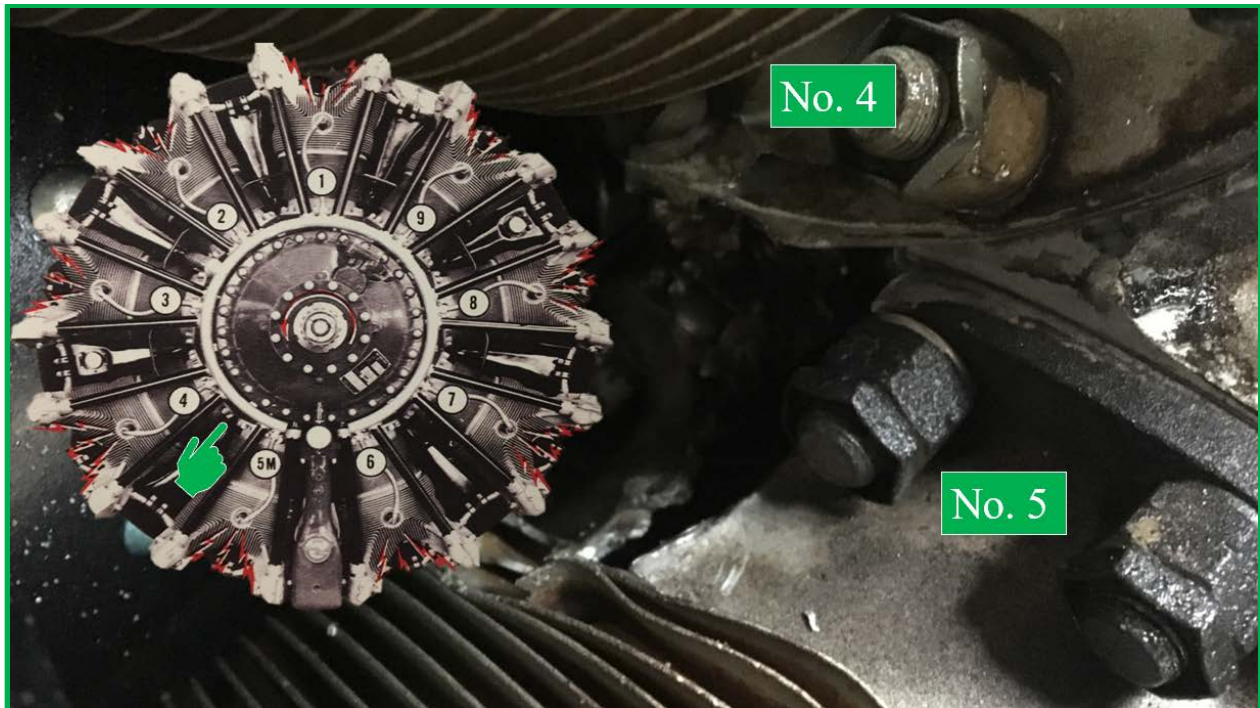
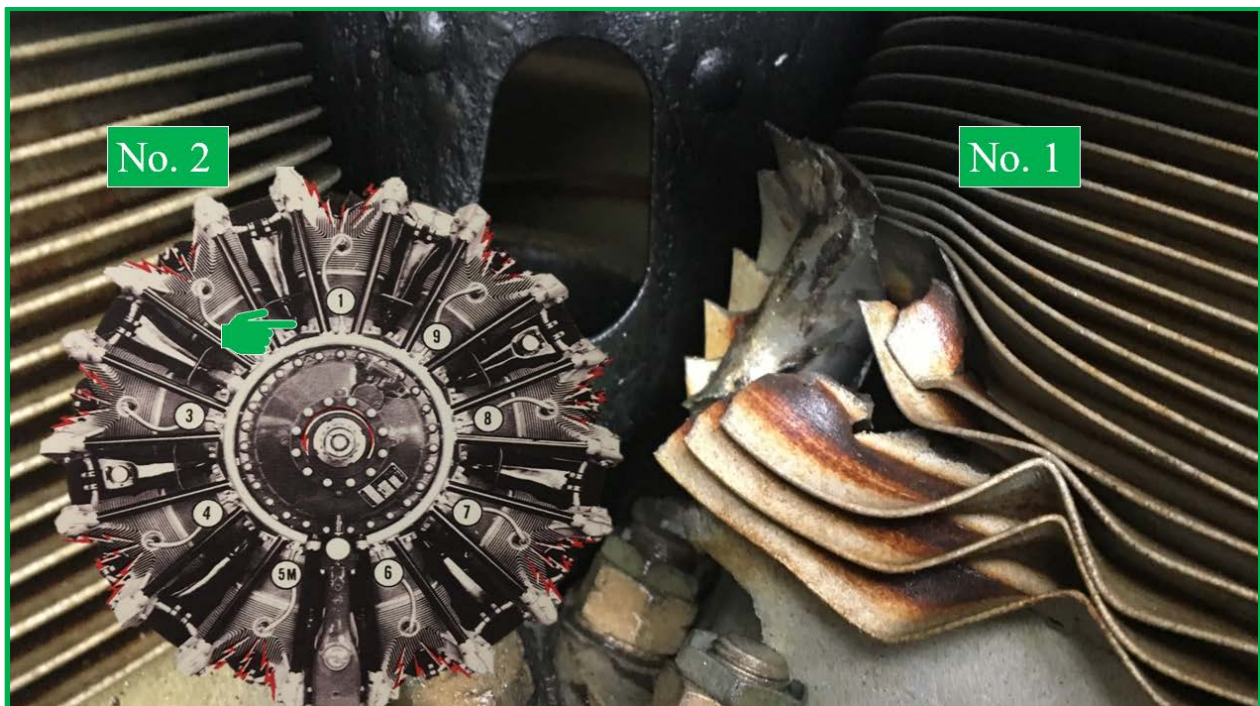
25 Damage at the base was noted between the Nos. 4 and 5 cylinders, and on the No. 1 cylinder.

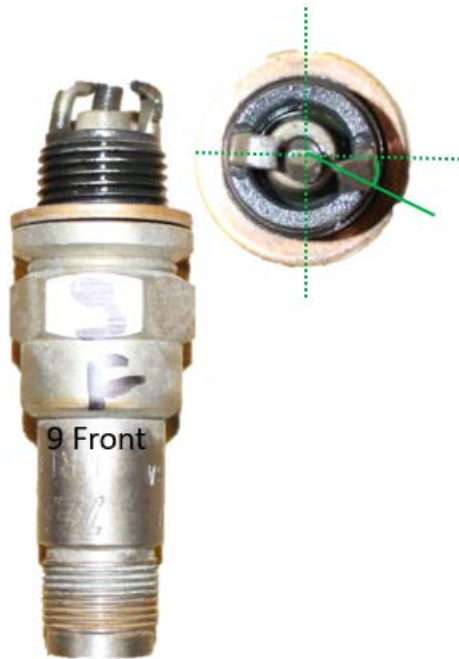
28 The forward sparkplugs were removed. The make and model of each was Tempest UREM37BY.  
29 All of the sparkplugs displayed normal wear. The number nine front sparkplug electrode was  
30 bent about 30°.

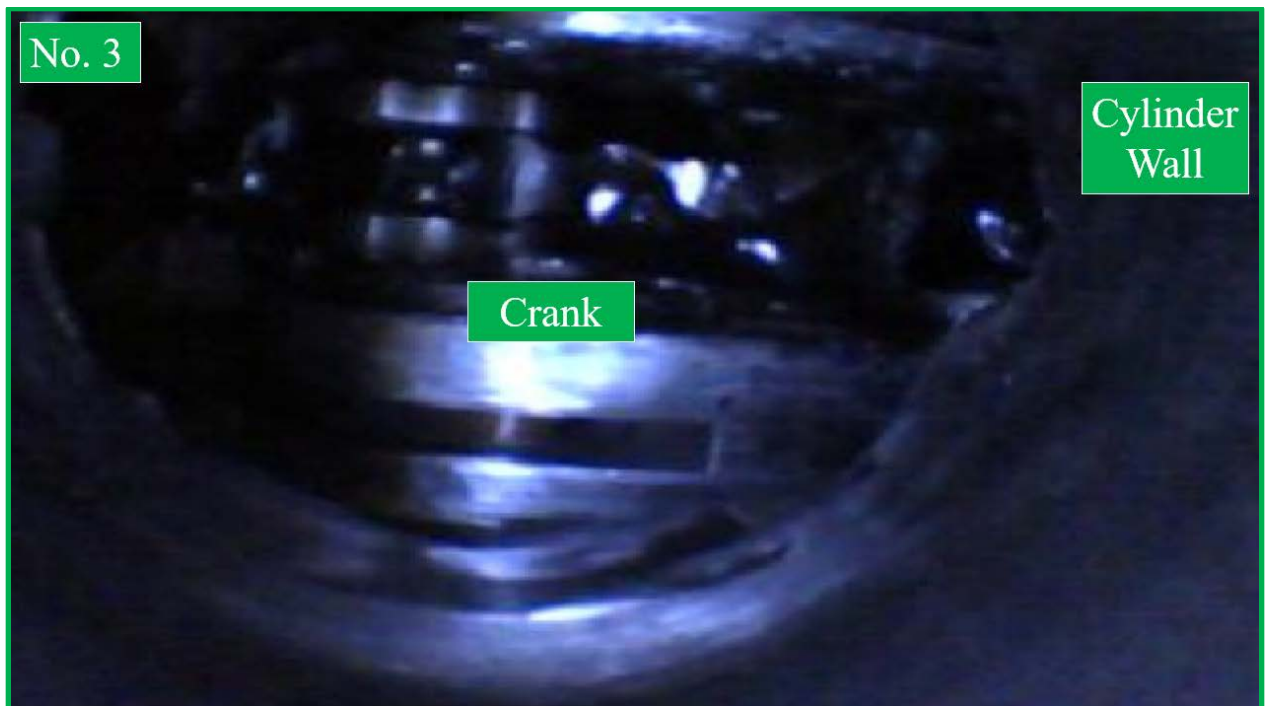
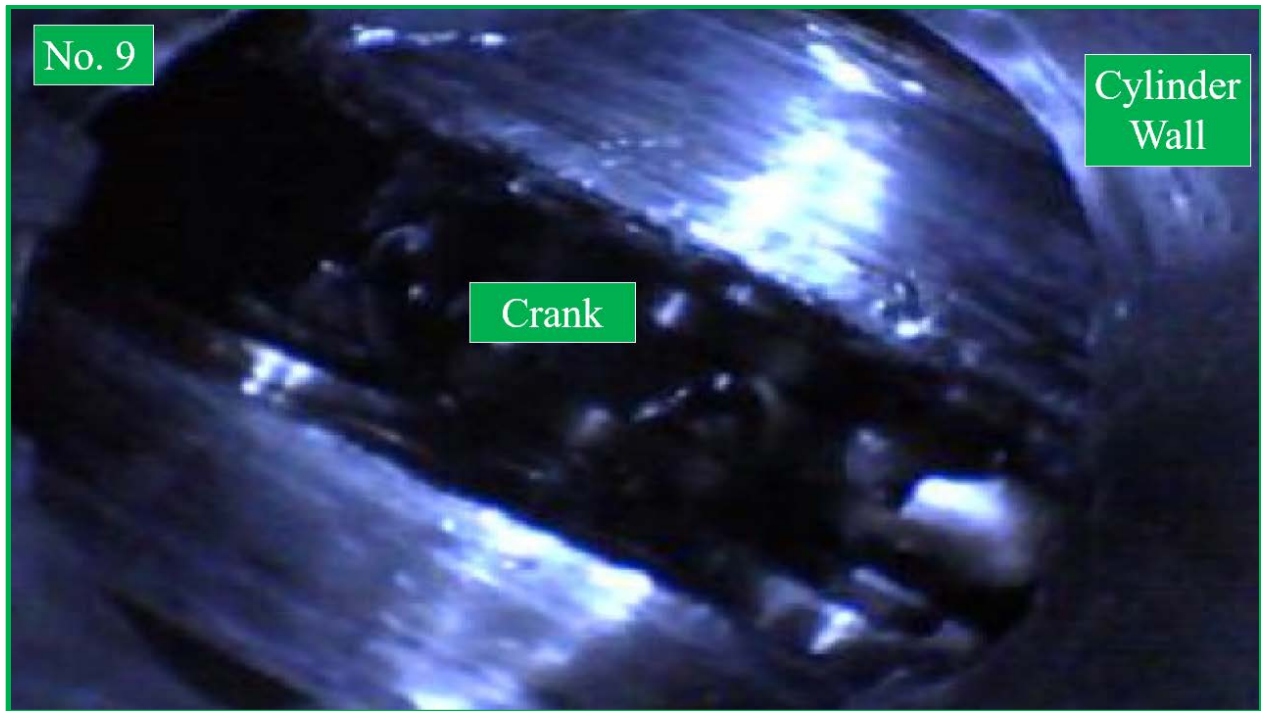
32 A bore scope (Vividia Able Scope) of the engine revealed that the Nos. 3 and 9 pistons were  
33 destroyed.

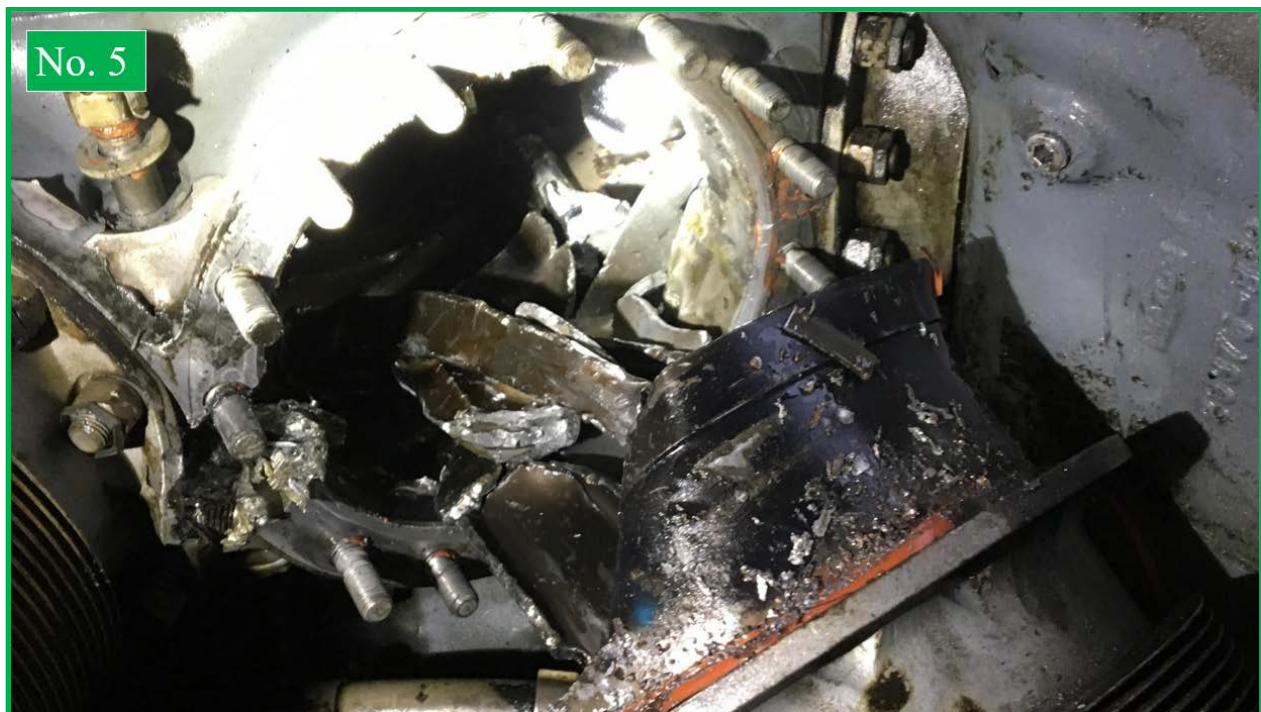
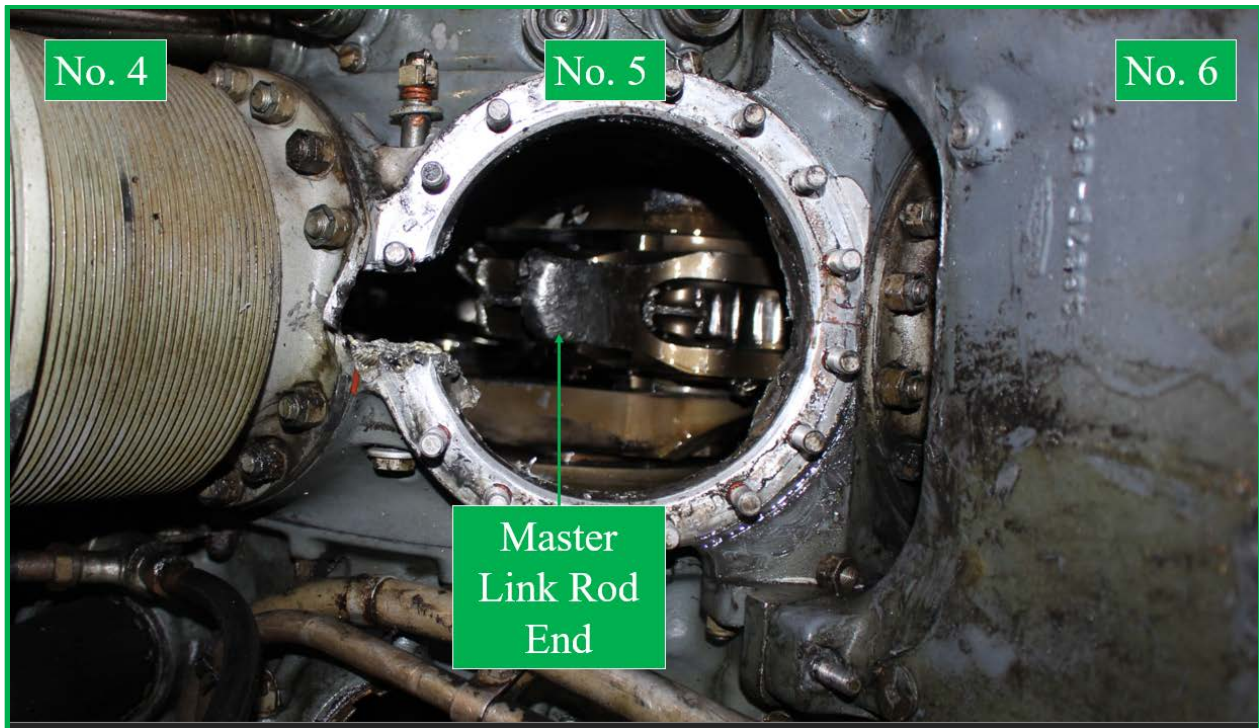
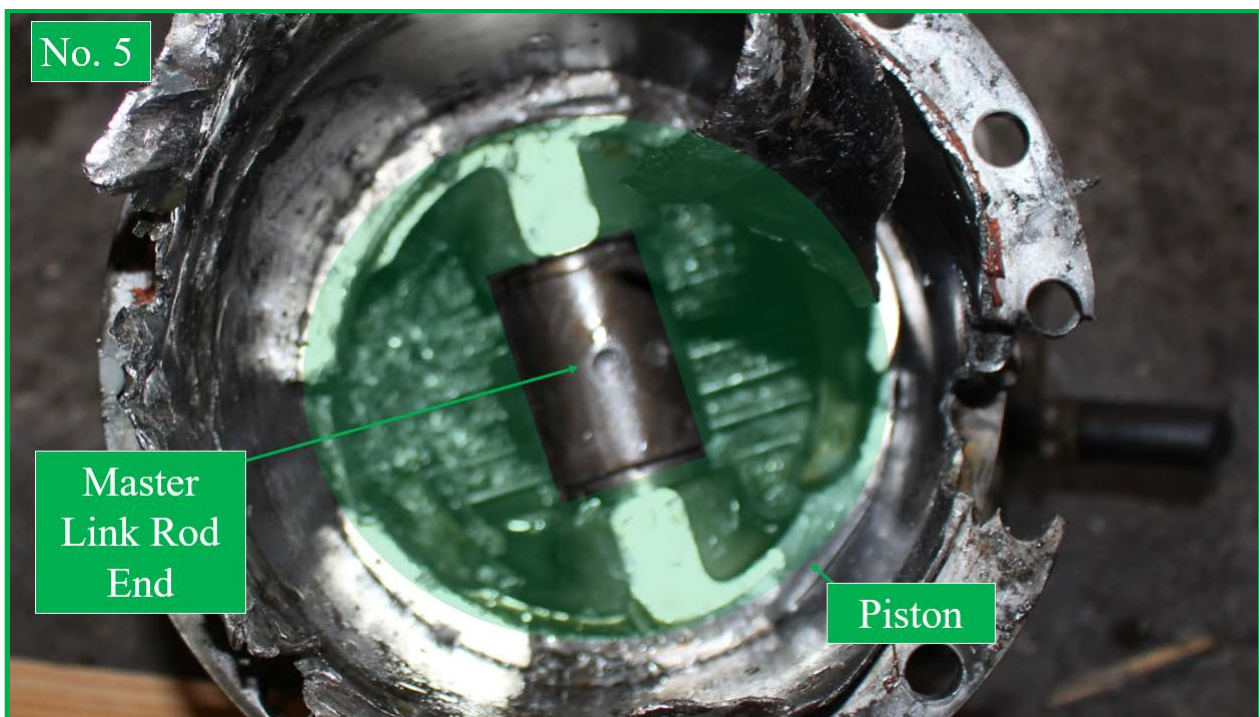
36 The No.5 cylinder was removed.

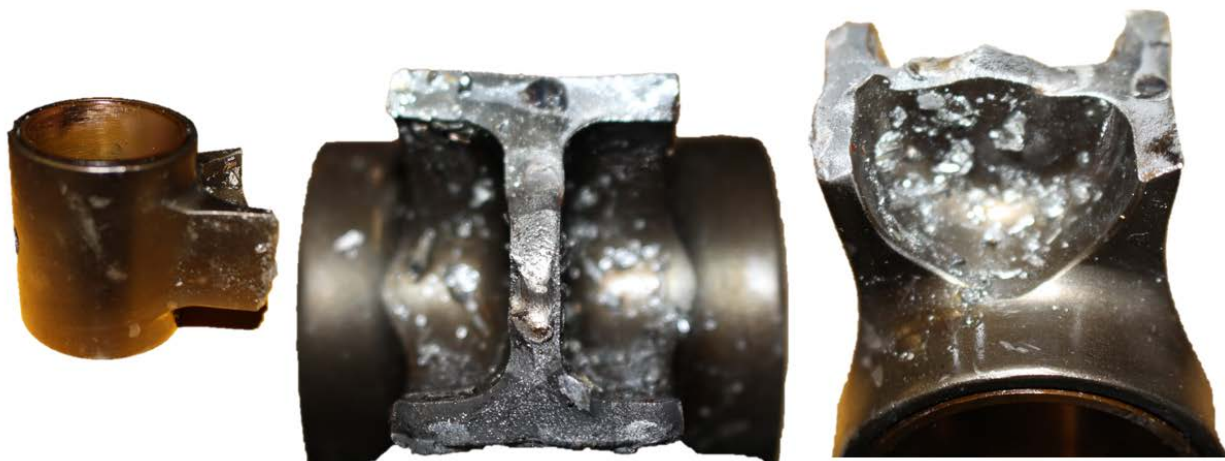
40 The cylinder head was cut, and the piston was removed. The piston pin was removed and the  
41 master link rod end was removed.
