# NATIONAL TRANSPORTATION SAFETY BOARD

MATERIALS LABORATORY FACTUAL REPORT

Report No. 19-051

Place : Agoura Hills, CA  
Date : October 23, 2018  
Vehicle : North American SNJ-5 (N7969C)  
NTSB No. : WPR19LA014  
Investigator : Jack Vanover (AS-WPR)

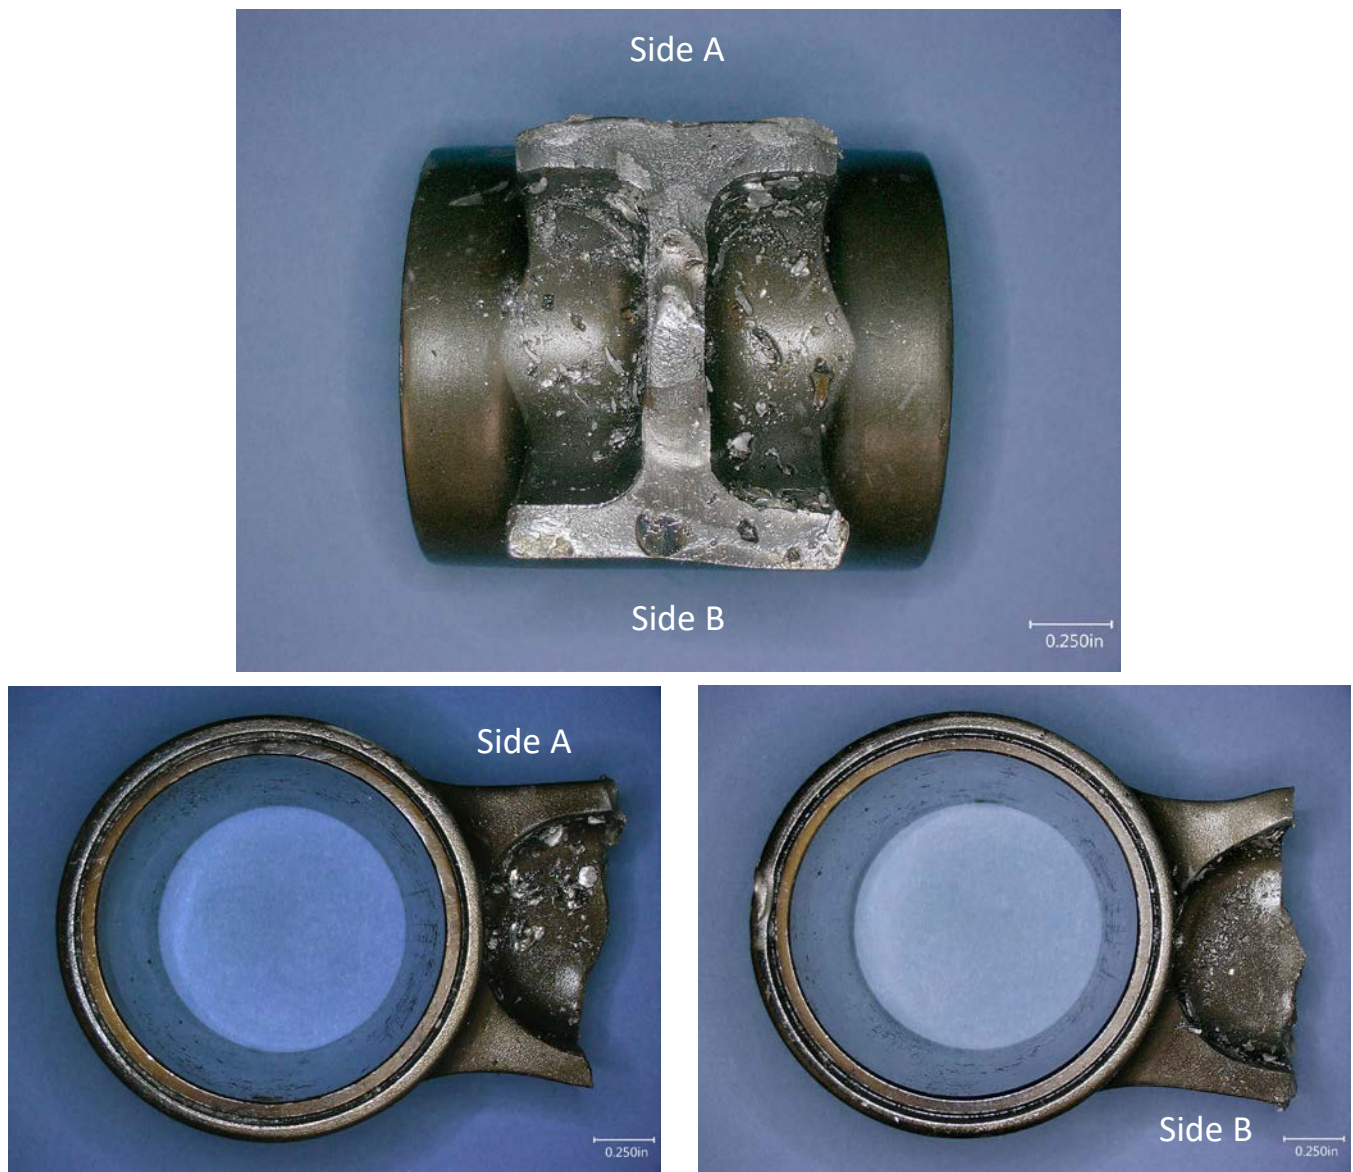
The purpose of this investigation is to determine the mode of fracture which occurred at the piston end of the #5 cylinder master-rod I-beam shaft from a Pratt and Whitney R-1340-AN1 nine-cylinder radial engine. As-received images are shown in Figure 1. The orientation of the master-rod as installed in the engine was not identified upon part receipt in the Materials Laboratory.

Figure 1 Digital microscope images of the fractured master rod, as-received.

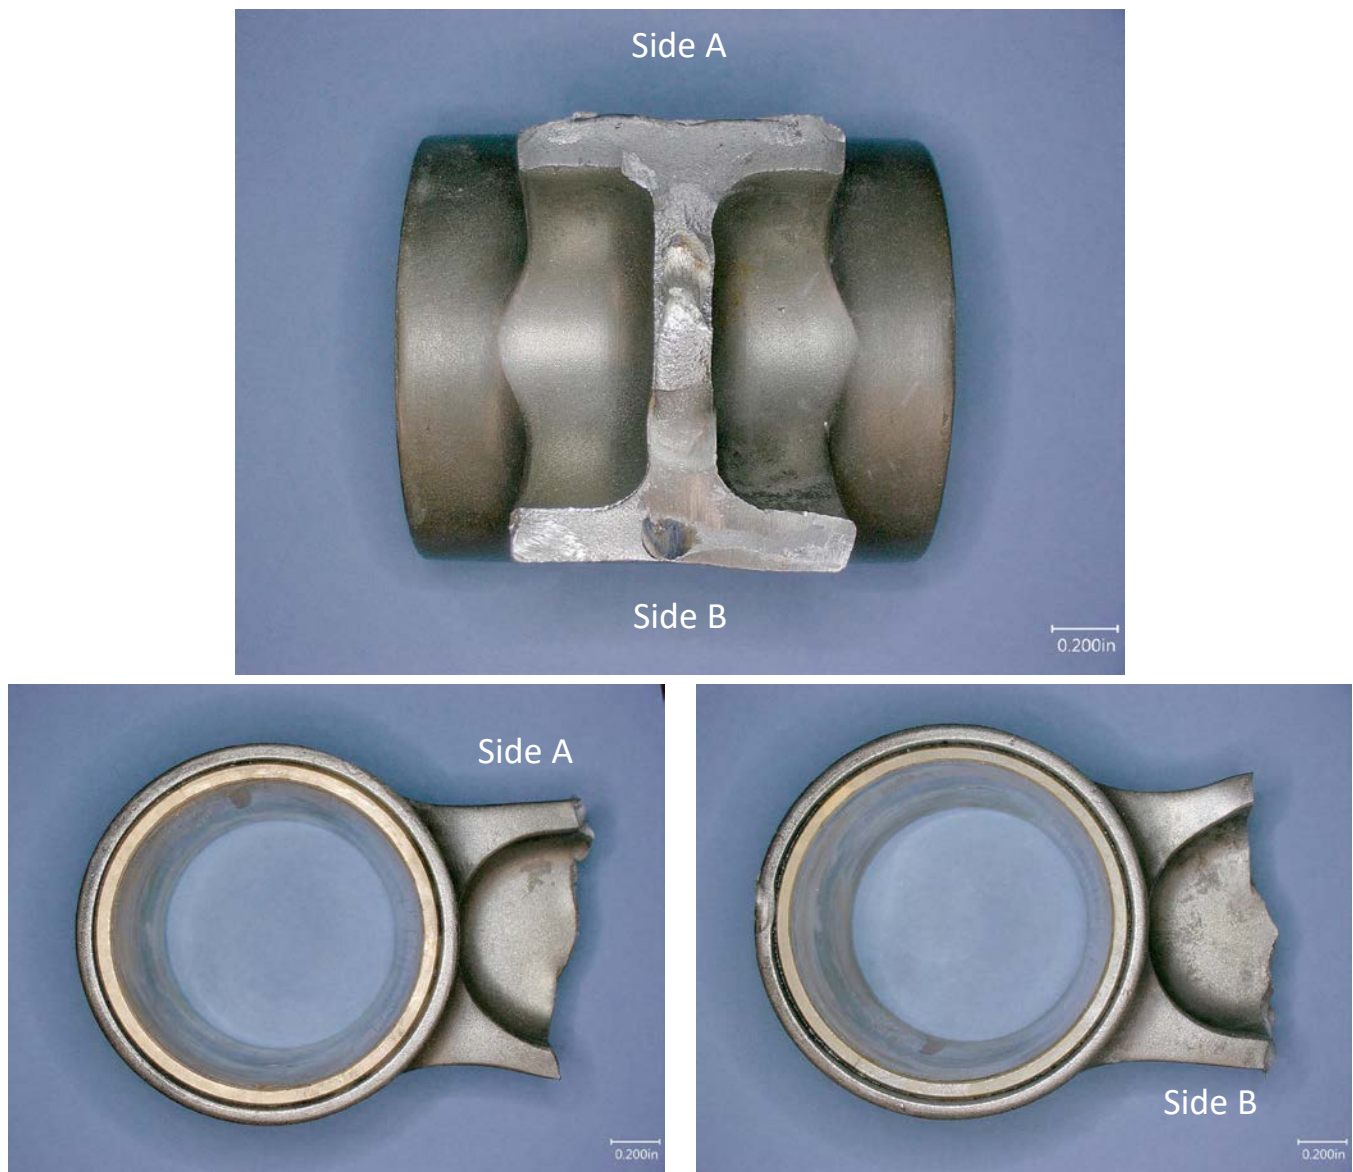
Figure 2 Digital microscope images of the fractured master rod, after cleaning.

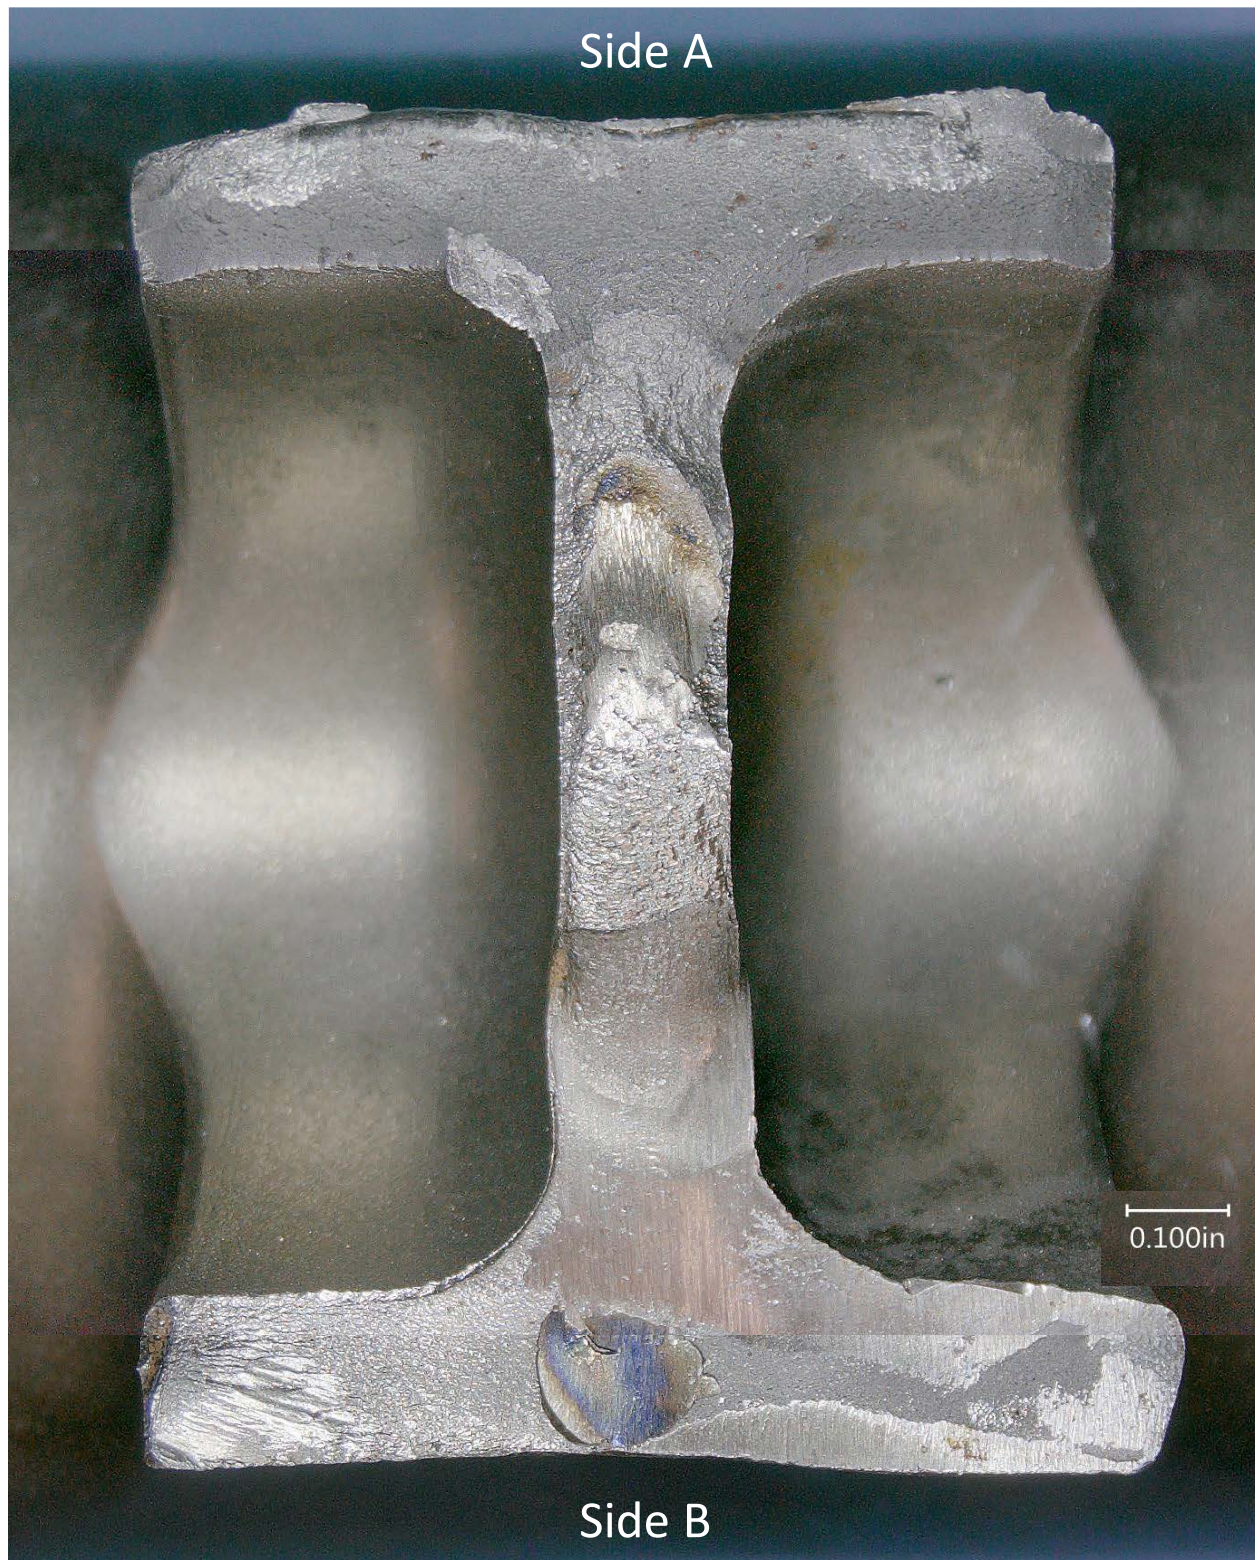
Figure 3 Digital microscope image of the fracture surface in the I beam of the master rod. The fracture surface exhibited mechanical damage over more than about 40% of the surface.

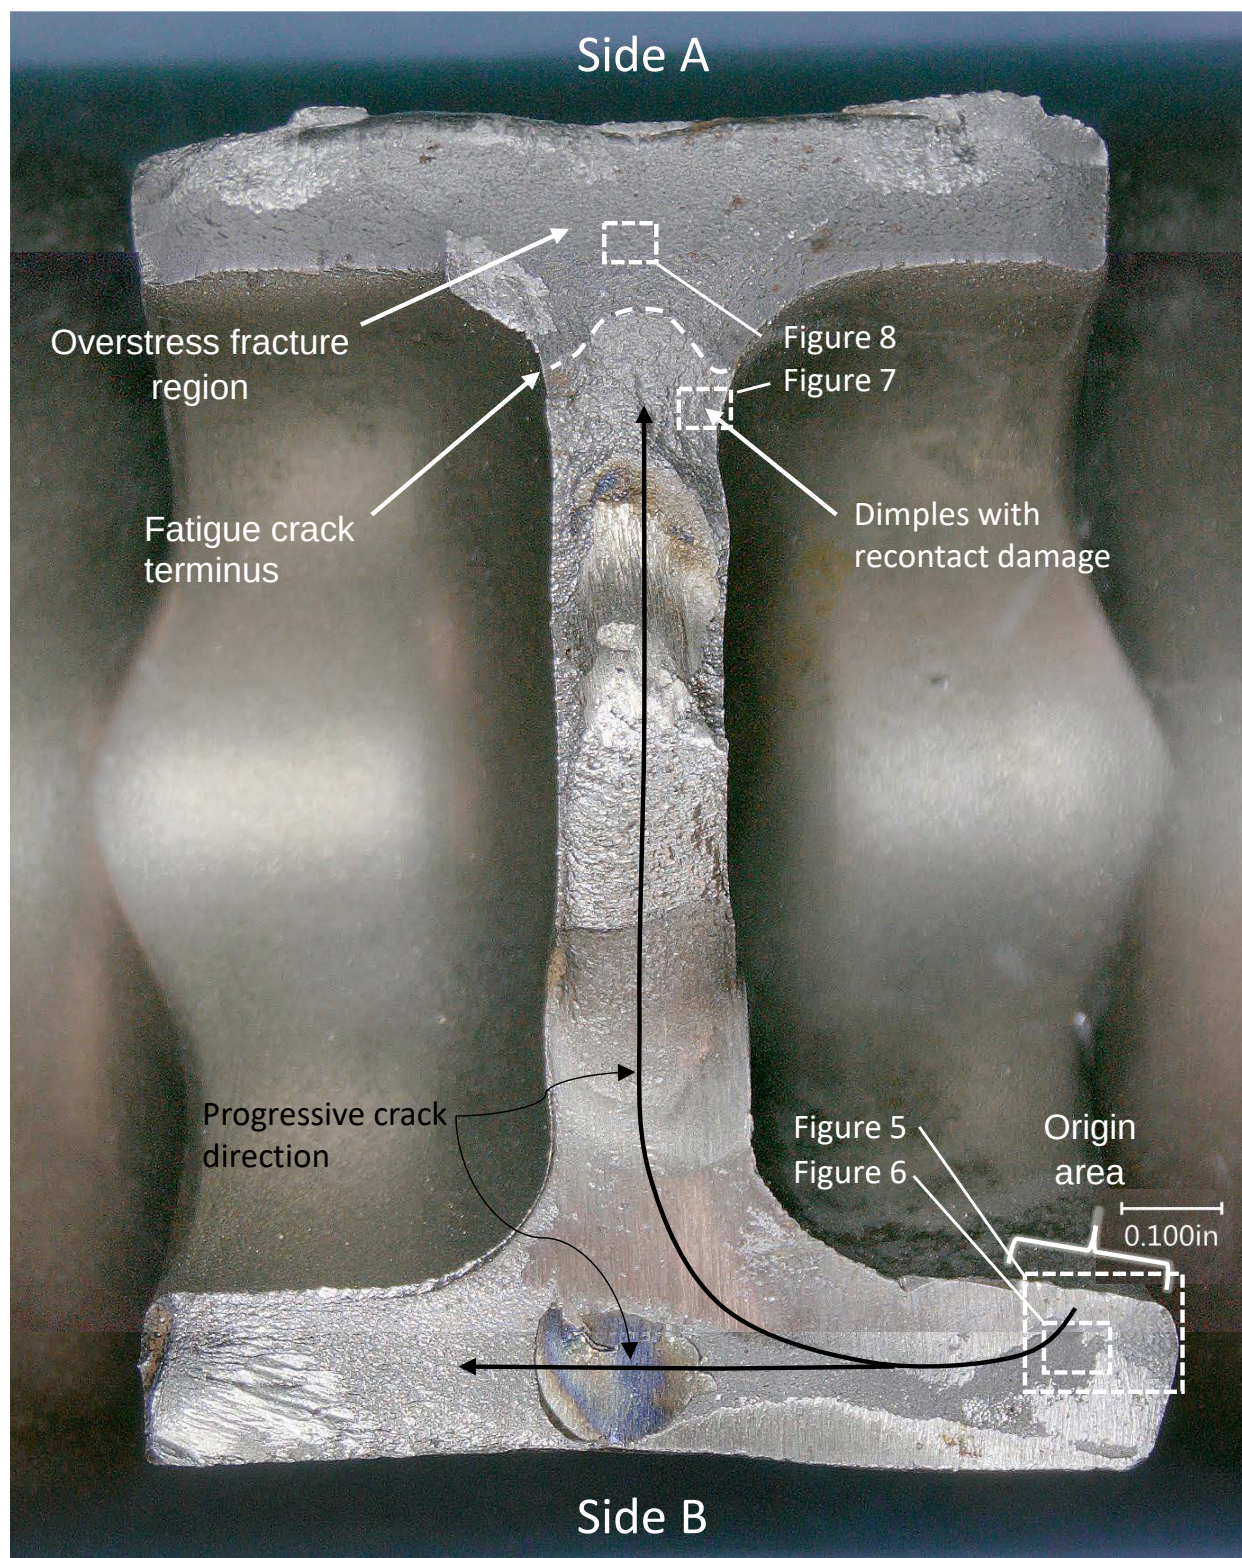
As identified in Figure 4, the fatigue crack progressed through the I beam, terminating at the location indicated in the figure. The remaining portion of the I beam fractured in overstress (Mode 1, monotonic fracture) based on the observed microvoid coalescence (MVC) fracture features (see Figure 7).

Figure 4 Digital microscope image of the fracture surface in the I beam of the master rod. This is the same image as shown in Figure 3 but with annotations of key features.

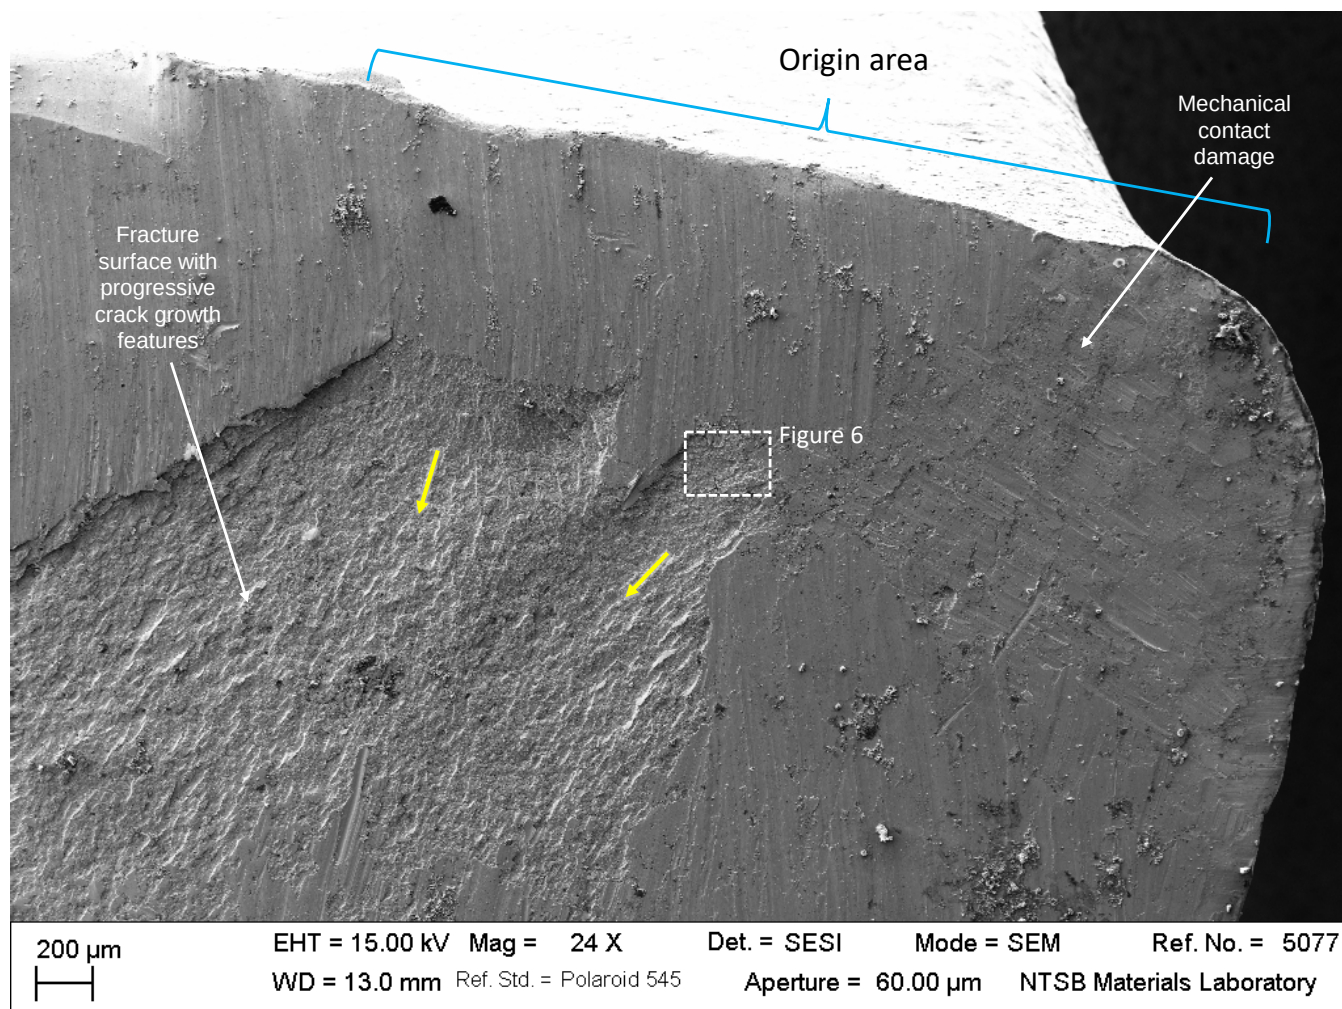
The master-rod piece was ultrasonically cleaned in acetone. Figure 2 shows views of the cleaned master-rod piece. A close view of the fracture surface is shown in Figure 3 and in Figure 4 with annotations. As revealed in the scanning electron microscope (SEM) image in Figure 5, a fracture initiation region on the I beam shaft is present, based on fine chevron and river pattern markings near the origin region (see yellow arrows in Figure 5). The fracture surface in the immediate origin region was damaged due to mechanical contact during the failure sequence.

Figure 5 Secondary electron SEM fractograph of the initiation region shown in Figure 4. The yellow unmarked arrows show the local direction of growing progressive cracks. A higher magnification image of this fracture surface is shown in Figure 6.

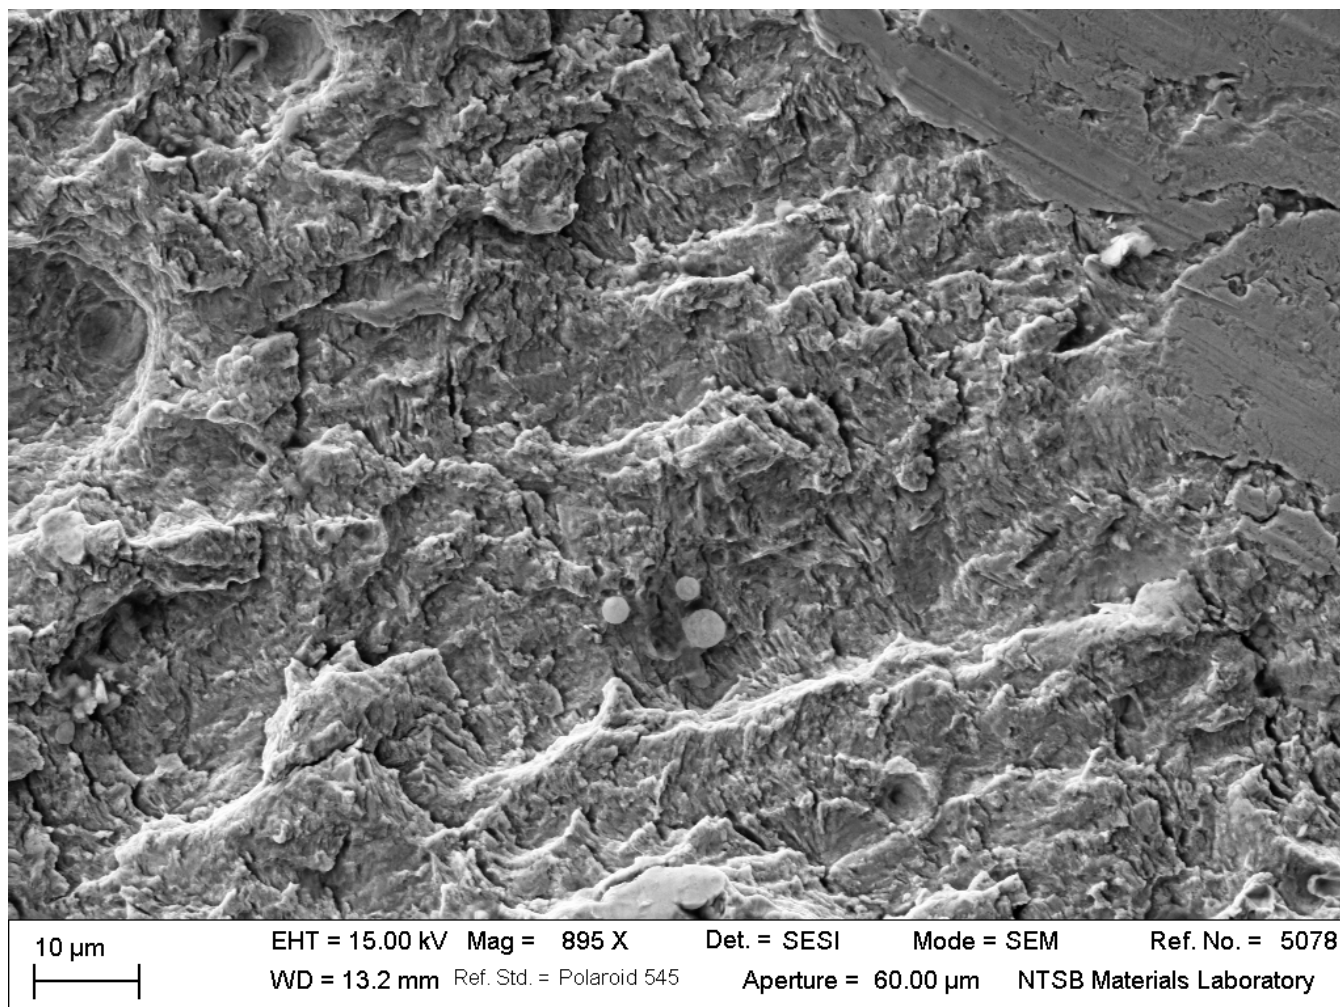
A higher magnification SEM image of the fracture surface adjacent to the origin region exhibited striation features typical of fatigue crack growth in hardened steel (see Figure 6).

Figure 6 Secondary electron SEM fractograph of the of the region identified in Figure 5 (undamaged fracture surface adjacent to the fracture origin). Striation features consistent with fatigue crack growth are present.

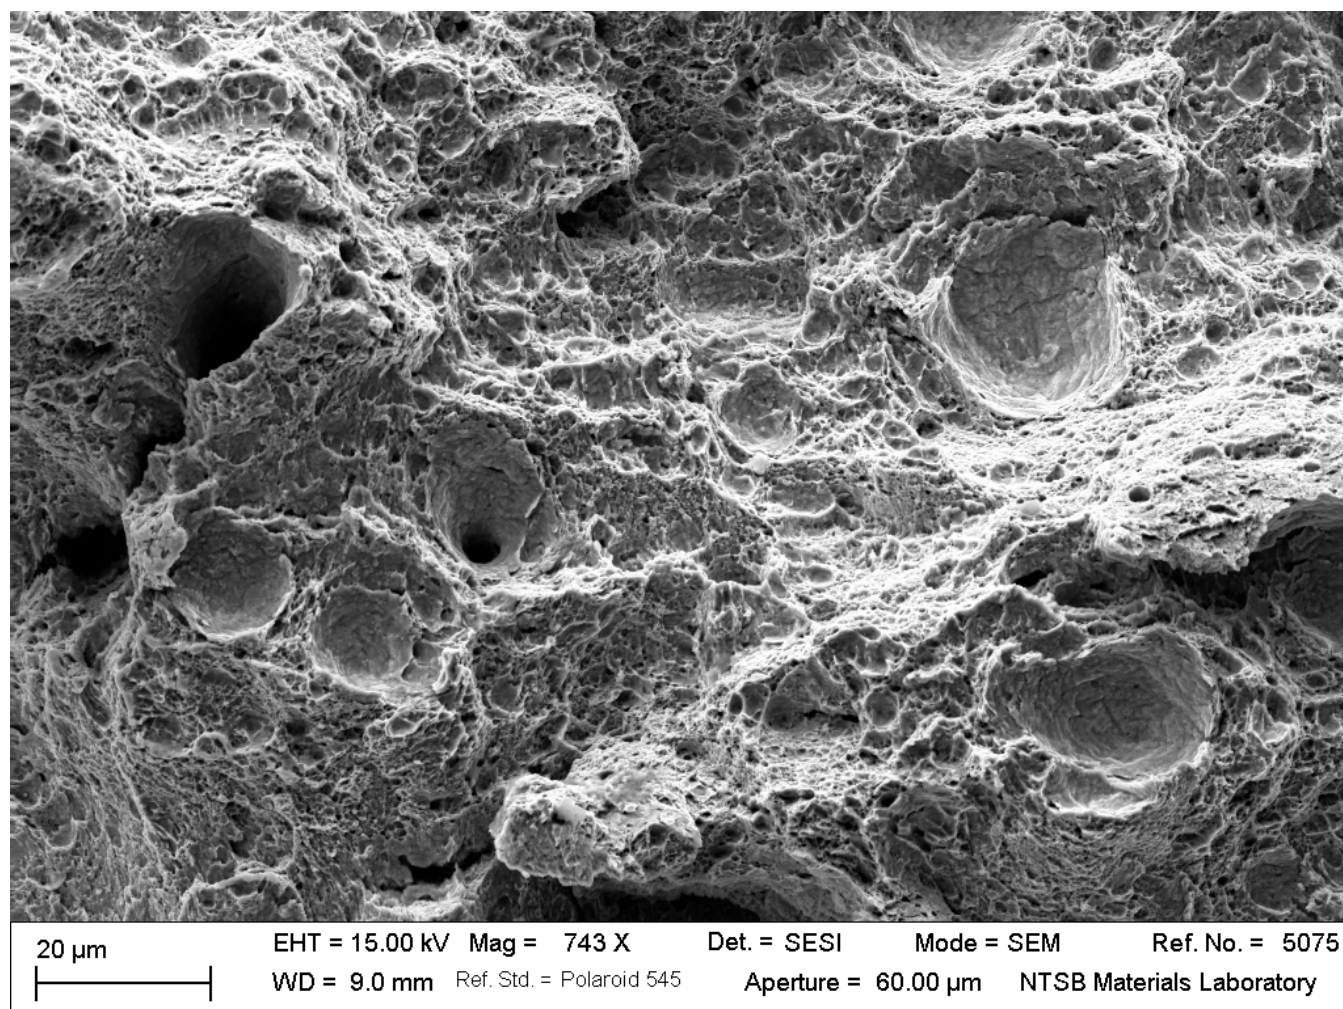
Figure 7 Secondary electron SEM fractograph of the final overstress fracture region as identified in Figure 4.
