## EXAMINATION NOTES

Investigators from the Safety Board, Cessna, and Continental Motors examined the wreckage on May 05, 2019, at the recovery facility, Plain Parts in Pleasant Grove, California.

The aircraft is a Cessna T210G, serial number T210-0234, and was manufactured in 1966. According to the owner, an annual inspection was endorsed as completed on March 27, 2018, at which time the airframe had accumulated a total time in service of 8,745.6 hours. The tachometer time at the wreckage indicated 8,829.3 (Hobbs 4121.6 hours).

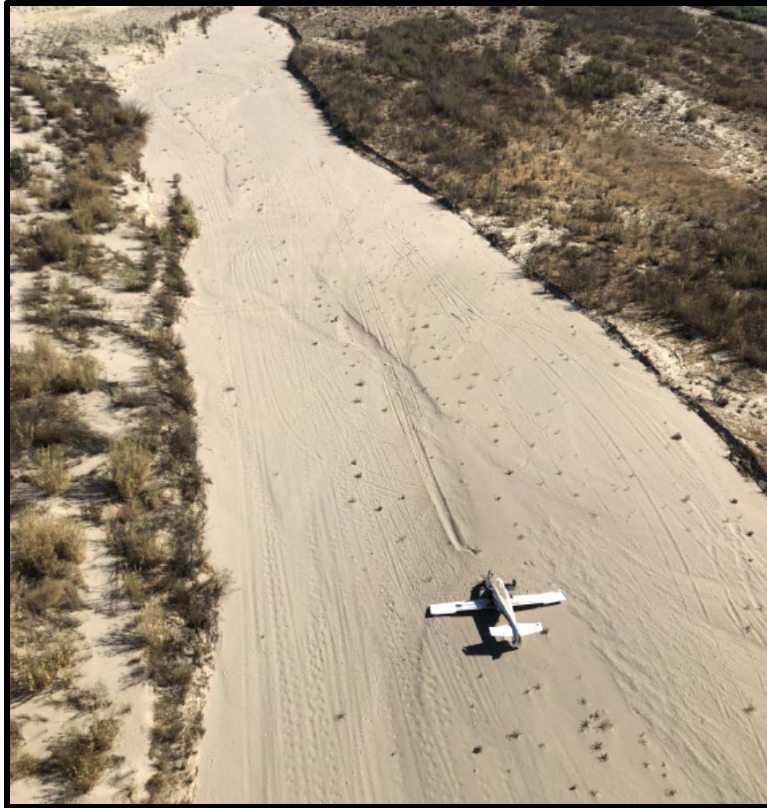
The main wreckage came to rest inverted in a dry river bed. The accident site was located about 1,650 feet from the departure end of runway 07. The front seat had a control quadrant on the left side; the levers were all bent and folded over to the right. The throttle was positioned in the mid-position and the mixture and propeller controls were full forward. The fuel boost pump was on selected on with both “hi” and “low” switches activated.

*Figure 1: Main Wreckage*

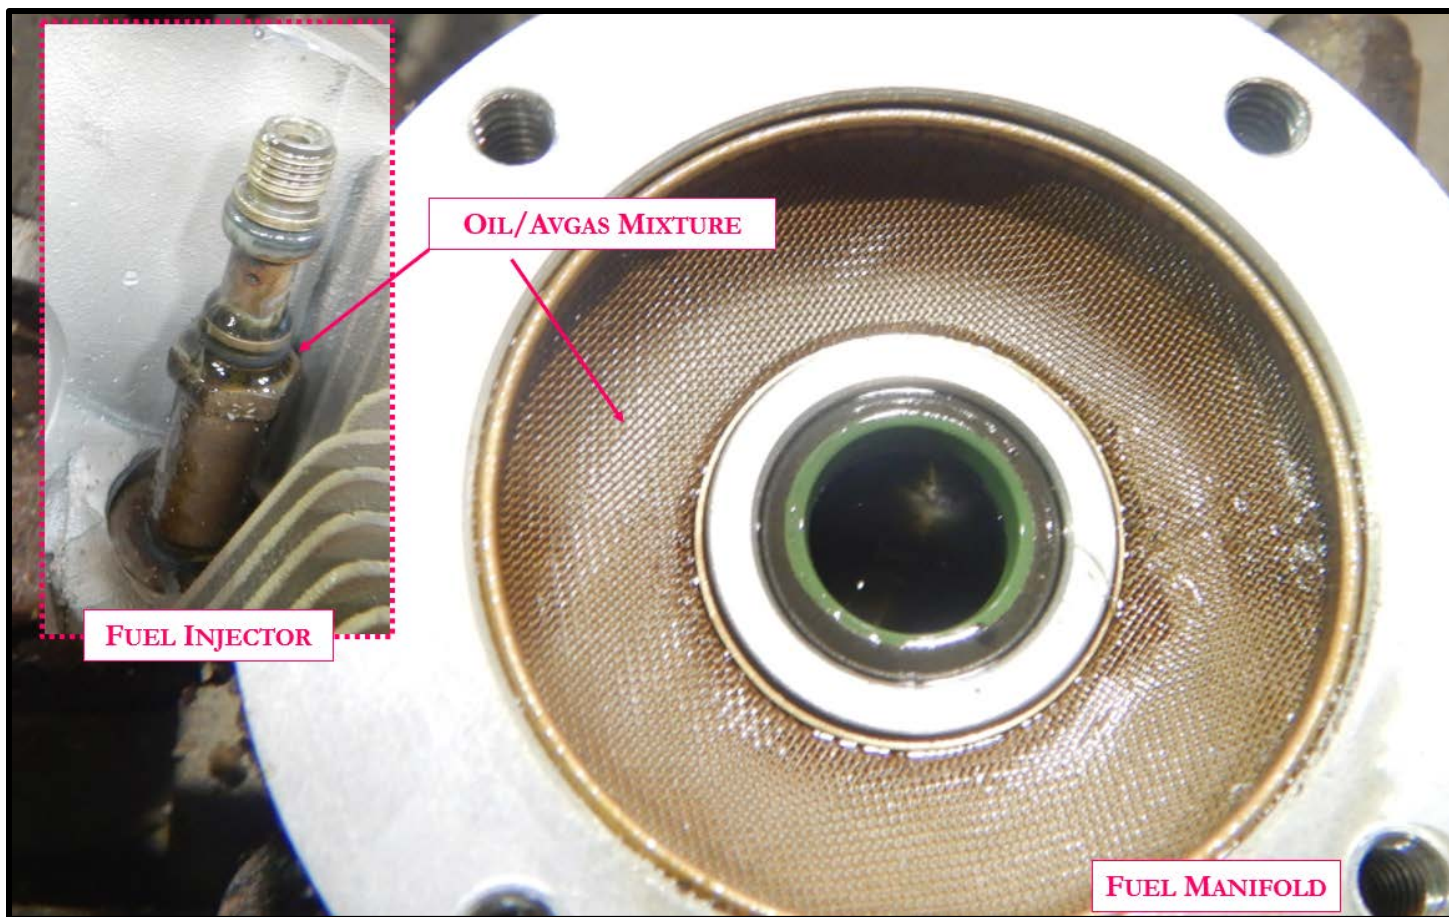
An examination of the fuel system revealed that the fuel selector handle was positioned on “BOTH.” The fuel gascolator contained a liquid consistent in odor and appearance with 100 LL Avgas. The fuel line from the fuel pump to the gascolator was removed and no fuel was present. Disassembly of the fuel manifold revealed a liquid that was brown in color and had an odor and appearance similar with a mixture of engine oil and Avgas.

In an attempt to determine the source of oil located in the fuel manifold, the fuel inlet hose was removed from the fuel manifold valve. No fuel or oil was present. The nose gear doors were opened and the airframe boost pump outlet fitting b-nut was released. No fuel or oil was found. The engine driven fuel pump dry-bay outlet pipe was removed and a trace amount of oily film was present. Fuel injectors from cylinders 1 and 5 were removed. When the air reference tubes were released from the fuel injectors bodies, dark oil began to escape from the fuel injectors. The fuel injectors were removed and inspected. Fuel injector #1 was saturated with oil while # 3 was open.

Figure 2: Fuel Manifold and a Fuel Injector (showing substance coating)

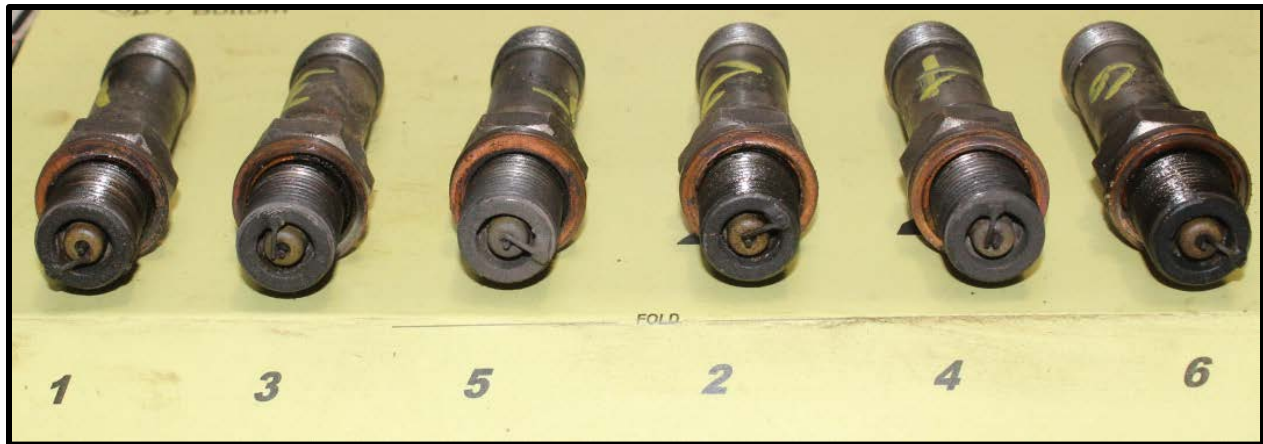
The upper sparkplugs were removed and examined. All sparkplugs were dark in color, but the engine manufacturer's representative stated that they were consistent with normal wear. A lighted borescope was used to perform an internal examination of each cylinders' combustion chamber, all of which displayed light combustion deposits. All piston domes exhibited normal combustion deposits except the No.4 cylinder, which exhibited a shiny, gritty substance across a portion of the piston dome. A sample of the substance was obtained and placing a magnet

near the sample revealed that the gritty compound was non-ferrous material. The intake and exhaust valves were unremarkable; the cylinder walls did not display any scoring or evidence of heat distress.

Figure 4: Spark Plugs

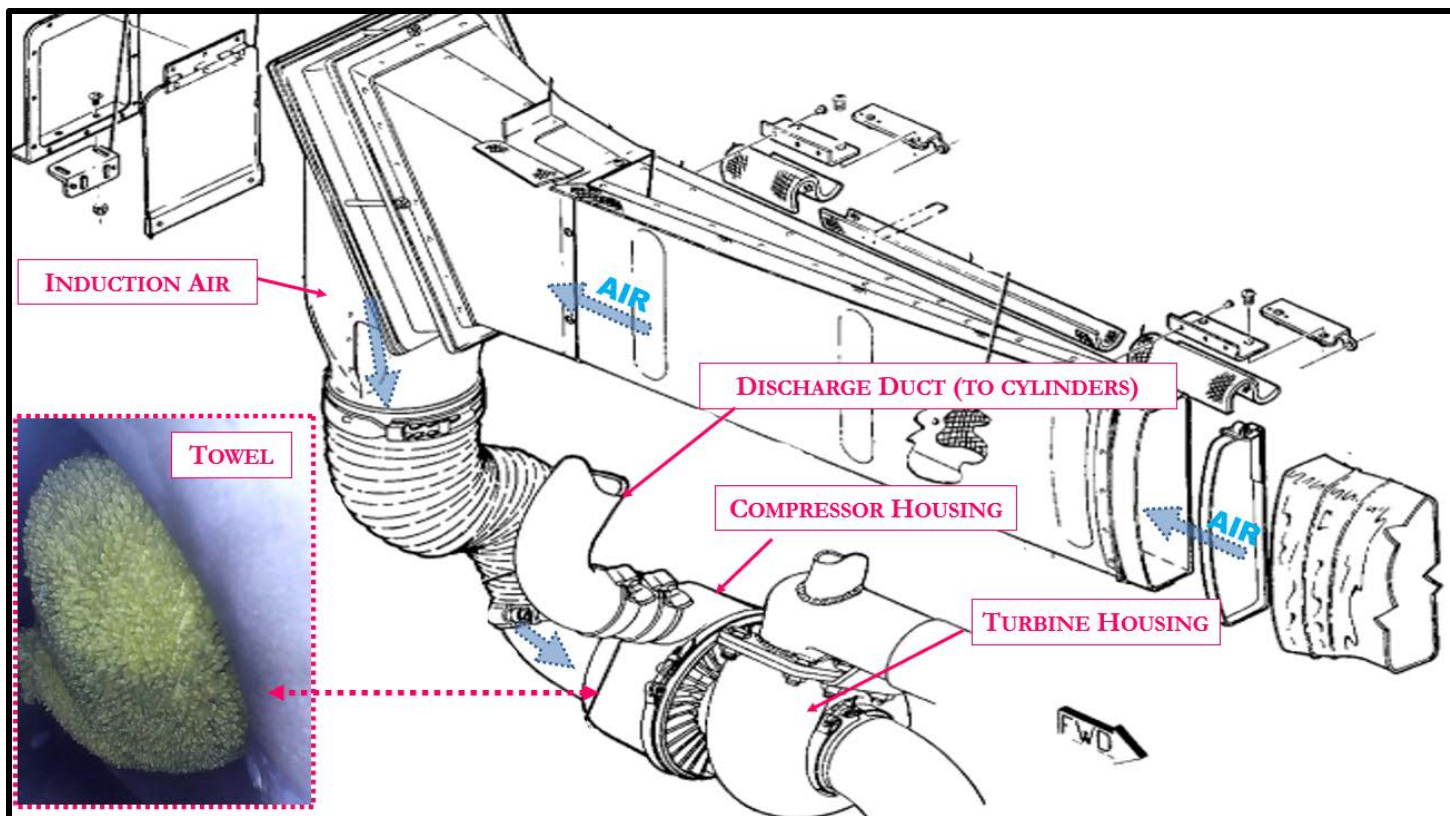
The turbocharger compressor outlet pipe/hoses (discharge duct) were disassembled, and oil was present in the conduit. The rubber connector nearest the turbo compressor inlet was removed and a lighted electronic borescope was used to inspect the inlet tube. A yellow terry cloth towel was discovered blocking the turbo inlet tube and the towel had become entangled with the turbo charger compressor wheel.

Figure 5: Towel Found in Compressor Housing

The pilot stated that at that date he performed an oil change and an airframe and powerplant (A&P) mechanic performed an inspection of the exhaust system for leaks. As part of the maintenance, he removed the airbox (six screws) to have access to the oil filter. He placed a towel in the scat tubing (not disconnected) in an effort to protect the turbocharger from foreign object damage (FOD).

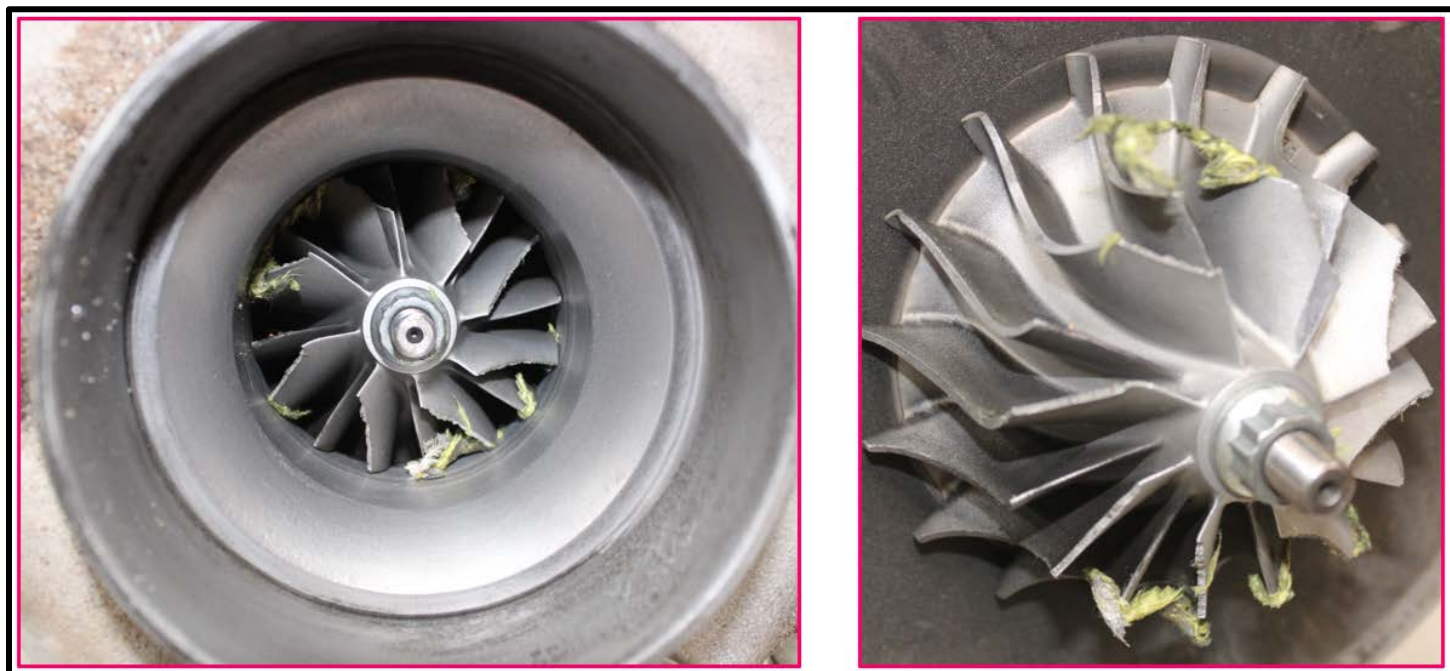
Figure 6: Compressor Wheel (with broken blades and towels residue)

The compressor wheel was damaged, and several blades were distorted. Once the towel was removed, the compressor wheel was free to rotate.

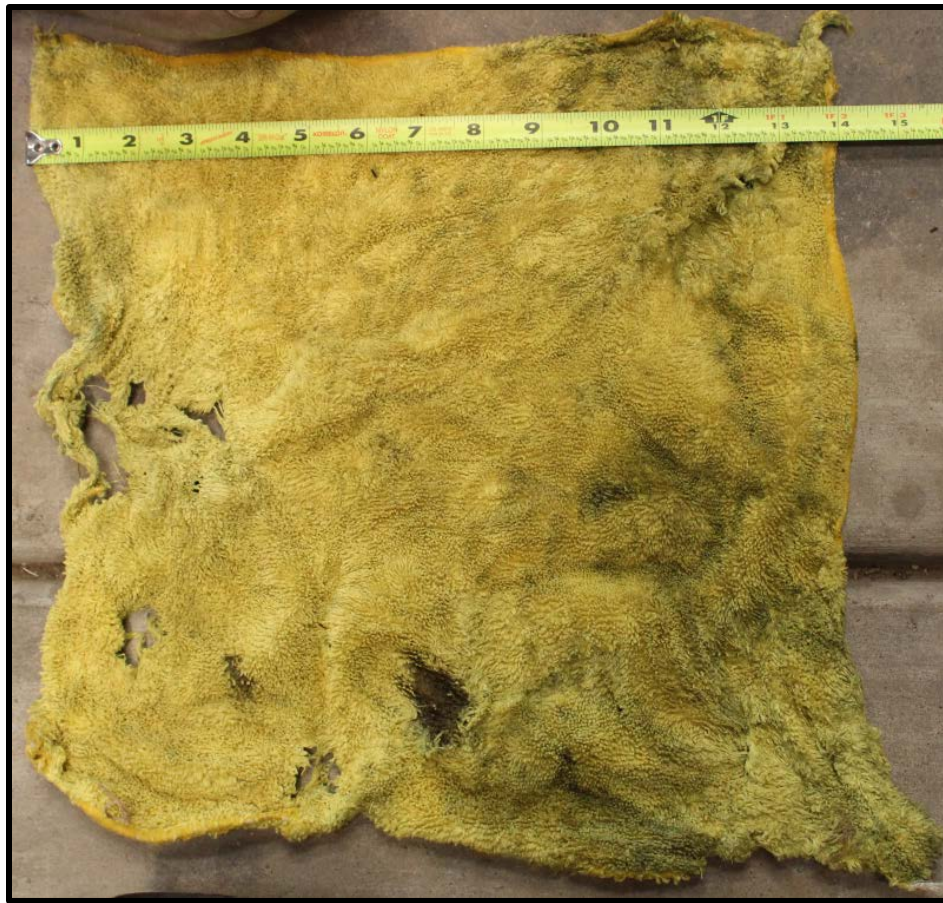
Figure 7: Towel Found

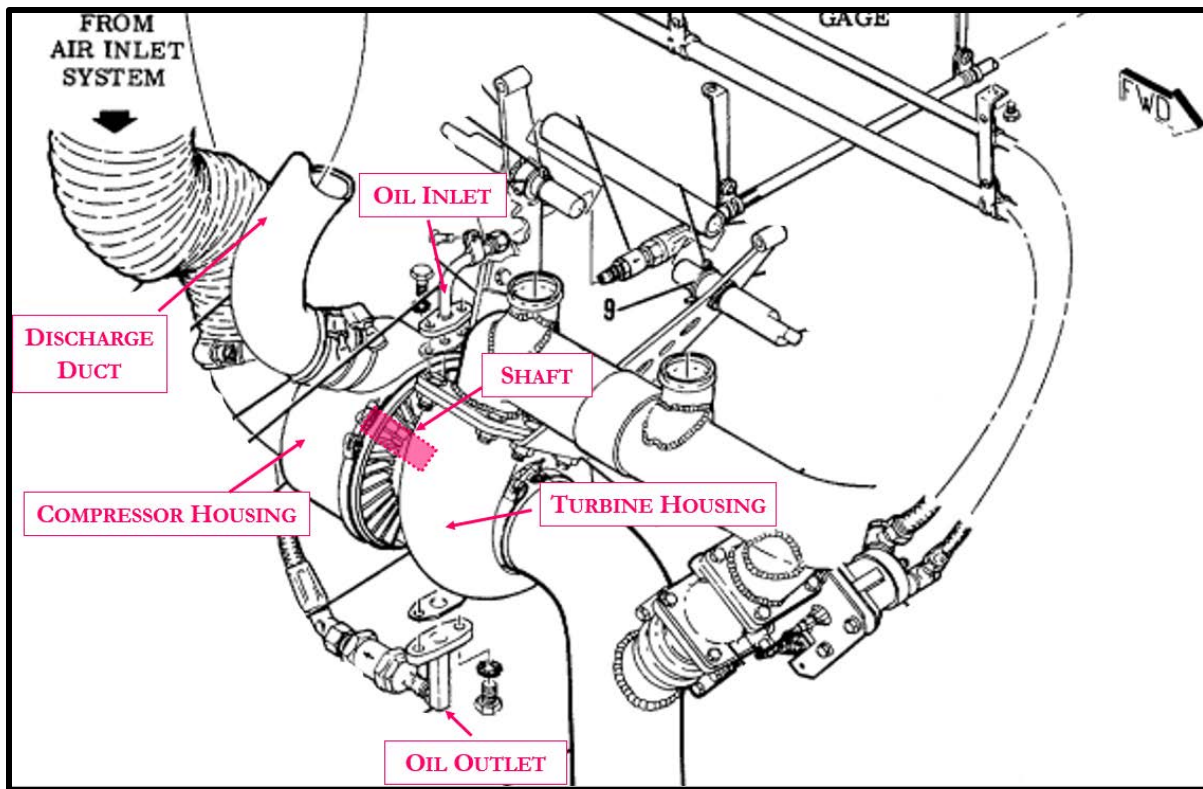
It was determined that when the turbocharger was unable to rotate normally, ring seals which are used to seal the turbo charger shaft will allow oil to escape the shaft bearing area and enter the compressor section allowing oil to migrate to the upper deck pressure plumbing, then to the fuel injectors. From injectors the oil could build in the cylinders and, when inverted, drain into the fuel manifold. This migration of oil likely occurred while the airplane was inverted after impact with the sandy riverbed.

Figure 9: Turbocharger System (showing oil)

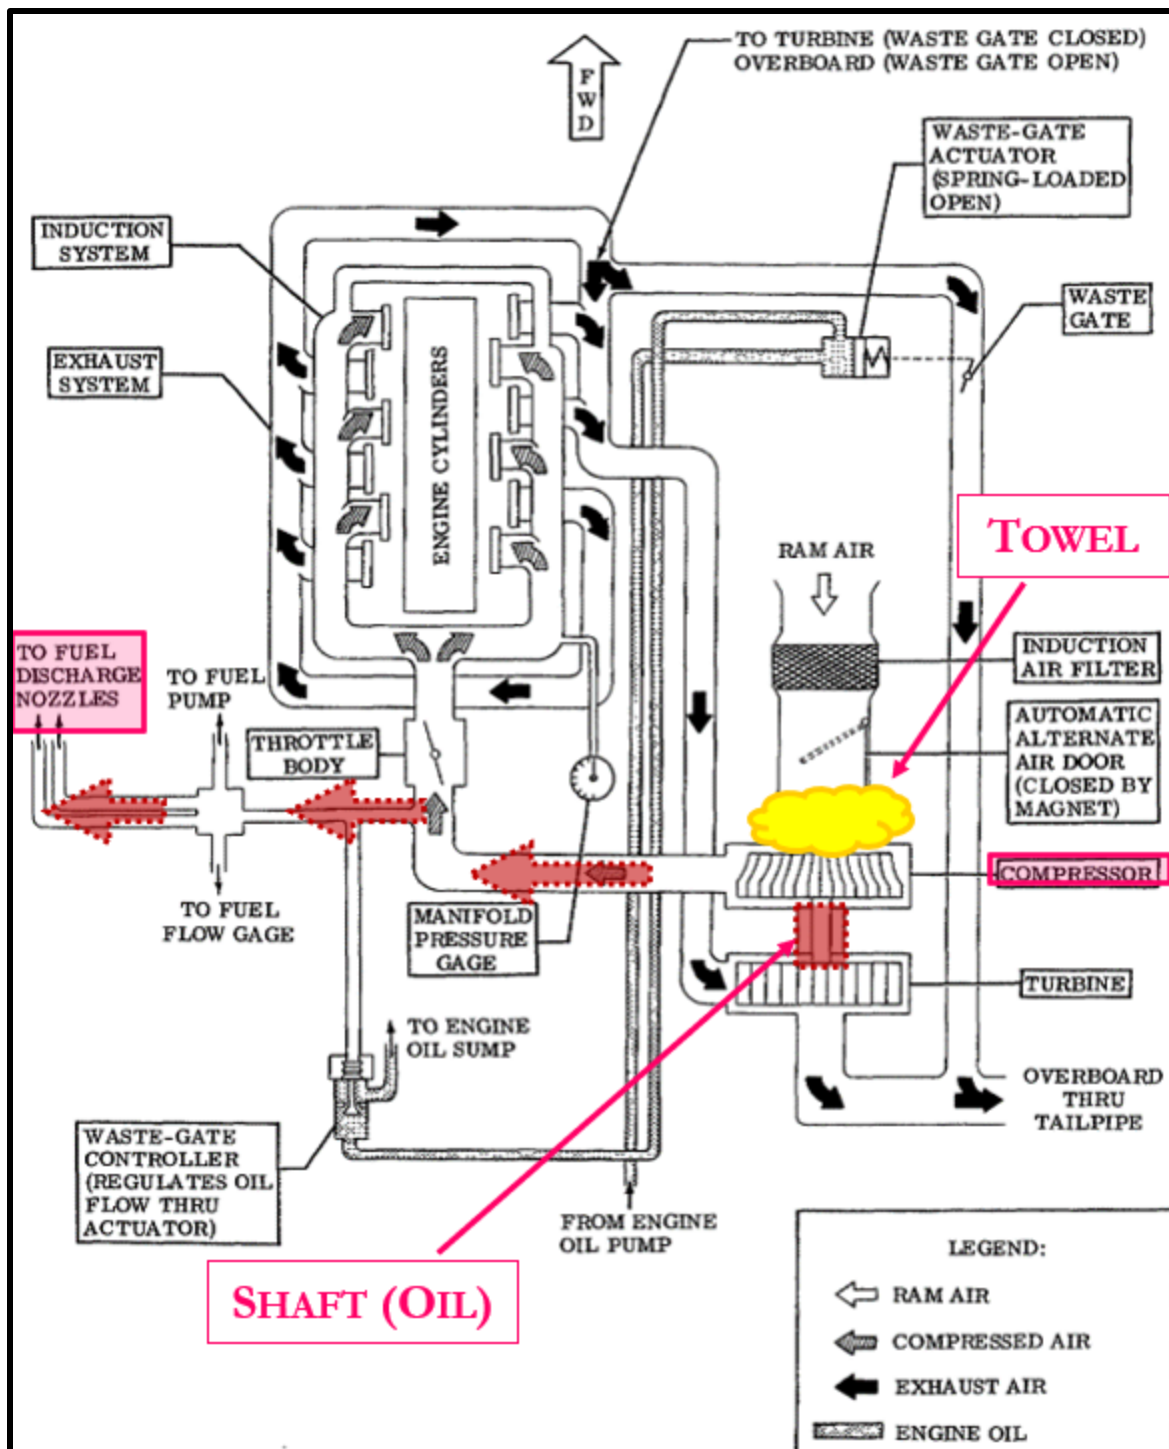
Figure 10: Turbocharger System (showing oil path to fuel nozzles)
