## ENGINE RUN REPORT

| ENGINE MODEL | O-470-K |
| AIRCRAFT MAKE & MODEL | Cessna 180D |
| FILE NUMBER | 18-272 |

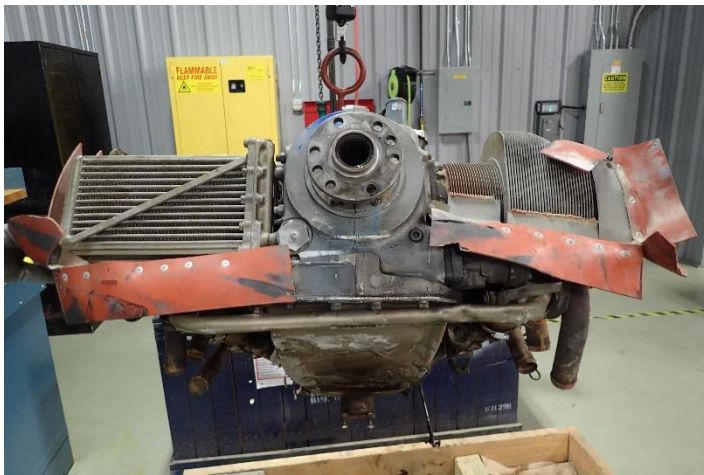
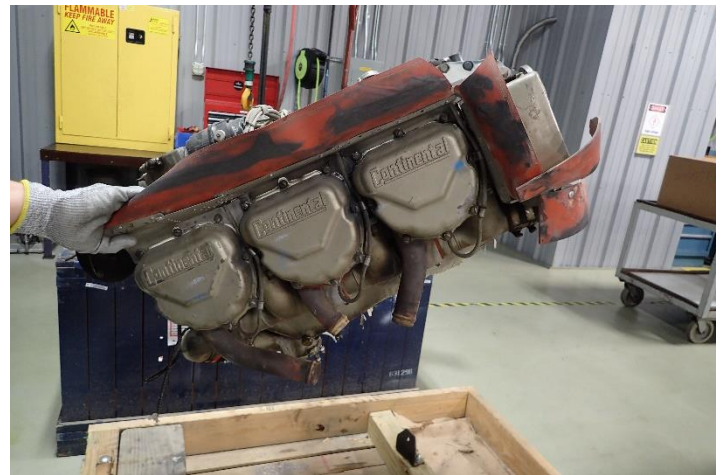
The engine displayed impact damage signatures to the oil sump, exhaust, and balance tube. The rest of the engine was undamaged. The crankcase was intact and there were no holes in the crankcase that would indicate a catastrophic internal engine failure. The propeller flange remained attached to the rest of the crankshaft and was undamaged. All six cylinders remained attached to their cylinder bays and were undamaged. The oil sump displayed impact damage signatures and was removed for replacement; the oil inlet screen was observed and displayed a small amount of sludge in the screen; however, the screen was not blocked. The camshaft was partially visible and displayed normal operating and lubrication signatures.

The induction system displayed impact damage signatures to the balance tube. There was a small hole noted at the impact damaged area and blue staining surrounded the hole. The induction risers were intact and there were no signs of fuel leaks observed around the risers. The exhaust system displayed impact damage signatures to the risers and to the muffler. The muffler heat exchanger shroud was removed and examined; there were no signs of exhaust leaks observed with any of the exhaust components.

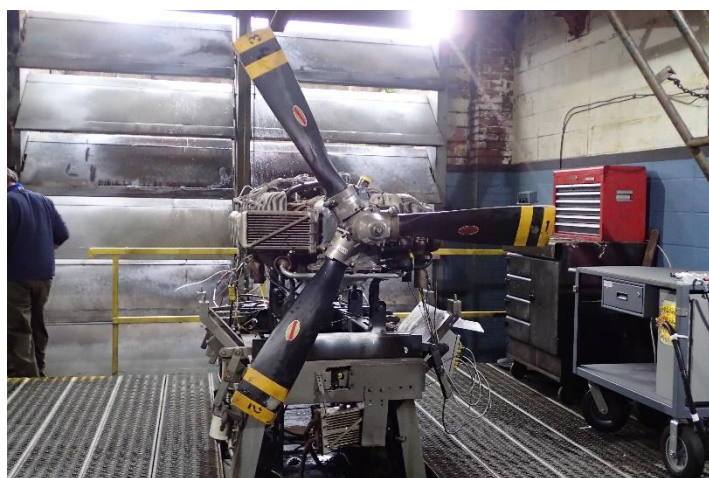
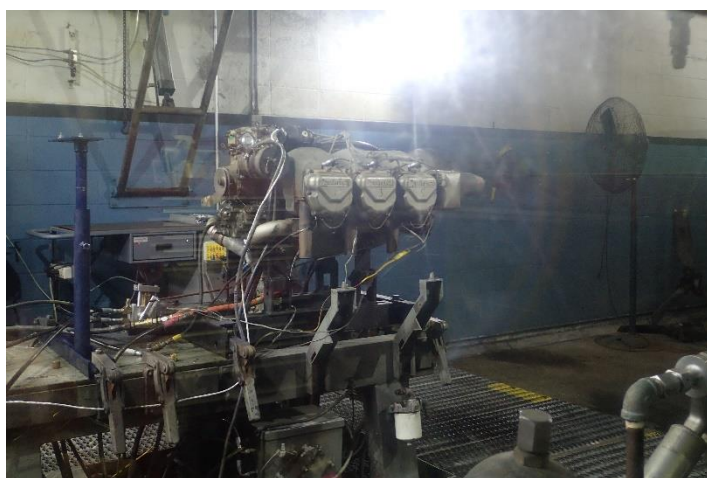
After the engine run was completed the carburetor was removed and disassembled. The internal components displayed normal operating signatures and the inlet screen contained a small amount of debris; however, the screen was not blocked.
