## **NATIONAL TRANSPORTATION SAFETY BOARD**

### **AIRFRAME AND ENGINE EXAMINATION (Rev A)**

**WPR19LA017**

Location: Cottonwood, California  
Date: October 30, 2018  
Aircraft: Cessna 180, N6414X, Serial # 18050914  
NTSB IIC: Michael Huhn

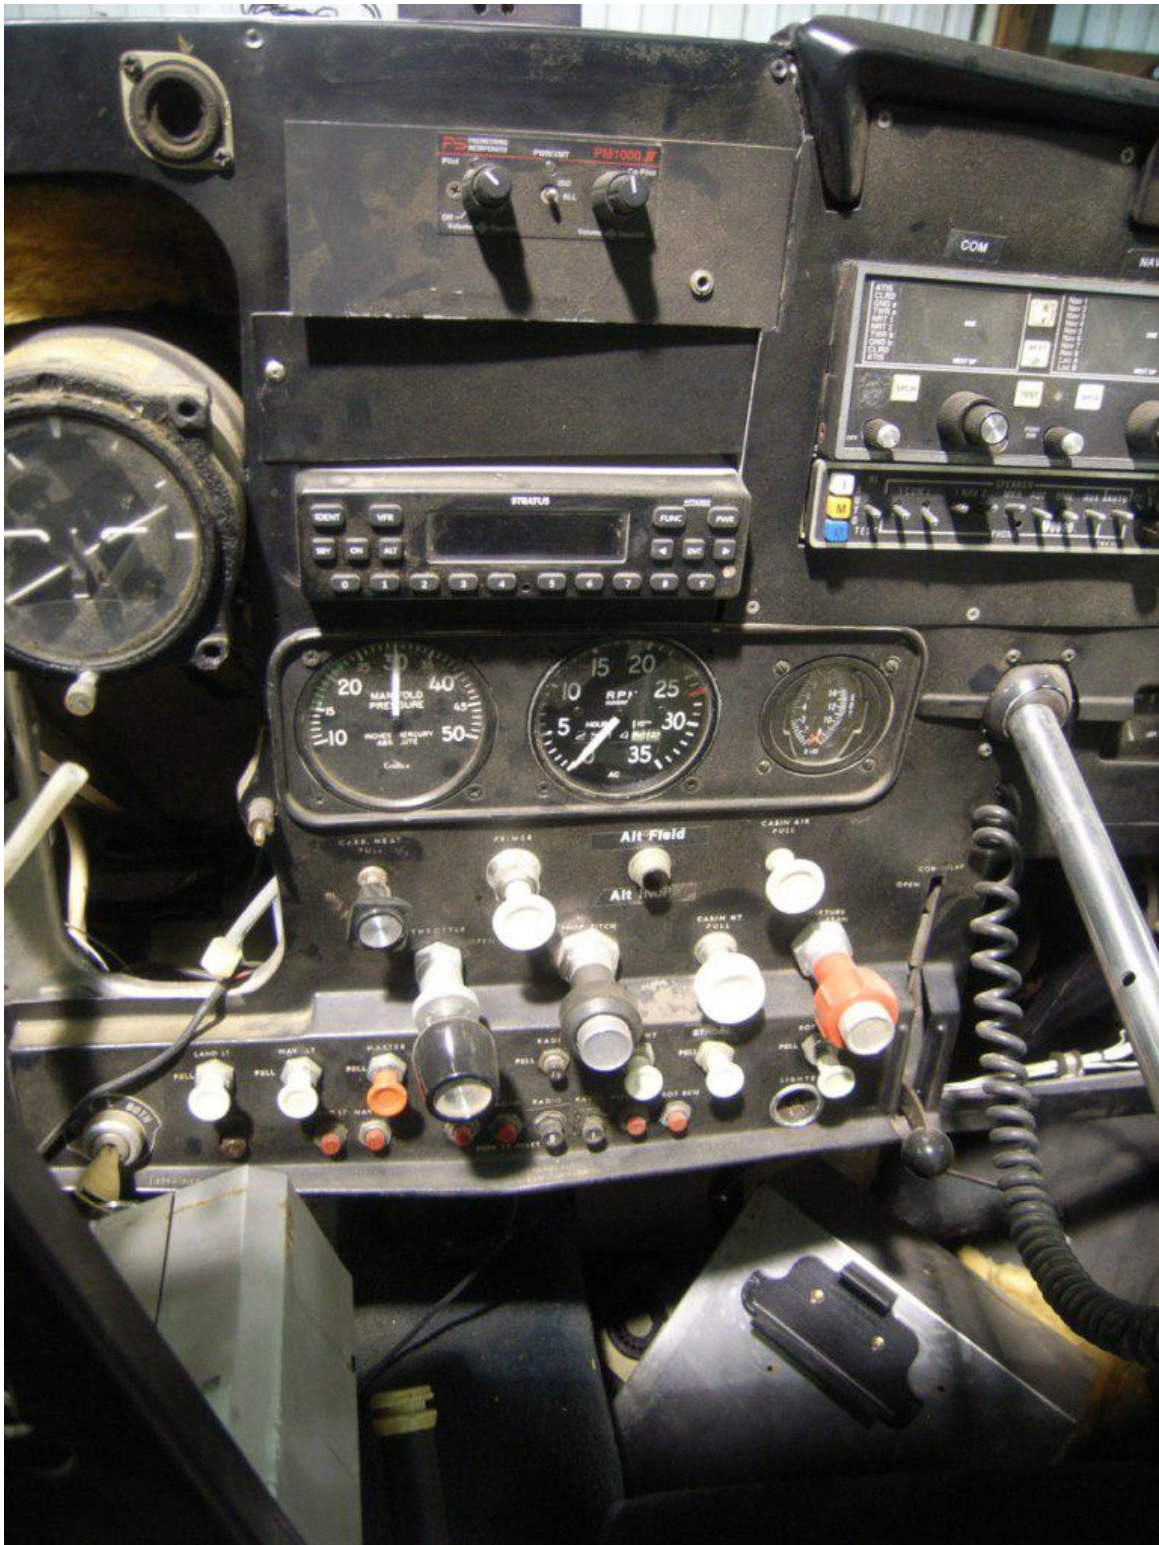
Figure 2 - Instrument Panel

- The wings and empennage had been removed (unbolted/disassembled) from the airframe for recovery and transport
- The front seats and left side of the instrument panel had been previously removed by the initial recovery mechanic, Mr. Eric Sawyer

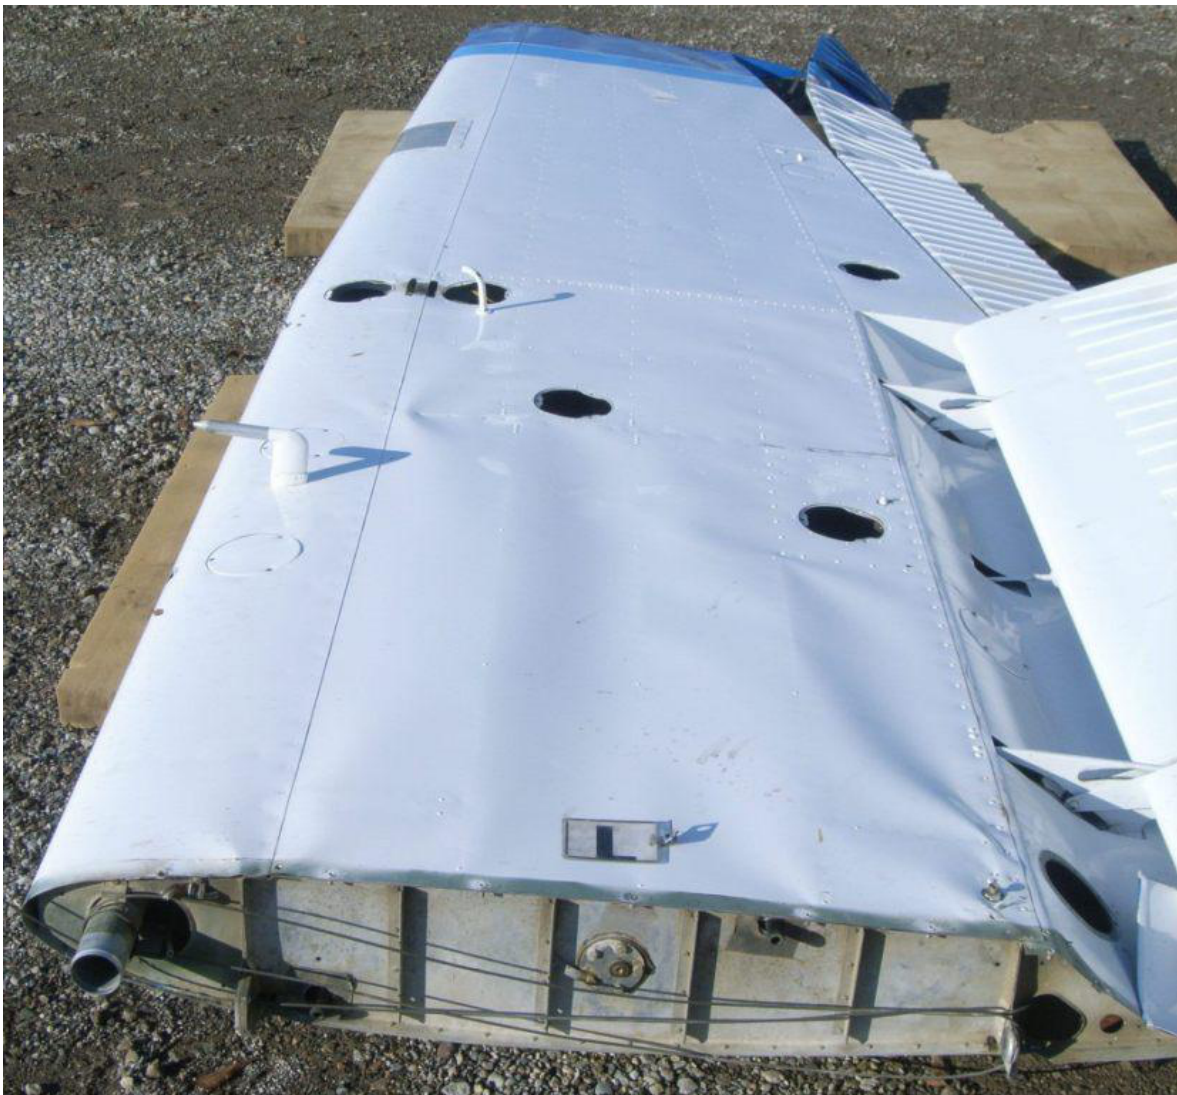
**Figure 5 - Left Wing Underside**

- Both wings had been unbolted and separated from the fuselage
- The right wing was intact
- The left wing was wrinkled at the outboard end, and the aft inboard end
- Both fuel tanks were intact and not breached
- Neither wing exhibited any fuel staining or other indications of leakage

- Maintenance records indicated that the bladders had been replaced in April 2018, and their condition was consistent with a young age
- Each fuel tank had a single fuel pickup port, located near the aft bottom inboard corner of the tank
  - A finger screen pickup would normally be installed in each of these ports; both were observed in the wreckage
- The fuel tank caps appeared relatively new
  - It could not be determined during the exam whether they were vented caps
  - The caps bore part numbers C-100084-1 on the cap, and (1?)00142-1 on the cap gasket
- The vent line in the left wing underside was undamaged and clear, and plumbed to the left bladder

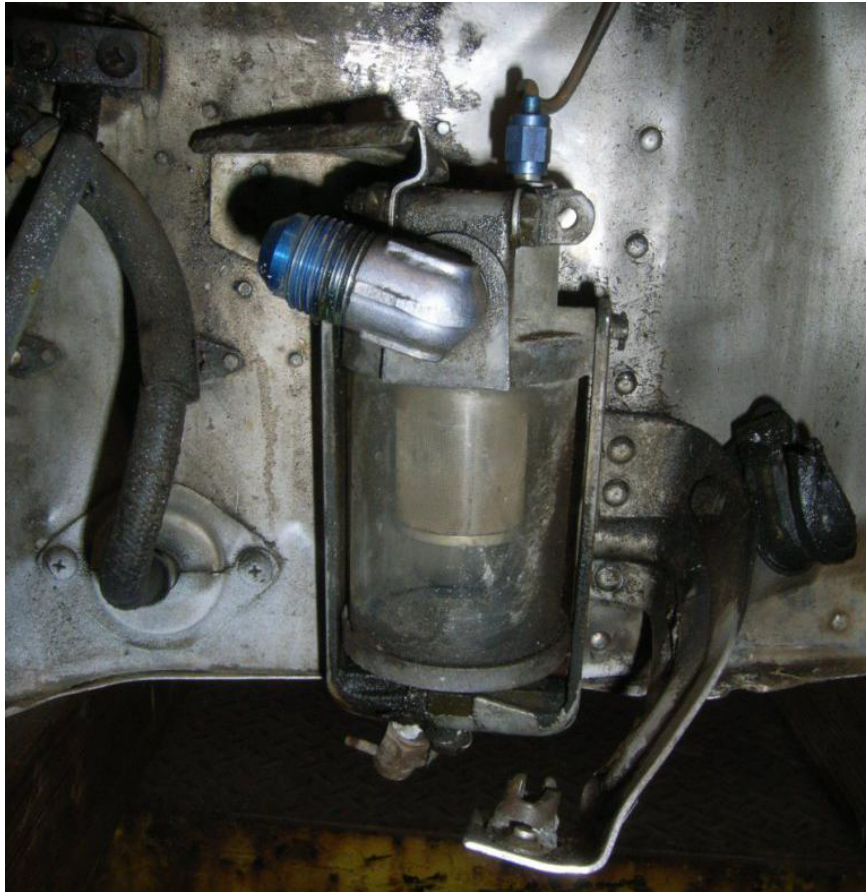
**Figure 11 - Fuel Strainer**

- The glass-bowl fuel strainer remained attached to the firewall, but its mount was deformed and the strainer was displaced from its normal position (consistent with accident impact)
- The glass bowl was intact, but contained no fuel
- The interior and screen appeared clean
- The fuel line from the strainer fuel outlet (to feed the engine) had been removed/unscrewed
- The drain valve assembly at the bottom was bent (consistent with accident impact) and inoperative

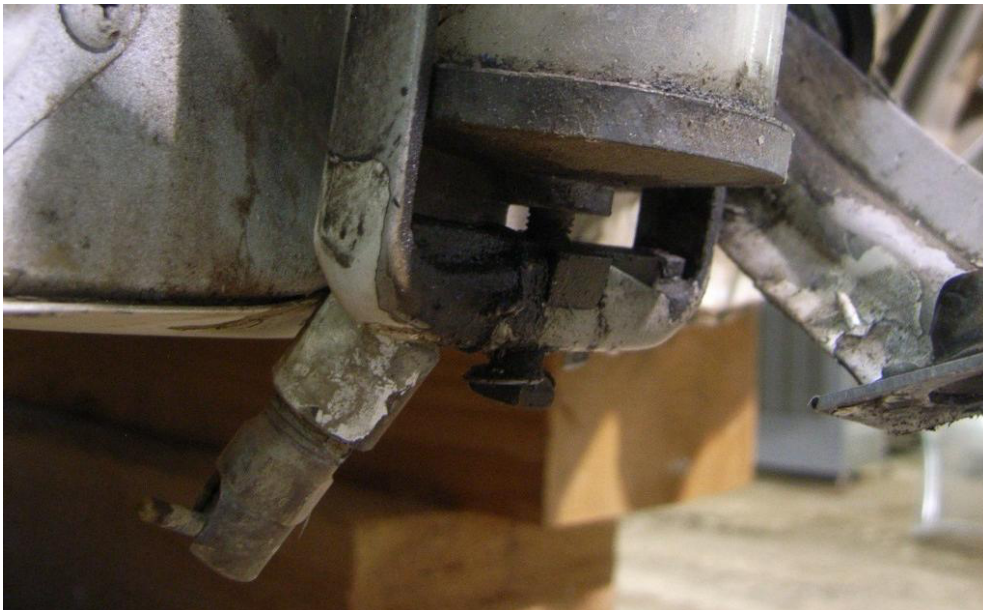
**Figure 12 - Deformed Fuel Strainer Drain Valve**

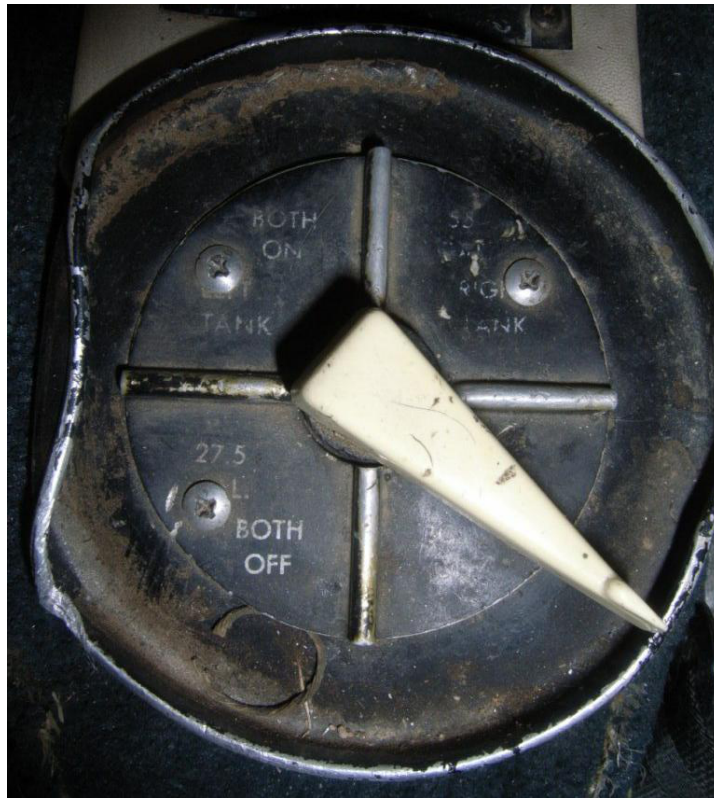
Figure 13 - Cockpit Fuel Selector

- A four-position cockpit fuel selector valve was situated in the center forward cabin floor
- It appeared undamaged, but its placard was worn to the point where some wording was illegible or absent

- The handle rotated freely in both directions through all four detented positions
  - The detented positions were 90° apart, such that when in the detents, the handle pointer pointed forward, right, aft, or left

- Clockwise from handle pointer forward, the positions were BOTH ON, RIGHT TANK, BOTH OFF, LEFT TANK
- In order to test the lines and fuel selector valve function, low pressure air was initially introduced into the LEFT tank line

- With the handle set to BOTH OFF, no results were observed
  - With the handle set to LEFT and then BOTH ON, Avgas began to fill the fuel strainer and leak out the damaged drain valve

- With the handle set to RIGHT, no results were observed
- The test was repeated using water, introduced first through the left fuel tank line, and then repeated with water introduced through the right fuel tank line. In all eight tests (four each per right and left side), the selector valve functioned as expected, as follows:

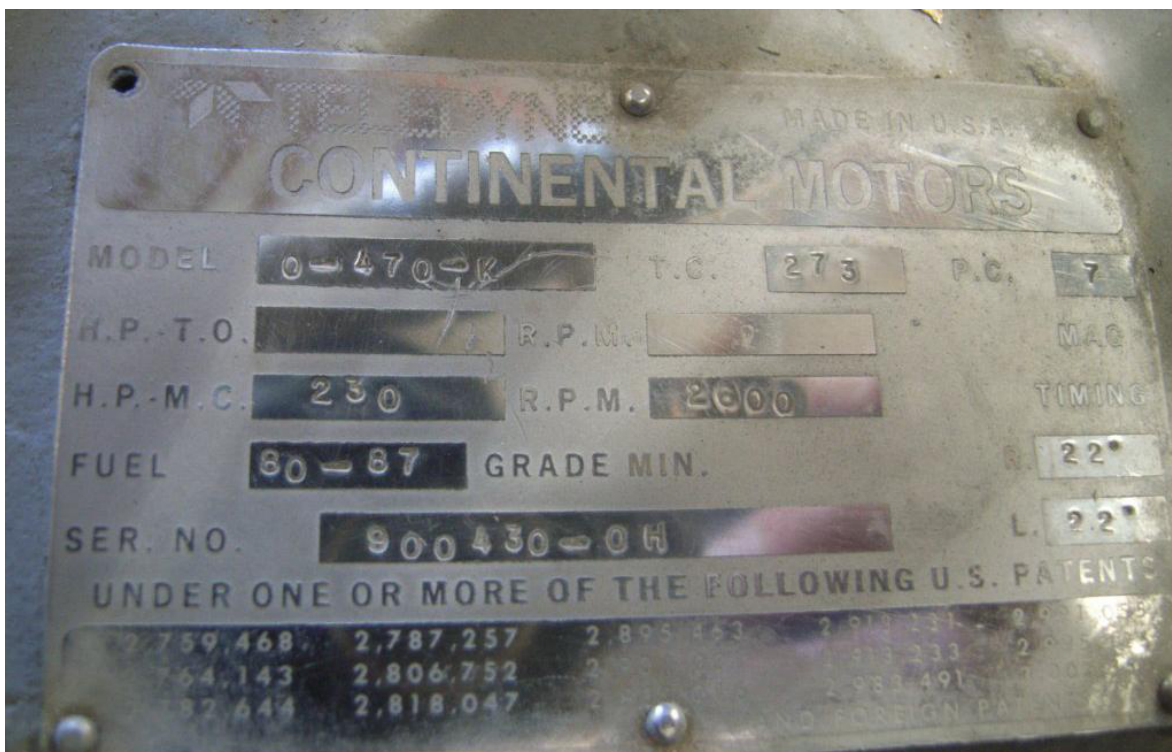
Figure 14 - Engine Dataplate

- The engine had been separated from the airframe, and the propeller had been unbolted from the engine
- The engine dataplate indicated the following
  - Continental Motors model O-470-K
  - Serial Number 900430-OH
  - Timing: 22°
- The engine stamped case number was 539488
- The engine was relatively undamaged
  - Both exhaust pipes leading to the muffler were bent
  - The muffler was displaced up and aft
  - The forward oil sump pan was pushed in/up and aft, but it was not cracked or otherwise breached
- The carburetor appeared undamaged, but the cowling airbox was crushed
- The throttle and mixture cables had been cut forward of the firewall
  - These cuts had been made by the first recovery person
- The throttle and mixture cockpit controls moved freely, and the motion was evident to the respective cable cuts
- The throttle and mixture cable ends remained attached to the carburetor

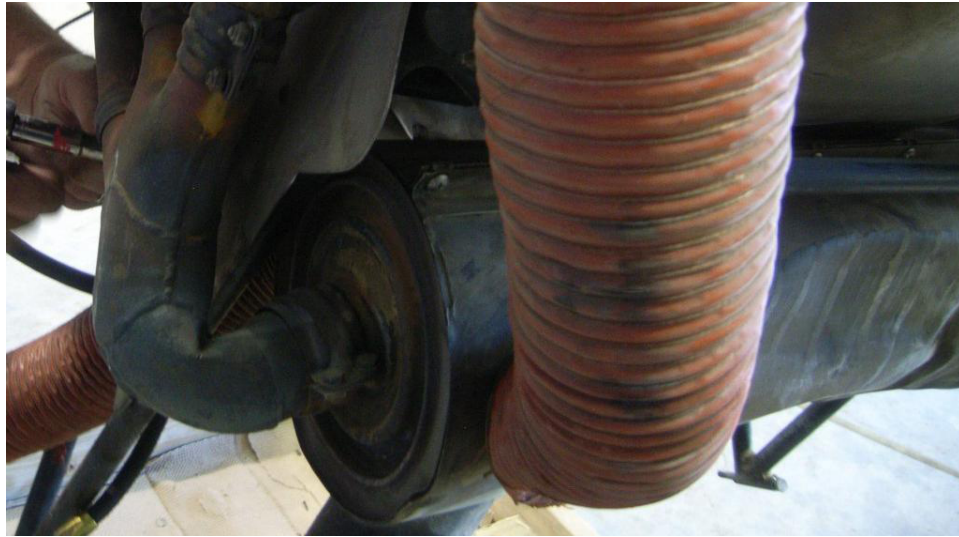
**Figure 19 - Deformed Exhaust Pipe**

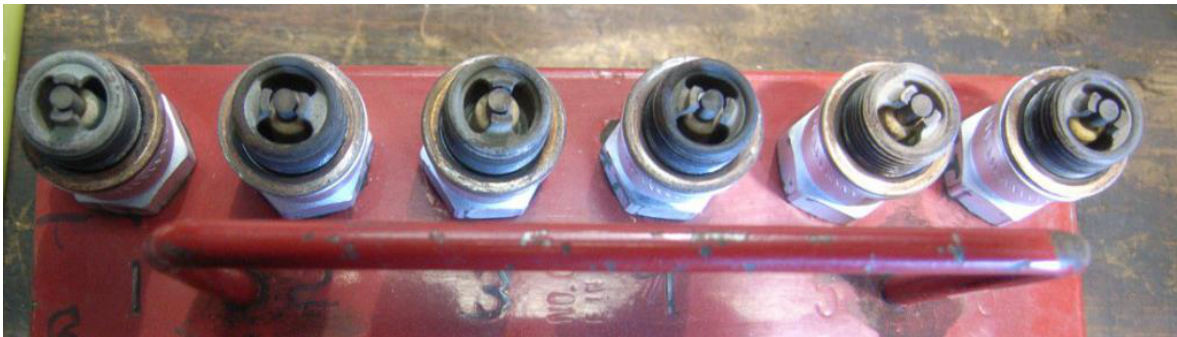
**Figure 20 - Upper Spark Plugs**

- All leads and spark plugs were found to be securely and properly installed
  - All 6 upper spark plugs exhibited clean, normal-appearance electrodes

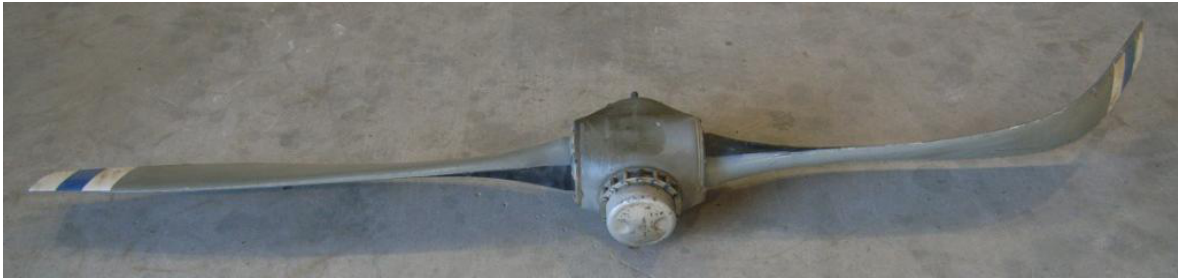
**Figure 21 - Propeller**

- The propeller was a 2-blade, all-metal, constant speed design
- The hub was intact, and both blades remained attached to the hub
- One blade was essentially undamaged
- The other blade was bent about 45° aft at about the 3/4 span point
  - The bent section displayed some leading edge gouging and chordwise scratching

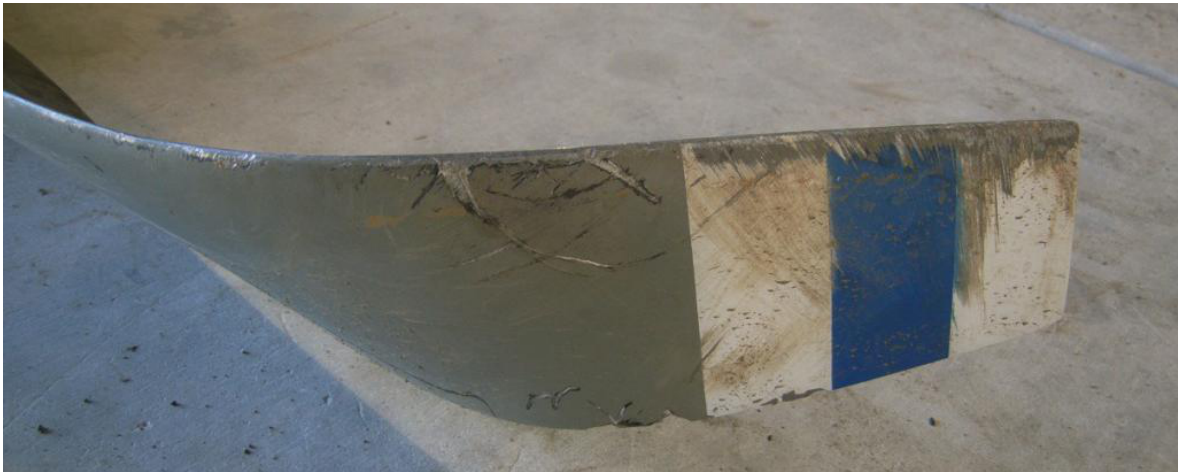
**Figure 22 - Bent End of Propeller**
