## **NATIONAL TRANSPORTATION SAFETY BOARD**

### **ENGINE EXAM / RUN**

**WPR19LA017**

Location: Cottonwood, California  
Date: October 30, 2018  
Aircraft: Cessna 180, N6414X, Serial # 18050914  
NTSB IIC: Michael Huhn

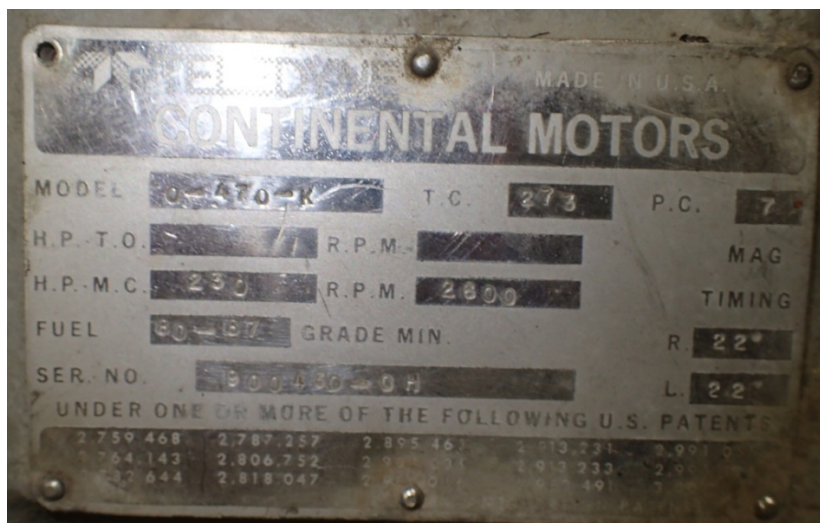
Figure 1 - Engine Data Plate

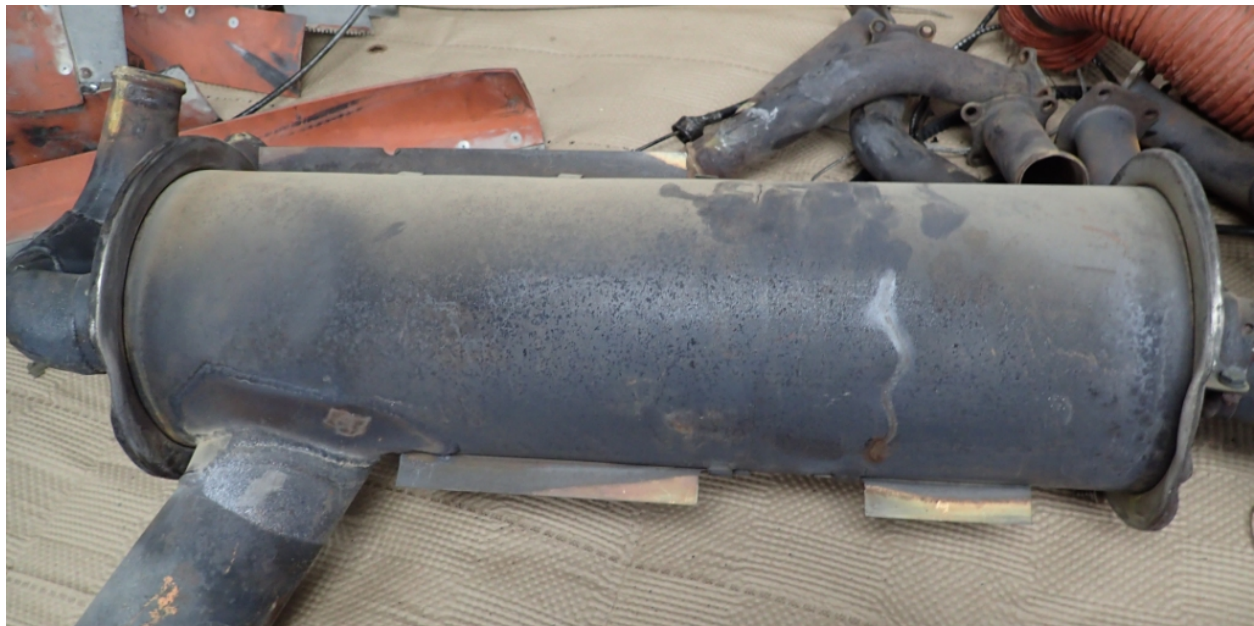
- Engine O-470K17H, SN 900430
- Muffler/exhaust had been removed for shipping
  - Muffler shroud was removed at CAT and muffler examined
  - No punctures, significant corrosion, or loose internal baffling were observed

**Figure 5 - Muffler with Shroud Removed**

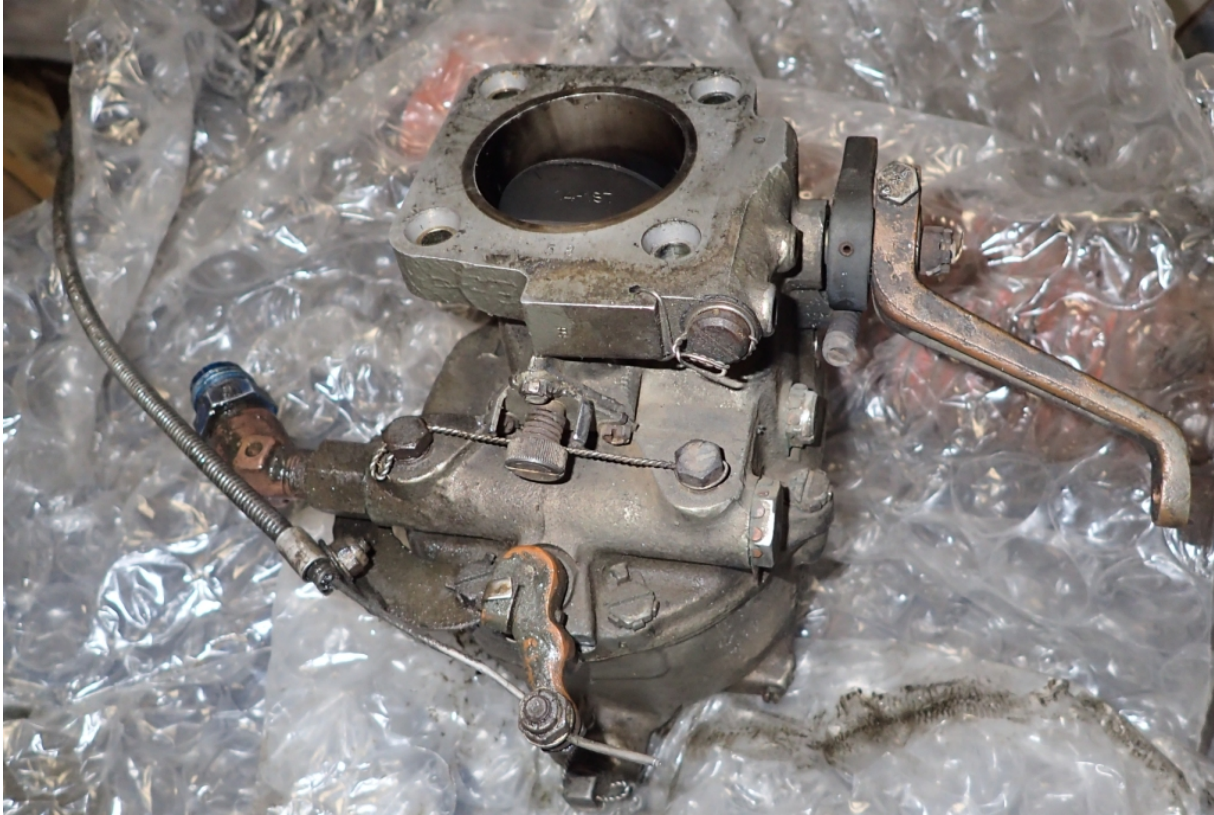
**Figure 6 - Carburetor as Received**

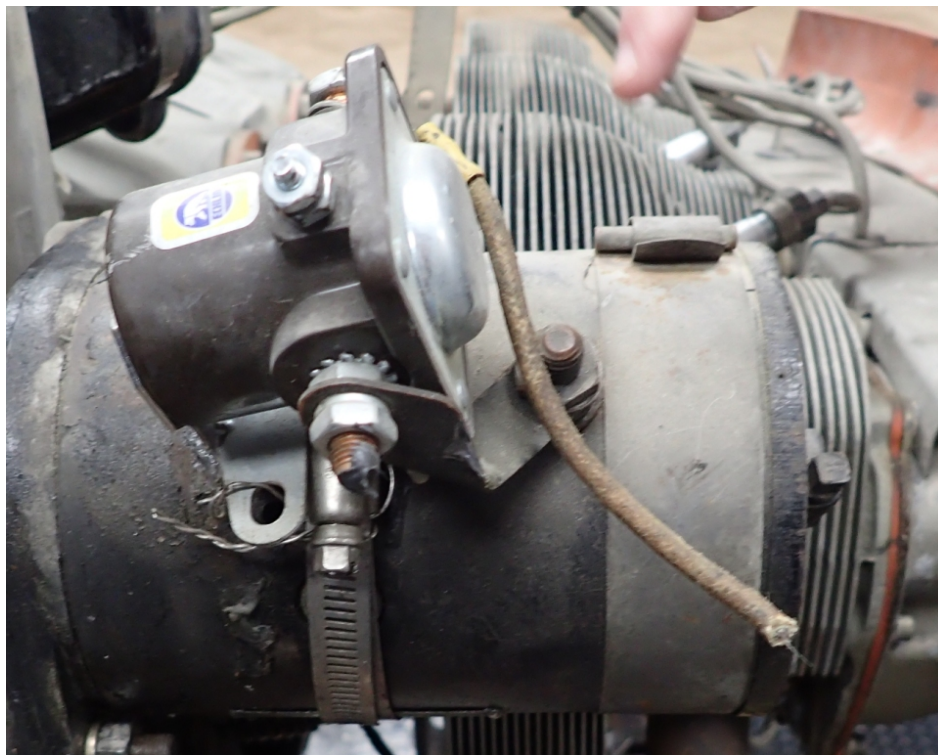
- Carburetor had been removed for shipping – reinstalled for test cell run
- A non-aviation solenoid was attached to the starter motor by an improvised means using a worm-clamp and safety wire

**Figure 7 - Starter with Non-Aviation Solenoid**

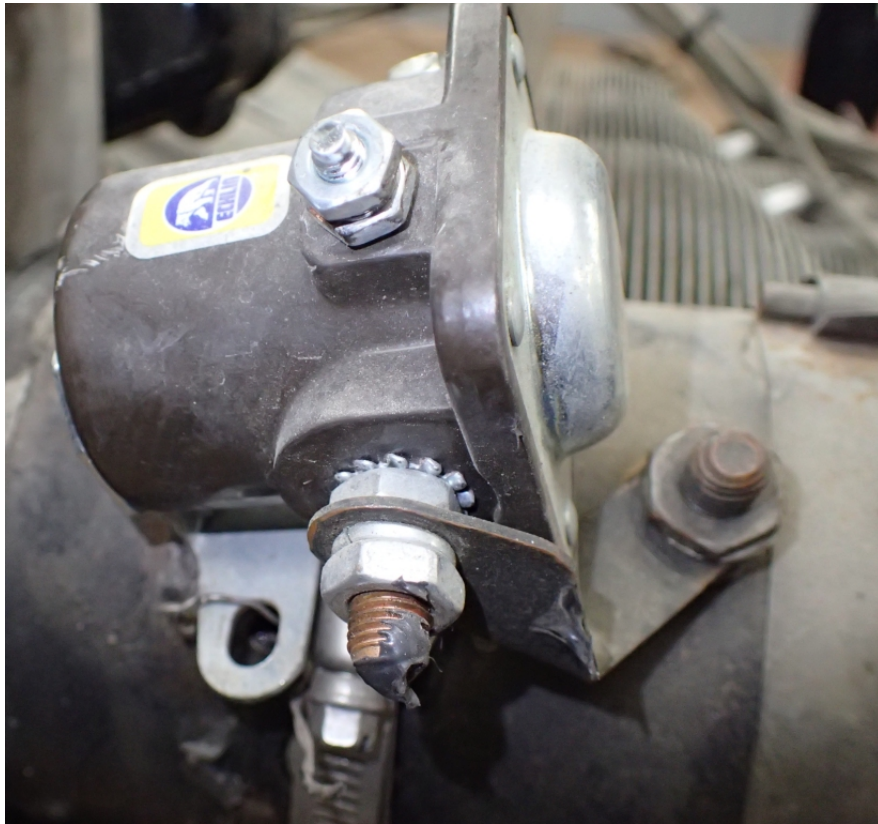
**Figure 8 - Close-up of Solenoid**

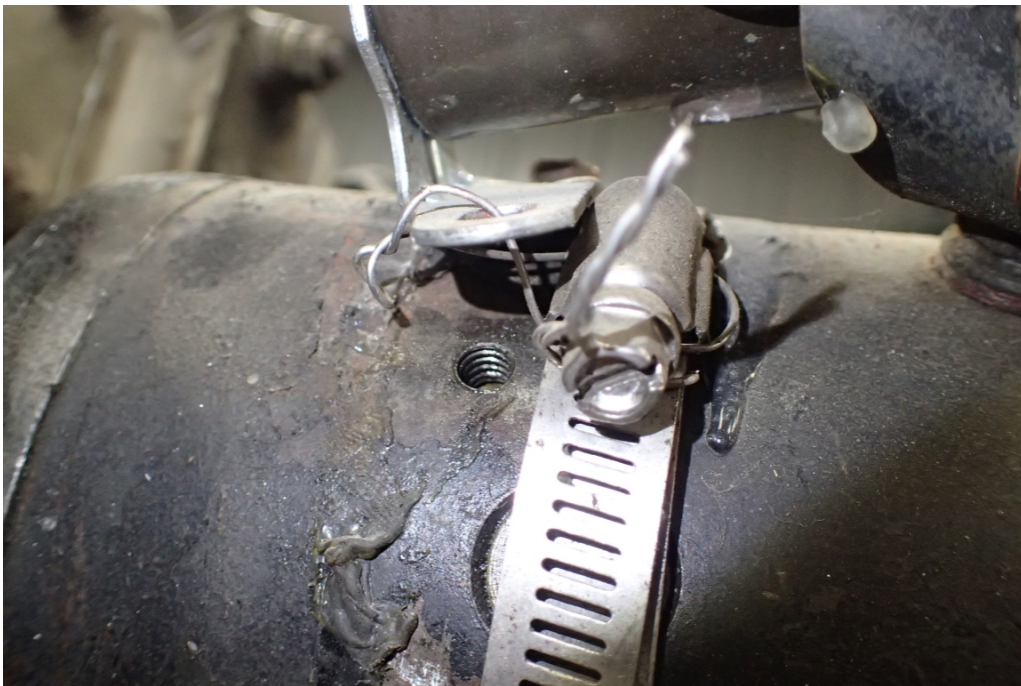
**Figure 9 - Solenoid Attach Hardware**

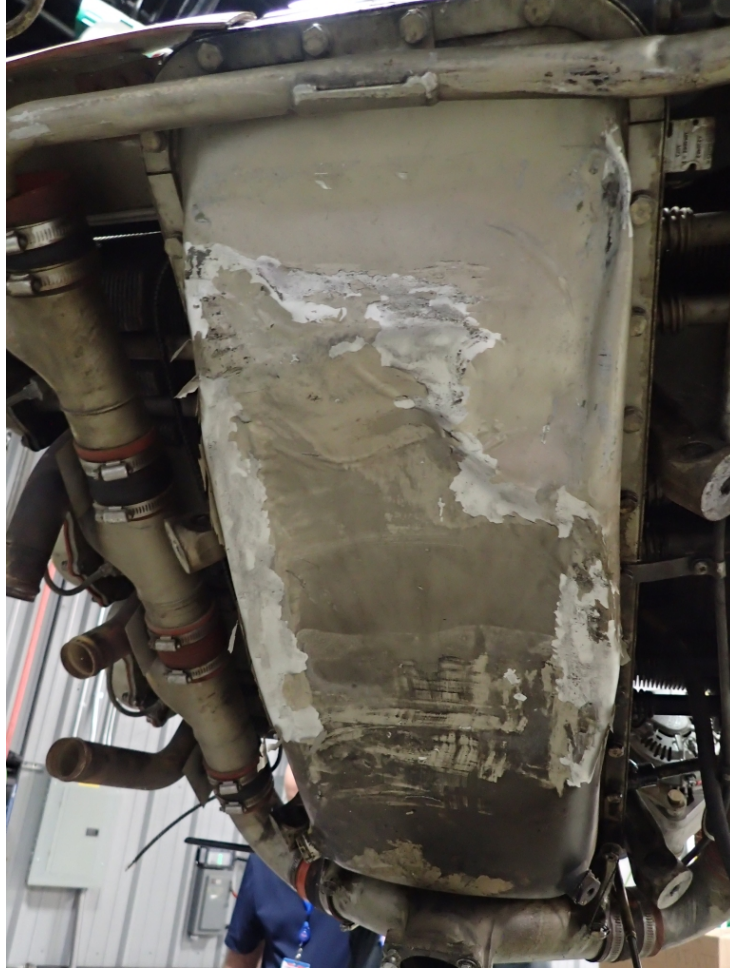
- Oil sump – slightly crushed from accident impact – no debris noted – replaced (to prevent blocking of oil pickup screen)
- Oil Pickup Screen – partially flattened by oil sump contact, but reused

**Figure 10 - Damaged Oil Sump**

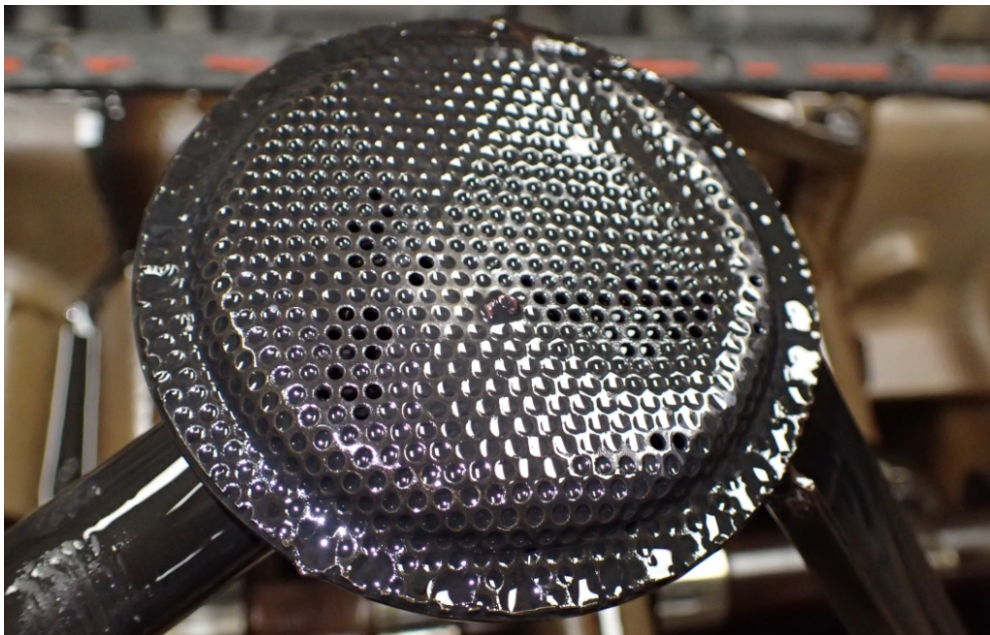
**Figure 11 - Oil Pickup Screen**

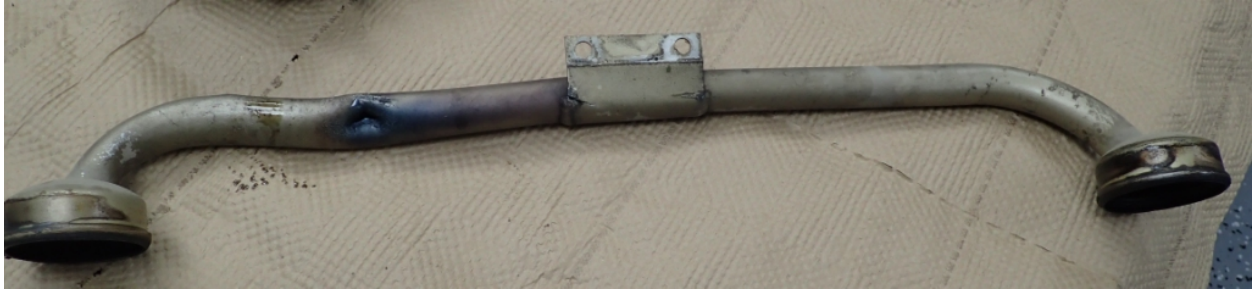
- Balance/crossover tube – Partly crushed, plus one puncture (all impact-related)
  - Blue deposition/staining (fuel) around puncture, including on puncture fracture surfaces

**Figure 12 - Balance Tube**

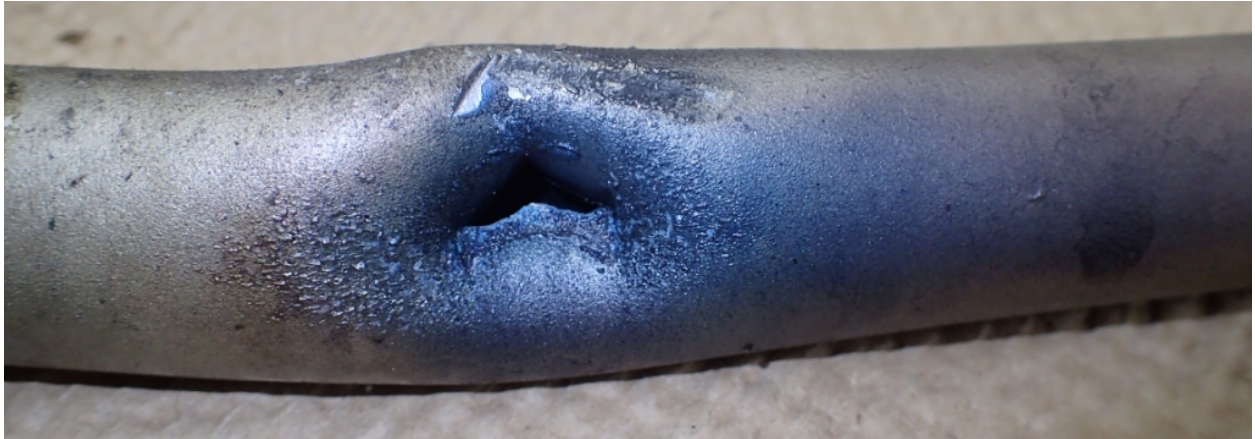
- Staining appeared to be from vapor ('soft' edges to staining) as opposed to liquid
  - No evidence of any blue staining on engine or components in vicinity of puncture

**Figure 13 - Puncture in Balance Tube**

- Replaced with new
- Cylinders borescoped (via top spark plug holes)
  - Spark plugs unremarkable/normal
  - Some minor debris (consistent with flaked-off combustion deposits) were observed in a few cylinders

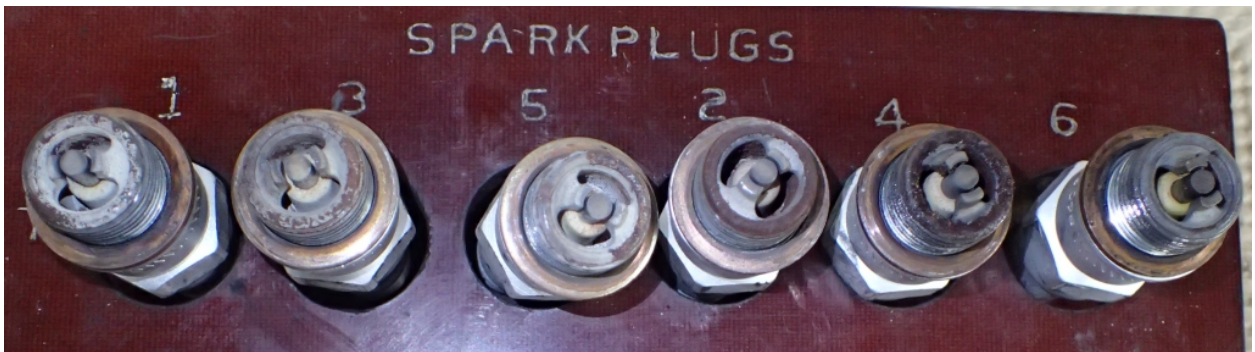
**Figure 14 - Top Spark Plugs**

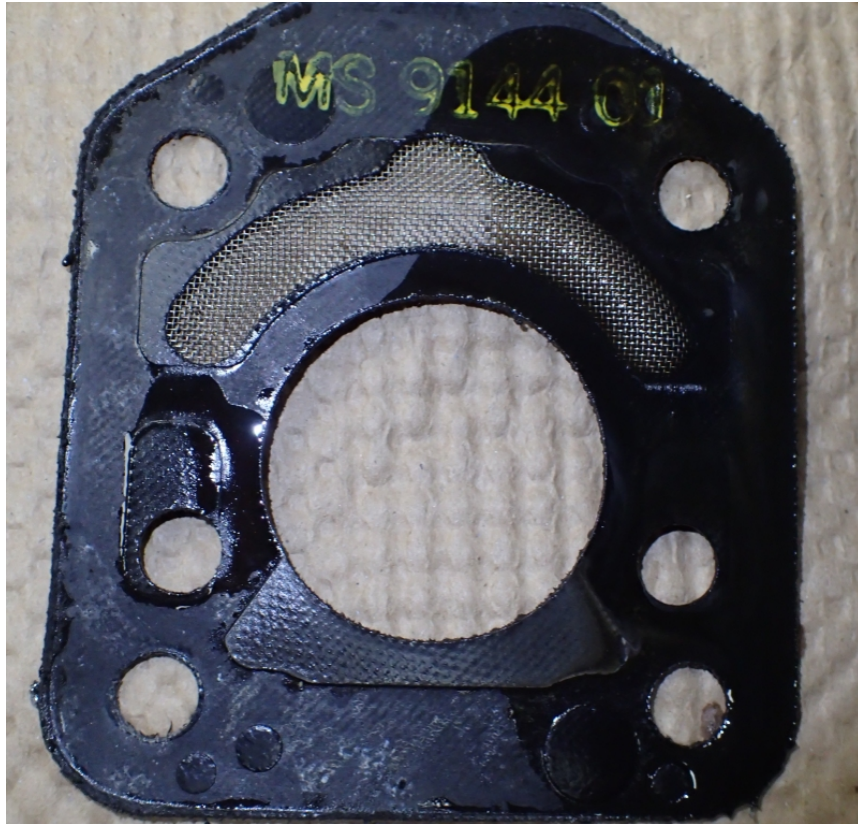
- Removed alternator, vacuum pump, and governor (used test cell governor)
  - Governor oil screen was free of debris
- Magneto timing
  - Spec: 22° Left: 24° Right: 23.5°

Figure 15 - Governor Oil Screen

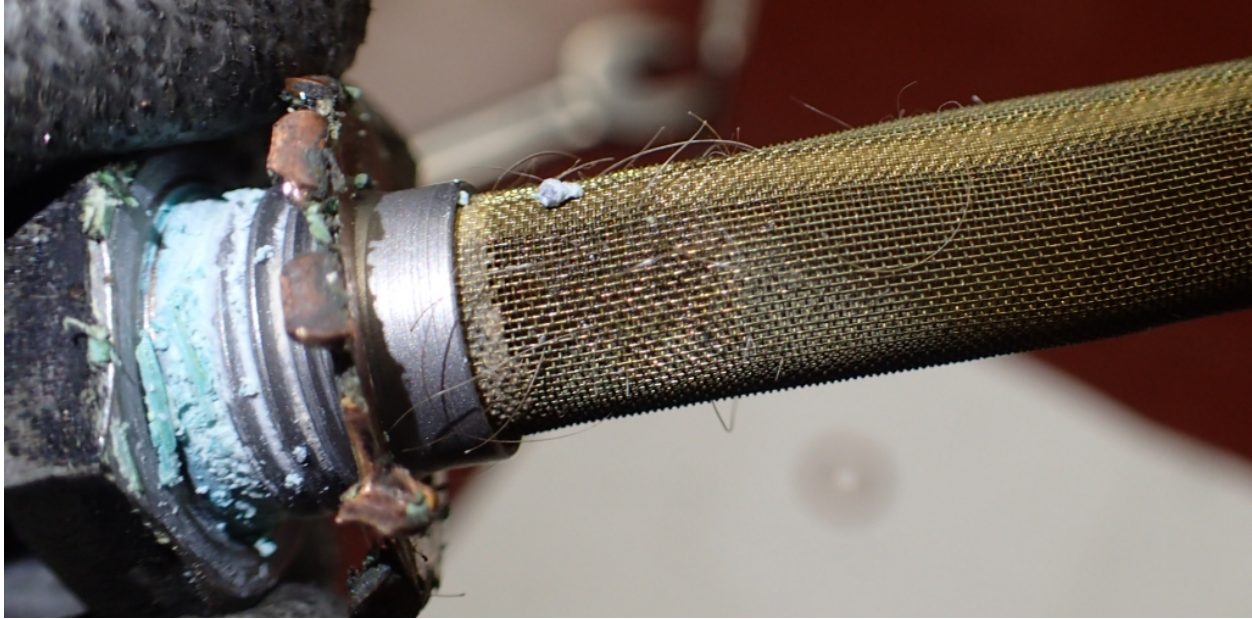
- Engine re-run following day to warm up in order to conduct compression checks
- Operating temperature engine compression checks (80 psi input)
  - o Cyl 1 - 68 psi
  - o Cyl 2 - 56 psi, rings/exhaust
  - o Cyl 3 - 73 psi
  - o Cyl 4 - 60 psi, exhaust
  - o Cyl 5 - 55 psi, rings
  - o Cyl 6 - 55 psi, rings
- Carburetor was removed from engine, examined, and disassembled
  - o No external irregularities noted
  - o Carburetor bowl was clean and free of debris or corrosion
  - o Metal floats intact/undamaged
  - o No indications of floats abrading against bowl walls
  - o Accelerator pump plunger intact and pliable
  - o Fuel inlet screen had several hair-like fibrous strands of undetermined origin or composition –insufficient to result in fuel flow decrease

**Figure 23 - Carburetor Fuel Screen and Fibrous Debris**
