## **NATIONAL TRANSPORTATION SAFETY BOARD**

### **INITIAL INFORMATION & ACTIVITIES**

**WPR19LA017**

Location: Cottonwood, California  
Date: October 30, 2018  
Aircraft: Cessna 180, N6414X, Serial # 18050914  
NTSB IIC: Michael Huhn

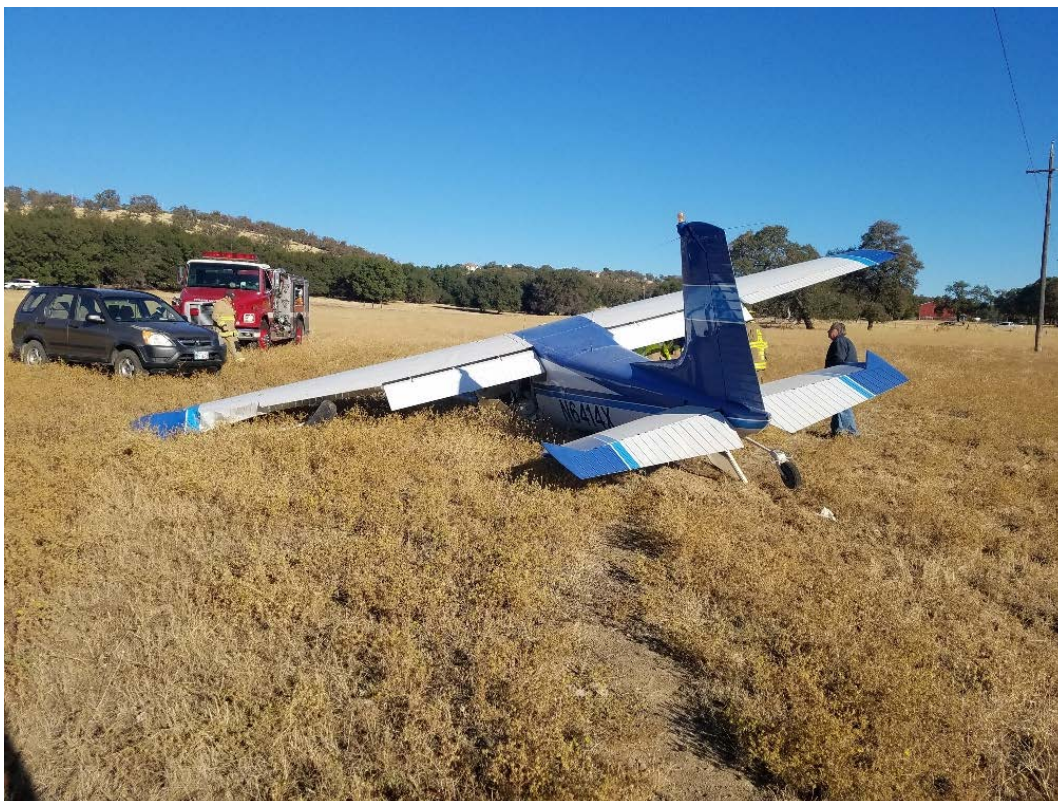
**Figure 2 - Final Location**

- Plane crashes at 0924 PDT
- The LMLG leg had fracture-separated at the fuselage, and the airplane was resting on the ground approximately 20 degrees left wing down
