## RECORD OF CONVERSATION

**Date: August 11, 2020**  
**Person Contacted: Mr. Corey Wehmeyer (FAA Aviation Safety Inspector - Airworthiness)**  
**NTSB Accident Number: WPR19LA019**

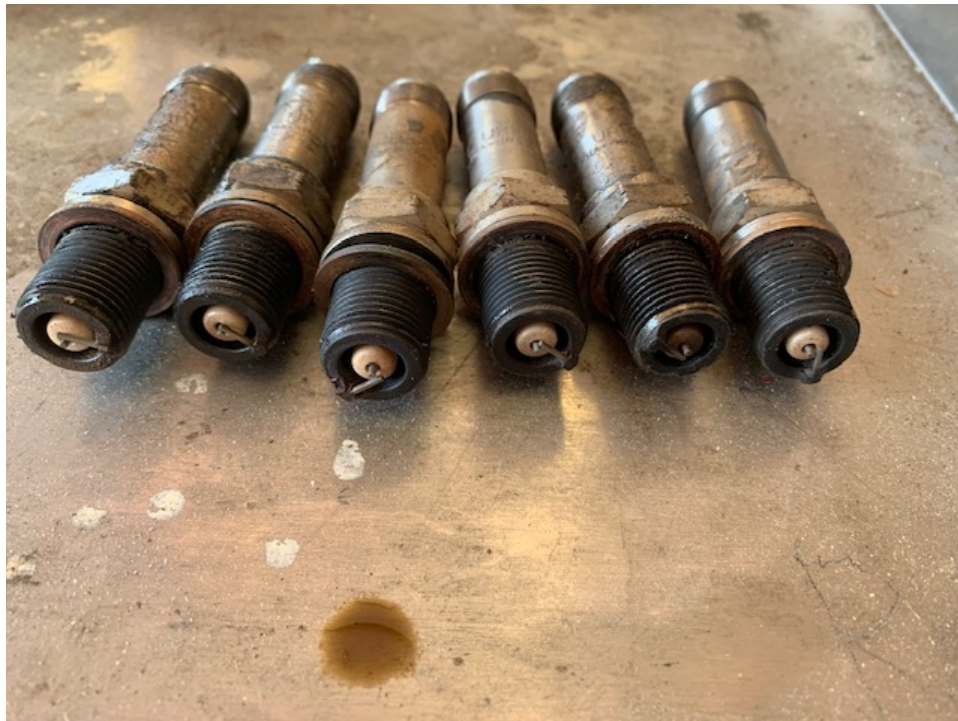
- The spark plugs were removed from the engine and were consistent with normal operations.
  - All spark plugs appeared similar and consistent with one another.

*Figure 1: Spark Plugs*

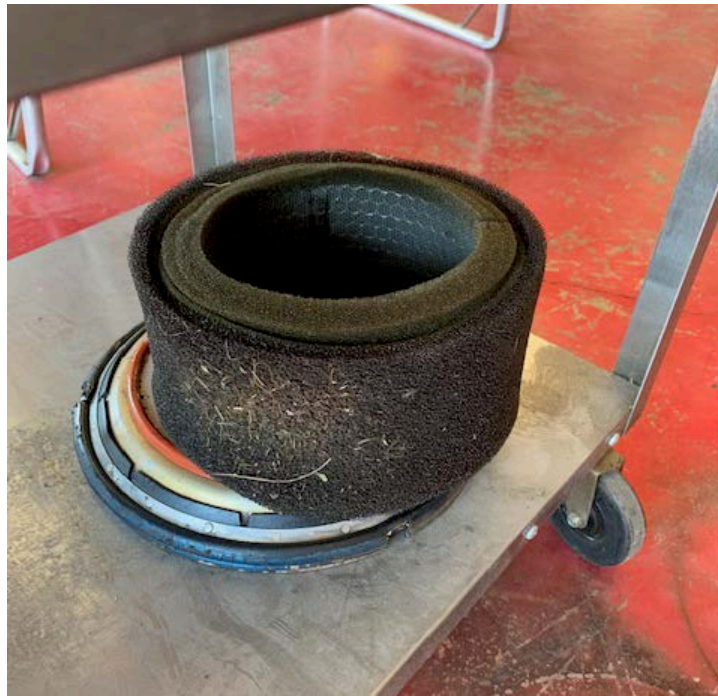
- The air filter was clear of debris
- The fuel strainer was removed from the engine and the screen/bowl were clear of debris.
- The oil filter was removed and was clear of debris.

*Figure 2: Air Filter*

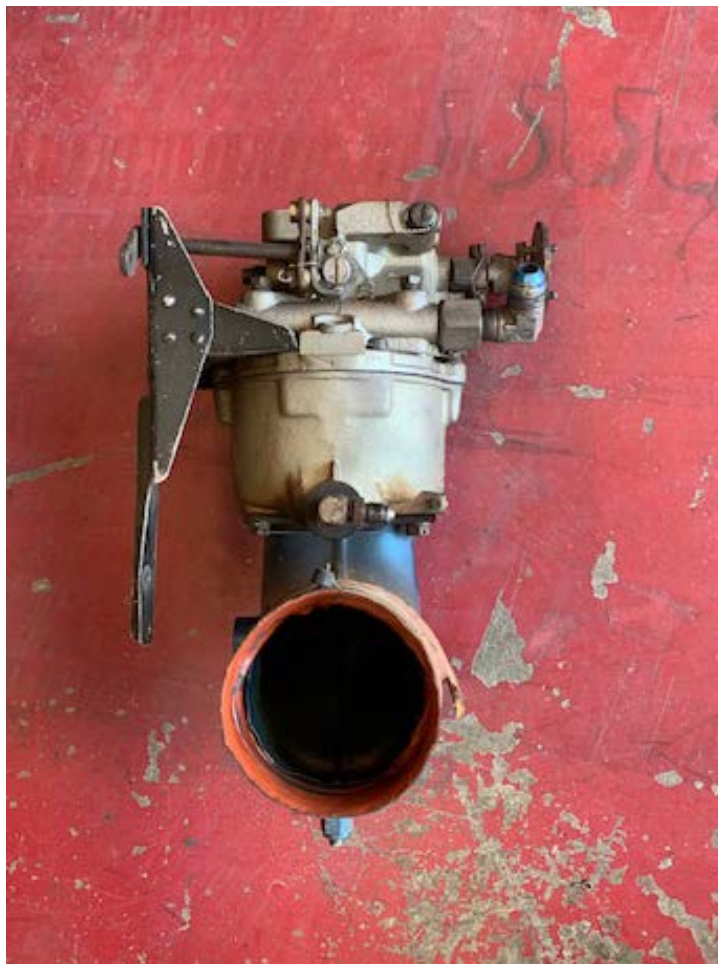
- The engine was rotated:
  - Thumb compression was established throughout
  - The valves opened and closed normally and consistently
- The carburetor was removed from the engine and disassembled.

*Figure 3: Carburetor*

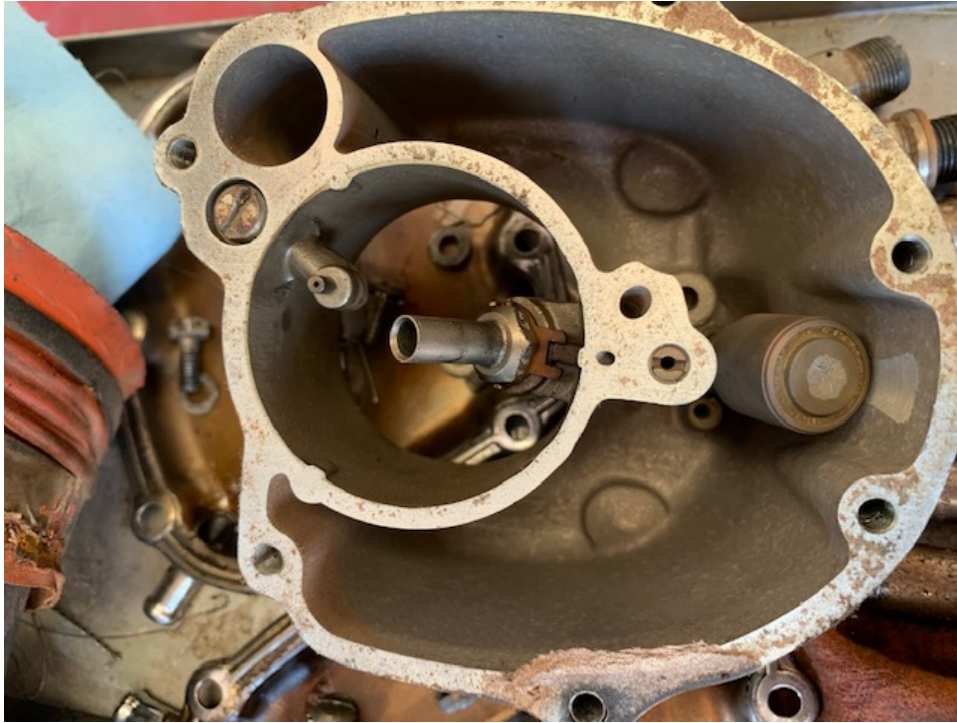
- The carburetor bowl was empty and there were no abnormalities noted to the internal components.
- The magnetos were removed from the engine and rotated.

*Figure 4: Carburetor Bowl*

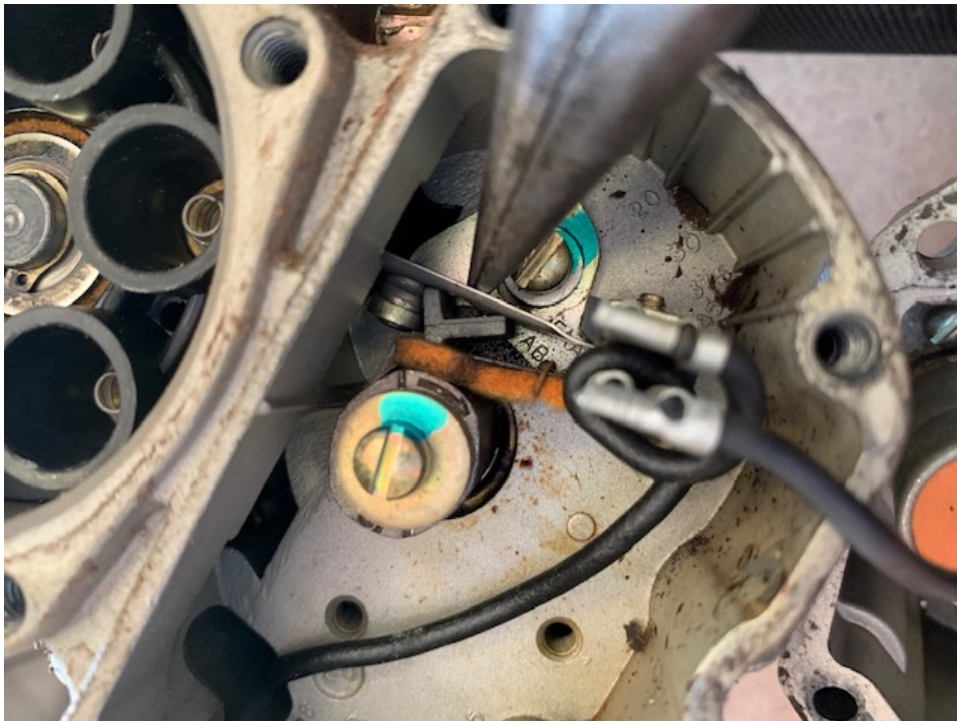
- The ignition leads were consistent with normal operations
  - The right magneto sparked normally; but no spark was obtained from the left magneto.
  - The left magneto was removed from the engine and disassembled

- The point on the cam follower was fractured, therefore, when the cam rotated around it wouldn't break the points and produce a spark.
      - It was unable to be determined if the damaged occurred before or during the impact sequence.

*Figure 5: Left Magneto*

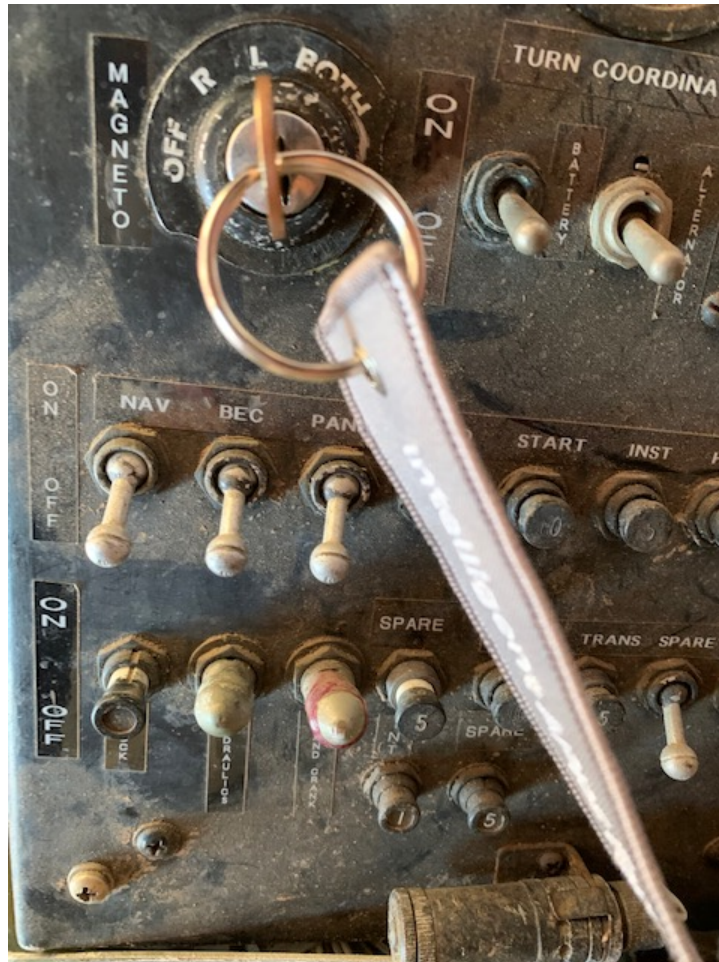
- The ignition switch was tested:
  - All four positions (R/L/BOTH/OFF) tested normally
    - However, when the switch was positioned in L/R and the key was jiggled, the ignition switch would temporarily ground out.

- It was noted that a long keychain was attached to the key, which extended over the hydraulics switch.
    - It is possible the CFI needed to move the keychain to turn off the hydraulics switch.

*Figure 6: Keychain in Relation to Hydraulics Switch*
