## **NATIONAL TRANSPORTATION SAFETY BOARD**

# **TAIL ROTOR BLADE EXAMINATION**

**WPR19LA028**

Location: Kailua, HI  
Date: October 27, 2018  
Aircraft: Bell 430, Registration Number: N430ST  
NTSB IIC: Albert Nixon

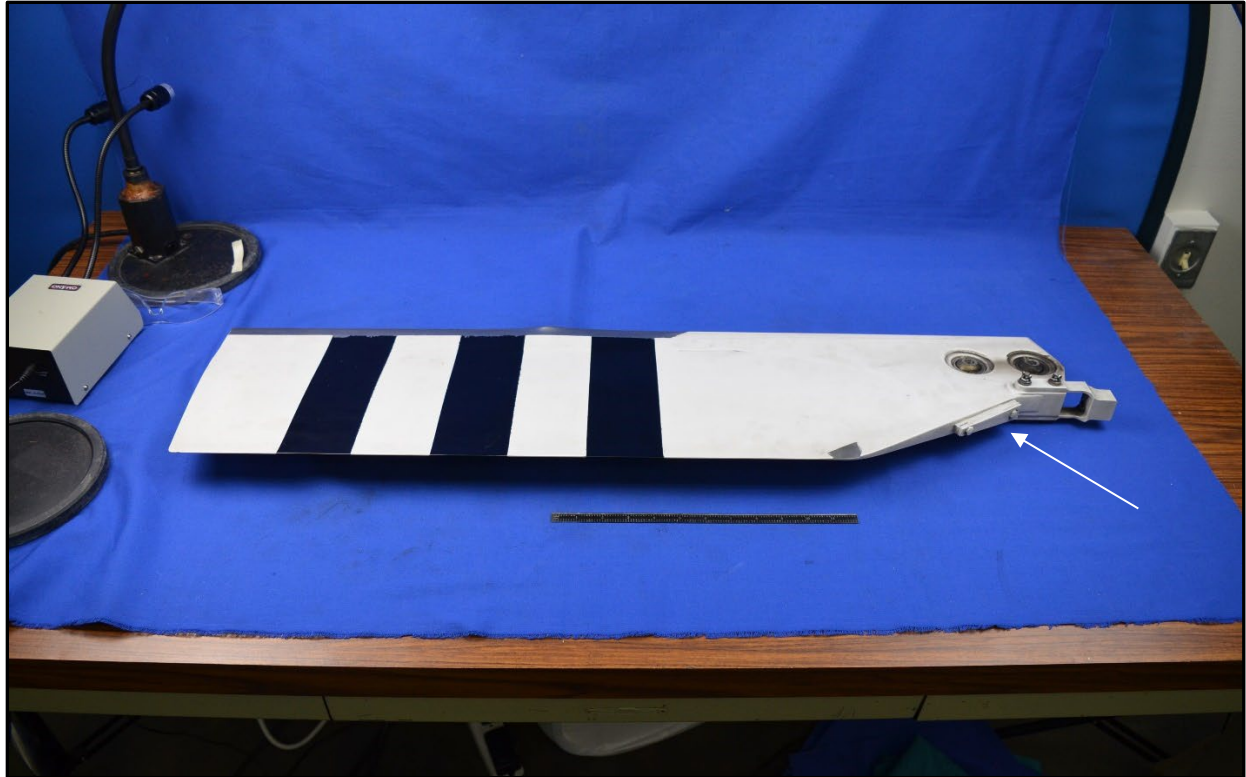
**Figure 1: Tail rotor blade (1) as received, with root enclosure and attached weights intact.**

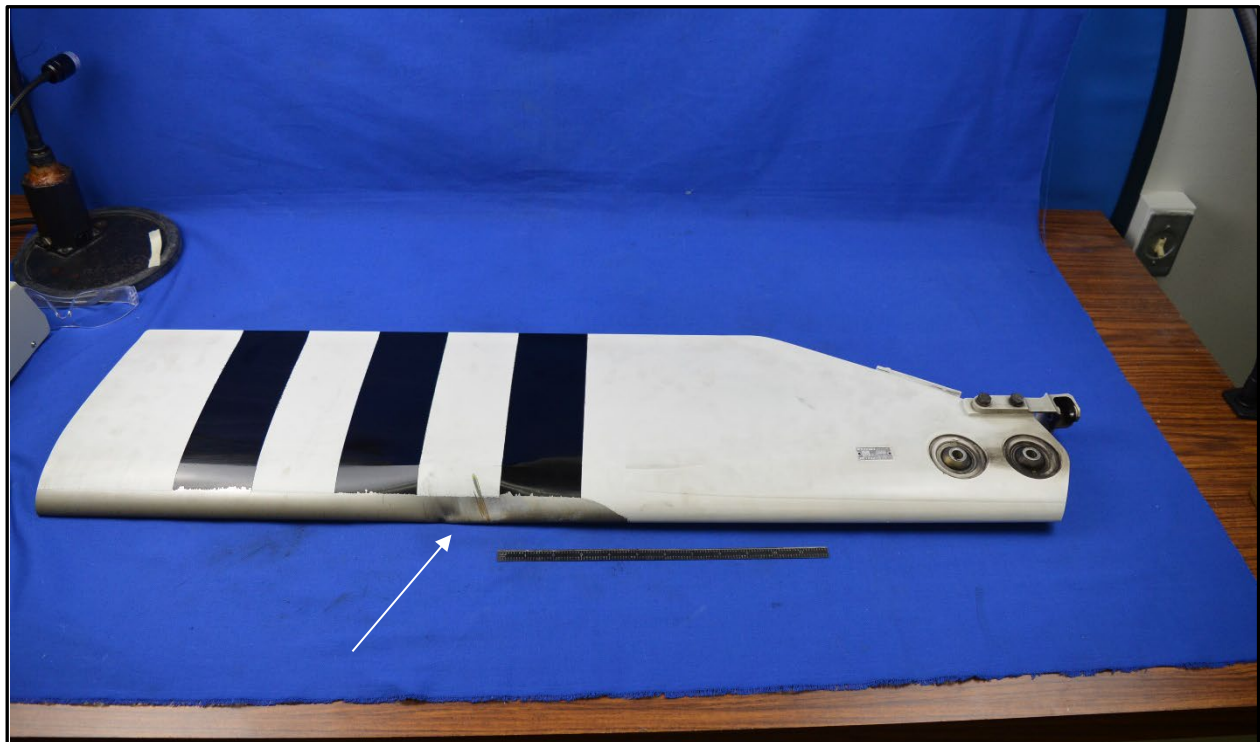
**Figure 2: Tail rotor blade (1) as received, with dent near mid-span of leading edge.**

The blade with the leading-edge rectangular indentation about mid-span, had its balance weights, bolts, and nut plates in the appropriate position and there was no evidence to indicate that the bolts had extended through the nut plate.

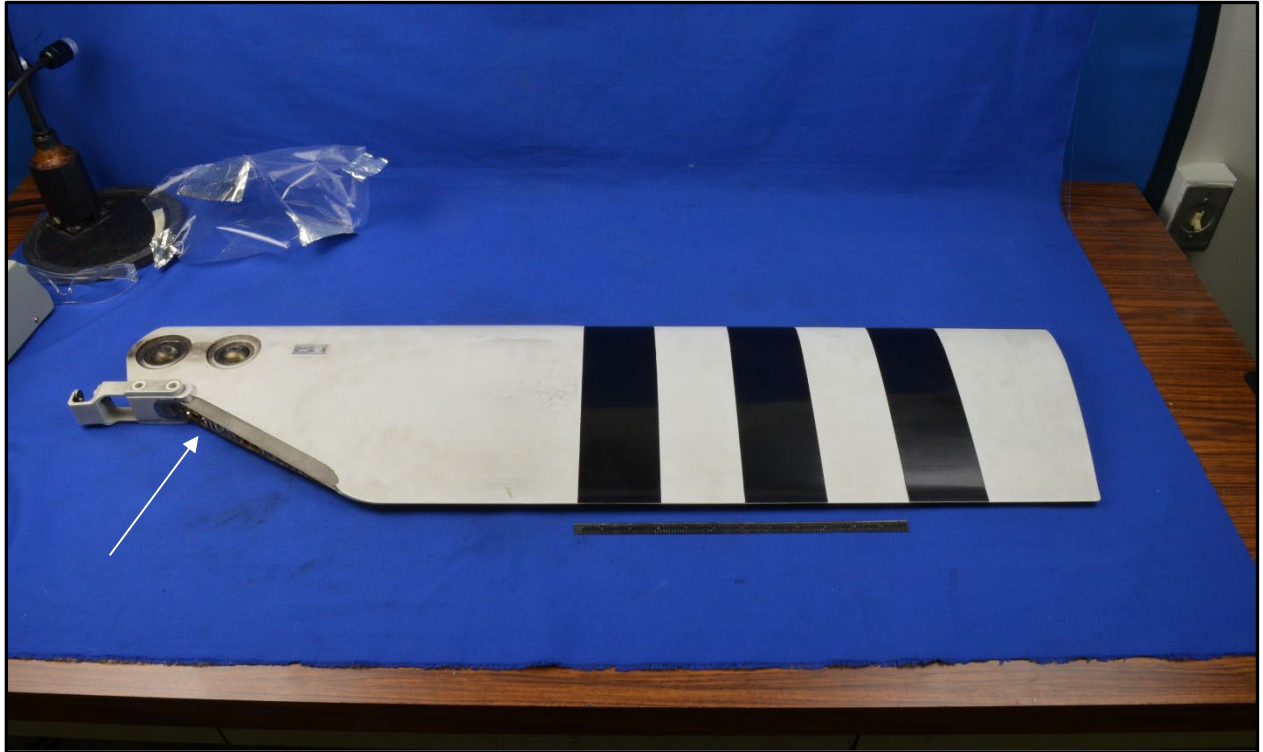
Visual examination of one of the suspect blades revealed that the root enclosure assembly (associated weights and attachment bolts) had separated from inboard edge of the rotor blade while inflight. Further, the second blade was observed to have about a 6-inch leading edge rectangular indentation about mid-span. The other blade's damage was consistent with impact damage from contact with the separated root enclosure.

**Figure 3: Tail rotor blade (2) as received, with root enclosure and attached weights separated.**

On the blade with the missing root enclosure assembly, the void below the outboard nut plate measured about 1.14 inches in depth. The weights, bolts, and nut plates were observed in the appropriate position. No evidence was noted that indicated that the bolts had extended through the nut plate. The scanning electron microscope (SEM) examination of the blade root area revealed corrosion concentrations close to the tang (blade root end closure) and less corrosion as away from the tang area. Examination of the tang area exhibited areas of oxidation.

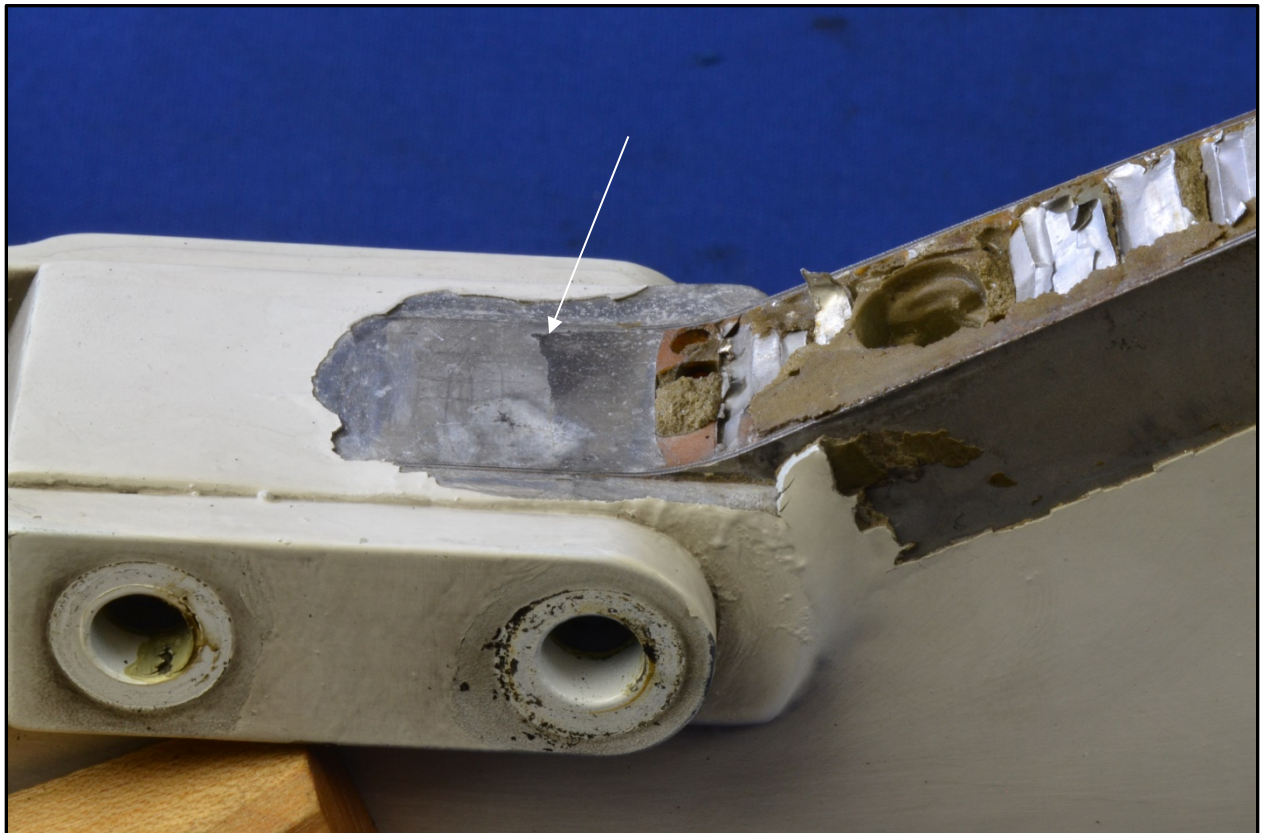
The surface of the root block to where the tang enclosure was bonded was corroded with paths of oxidation extending outboard. These oxidation paths would be consistent with moisture between the adhesive and the blade enclosure.

**Figure 4: Tail rotor blade (2) root enclosure area with decolorization and oxidation.**
