## **NATIONAL TRANSPORTATION SAFETY BOARD**

# **AIRFRAME AND ENGINE EXAMINATION**

**WPR19LA039**

Location: Los Banos, California  
Date: December 6, 2018  
Aircraft: Airplane Beech A36TC, Registration Number: N361TC, Serial #: EA-139  
NTSB IIC: Tealeye Cornejo

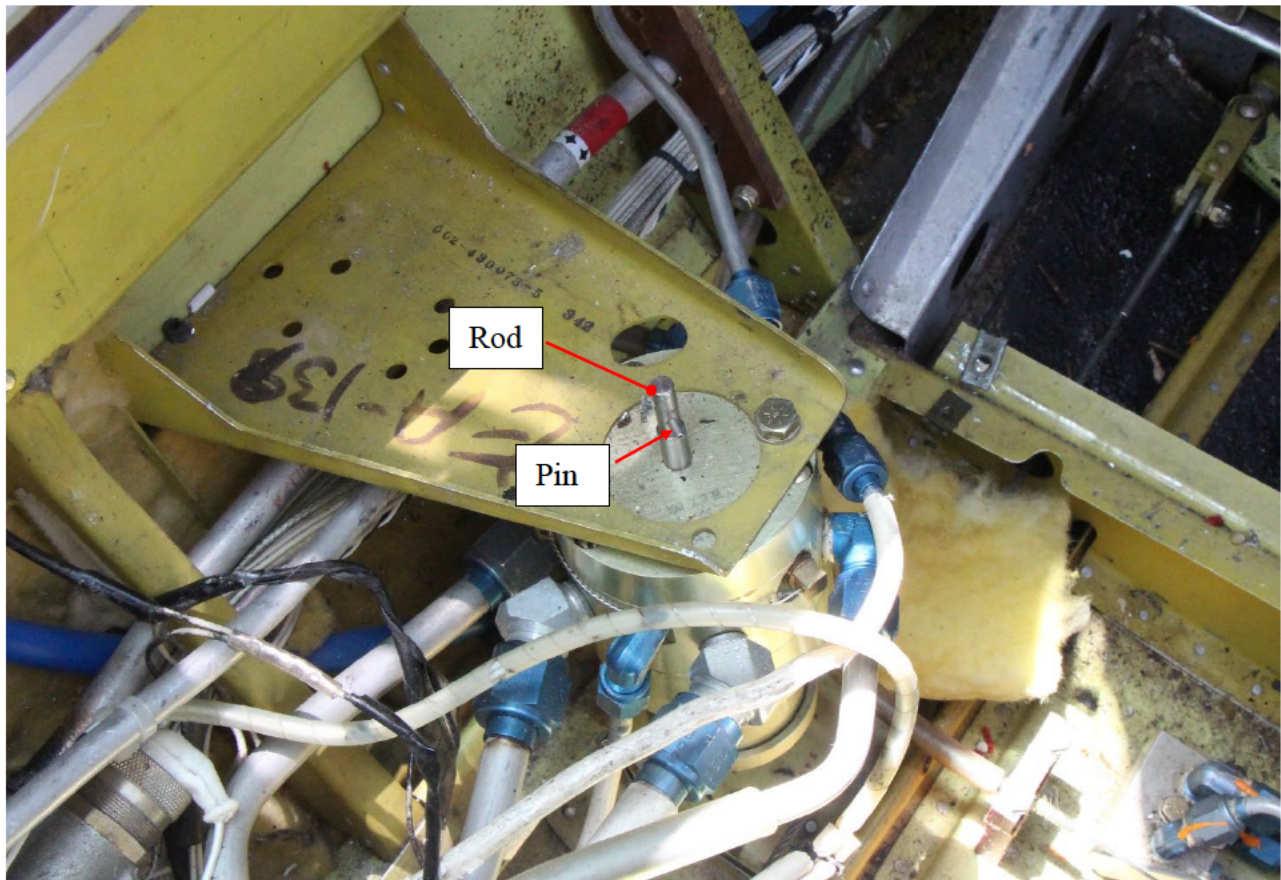
- The fuel selector valve cover and handle had been removed, but the fuel selector rod that rotates the valve was intact and attached to the unit. The fuel selector handle attaches to the rod via two pins; one of which had separated and was not recovered.

**Photograph 1: Fuel Selector Valve and Gascolator**

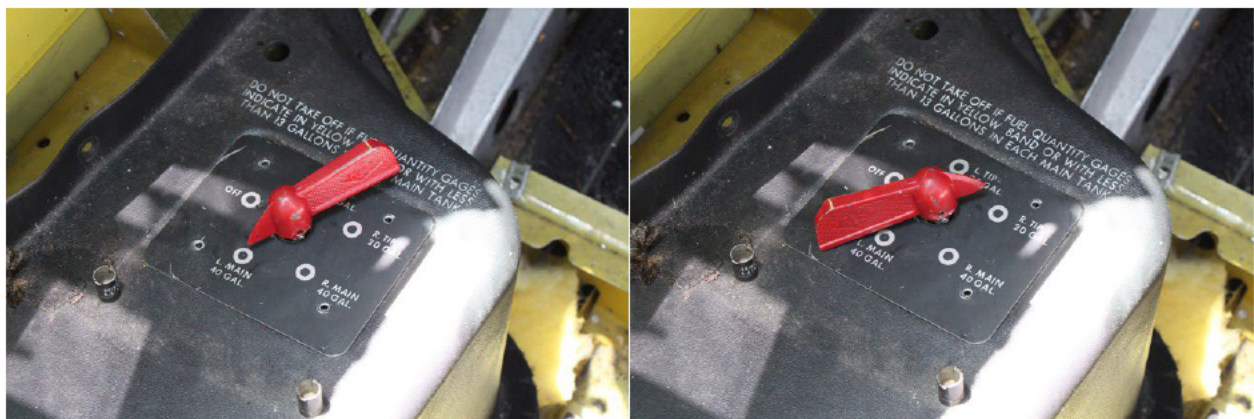
- fuel selector handle operates a ring with one hole at bottom of unit that expels fuel to engine via selected tank
- The fuel selector ring porthole lines up with desired tank; in this case the ring porthole was between detents.
- Based on selector position, the detent may have been between the Left and Right tip tanks; see photographs 1-3
- Fuel gascolator screen was free of debris (see photograph 4)

**Photograph 2: Possible Fuel Selector Positions Based on Location of Selector Rod**

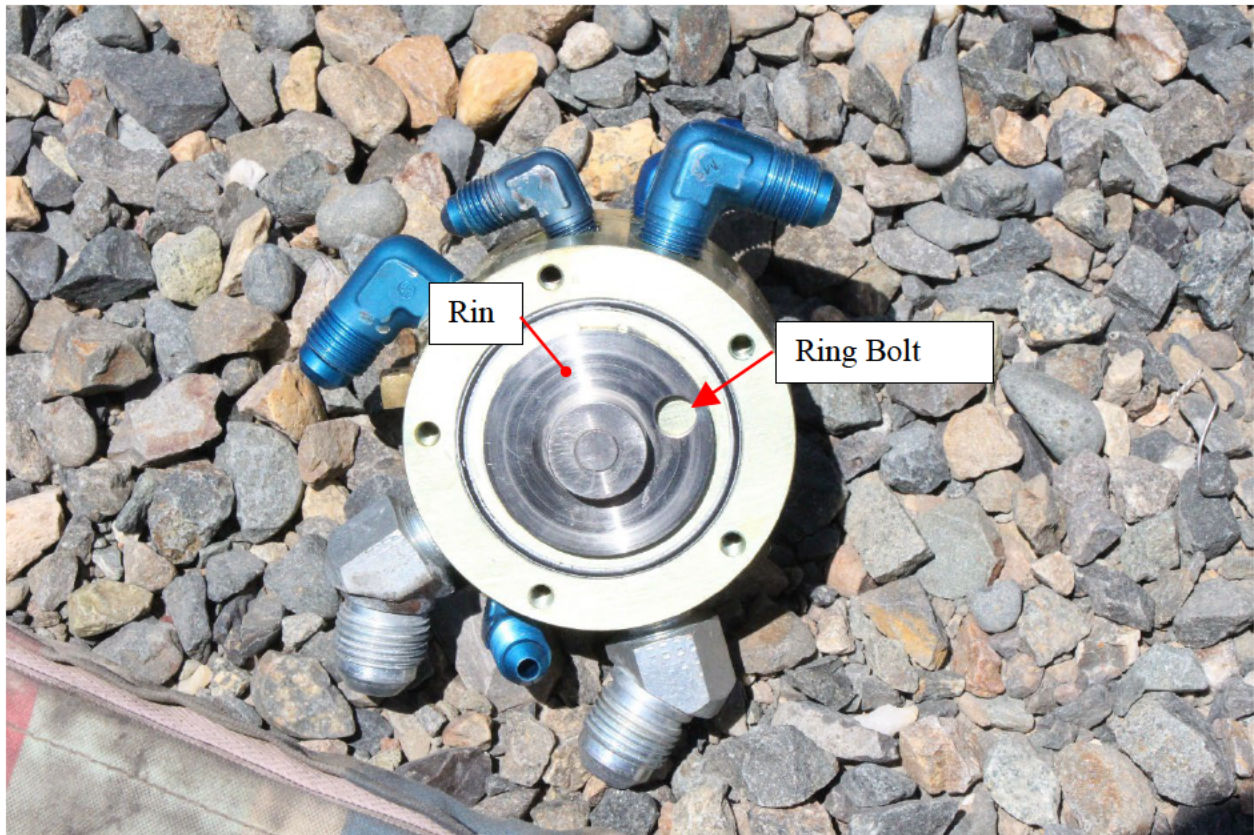
- Fuel manifold did not display fuel; manifold filter was free of debris
  - Fuel injectors were all clear
- Fuel System (Airframe)
  - Fuel selector ring was in between detents

**Photograph 3: Fuel Selector Ring and Porthole Between Detents**

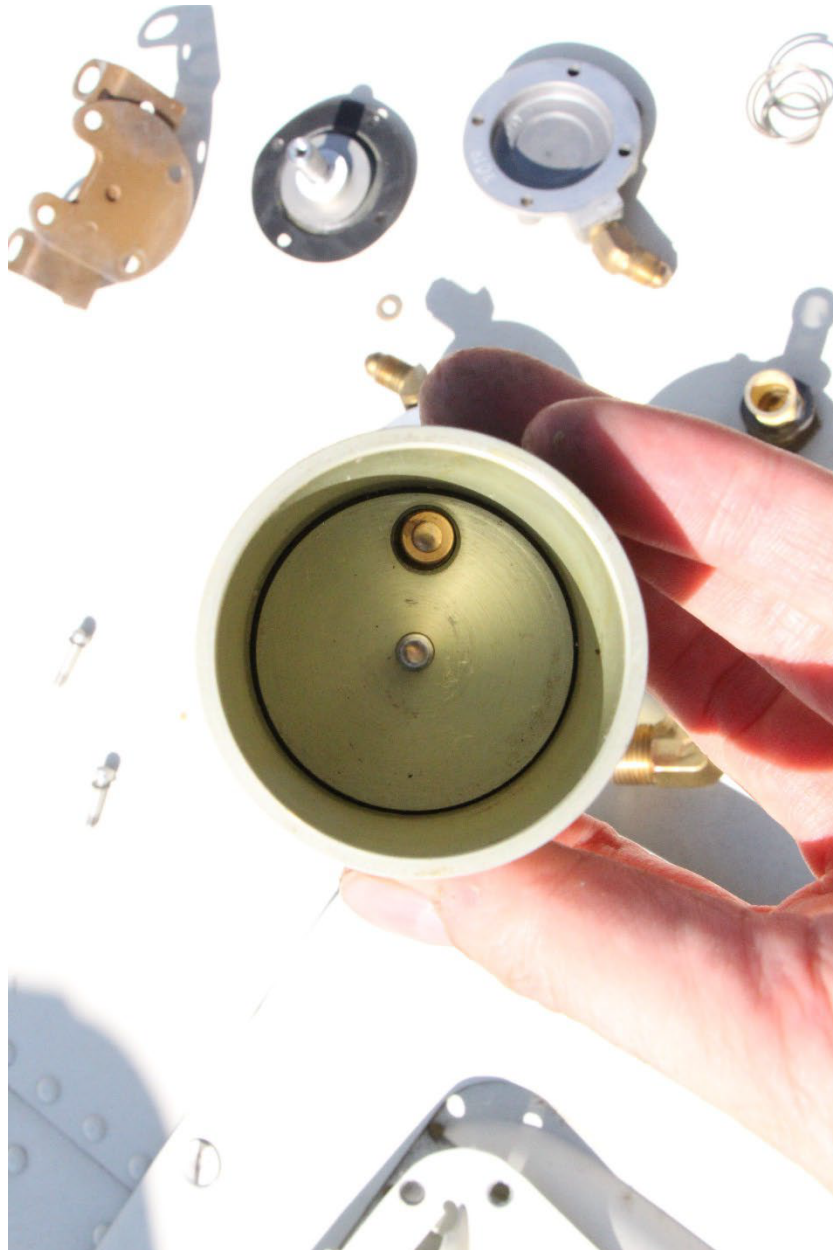
**Photograph 4: Gascolator Fuel Bowl**
