**NATIONAL TRANSPORTATION SAFETY BOARD**

**WRECKAGE EXAMINATION (SUMMARY OF  
FINDINGS)**

**WPR19LA041**

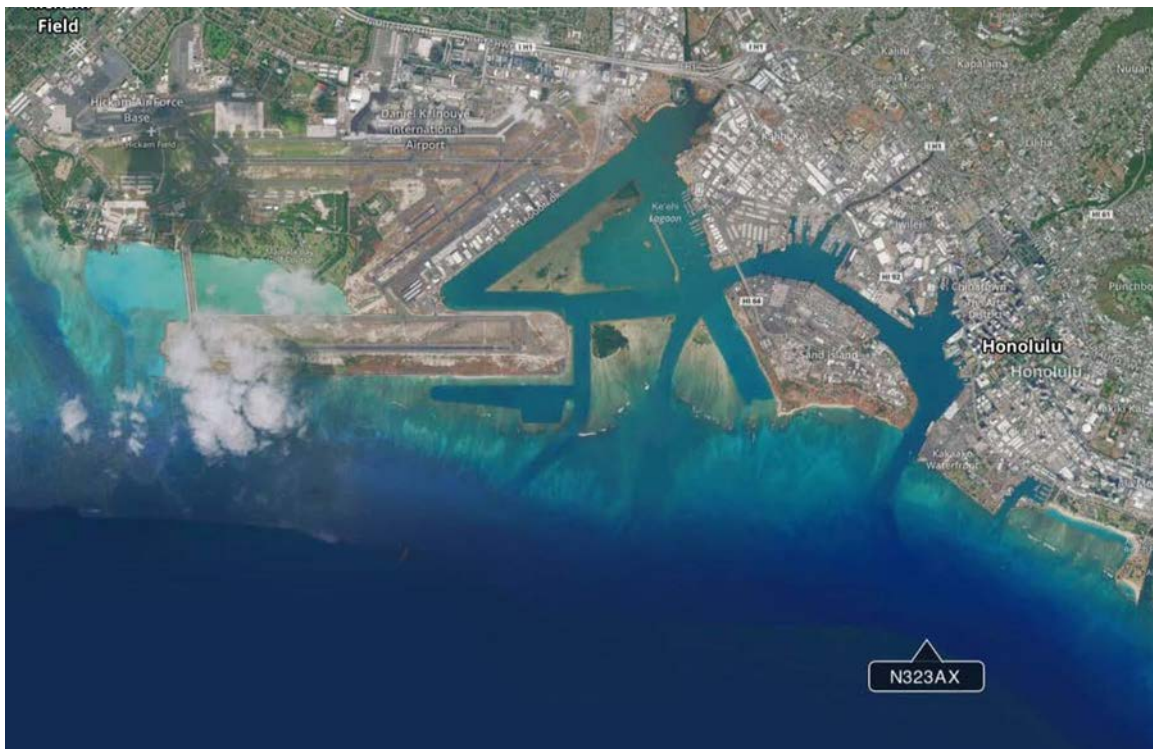
Wreckage location

The aircraft impacted the water in the vicinity of N21.2856 W157.8680 with a water depth of 250 feet. The aircraft impacted the water in an upright, slightly nose low, wings level attitude at 179 knots indicated airspeed. Eyewitnesses reported two external fuel tanks floating momentarily post-impact but reported that the remainder of the aircraft stayed intact and sunk. Following an exhaustive search, the aircraft was located, and extensive salvage operations were conducted to mitigate safety and environmental risks to the public as well as provide as much evidence as reasonably possible for the mishap safety investigation. The salvage operation recovered portions of the cockpit's panels as well as the aircraft's fuselage aft of the front of the engine. The fuselage and engine section were recovered from the water late in the evening of 8 January 2019. Germane to this investigation, the throttle quadrant, LP cock, EGT gauge, RPM gauge, TTC switch, TTC box, and G3X SD card were not recovered.

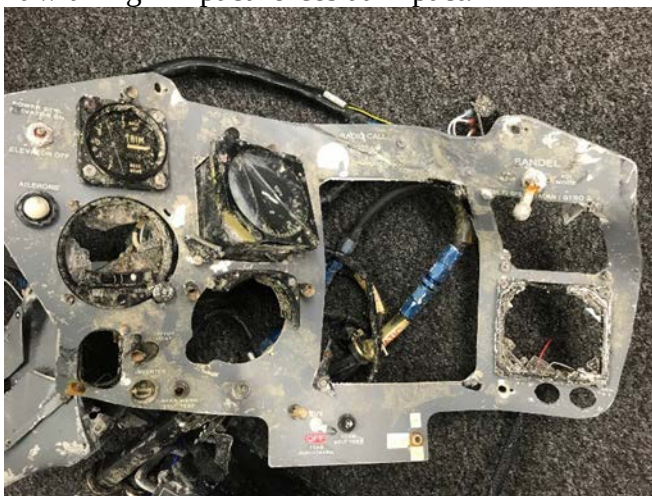
Instrument panel

**Cockpit.** The cockpit panels salvaged were investigated. Cockpit switches were generally unreliable either missing, broken, bent, or moved from position. Cockpit gauges recovered all had broken glass with significant damage noted. While heavily damaged, the airspeed gauge was deemed reliable, indicating 179 knots at impact. The degree of damage to the cockpit items recovered was consistent with high impact forces at impact.

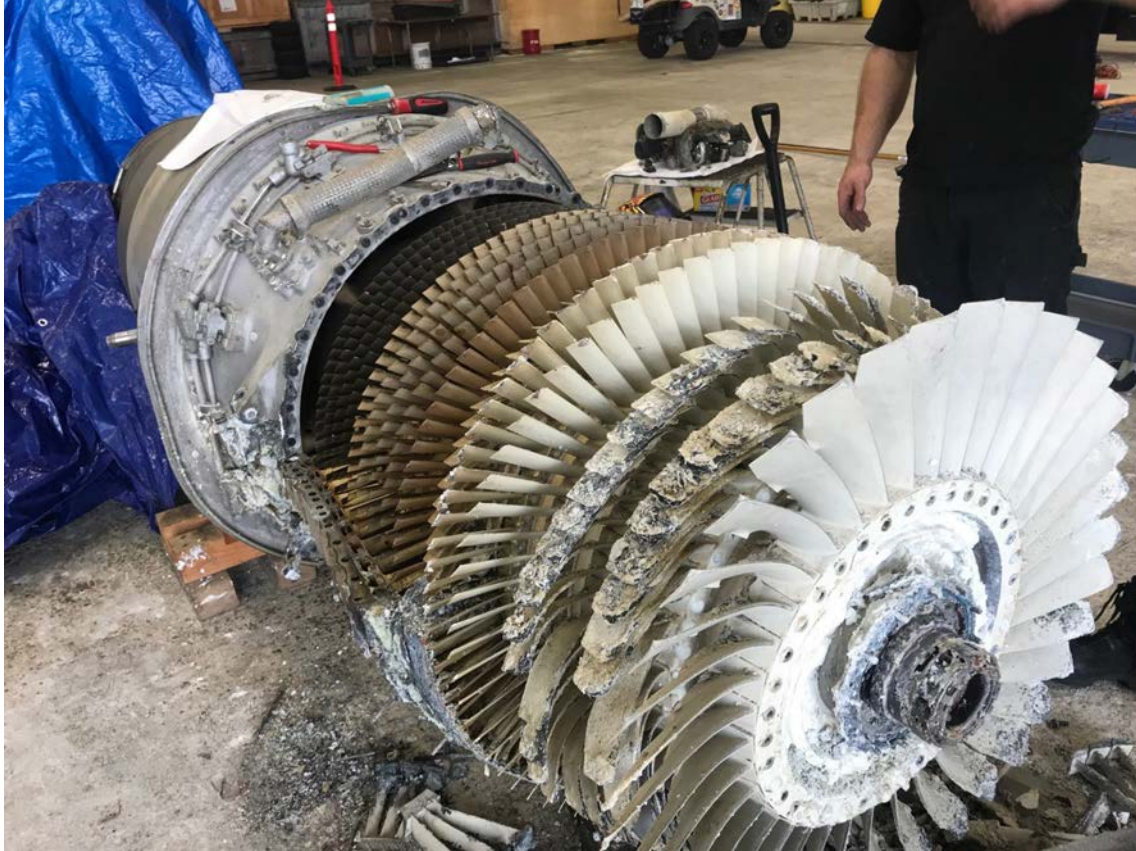
Engine

**Engine.** The engine was cut free and removed from the fuselage for evaluation. Following a freshwater rinse, the engine's general integrity was evaluated. It was observed that there was significant corrosion from saltwater exposure, particularly to magnesium components. The engine's compressor blades showed signs of damage from the engine casing being pushed inward upon water impact. However, there were no signs of damage from either internal or external FOD. There were also no "witness marks" in the tailpipe which would have signaled a potential FOD event. The degree of blade impact deflection observed indicates that the blades were turning upon impact, however not likely at full power as there was no "corn-cobbing" of blades as would be expected if the engine were turning at maximum thrust.

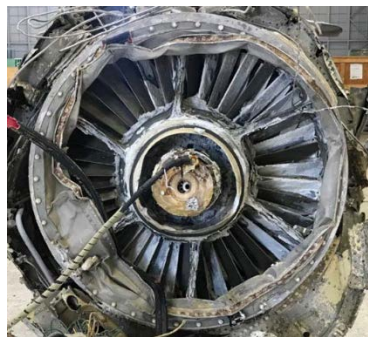
Inlet guide vanes

**Inlet guide vanes** The inlet guide vanes were evaluated and were observed to be in the fully closed position. There was significant post-impact corrosion observed.

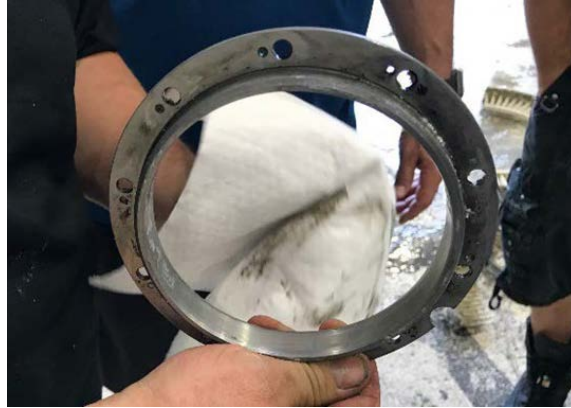
Engine bearings

**Engine bearings.** Once post-impact corrosion was removed, the engine was rotated by hand and showed no indications of seizure. An engine stage was separated, and the bearing showed no signs of seizure.

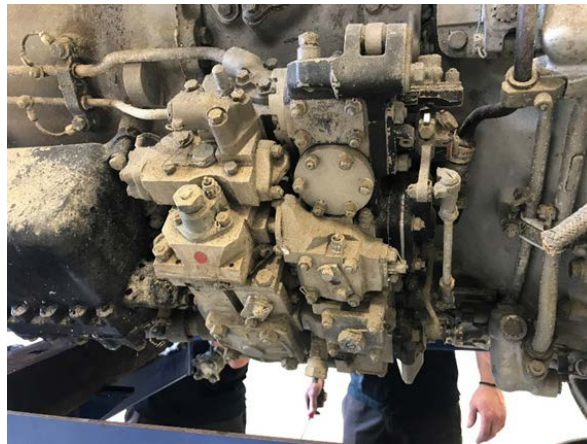
Fuel Control Unit

**Fuel control unit (FCU).** The throttle linkage to the FCU was tested and found to move smoothly, indicating no signs of failure (video available upon request). The FCU was removed and one solenoid which rolls the engine back when commanded was tested on site and functioned as designed. The FCU was shipped to Lortie Aviation for full bench testing. The testing was completed on 14 January and the FCU functioned as designed and was assessed to be fully functional.

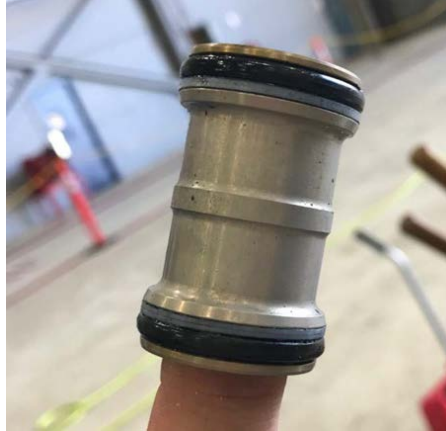
Fuel line

**Fuel line.** The fuel line between the FCU and fuel-oil heat exchanger was removed and inspected. The line's gaskets were observed to be in good condition the line was assessed as fully functional.

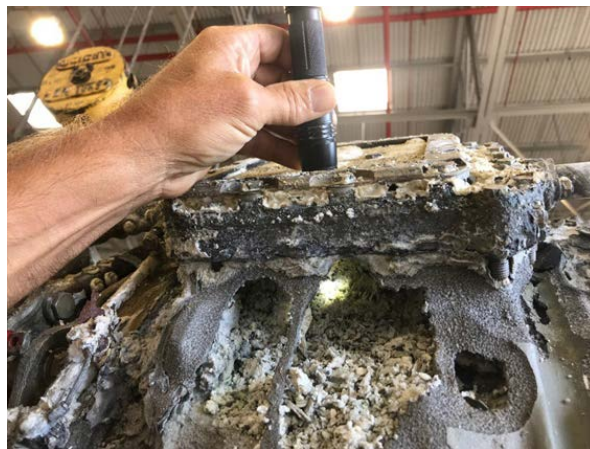
Bleed air valve

**Bleed air valve.** There was a large degree of post-impact corrosion around the bleed valve. A light was directed through the top of the bleed air valve and the light was seen on the other side indicating that the bleed valve was in the open position. The bleed valve was removed and cleaned. The bleed valve opened and closed when commanded by hand and was assessed to be fully functional.

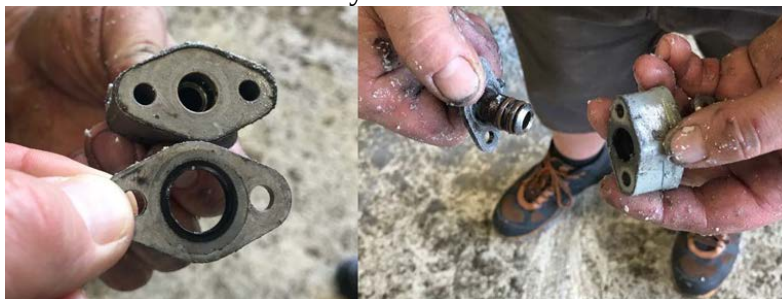
**N2 line.** The N2 line was inspected for general integrity and no defects were noted. The N2 line was removed and the “spezial” gasket and O-rings were observed to be in good condition with no defects noted and were assessed to be fully functional.

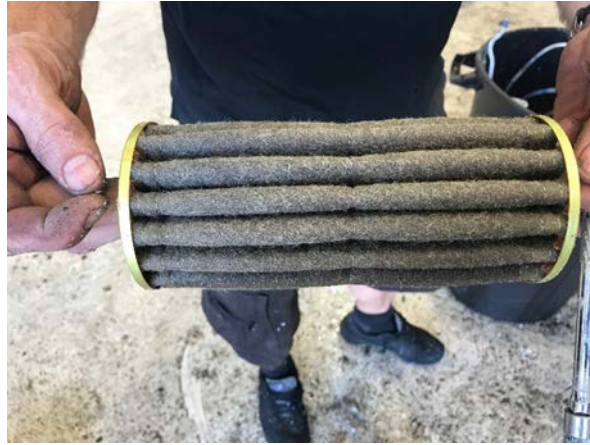
Fuel Filter

**Fuel filter.** The fuel filter was removed and inspected. The fuel filter was clean, with no debris noted, and was assessed to be fully functional.

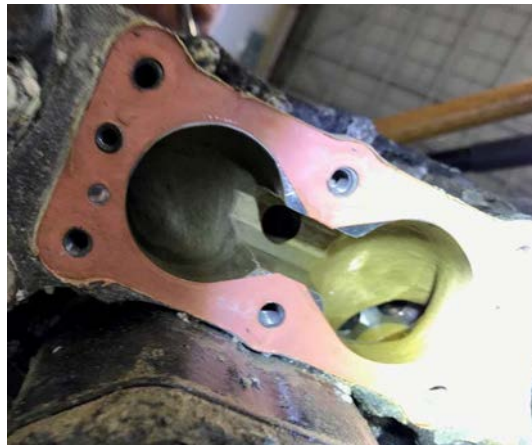
Fuel pump

**HP Fuel pumps.** There was significant post-impact corrosion observed in the vicinity of the HP fuel pumps. The pumps were removed, cleaned, and evaluated on site. The fuel pump heads showed no signs of scorching, the presence of which would have indicated air in the fuel line. The pump shaft was observed in good condition. The pumps were turned by hand (video available upon request) and the pumps turned as designed, even pumping residual fuel from the component. The HP fuel pumps were assessed on site as fully functional but were shipped to Lortie Aviation for full bench testing.

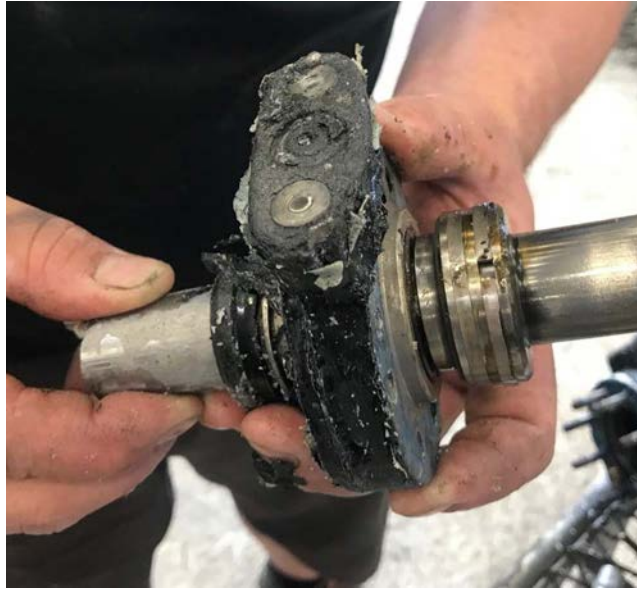
**PV Ram.** The PV Ram was removed and disassembled on site. The PV Ram diaphragm was evaluated and observed to be in good condition with no pinholes or rips. The PV Ram temperature probe was evaluated and was observed to be in good condition with no signs of scorching or burning smell which would have been indicative of a failure. The position of the PV Ram shaft was positively against the stops, indicating without doubt that the IGVs were

commanded “closed” and the bleed valve was commanded “open”. The PV Ram was assessed on site as fully functional, however it was shipped to Lortie Aviation for full bench testing.
