## Air Safety Investigations Aircraft Incident/Accident Technical Report

| Aircraft Incident/<br>Accident Information | Year: 1956 | Make: Cessna | Model: 180 |
| Location: Townsend, MT | | Date: 01-02-19 | Time: 1650 MST |
| Senior Air Safety Investigator: Peter J. Basile | | Report #: ASI-19-AK-T | Report date: 06-05-19 |

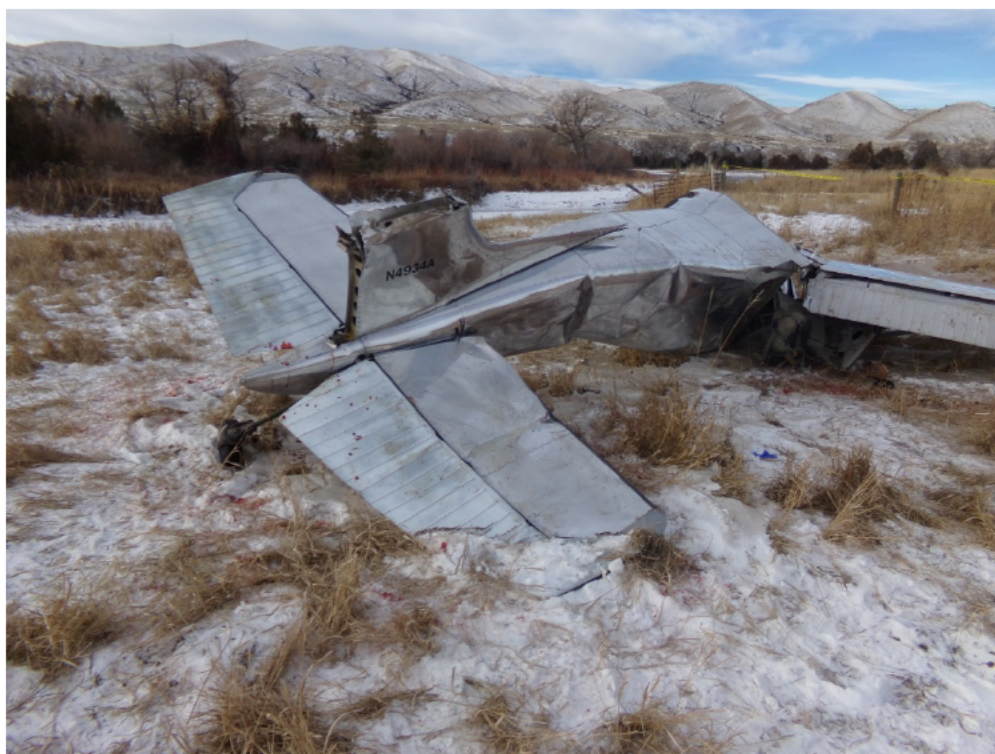
The leading edge of the vertical stabilizer sustained two powerline impacts. One powerline penetrated the leading edge and struck the forward spar. The other powerline cut completely through the vertical stabilizer and severed the top 2.5 feet of the surface. The powerline struck the leading edge of the rudder and separated it from the structure. The leading edge of the vertical stabilizer exhibited powerline arcing and the leading edge of the rudder had multiple powerline cable strand striations. The aircraft impacted the ground in a nose down attitude and sustained lower forward cabin compression damage.

On-site Photographs taken by the Broadwater County Sheriff's Department

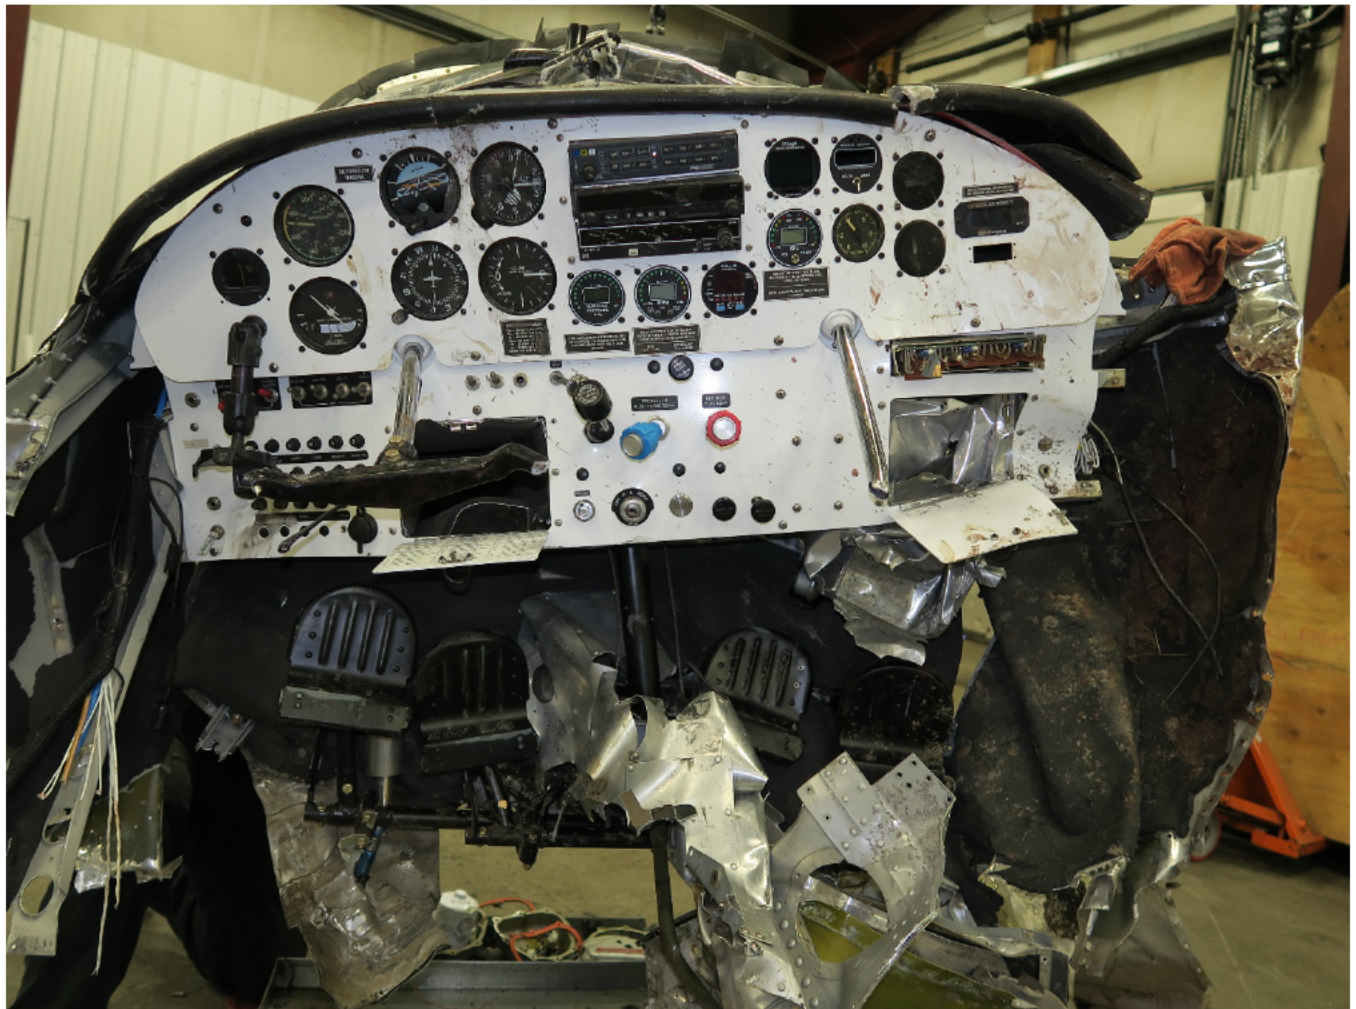
Instrument Panel

Control cable continuity was established for all flight controls. The fuel selector valve was on the RIGHT tank. The wings had minor leading edge impact damage. The instrument panel and rudder pedals were separated from the fuselage by recovery personnel and remained attached to the firewall and engine.
