# Continental Motors

## ENGINE EXAMINATION REPORT

| ENGINE MODEL | O-470-K (P. Ponk conversion to O-470-50) |
| FILE NUMBER | 18-346 |

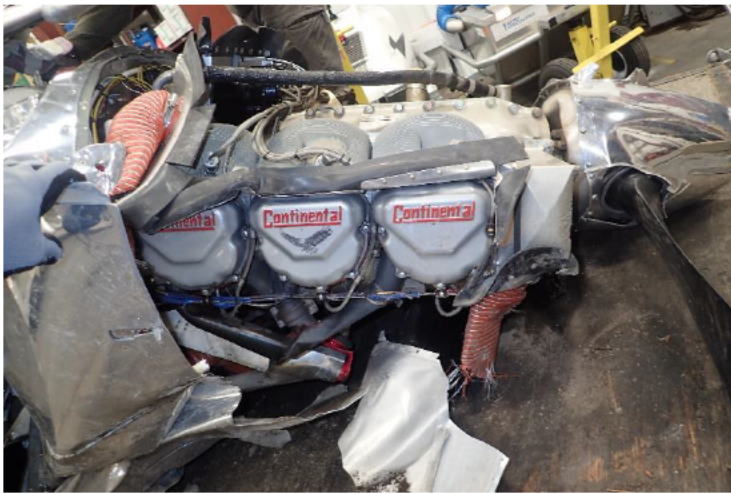
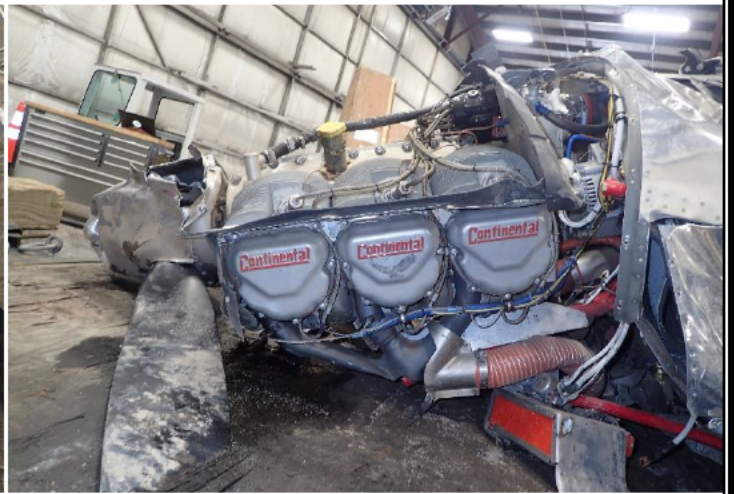
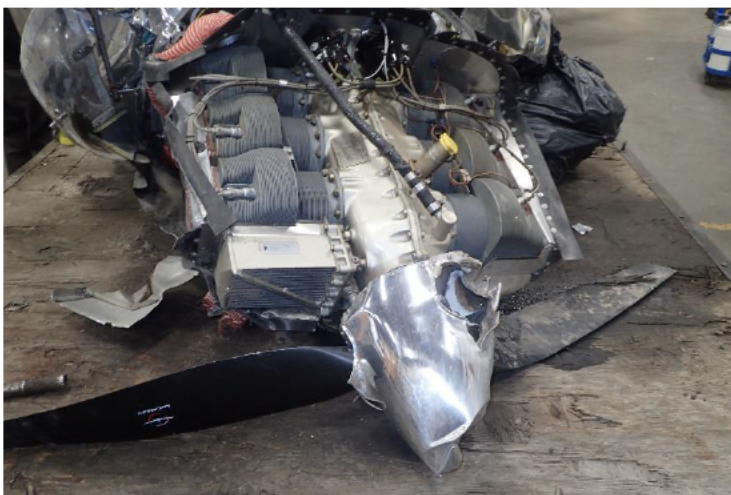
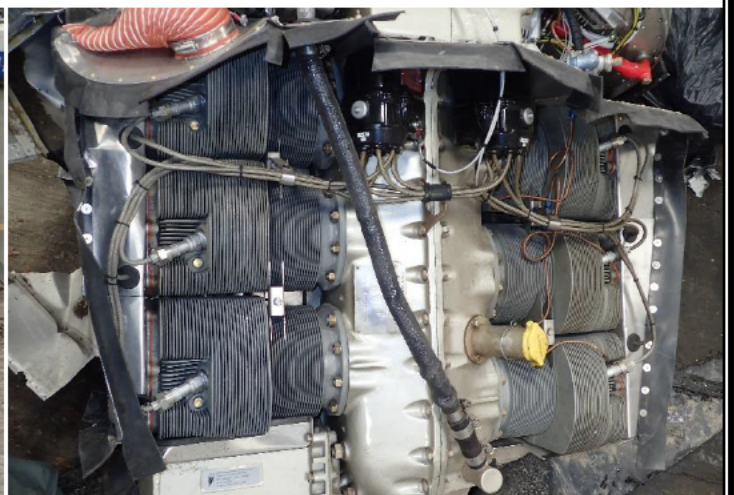
The engine remained partially attached to the airframe through cables, wires, and hoses; all four engine mounts were broken. The engine displayed impact damage signatures with the damage concentrated to the bottom and rear of the engine. The crankcase remained intact and there were no breaches to indicate a catastrophic internal engine failure. The three blade, constant speed propeller remained attached to the crankshaft, one of the propeller blades had released from the hub. All six-cylinder remained attached to their cylinder bays and displayed minor impact damage signatures.

Both of the magnetos remained attached to their installation points and were undamaged. The ignition harness remained attached to both magnetos and to each spark plug; the harness displayed some impact damage signatures to the bottom ignition leads. All of the spark plugs remained attached to their cylinders and were undamaged.

The carburetor remained attached to its installation point and displayed impact damage signatures. There were no signs of fuel leaks noted around the carburetor.

The induction system displayed impact damage signatures with most of the damage occurring to the rear portion of the induction system. There were no signs of induction leaks noted. The exhaust system displayed impact damage signatures; the heat exchanger and tailpipe had broken free from the rest of the system. There were no exhaust leaks noted.

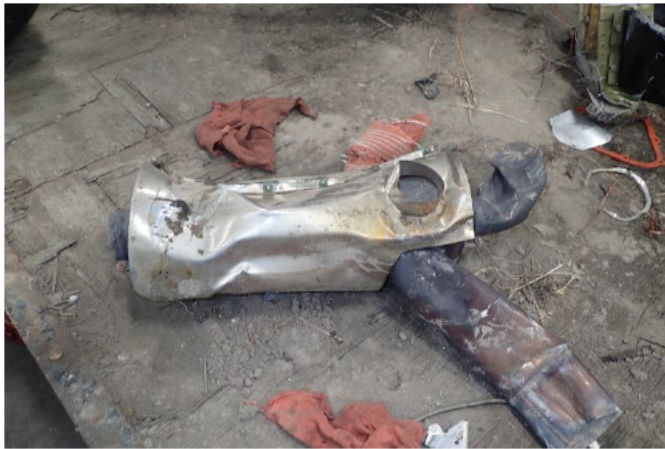
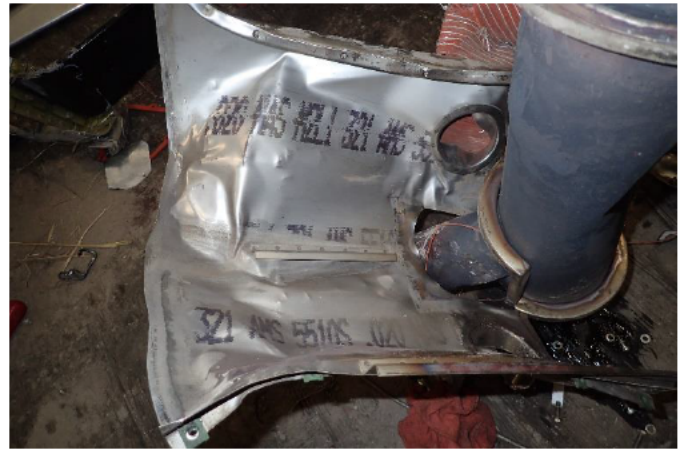
### EXHAUST SYSTEM

The exhaust system displayed impact damage signatures in the forms of crushing, bending, and tearing. The cabin heat exchanger and tailpipe had broken free from the rest of the exhaust system. The cabin heat exchanger shroud was removed and there were no signs of exhaust leaks. There were no anomalies noted with the exhaust system.

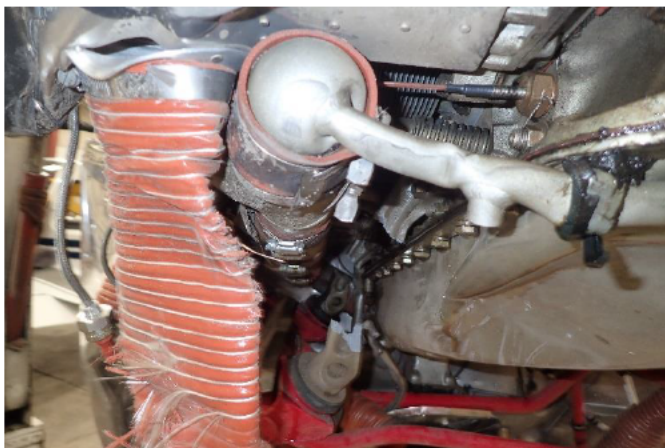
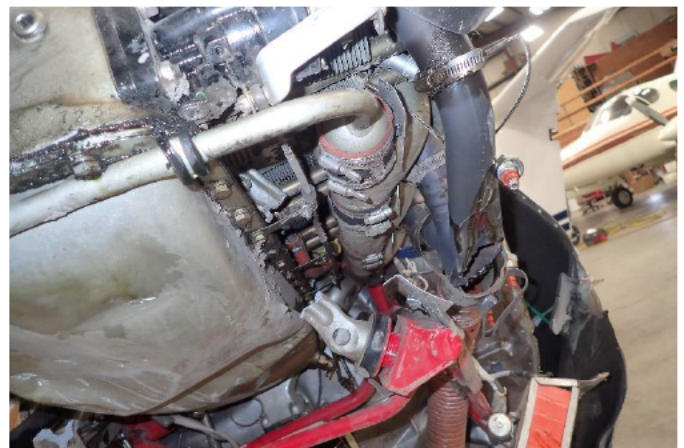
### INDUCTION SYSTEM

The induction system remained attached to the engine and displayed impact damage signatures. There were no signs of induction leaks or other anomalies noted.

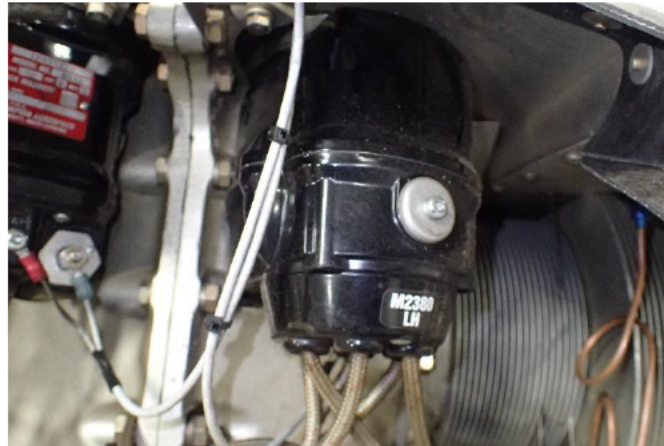
## LEFT MAGNETO

The magneto remained attached to its installation point and was undamaged. During crankshaft rotation it was noted that the magneto impulse coupling operated normally. During impulse coupling operation it was noted that the magneto was capable of producing a spark for all six ignition leads. There were no anomalies noted.

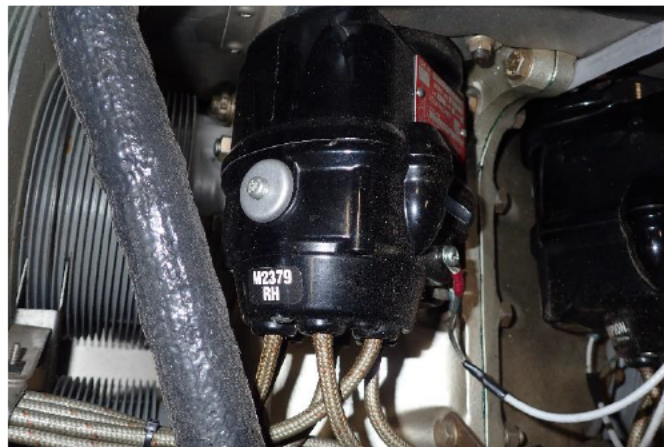
## RIGHT MAGNETO

The magneto remained attached to its installation point and was undamaged. During crankshaft rotation it was noted that the magneto impulse coupling operated normally. During impulse coupling operation it was noted that the magneto was capable of producing a spark for all six ignition leads. There were no anomalies noted.

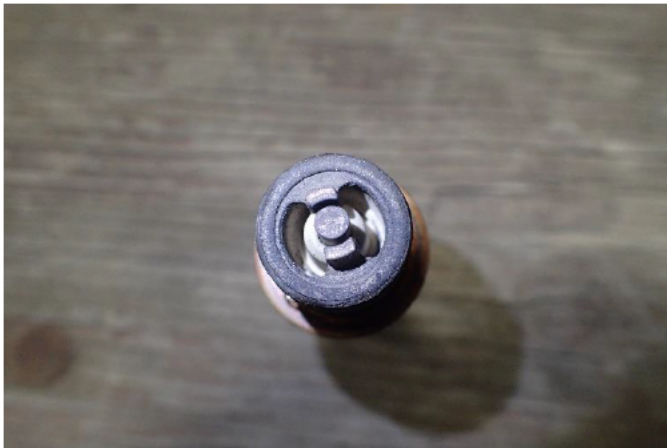
#1 Top Spark Plug

All of the spark plugs remained installed in their cylinders and were undamaged. The top spark plugs were removed, and the electrodes were visually inspected. The electrodes displayed normal operating and wear signatures. The bottom spark plug electrodes were inspected using a lighted borescope; the electrodes displayed normal operating signatures. There were no anomalies noted.

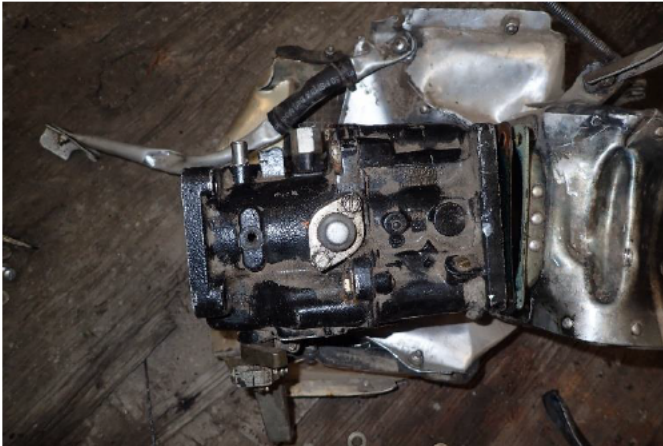
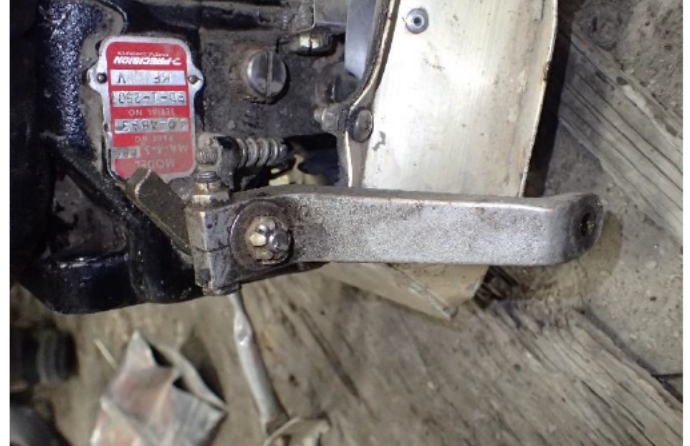
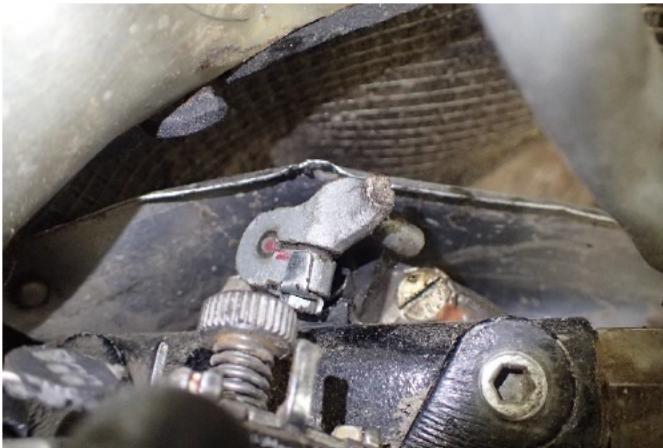
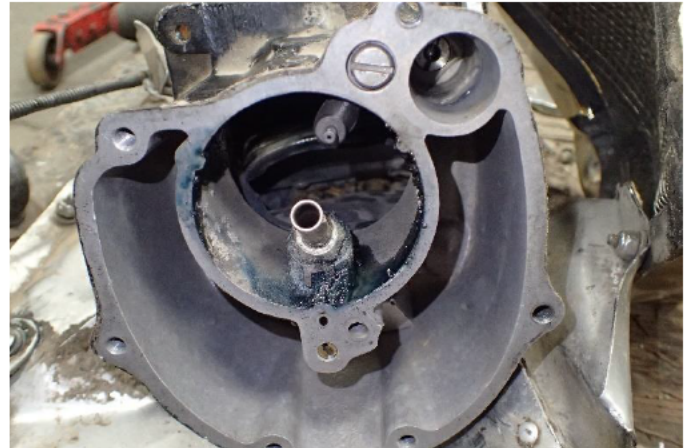
### CARBURETOR

The carburetor remained attached to its installation point and displayed impact damage signatures; a portion of the mixture control arm had broken free from the rest of the arm. The carburetor was removed and disassembled. The internal components displayed normal operating signatures and there was blue staining near the carburetor jet. The fuel inlet screen was removed and was noted to be free of contaminates.

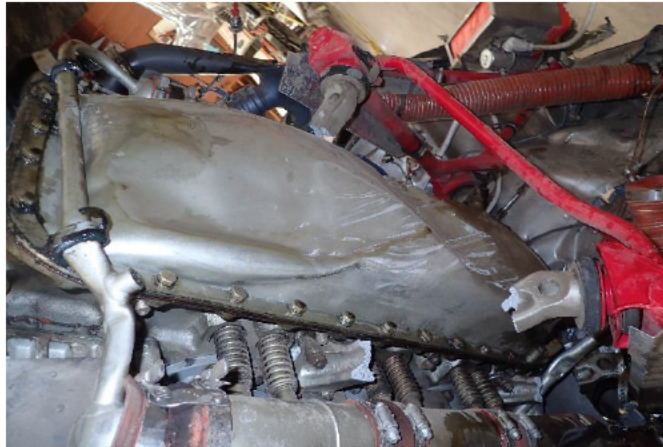
### OIL SUMP

The oil sump remained attached to the engine and displayed impact damage signatures; the sump was crushed, and the quick drain valve was broken. There were no anomalies noted with the sump.

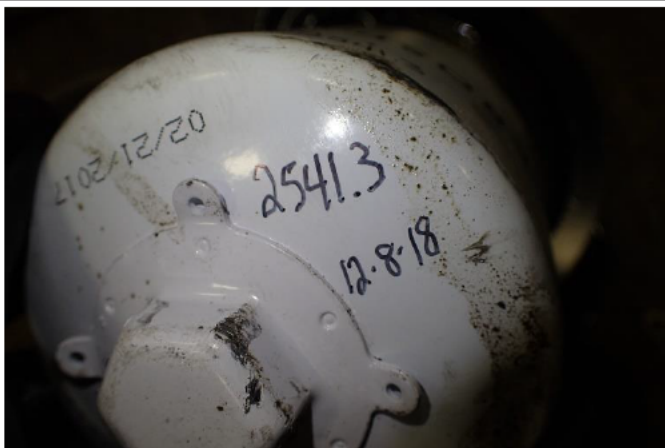
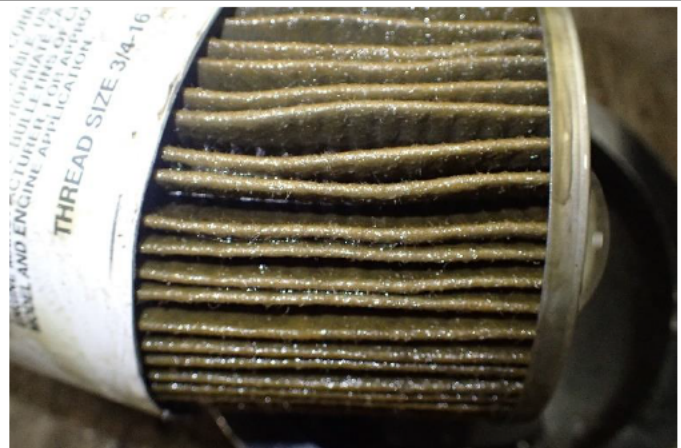
### OIL FILTER

The oil filter remained attached to the oil filter adapter and displayed impact damage signatures. The oil filter housing had the following written on it: "2541.3" and "12-8-18". The oil filter housing was cut open and the filter pleats were visually inspected. There was no metallic material found within the filter pleats. There were no anomalies noted.

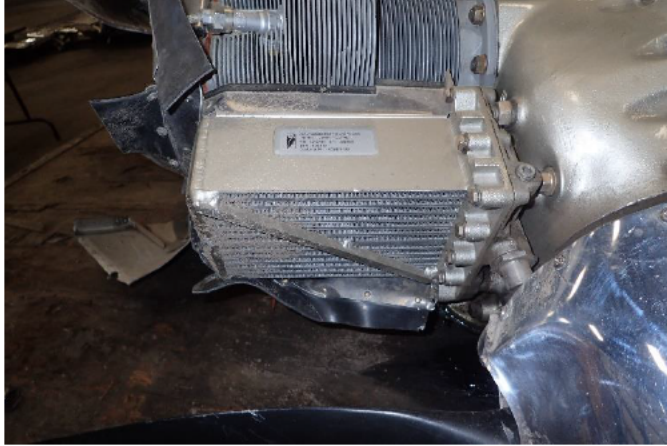
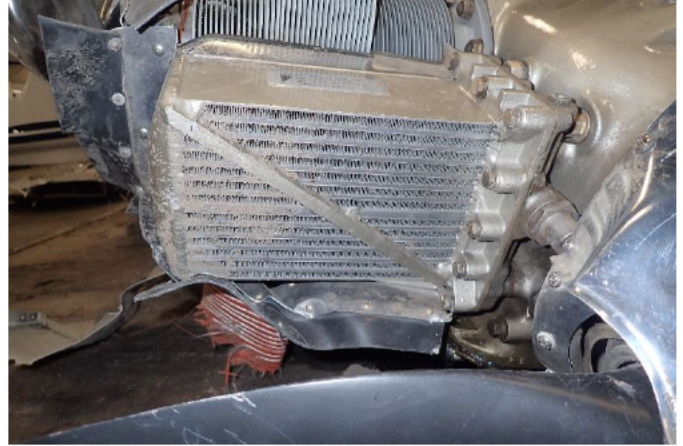
## OIL COOLER

The oil cooler remained attached to its installation point and displayed minor impact damage signatures. There were no anomalies noted.

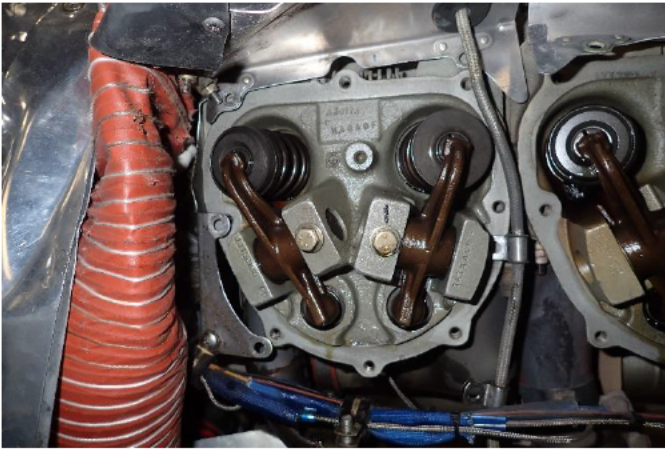
#1 Cylinder

All of the cylinders remained attached to their cylinder bays and displayed only minor impact damage. The cylinders were inspected using a lighted borescope; the piston faces, cylinder bores, and valve heads displayed normal operating and combustion signatures. During crankshaft rotation all of the cylinders displayed good thumb compression and suction. The overhead components (valves, springs, and rocker arms) displayed normal operating and lubrication signatures. There were no anomalies noted.

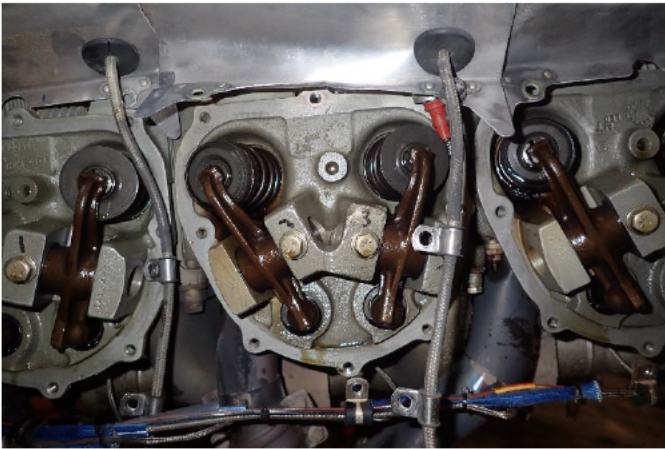
#3 Cylinder (borescope photo obscured by oil on lens)

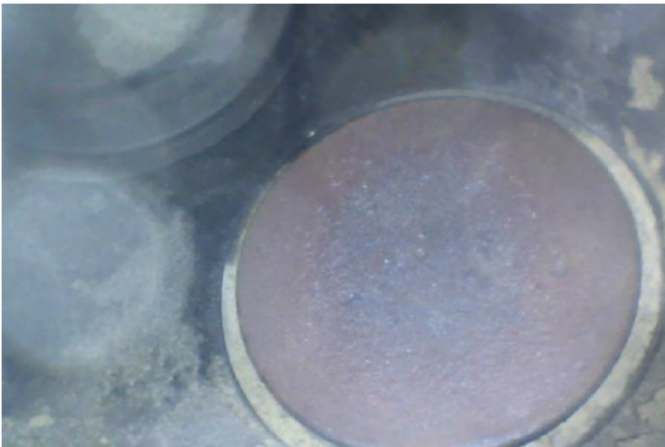
#1 Exhaust Valve

The valve heads were inspected using a lighted borescope. The valve heads displayed normal operating and combustion signatures. During crankshaft rotation all of the valves operated normally. There were no anomalies noted.

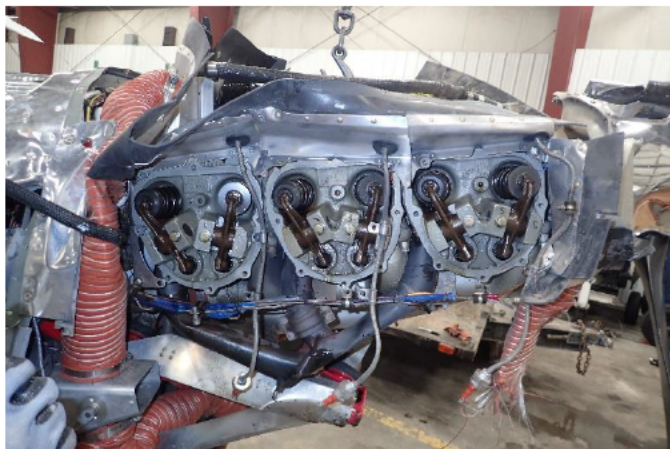
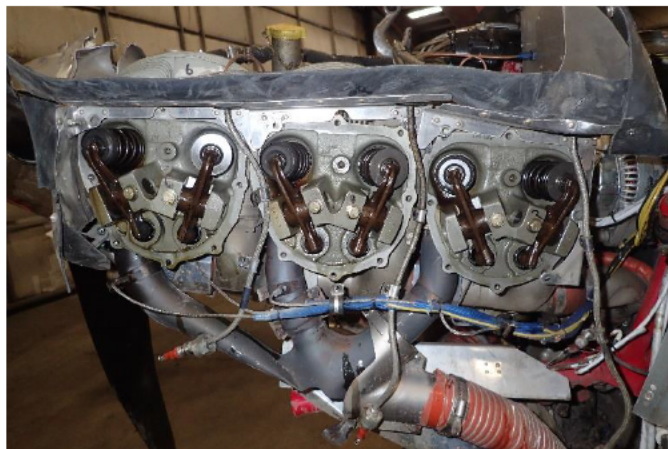
### ROCKER ARMS AND SHAFTS

All of the rocker arms remained attached to their installation points and were undamaged. The rocker arms displayed normal operating and lubrication signatures. It was noted that during crankshaft rotation all of the rocker arms operated normally.

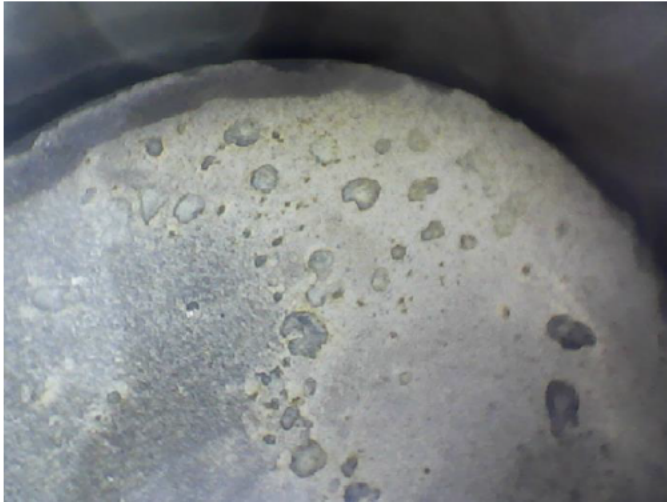
#1 Piston

The piston faces were inspected using a lighted borescope. The piston faces displayed normal operating and combustion signatures. During crankshaft rotation all of the pistons were noted to operate normally. There were no anomalies noted.

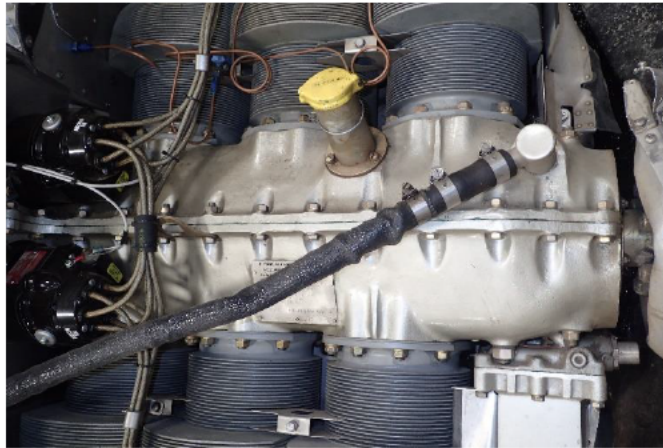
## CRANKCASE ASSEMBLY

| CRANKCASE | Casting Number: | 1-3-5: Not observed | 2-4-6: 539488 | S/N: 723 |
|---|---|---|---|---|
| Condition: | The crankcase remained intact and displayed minor impact damage. There were no breaches in the crankcase that would indicate an internal engine failure. There were no anomalies noted. | | | |

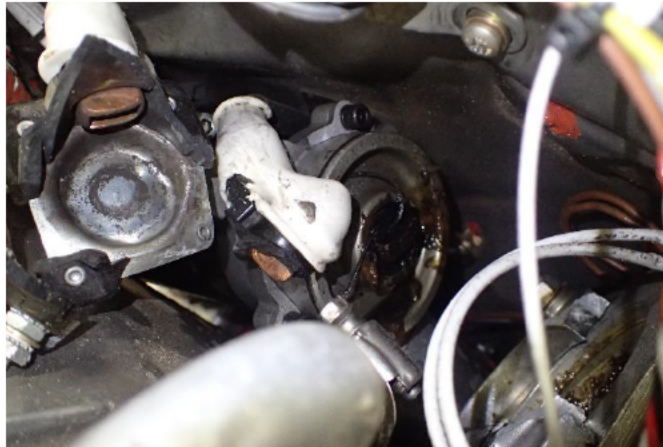
### STARTER

The starter had broken free from the starter adapter and displayed impact damage signatures. There were no anomalies noted.

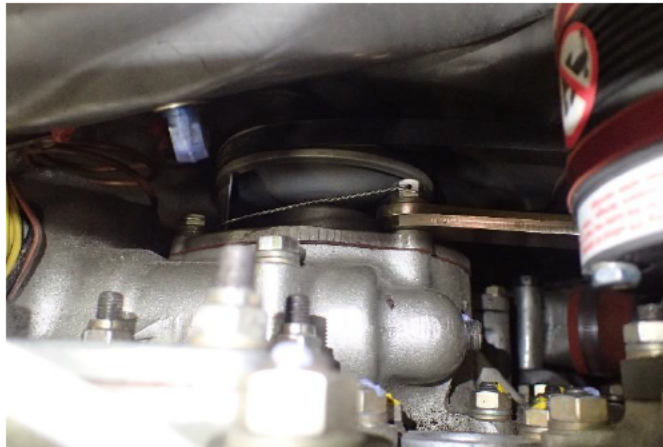
### STARTER ADAPTER

The starter adapter displayed impact damage signatures; the starter had broken free from the attach flange. There were no anomalies noted with the adapter.

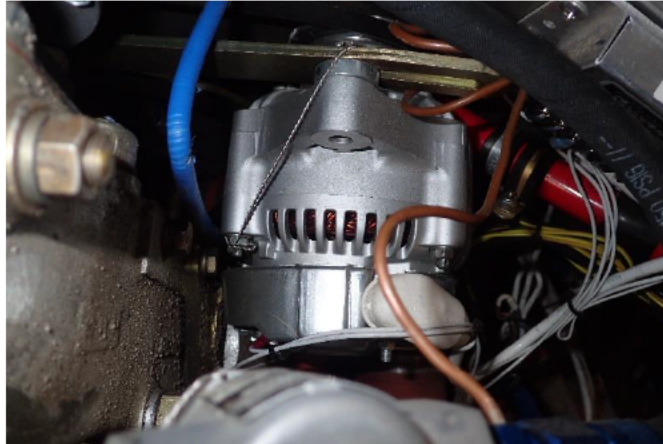
## ALTERNATOR

The alternator remained attached to the engine and was only partially visible. There were no anomalies noted with the visible portions of the alternator.

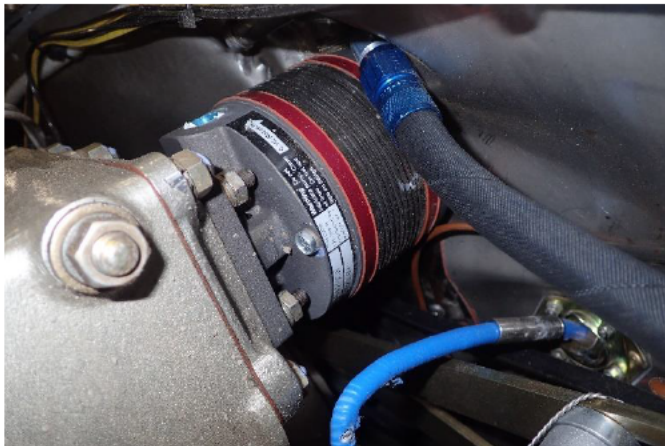
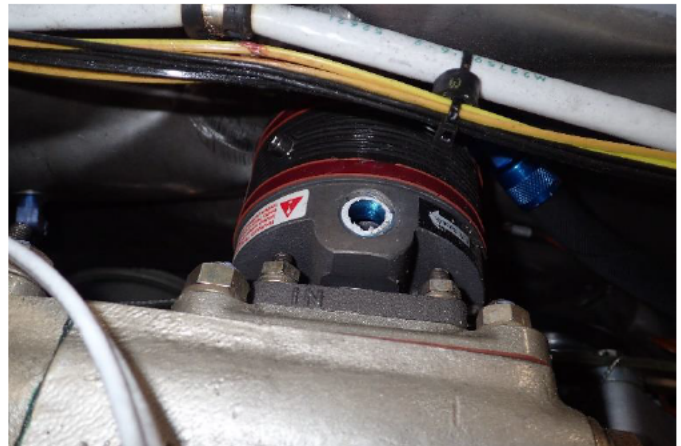
## VACUUM PUMP

The vacuum pump remained attached to its installation point and displayed impact damage signatures. There were no anomalies noted.

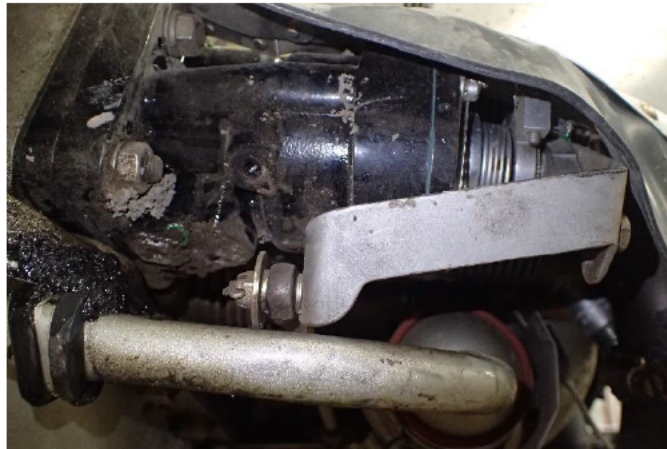
PROPELLER  
GOVERNOR

The governor remained attached to its installation point and the governor displayed impact damage signatures. There were no anomalies noted with the governor.

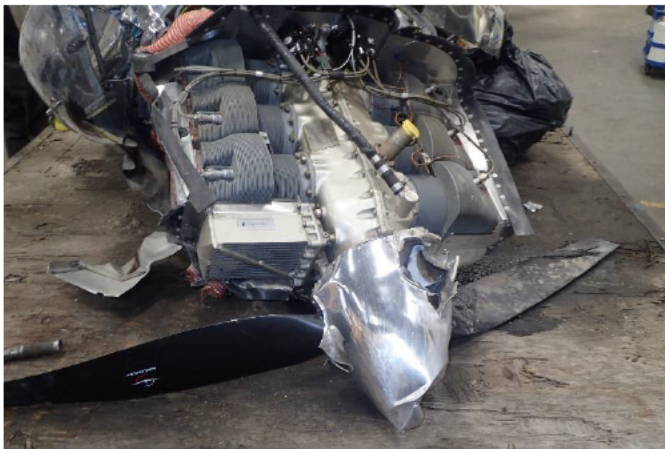
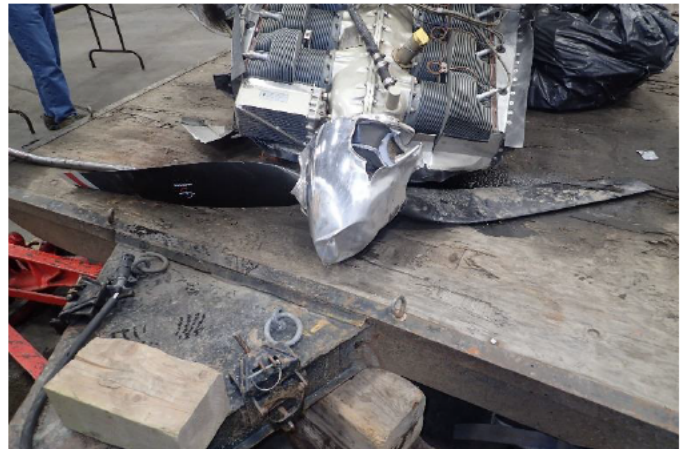
## PROPELLER

The three blade, constant speed propeller remained attached to the crankshaft and two of the three blades remained within the propeller hub. The propeller blades displayed impact damage signatures. Propeller blade "A" had released from the hub and displayed minor twisting deformation and leading-edge polishing. The propeller blade marked "B" displayed minor twisting and leading-edge polishing. The propeller blade marked "C" displayed aft bending deformation and minor leading-edge polishing.
