# NATIONAL TRANSPORTATION SAFETY BOARD

## MATERIALS LABORATORY FACTUAL REPORT

Report No. 19-069

Place : San Diego, California  
Date : December 30, 2018  
Vehicle : Piper PA-46-350P, N4161X  
NTSB No. : WPR19LA060  
Investigator : Elliott Simpson, AS-WPR

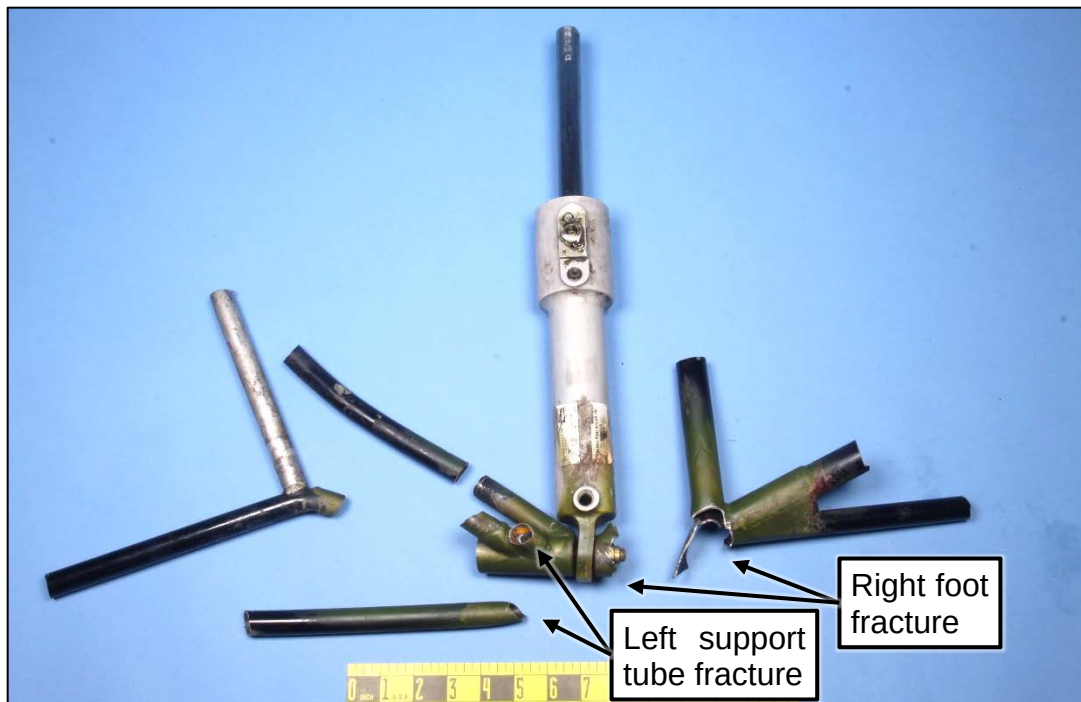
An overall view of the submitted engine mount pieces with attached nose landing gear actuator is shown in figure 1. The engine mount was fractured at the right attachment foot and at one of the support tubes on the left attachment foot as indicated in figure 1. The nose landing gear actuator remained bolted to pieces of the left and right attachment feet.

As shown in figure 1, the ends of the engine mount away from the inspection area were covered with black paint. In the inspection area, the black paint had been removed, and the surfaces were covered with a thin yellowish green coating. No evidence of a semitransparent brown waxy film consistent with Dinitrol AV8 or AV30 was observed.

Figure 1. Overall view of the fractured engine mount pieces with attached nose landing gear actuator.

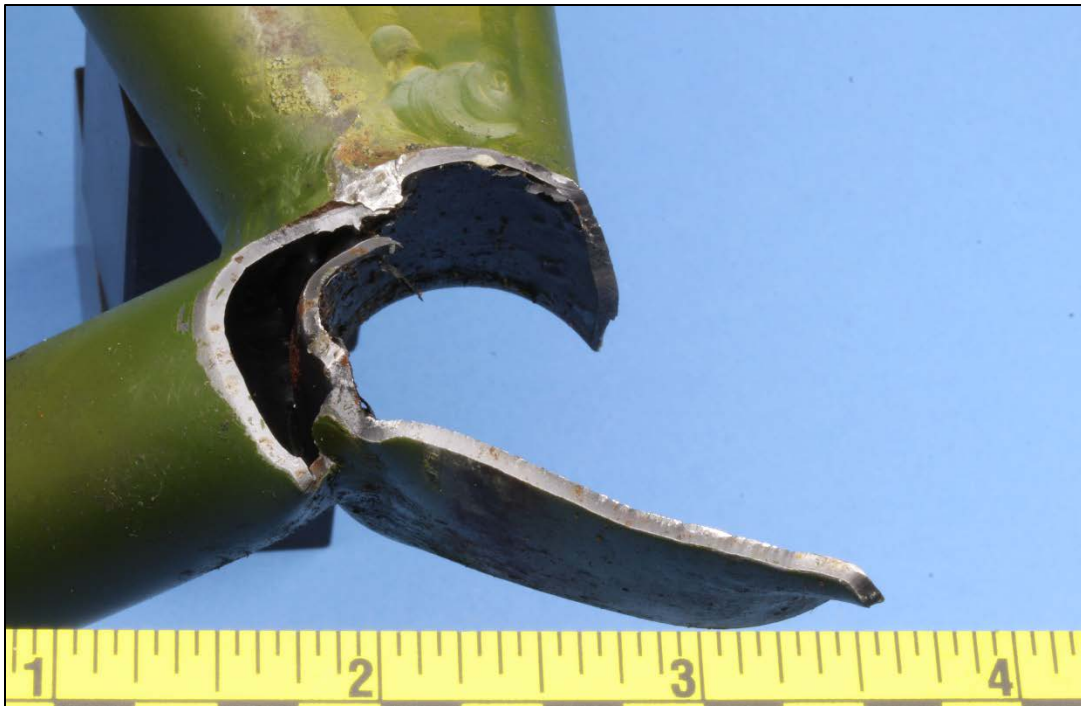
The fractures were examined using an optical stereomicroscope, and all fracture features had a uniform matte-gray appearance on slant angles, features consistent with ductile overstress fracture. A photograph of the fracture at the right attachment foot is shown in figure 2. No evidence of any preexisting cracks was observed.

Figure 2. Close view of the fracture at the right nose landing gear actuator attachment foot.
