## **NATIONAL TRANSPORTATION SAFETY BOARD**

# **LANDING GEAR EXAMINATION**

**WPR19LA060**

Location: San Diego, California  
Date: December 30, 2018  
Aircraft: PA46-350P, N4161X  
NTSB IIC: Elliott Simpson

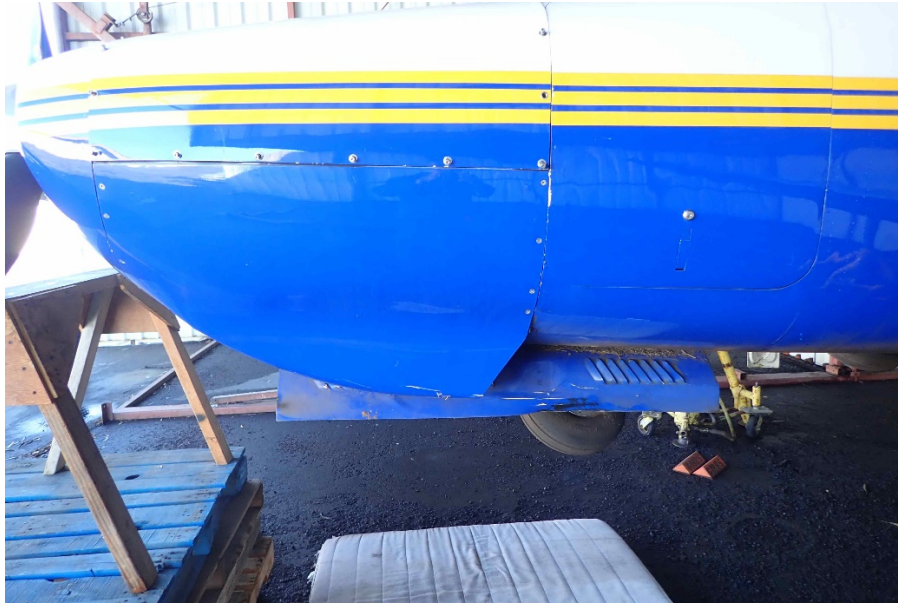
Photo1 – Nose Landing Gear

The nose landing gear appeared partially retracted and rotated, with the wheel showing just below the open gear doors (Photo 1). The oleo strut and trunnion assembly remained attached to the fuselage, the scissor link appeared undamaged, and the steering horn remained attached to the nose wheel. The down spring was intact. The tire appeared firm, and the left side of the tire lip exhibited indication of recent scuffing and material removal when compared to the right edge, which was raised and undamaged (Photo 2). The only damage observed was to the rub lock tang of the steering horn, and its associated roller on the engine mount (Photo 3).

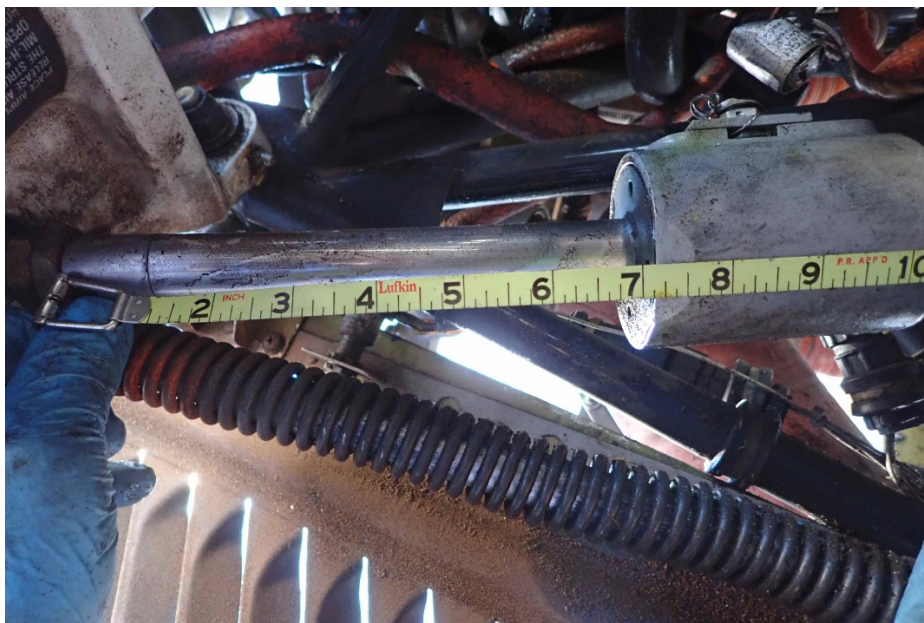
Photo 4 – Nose Landing Gear Actuator Piston

The actuator remained attached to the trunnion, and exhibited 7 1/8 inches of extension (full extension 6 7/8 per Piper) which appeared to indicate full extension (Photo 4). The actuator piston appeared to be locked in the extended position. The upper section of the actuator had broken free from its associated engine mount attach point, and was impinging against the firewall.

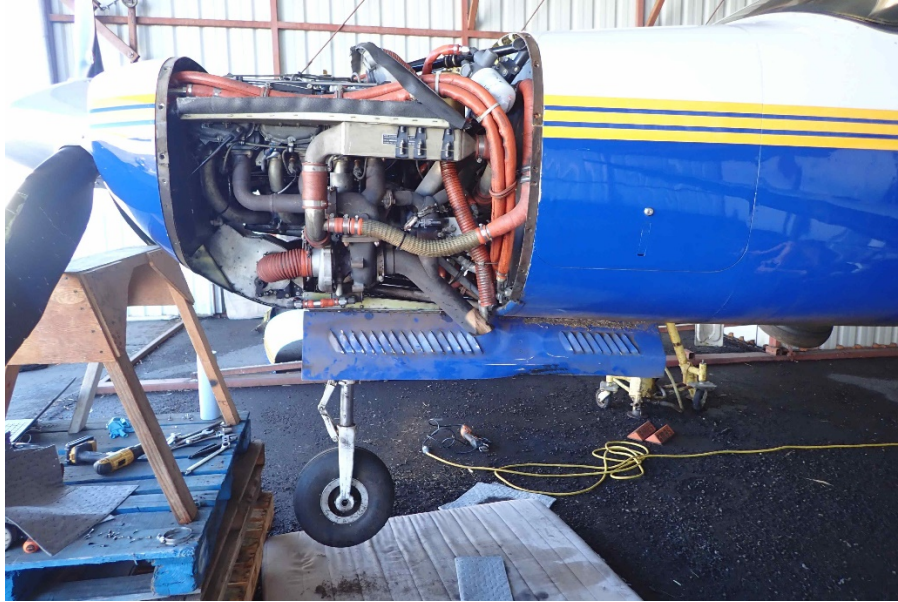
Photo 5 – Nose Landing Gear Extended

The actuator along with the damaged upper engine mount components was removed for further examination. With the actuator removed, the nose landing gear trunnion fell forward, and the gear fell and locked into place with the aid of the down spring (Photo 5). In this mode, the steering arm made contact with the steering horn and rollers, and no significant play was observed. Movement of the foot pedals now resulted in turning movement of the nose wheel.
