**The New Piper Aircraft, Inc.**  
2926 Piper Drive  
Vero Beach, Florida, U.S.A. 32960

# SERVICE *No. 1060* BULLETIN

**Brake Pedal Binding**

PA-46-310P Malibu

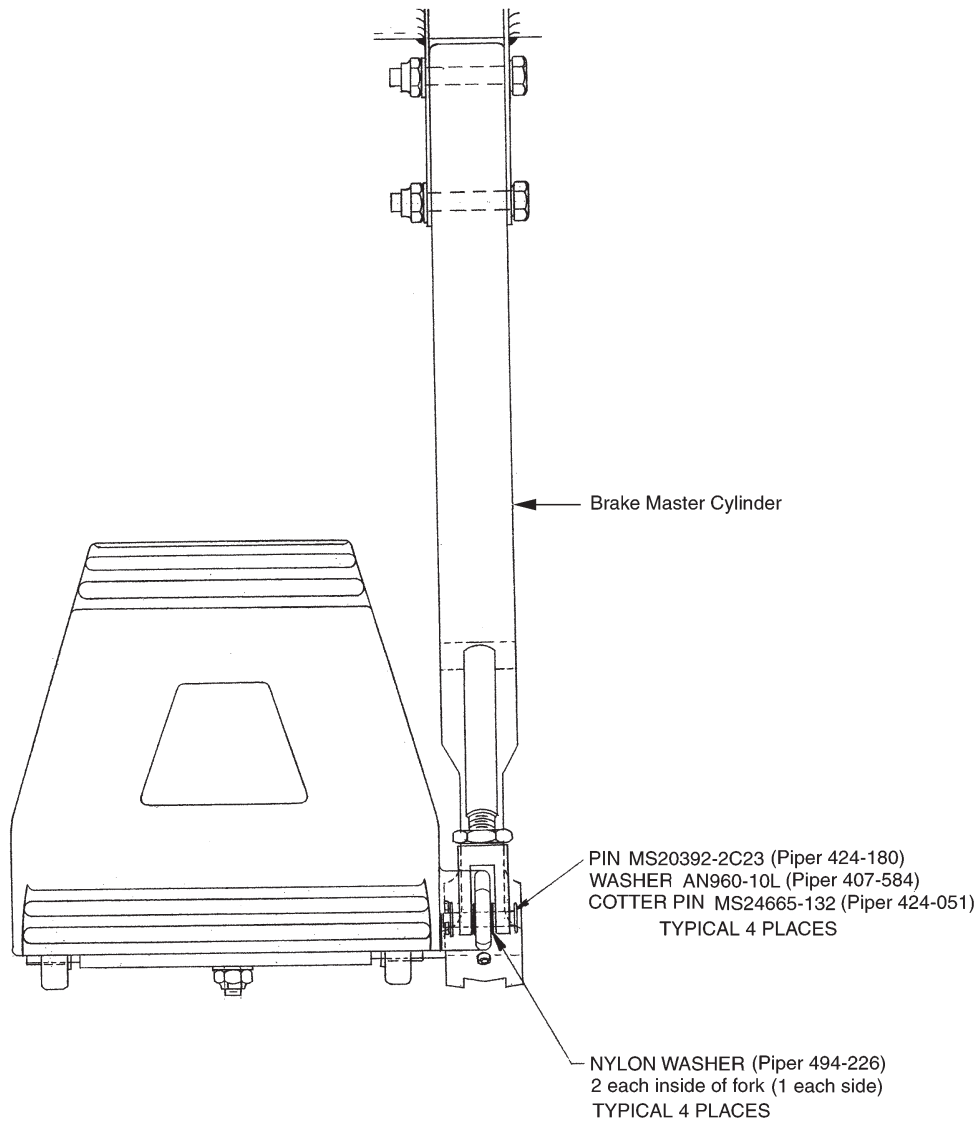
It has been discovered that the pin that attaches the brake master cylinder to the rudder pedals may be restricted in its movement, due to the installation of a spring washer, causing the brake pedals to bind and not fully release pressure to the brake system. This Service Bulletin provides instructions for the removal of the spring washer.

**Figure 1**  
Brake Master Cylinder to Rudder Pedal Attach Pin Installation  
(Shown with the spring washer removed)

1. Remove the attach pin and related hardware that attaches the brake master cylinder to the rudder pedal (4 locations).
2. Discard the spring washer and inspect the remaining hardware for condition and replace with new, if required.
3. Reinstall the attach pin and hardware without the spring washer.
4. Make a logbook entry indicating compliance with this Service Bulletin.

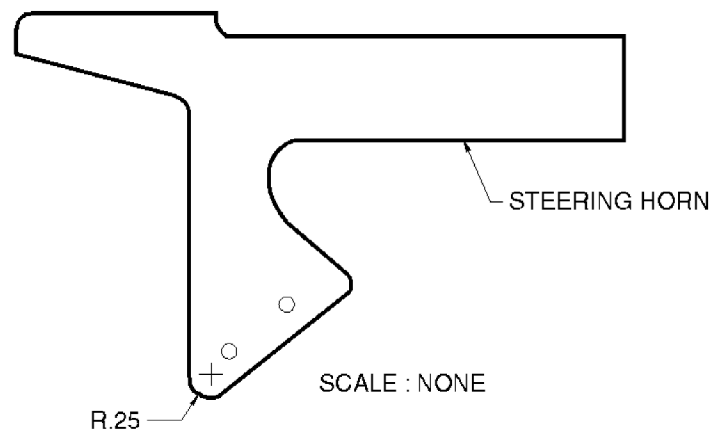
**Figure 1**  
Steering Horn

It has been discovered that when the aircraft is being towed (full left turn), the steering horn may contact and damage the engine mount tube located in the vicinity of the Nose Landing Gear (NLG).

1. Jack up the airplane per the Maintenance Manual. Gear is to be clear of the floor.
2. Disconnect both nose gear doors.
3. Retract the landing gear.
4. Trim the steering horn (P/N 85154-002) to incorporate the 0.25 radius as illustrated in Figure 1, (re-identify to P/N 85154-012) or replace the steering horn with a new steering horn, P/N 85154-012.

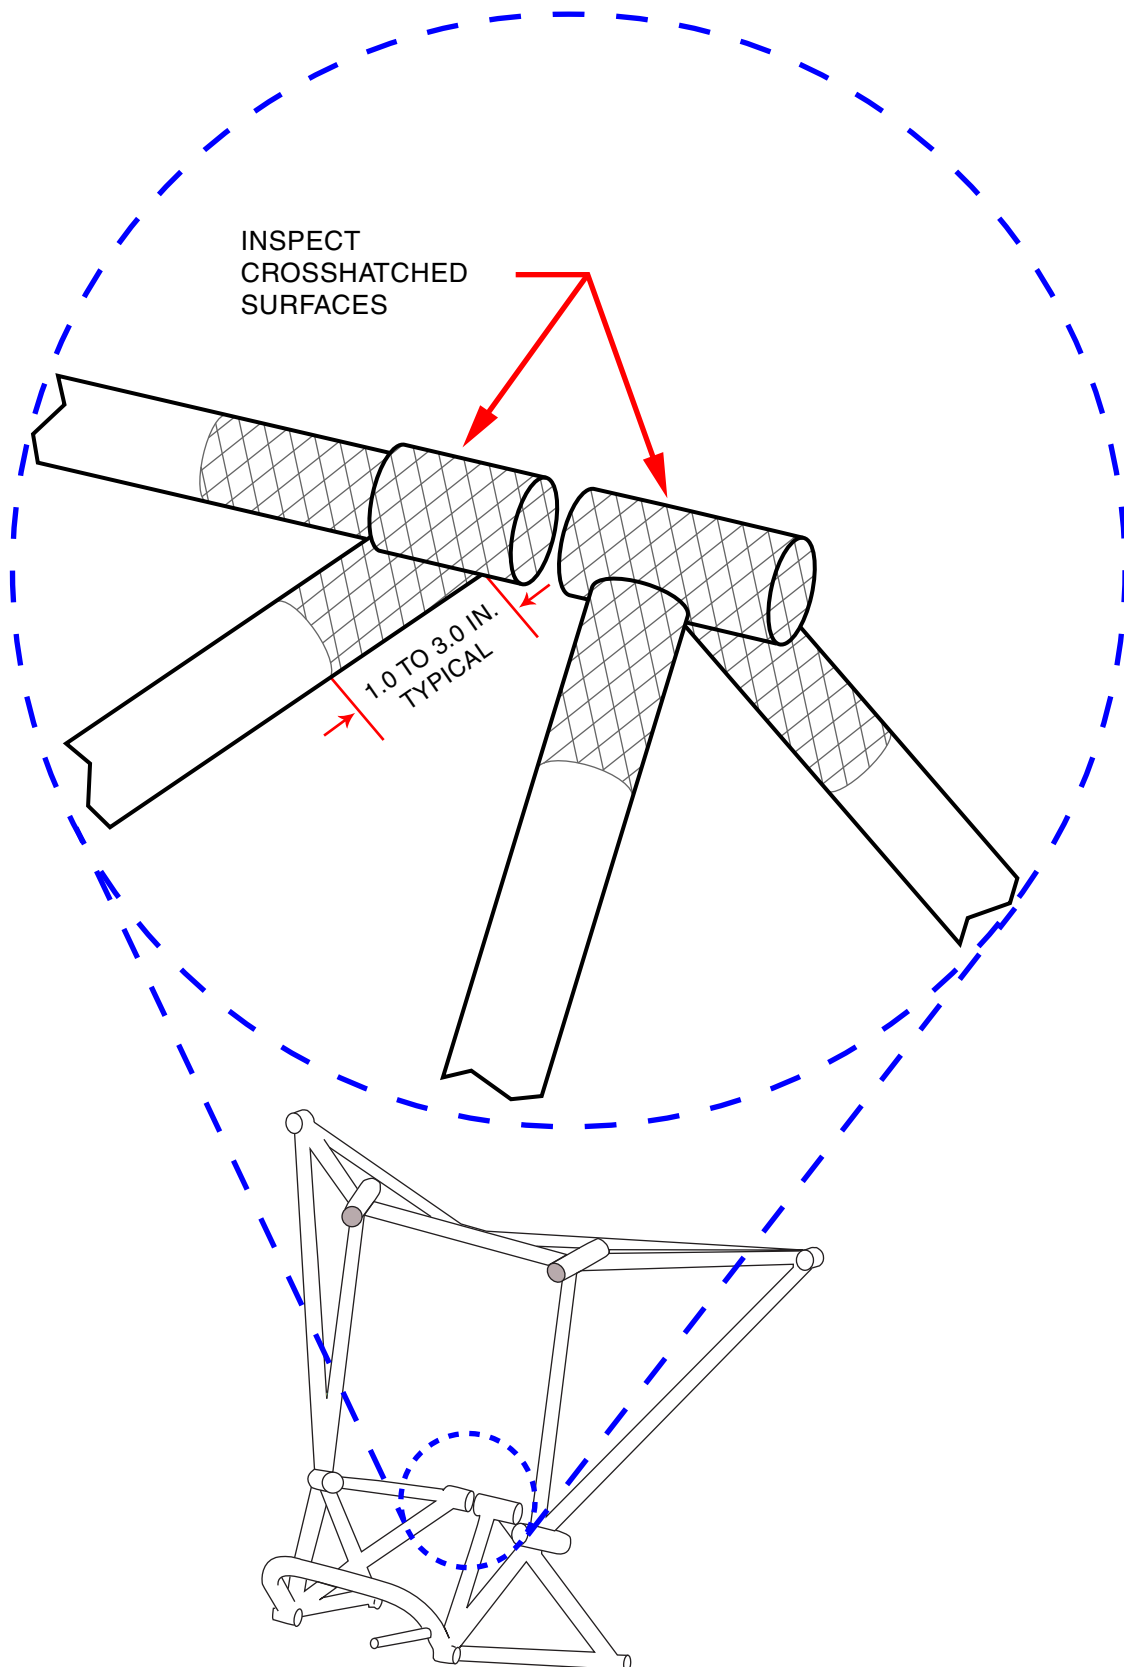
**Figure 1**  
Engine Mount Inspection Areas

Cracks may develop in the area of the nose gear actuator attach feet on the engine mount (see Figure 1). This condition can occur when the nose landing gear is subjected to excessive loads due to hard landings, rough field operations, excessive speed turns, improper airplane towing (sudden, aggressive starts and stops), or other improper operations.

1. Clean the engine mount actuator attach feet area.
2. Completely remove all of the paint or Dinitrol AV8 and AV30, if the paint was previously removed and covered with Dinitrol AV8 and AV30, from the inspection area (refer to Figure 1).

3. Perform fluorescent penetrant inspection of the nose gear actuator attach feet for cracks per AC 43.13-1B, Chapter 5, Section 5. Inspect the surfaces identified in Figure 1, with specific emphasis on welded areas.
4. If a crack is discovered, the engine mount must be replaced prior to further flight (refer to Table 1).
5. If no cracks are found, continue the repetitive inspection per the compliance time above.
6. Clean the feet and apply a two-coat corrosion prevention compound (CPC) to the area where the paint was removed. This two-coat CPC consists of Dinitrol/Ardrox AV8 as a primer coating and (after the AV8 has dried) Dinitrol/Ardrox AV30 as a top coating.
7. Make an appropriate logbook entry of compliance with this service bulletin for each repetitive inspection.

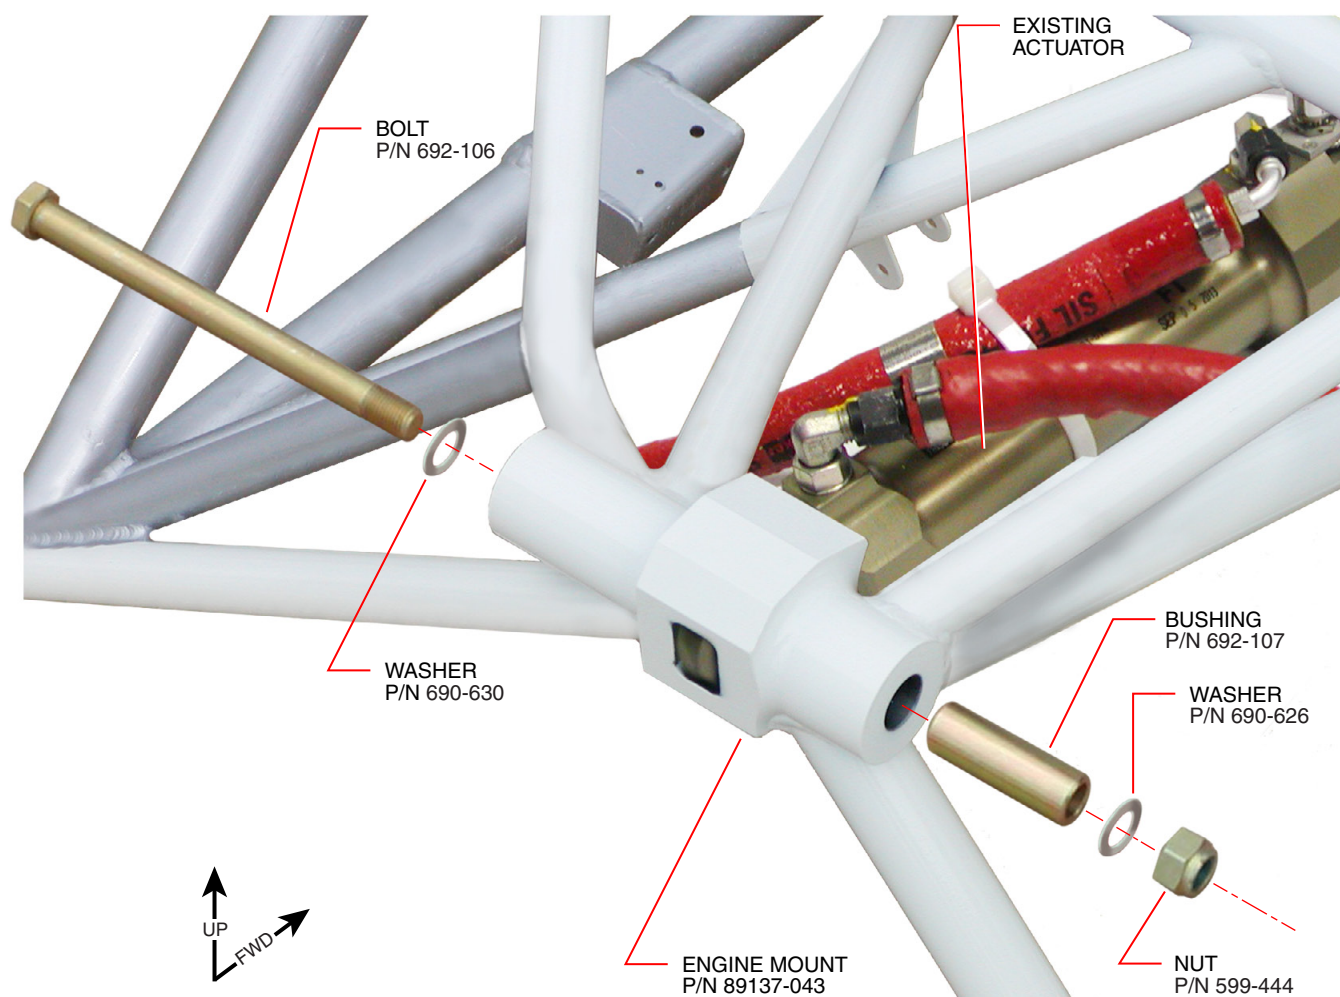
**Figure 2**

Engine Mount Hardware Installation - P/N 89137-043 Only

1. If cracks are found on the engine mount, order the appropriate replacement engine mount found in Table 1, and hardware, as required.
2. Install the new engine mount according to procedures in the applicable Piper airplane maintenance manual. For PA-46-350P Mirage or PA-46R-350T Matrix model airplanes only: fasten the aft end of the nose gear actuator to the engine mount using the hardware arrangement shown in Figure 2. Torque nut according to requirements in section 91-10-00 of the applicable Piper airplane maintenance manual. At all other locations, hardware in serviceable condition may be reused.

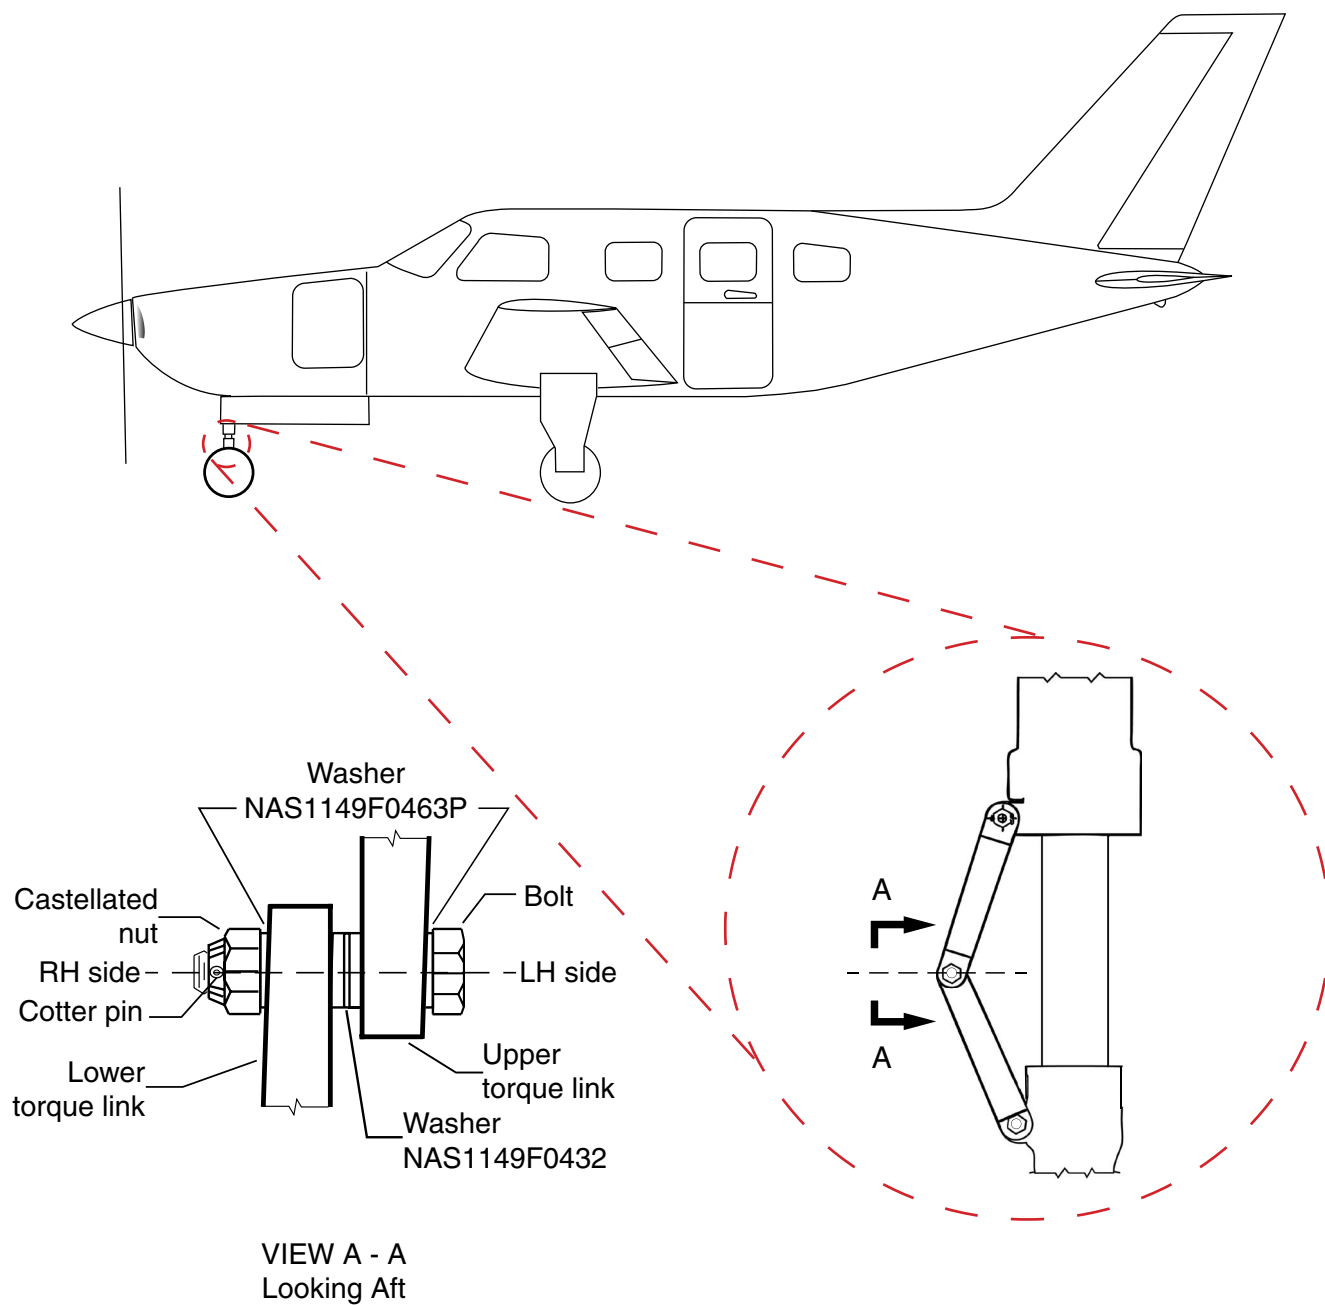
Under certain conditions, use of tow straps may cause the loss of this cotter pin, which is the only means of preventing loss of the free running castellated nut and the torque link connecting bolt.

Proper orientation of hardware shown  
**Figure 1**

1. Order replacement hardware as shown in TABLE 1.
2. Locate the torque link connecting bolt and associated hardware, as shown in Figure 1.
3. Remove and discard the existing cotter pin and castellated nut.
4. If necessary, remove torque link connecting bolt and reinstall to orient bolt head on left hand side of aircraft, as shown in Figure 1.
5. Install new self locking Castellated Nut (MS14144-4), Piper P/N 603-816 onto existing torque link connecting bolt, as described in the applicable maintenance manual. Tighten castellated nut only tight enough to allow no side play in the upper and lower torque links, yet still be loose enough to allow the torque link connecting bolt to freely rotate.
6. Secure castellated nut with new Cotter Pin (MS24665-132), Piper P/N 424-051.
