## ENGINE

Both engines were found within the debris path and were recovered with the rest of the wreckage. Both engines were examined and no anomalies were noted that would have precluded normal operations.

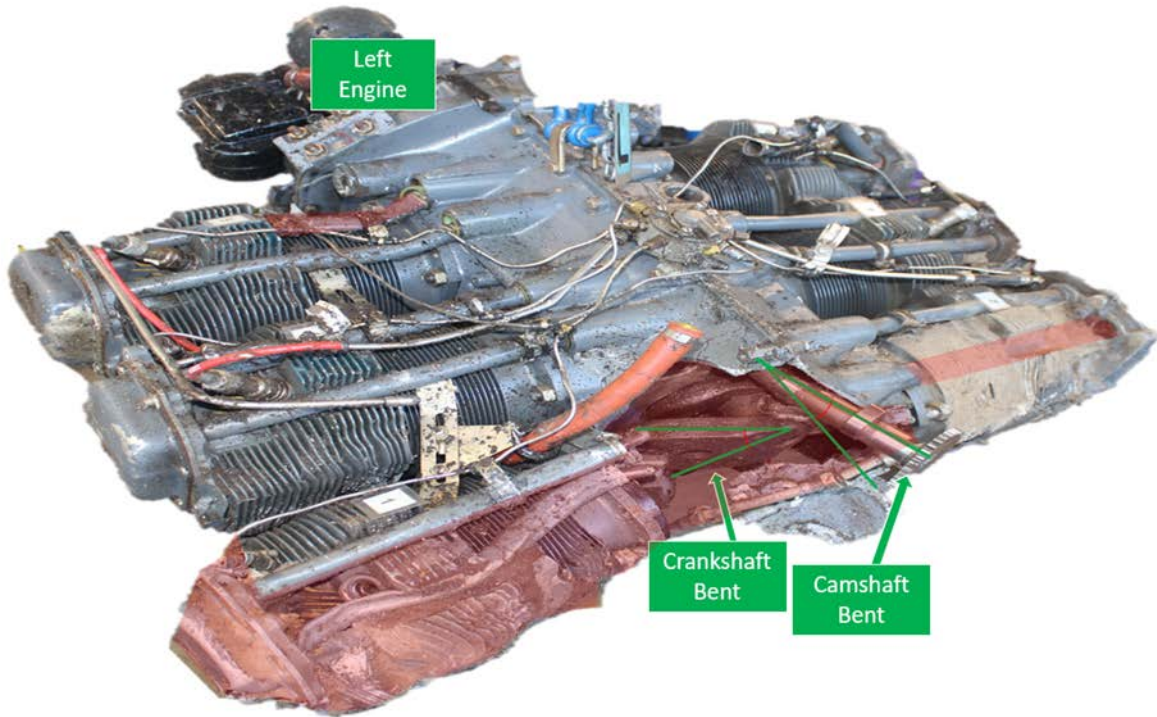
Left (SN# L-2441-61A)

Left magneto fracture separated from engine. Right magneto remained attached. Red shaded areas represent impact damage noted during exam.

No1- Intake and exhaust push rod displaced. Top sparkplug not present.

No2- Extensive impact damage around valve cover. Exhaust push rod displaced. Intake and exhaust pipes fracture separated. Top sparkplug not present.

No3- Intake and exhaust push rod showed evidence of impact damage.

No4- Intake and exhaust push rod displaced.

No5- Intake and exhaust push rod displaced.

No6- exhaust push rod fracture separated. Intake push rod displaced.

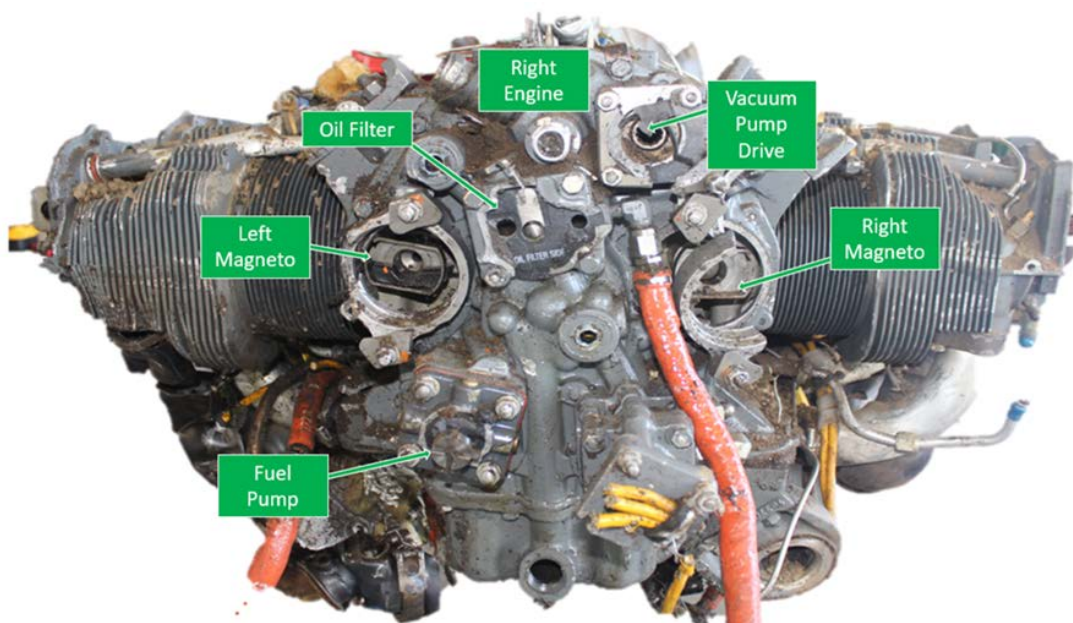
Right (SN# RL-7193-61A)

The right and left magneto, oil filter, fuel pump, and vacuum pump were fracture separated.

No1-Cracked across head and sparkplug insert. Intake and exhaust push rod displaced. Intake and exhaust pipes fracture separated. Bottom spark plugs not present.

No2- Extensive impact damage around valve cover. Both Intake and exhaust push rod fracture separated. Intake and exhaust pipes fracture separated.

No3- Intake and exhaust push rod displaced. Bottom spark plugs not present. Intake and exhaust pipes fracture and partially separated.

No4- Intake and exhaust push rod displaced. Intake and exhaust pipes fracture and partially separated.

No5- Intake and exhaust push rod displaced. Bottom spark plugs broken. Intake and exhaust pipes fracture and partially separated.

No6- Intake and exhaust push rod displaced. Intake and exhaust pipes fracture and partially separated.

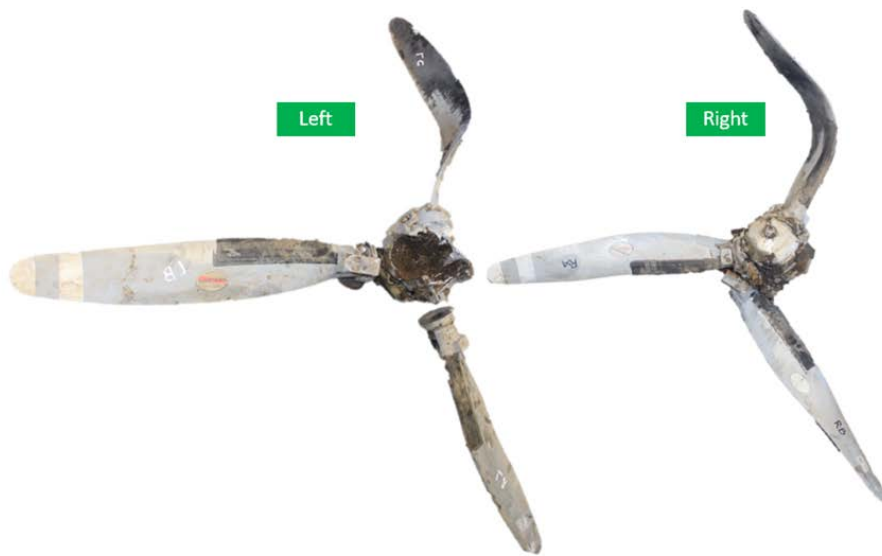
The propellers were found separated from the engines. Both propellers displayed impact damage symmetry. Chordwise scratches and leading edge gouges were present on blades from both propeller assemblies. The photo of the left propeller was reversed to compare it against the right propeller.
