# NATIONAL TRANSPORTATION SAFETY BOARD

## MATERIALS LABORATORY FACTUAL REPORT

Report No. 19-009

Place : Roll, Arizona  
Date : January 19, 2019  
Vehicle : Hill Group LLC CCX-2000, N57FX  
NTSB No. : WPR19LA070  
Investigator : Joshua Cawthra, ASI-WPR

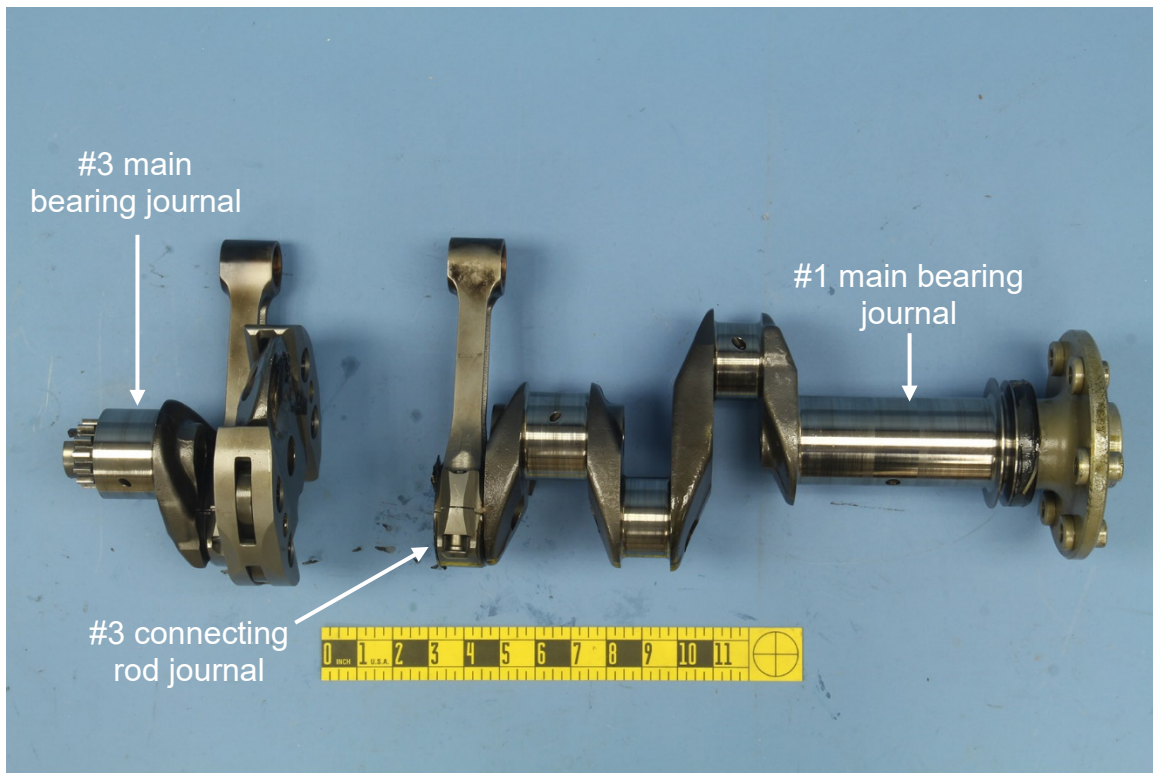
**Figure 1:** Image of the fractured crankshaft with the numbers 3 and 4 connecting rod assemblies still attached. The crankshaft fractured at the aft end of the number 3 connecting rod bearing.

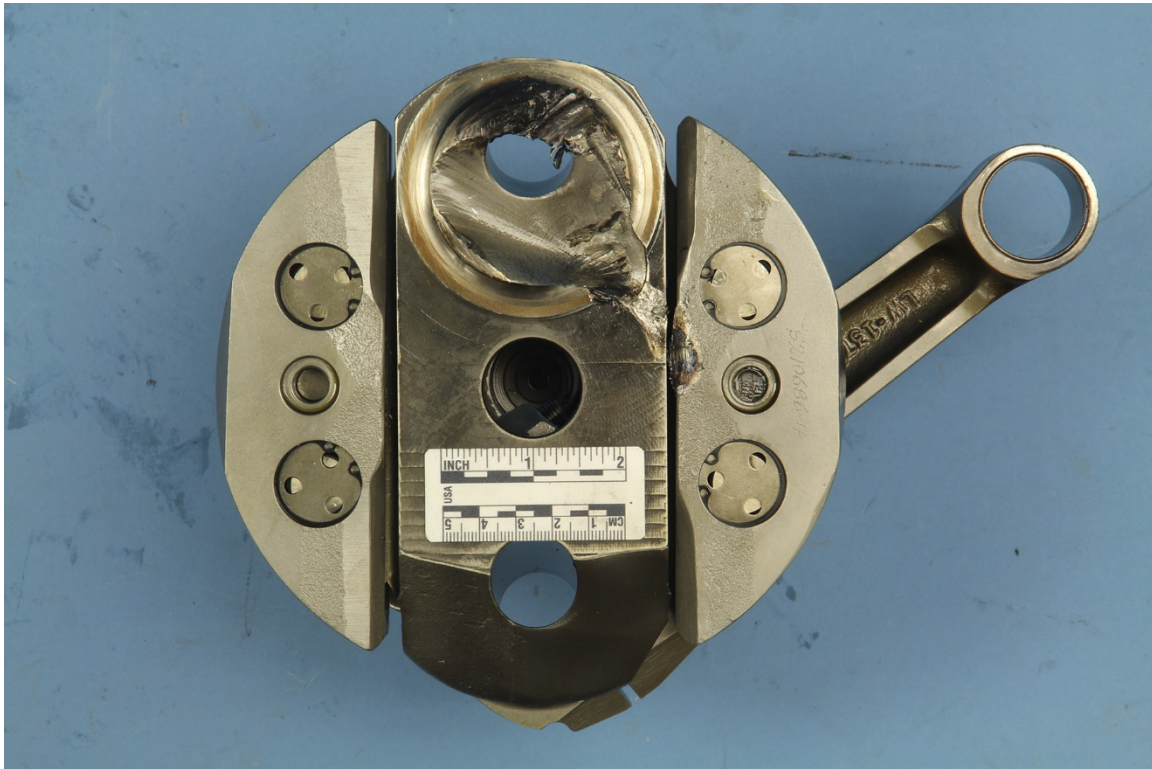
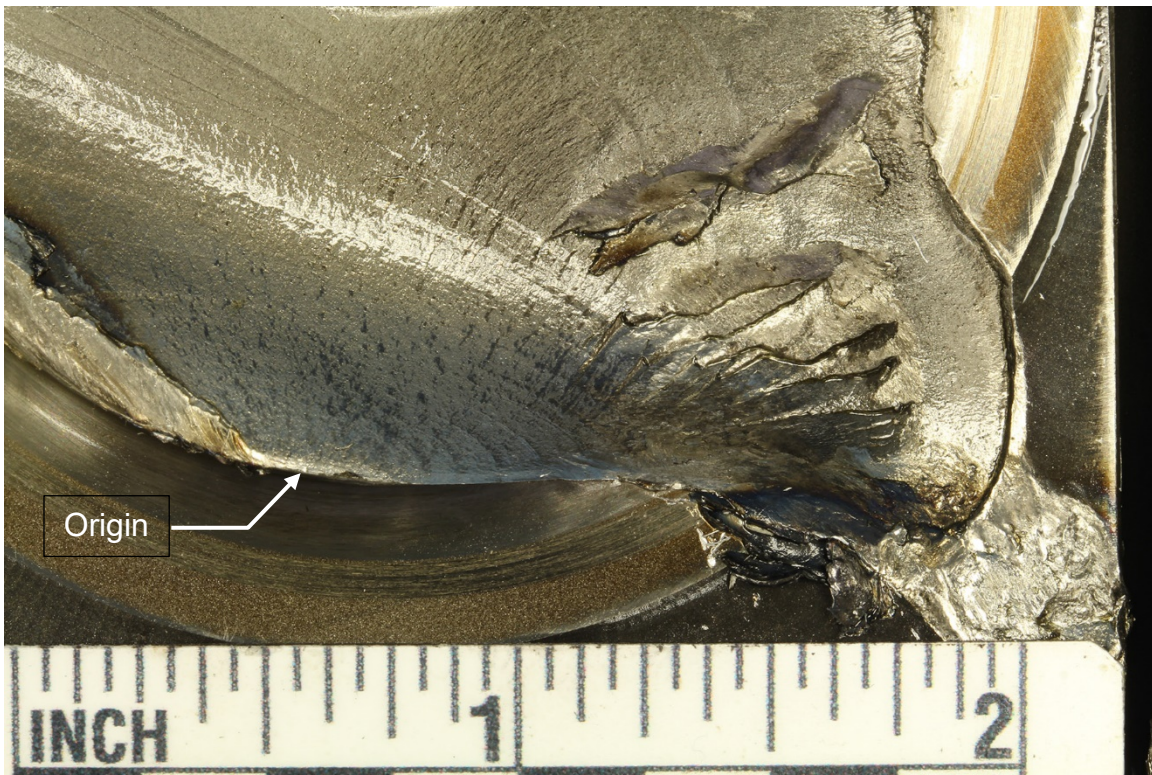
A crankshaft fractured in two pieces was submitted to the NTSB Materials Laboratory for examination along with the two crankcase halves, the bearing shells, and the connecting rod assemblies for the numbers 3 and 4 cylinders (still attached to the crankshaft), as shown in figures 1 – 3. The cylinder positions and connecting rod journals were numbered starting at the front end and increased in number toward the aft end. Using this numbering system, the crankshaft was fractured at the aft end of the number 3 connecting rod bearing journal at the transition radius to the counterweight assembly as seen in figures 1 and 4. The fracture surface was examined using a stereo binocular microscope and the fracture was observed to be comparatively flat with radial lines and curved crack progression marks that were consistent with fatigue crack progression. Examination of the origin area indicated that the crack originated at the surface at the location indicated in figure 4b. As seen in the images, with the crankshaft clocked with the number 3 connecting rod journal at the 12 o'clock position, the origin was approximately at the 6 o'clock position on the journal itself. The journal surface at the fracture origin was examined for any notable features but none were found. Other areas around the origin exhibited rubbing and deformation consistent with damage after

**Figure 4:** Images of the crankshaft aft fracture face at the aft end of the number 3 connecting rod journal: a) Image showing the counterweight assembly and the fracture surface and b) higher magnification image of the fracture origin area.

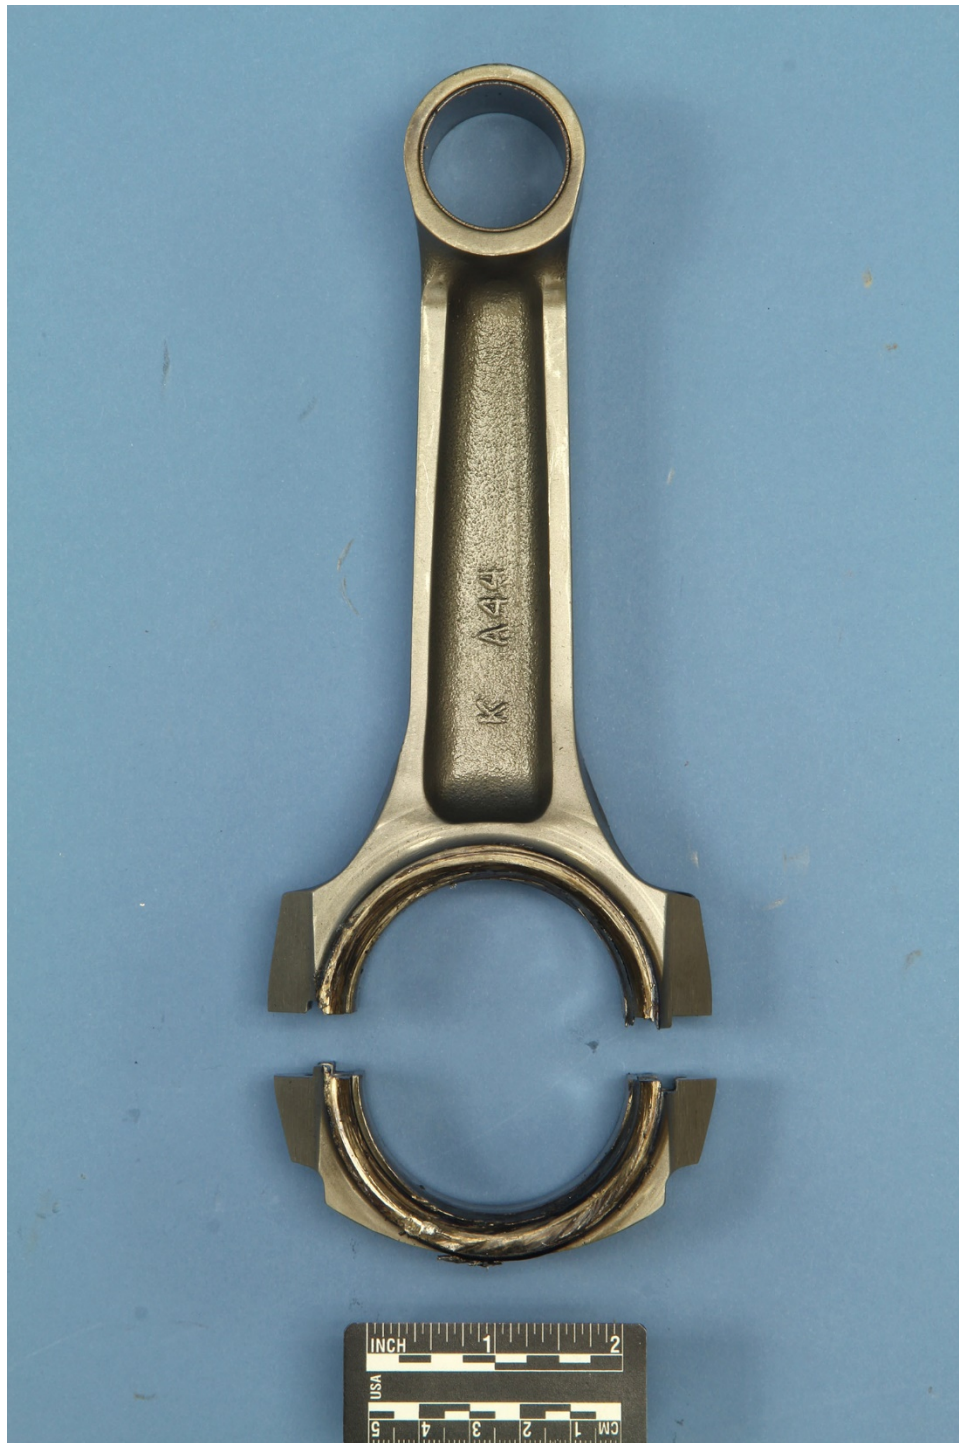
The numbers 3 and 4 connecting rods were disassembled and the bearing shells were examined visually. The number 3 connecting rod and endcap are shown in figure 5 and the yoke and endcap bearing surfaces are shown in figures 6a and 6b, respectively. The aft face of the yoke and endcap exhibited mechanical and thermal damage. Similarly, the aft ends of the bearing shells were mechanically damaged and discolored and the shells had been displaced forward from the installed position. The features were consistent with damage after the separation of the crankshaft.

**Figure 5:** Image of the number 3 connecting rod and endcap after removal from the crankshaft.

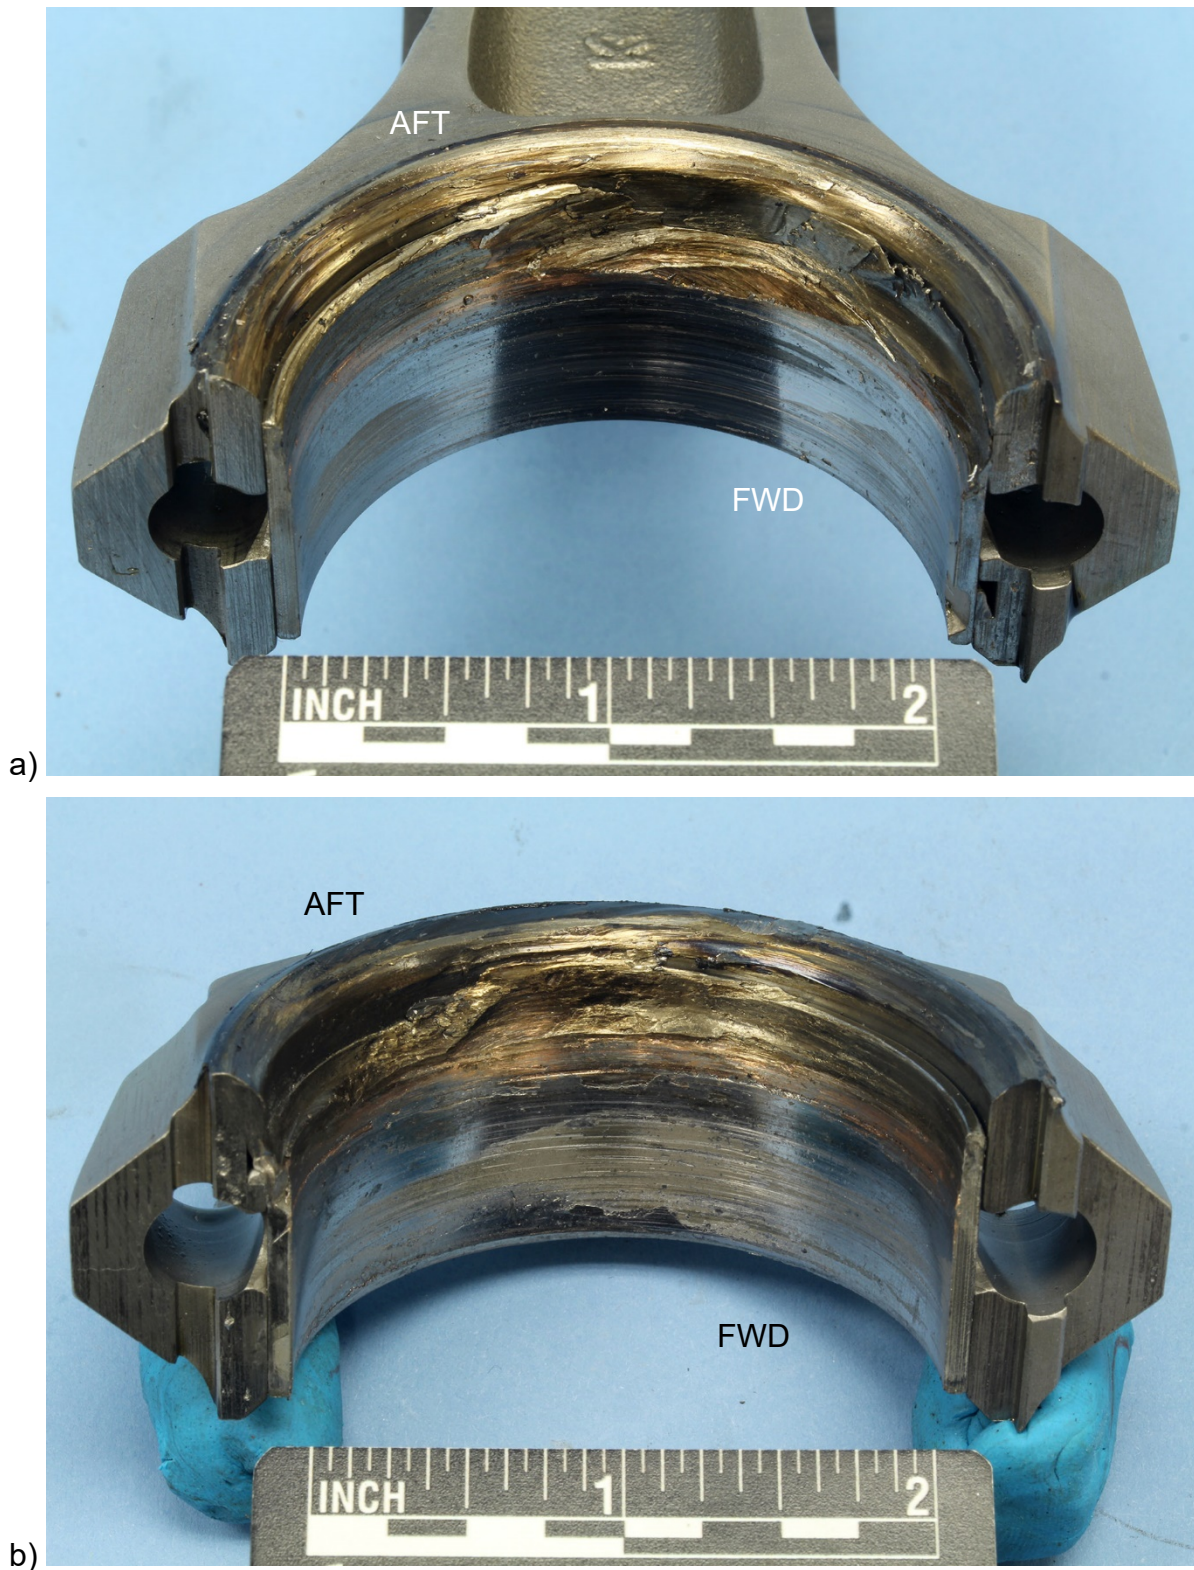
**Figure 6:** Images of the number 3 connecting rod bearing inserts: a) yoke side and b) endcap side.

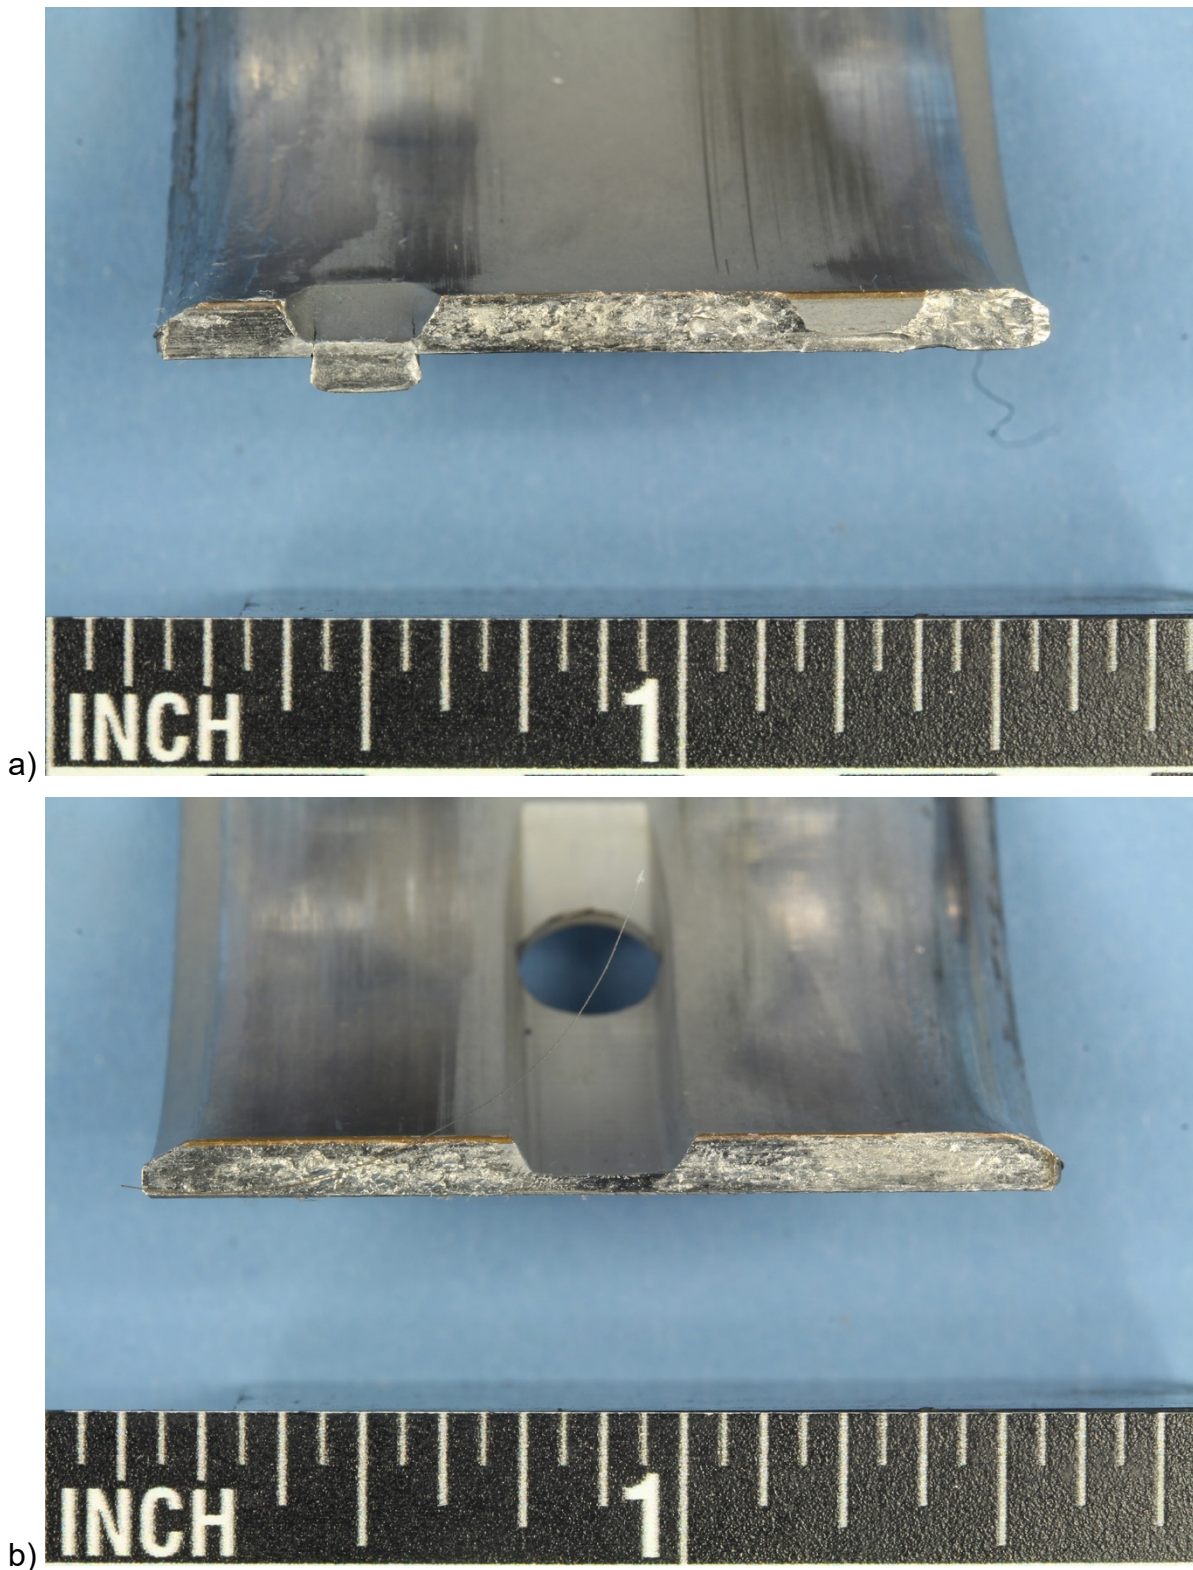
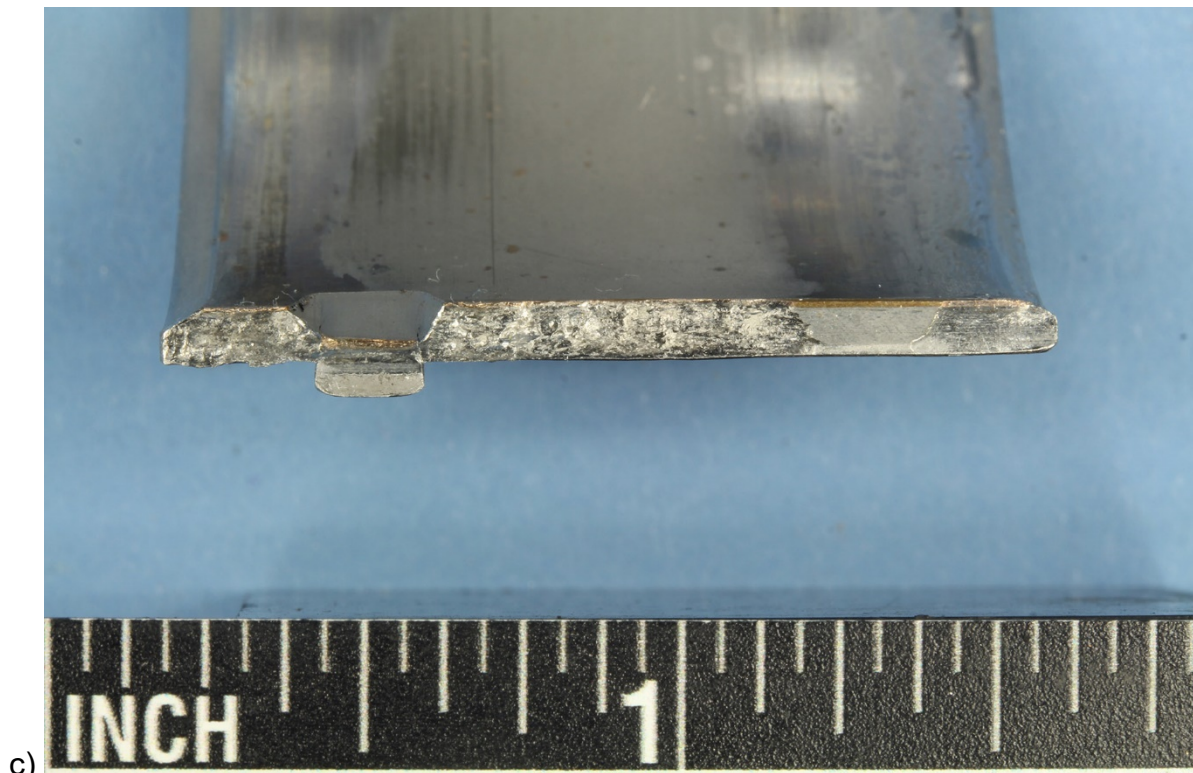
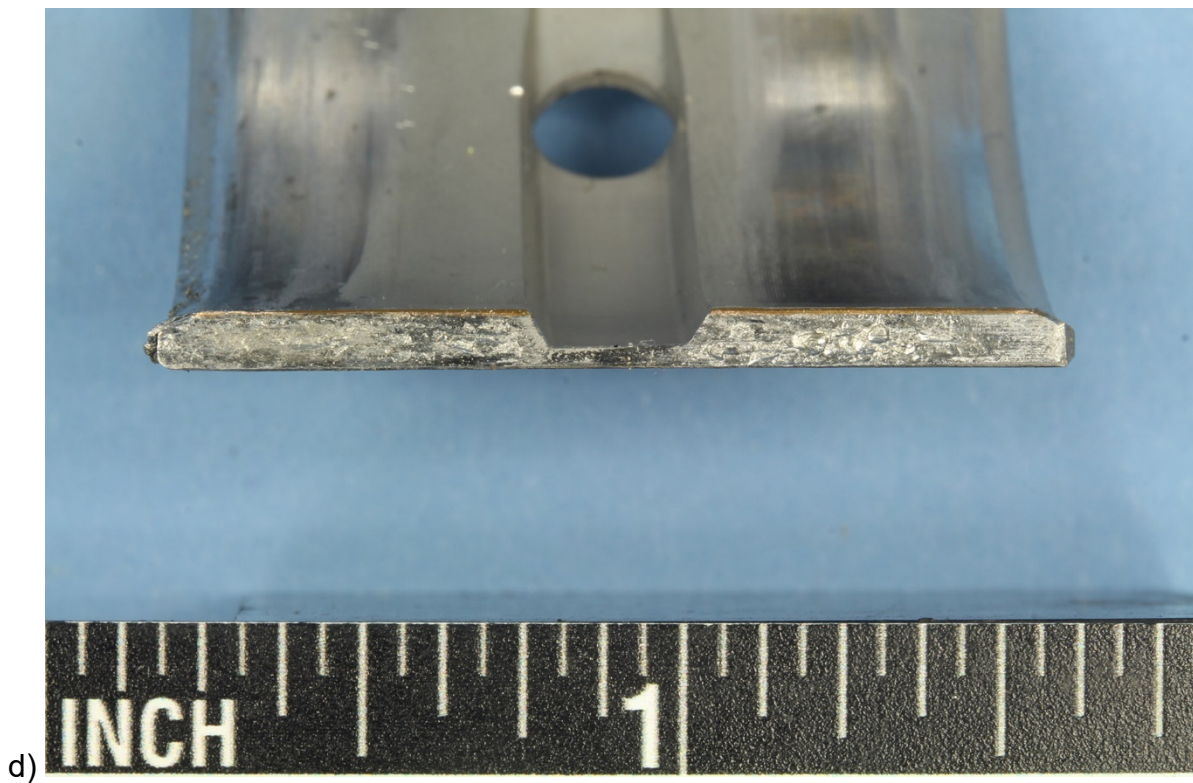
The main bearing shells were also examined visually. For convenience, the main bearings were also numbered starting at the front of the engine and increasing toward the aft end. The end faces of the number 3 main bearing shells (aft end of engine) are shown in figures 7a – d. For comparison, images of one of the number 2 main bearing shells (mid-engine) are shown in figures 8a and b. The number 3 main bearing shell end faces exhibited a comparatively shiny appearance with spots of disturbed material, consistent with polishing and galling. The end face of the right side insert tang in figure 7a also exhibited a polished appearance. By comparison, the end faces of the number 2 main bearing shells exhibited a machined surface finish with spots of polishing. The backsides of the number 3 shells, shown in figure 3b, exhibited a black appearance where in contact with the saddle whereas the other shells exhibited a silver metallic appearance in similar areas.

**Figure 7:** Images of the number 3 (aft) main bearing shell end faces showing galling and rubbing damage: a) right-side insert – tang end; b) right-side insert – flat end;

**Figure 7 (cont.):** c) left-side insert – tang end; and d) left-side insert – flat end.

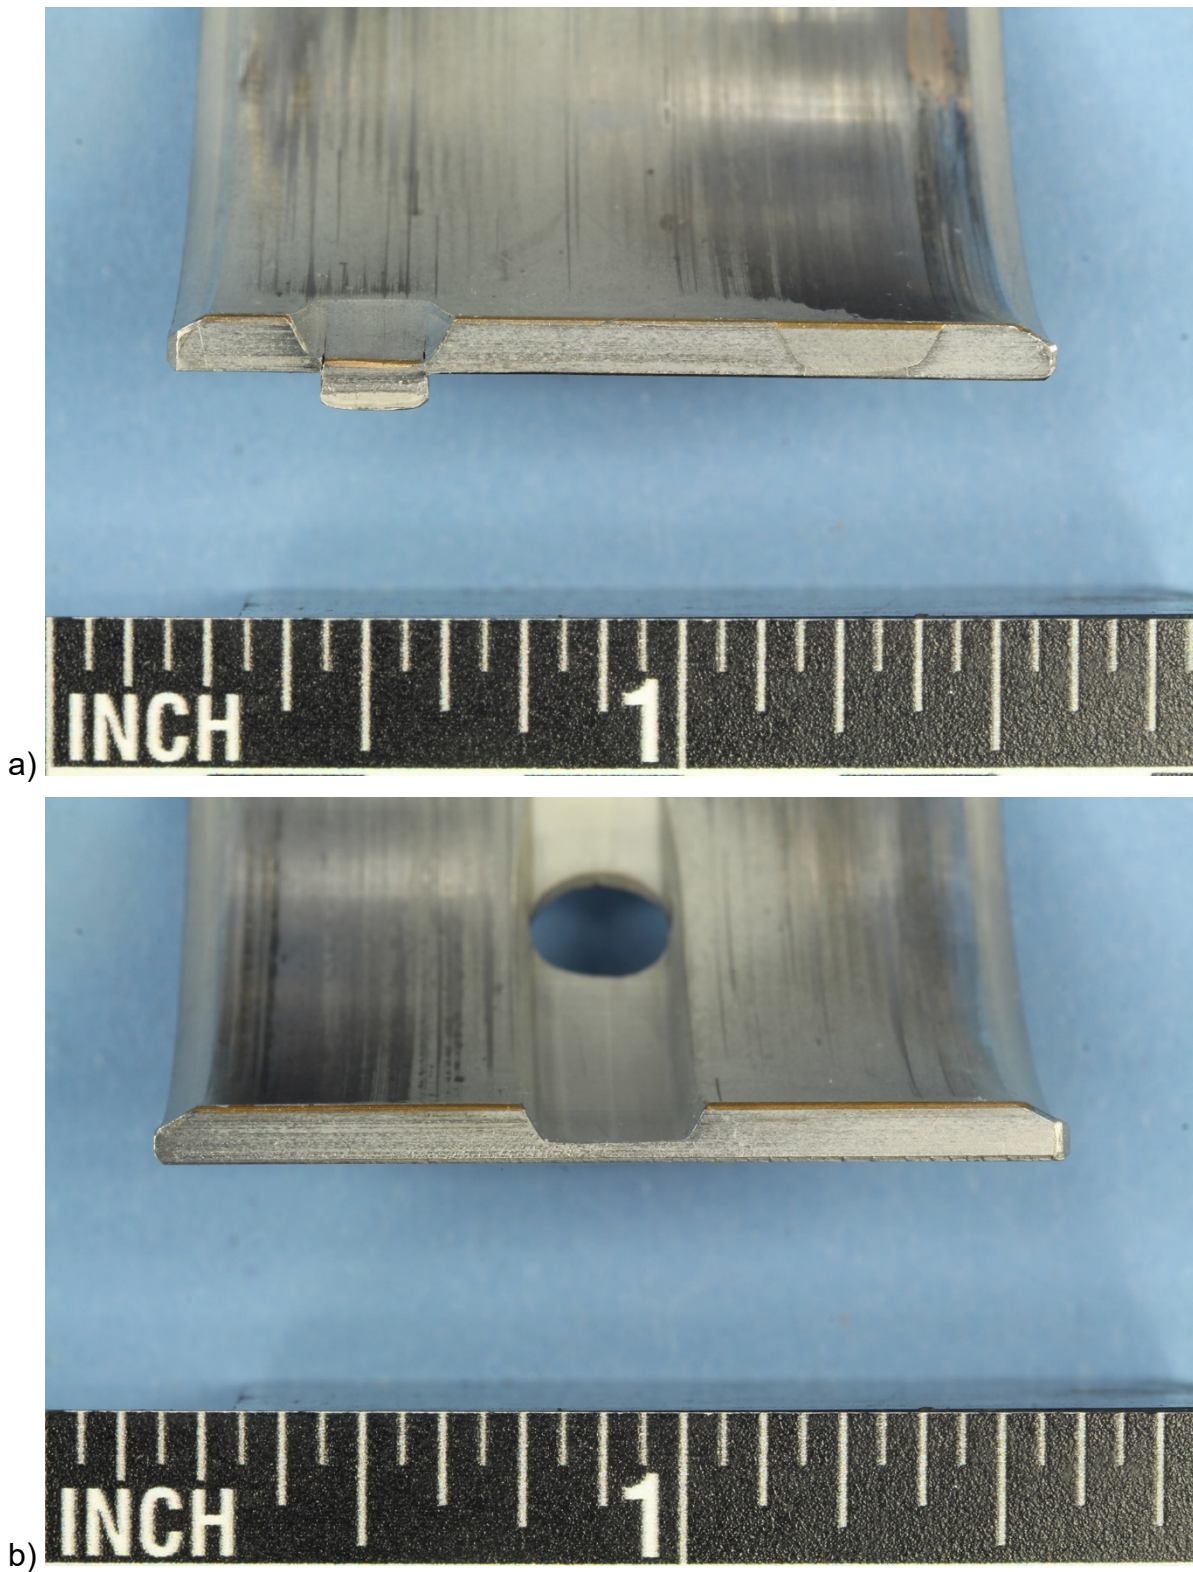
**Figure 8:** Images of the number 2 (mid) main bearing right-side shell end faces: a) tang end and b) flat end.

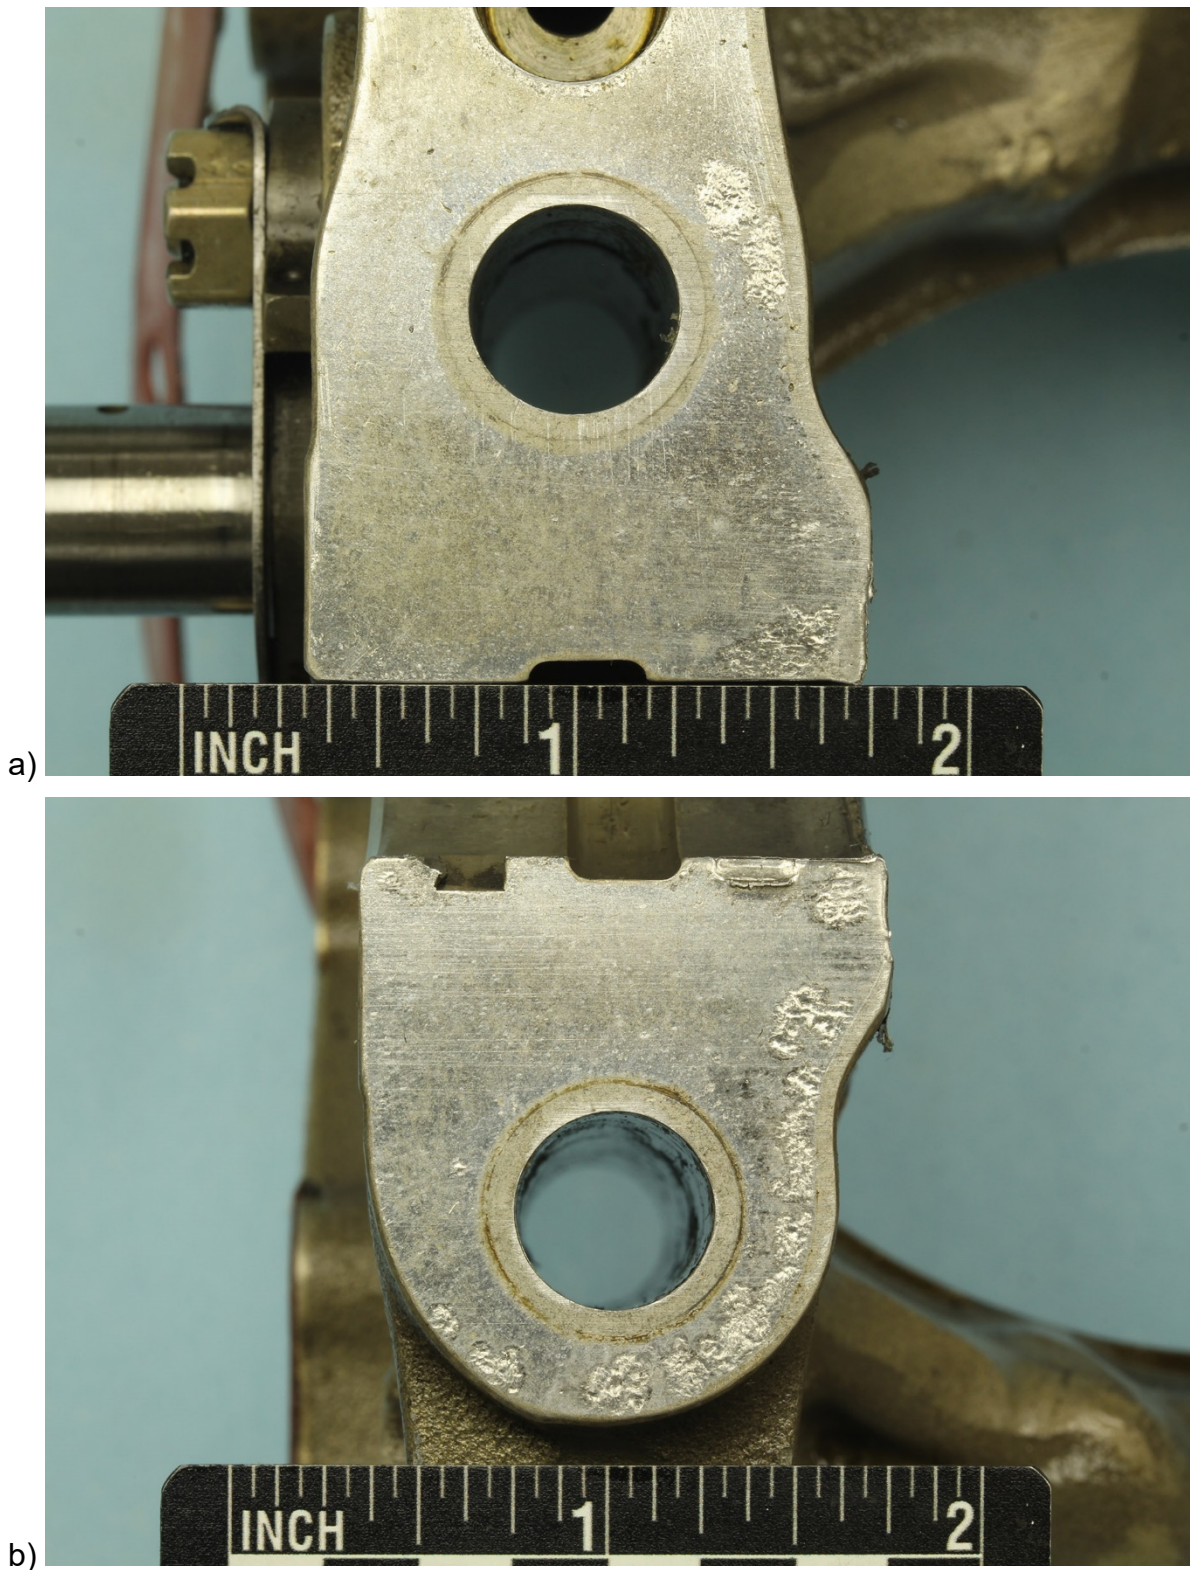
The crankcase main bearing saddle boss landings similarly exhibited differences in their surface condition. The number 3 boss landings, shown for the left crankcase half in figures 9a and 9b, exhibited polishing of the landings and galling of the forward regions. By contrast the remaining landings exhibited a matte appearance consistent with the machined finish on the as-manufactured case, as shown for one of the number 2 landings in figure 10.

**Figure 9:** Images of the crankcase left-side aft saddle boss landings (see figure 2b). The landings exhibited features consistent with polishing and galling: a) upper landing and b) lower landing.

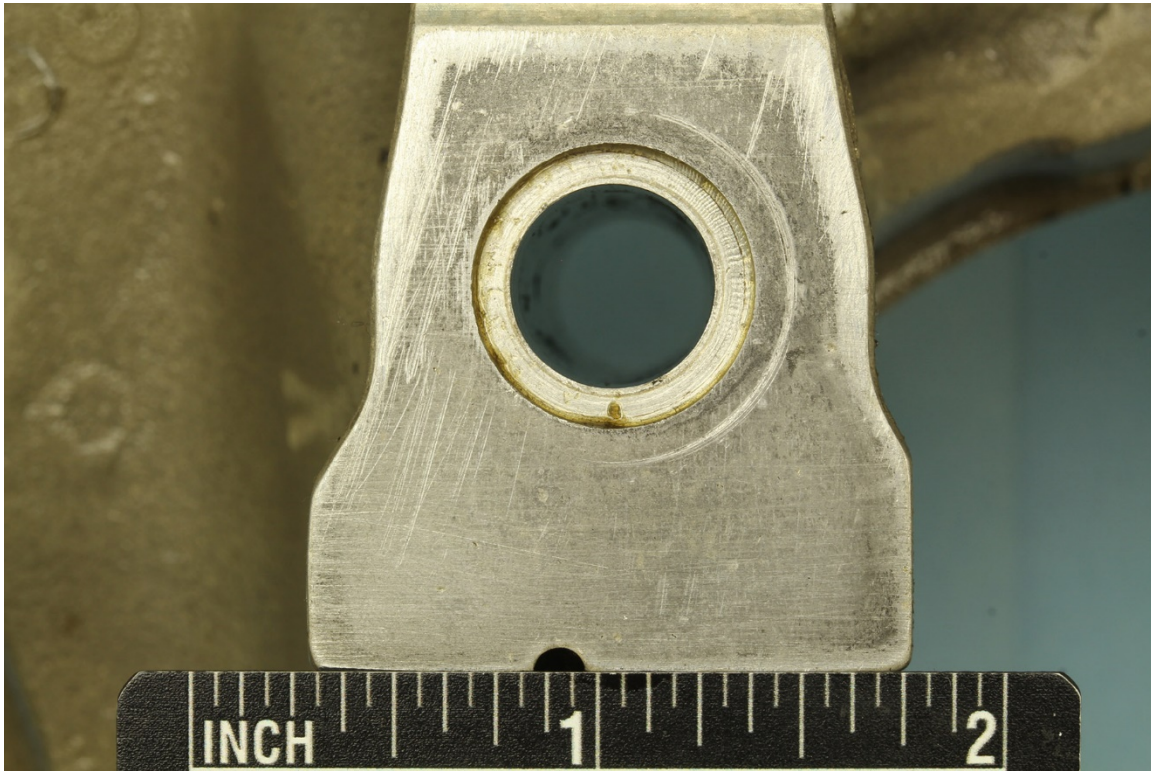
**Figure 10:** Image of the crankcase right-side number 2 (mid) upper landing. The landing had a matte appearance, consistent with a machined surface finish.

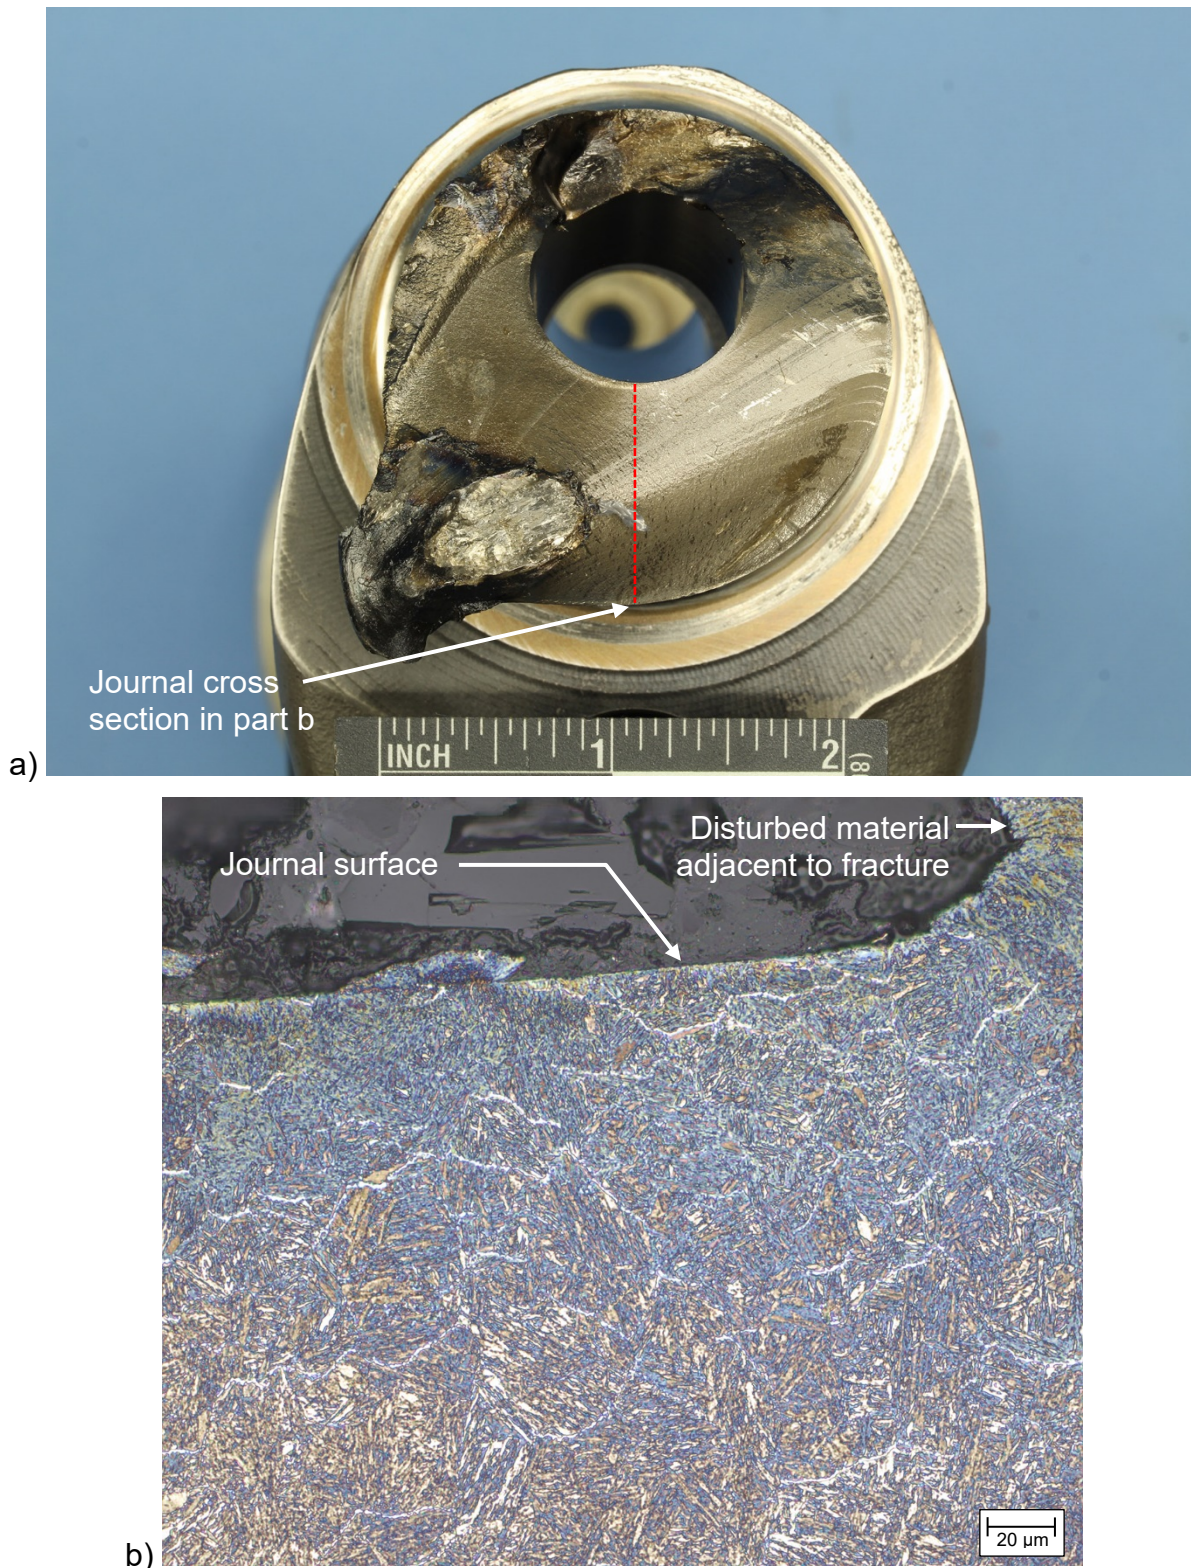
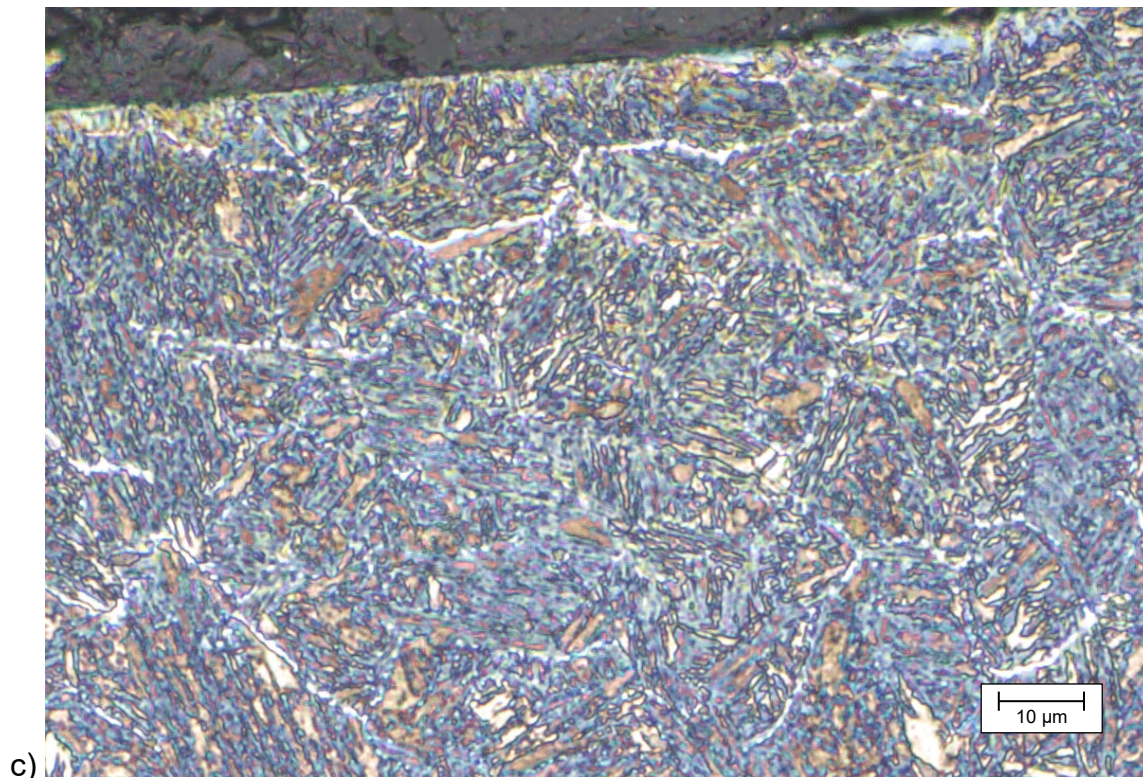
Finally, the material microstructure of the crankshaft at the journal surface near the fatigue origin was examined by cutting a section of the number 3 connecting rod journal and preparing a metallographic cross section. The forward fracture face is shown in figure 11a with a red dashed line indicating the plane of the cut (in and out of the page). The journal was cut and sectioned using a water-cooled abrasive cutting saw and mounted in resin. The cross sectioned face was ground using silicon carbide papers and polished with a series of diamond and aluminum oxide suspensions in accordance with standard laboratory procedures. The polished face was etched with a 5% solution of nitric acid in methanol (5% Nital) to reveal the material microstructure as shown in figure 11b. The location of the journal bearing surface and the direction toward the fracture face are indicated in the figure. A higher magnification view of the surface is shown in figure 11c. The material at the surface was examined for indications of a white layer but none were found.

**Figure 11:** a) Axial view of the forward piece of the fractured crankshaft viewing the forward fracture face. A red dashed line indicated the location of the cut for the metallographic cross section; b) etched and polished metallographic cross section at the journal surface adjacent to the fracture (5% Nital, bright field);

**Figure 11 (cont.):** and c) Higher magnification image of the microstructure showing the absence of a white layer at the journal bearing surface.

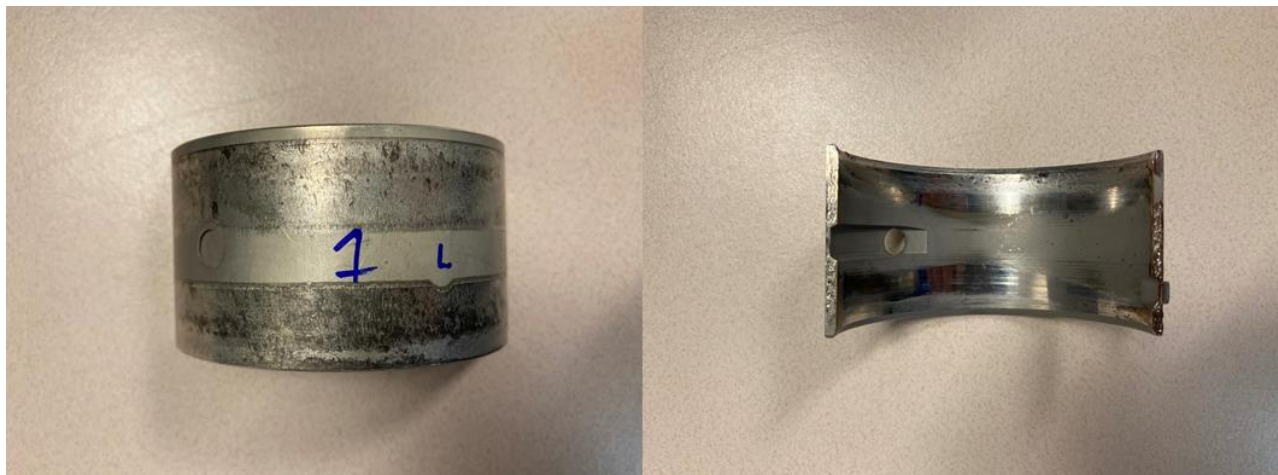
**Figure-2: This figure shows the left side rear main bearing**

| Visual Inspection Results (Left Rear Main Bearing) | |
|---|---|
| Bearing Face | Bearing face wear has a polish finish with light scoring. The wear is mostly located on the side of the bearing, and very light wear in the middle. |
| Tang | Tang has light polishing on the tip. |
| Parting Surface | Bearings show fretting and displaced material on the parting surface. |
| Side Edges | Bearings show significant wear on the front side chamber. |
| Back Surface | Fretting signatures are present. Fretting appear to be worse on front side of the bearing. |

From these examples, the wear characteristics record in Table-2 and -3 showed the rear two bearings have signs of fretting, wiping, and misalignment. The back of the bearing and parting lines show displaced material and material transfer on the surfaces which would fall under fretting. The front edges of the bearings showed significant wear on the chamfer. Each chamfer had displaced material from what looks to be metal to metal contact similar to the conditions under wiping. Since the center of the bearing face shows almost no wear and the edges showing excess wear, this is likely due to misalignment or out of spec journal geometry.

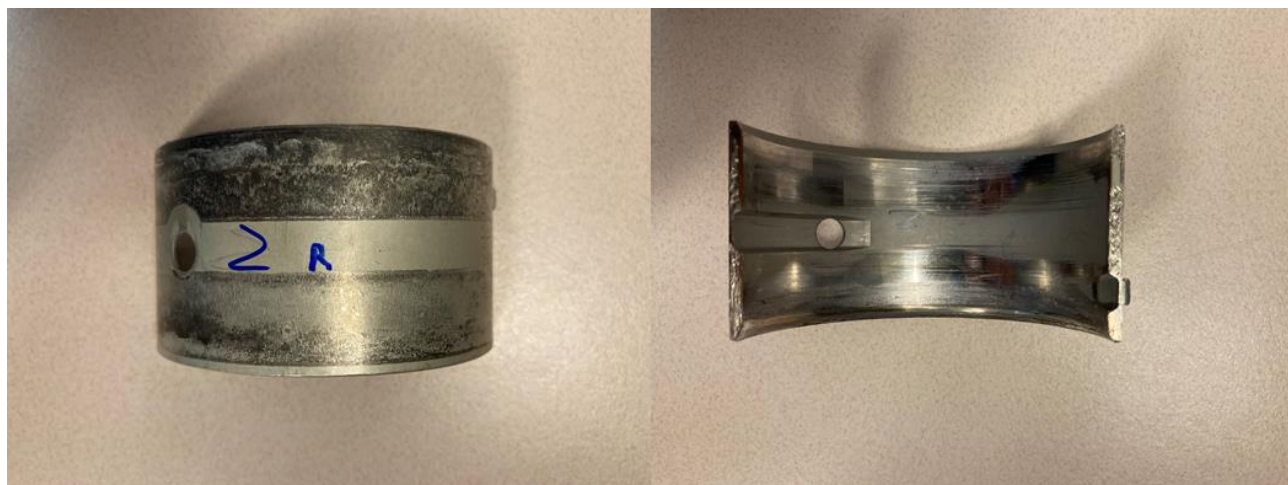
**Figure-3: This figure shows the right side rear main bearing**

| Visual Inspection Results (Right Rear Main Bearing) | |
|---|---|
| Bearing Face | Bearing face wear has a polish finish with light scoring. The wear is mostly located on the side of the bearing, and very light wear in the middle. |
| Tang | Tang has light polishing on the tip. |
| Parting Surface | Bearing show fretting and displaced material on the parting surface. |
| Side Edges | Bearings show significant wear on the front side chamber. Chamfer is completely rounded through the side edge. |
| Back Surface | Fretting signatures are present. Fretting appears to be worse on front side of the bearing. |

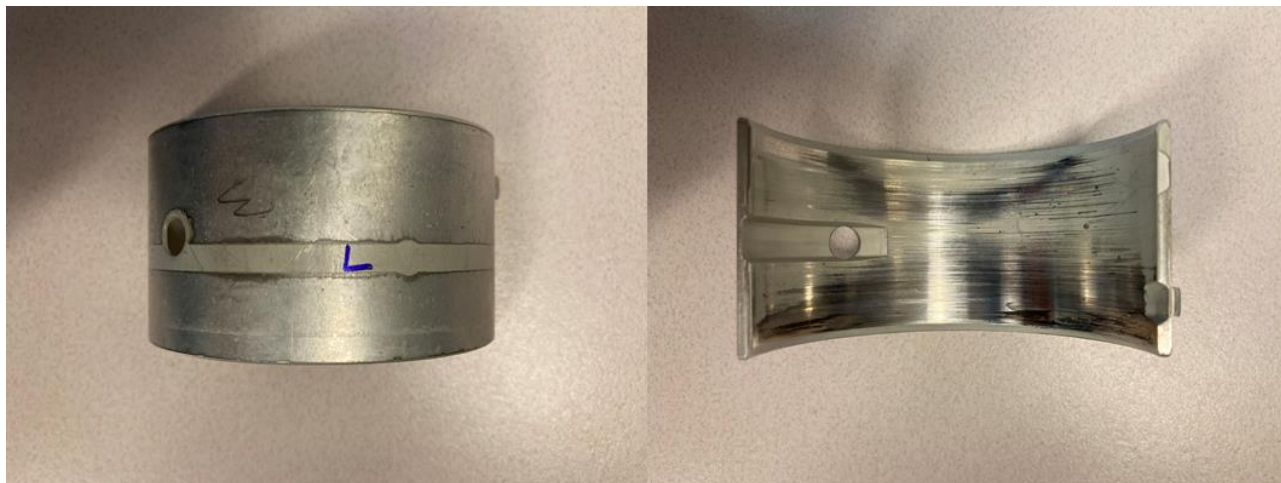
**Figure-4: This figure shows the left side middle main bearing**

| Visual Inspection Results (Left Middle Main Bearing) | |
|---|---|
| Bearing Face | Bearing face shows mostly normal wear. There is some scoring and most of the wear is on the aft side of the bearing with some discoloration. |

The wear characteristics record in Table-4 and -5 showed the middle two bearings have signs of light wiping. Slight excessive wear on the aft side of the bearing face showed sign that metal to metal contact had occurred.

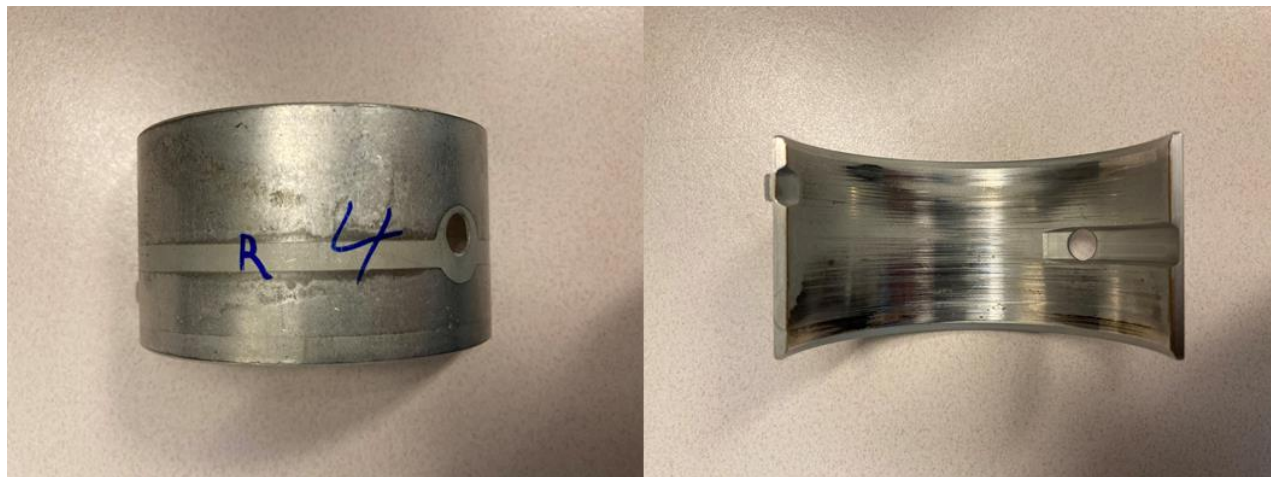
**Figure-5: This figure shows the right side middle main bearing**

| Visual Inspection Results (Right Middle Main Bearing) | |
|---|---|
| Bearing Face | Bearing face shows mostly normal wear. There is some scoring and most of the wear is on the aft side of the bearing with some discoloration. |
