## **NATIONAL TRANSPORTATION SAFETY BOARD**

# **AIRFRAME AND ENGINE EXAMINATION**

**WPR19LA070**

Location: Roll, AZ  
Date: January 19, 2019  
Aircraft: CCX-2000, N57FX, Serial #: CCX-2000-0005  
NTSB IIC: Josh Cawthra

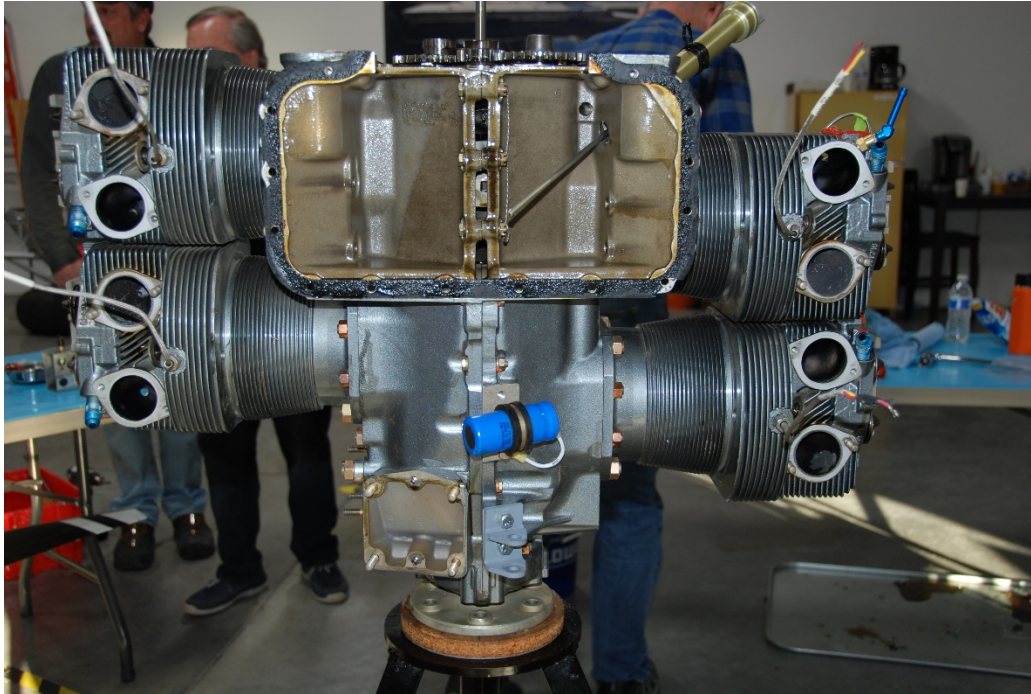
*Figure 3 Engine CC-363i*

The engine was seized, and manual rotation via the crankshaft flange was not possible. The cylinders, overhead components and accessories were in place and no external damage was noted. Internal examination of the piston cylinders, utilizing a lighted borescope, revealed that the valves were in place and no mechanical damage was observed. Normal, gray colored combustion deposits were observed on the piston and associated valve faces. The oil sump, associated oil lines and filter were in place and no leaks or damage were noted. The oil filler cap and fill tube were intact, and no anomalies were noted. The oil dip-stick showed approximately 7 quarts. The fuel delivery servo, fuel pumps, manifold and supply lines were in place; nominal damage was noted to the fuel servo adaptor flange and the snaffle valve was fractured. The dual electronic ignition system was in place and no damage was noted. The exhaust system was in place and secure. The distal end of the exhaust pipe was bent. The sparkplugs were removed and exhibited normal color and wear; no mechanical damage was noted. All airframe to engine controls and components were in place and no anomalies were noted.

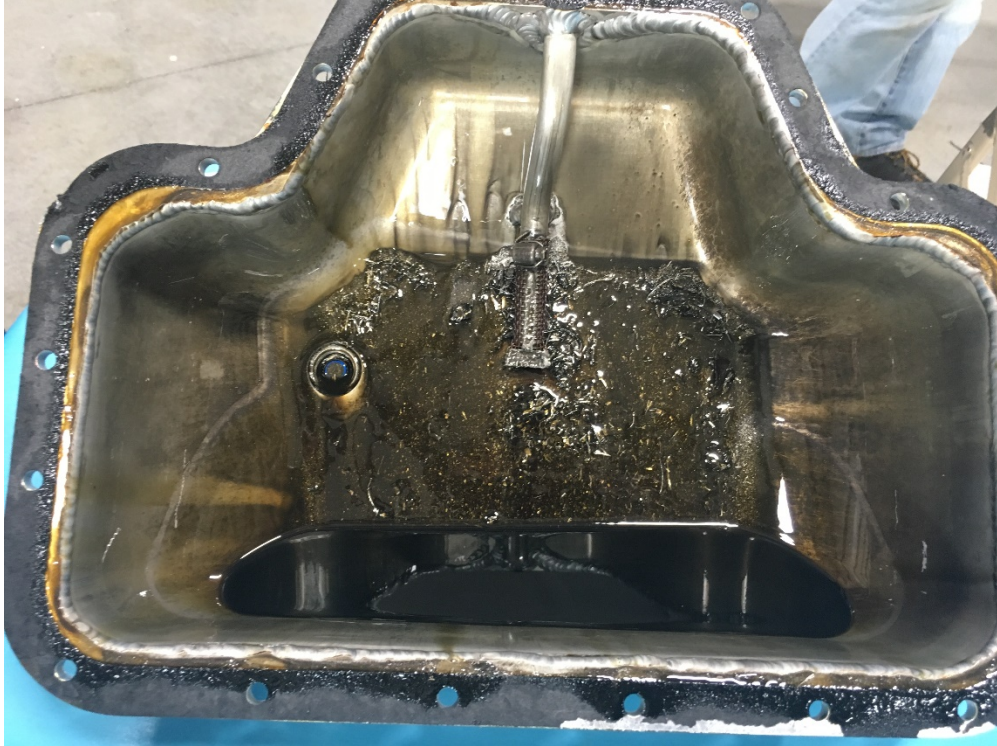
*Figure 4 Oil Sump*

- The camshaft was in place and nominal damage was observed to the shaft and lobes.
- A significant amount of metallic debris was noted through the engine, oil filter, oil sump and finger screen.

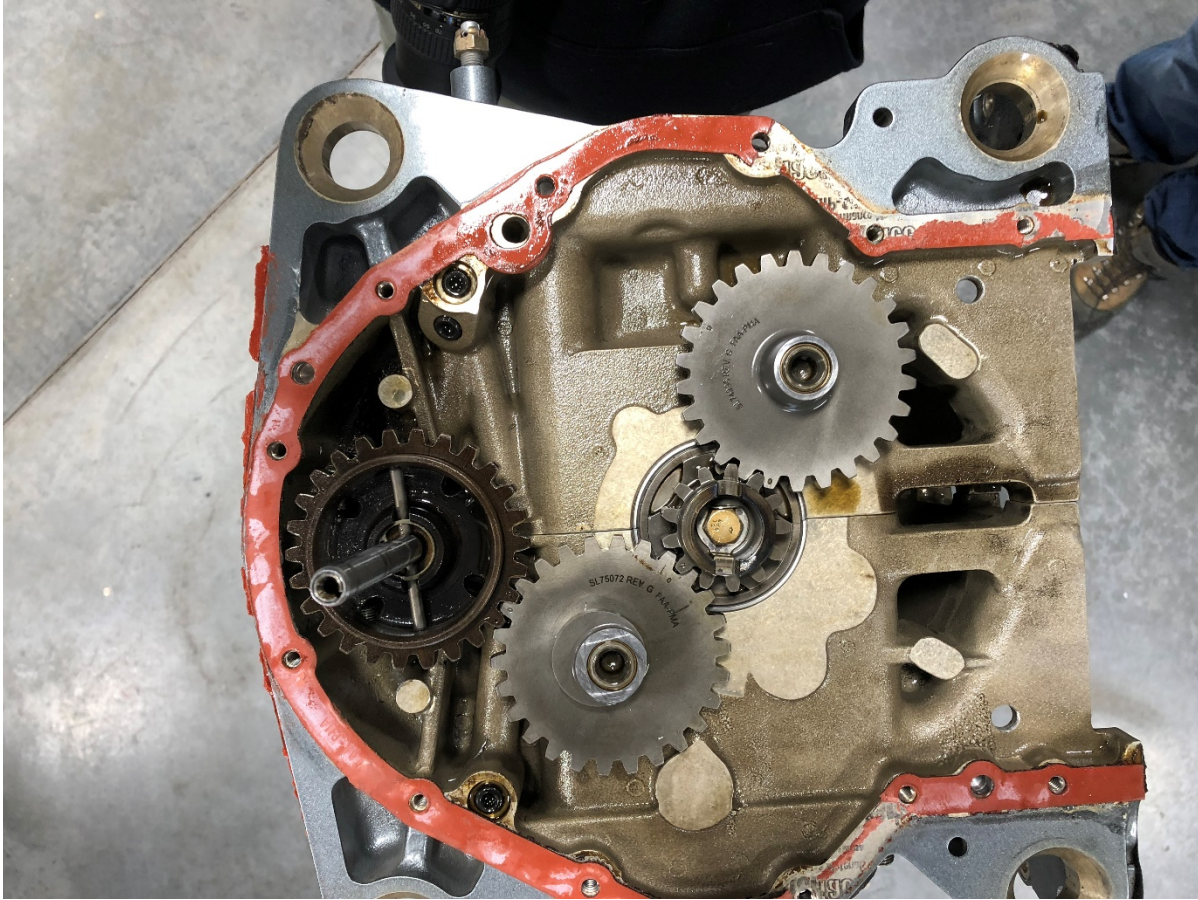
*Figure 5 Accessory Gears*

- The accessory gears were in place, properly clocked and undamaged
- The pistons and associated piston pins, connecting rods, rod-end caps and bearings were in place and remained attached to the crankshaft. The number four connecting rod was seized to the crankshaft. The remaining connecting rods moved freely about their respective journals.

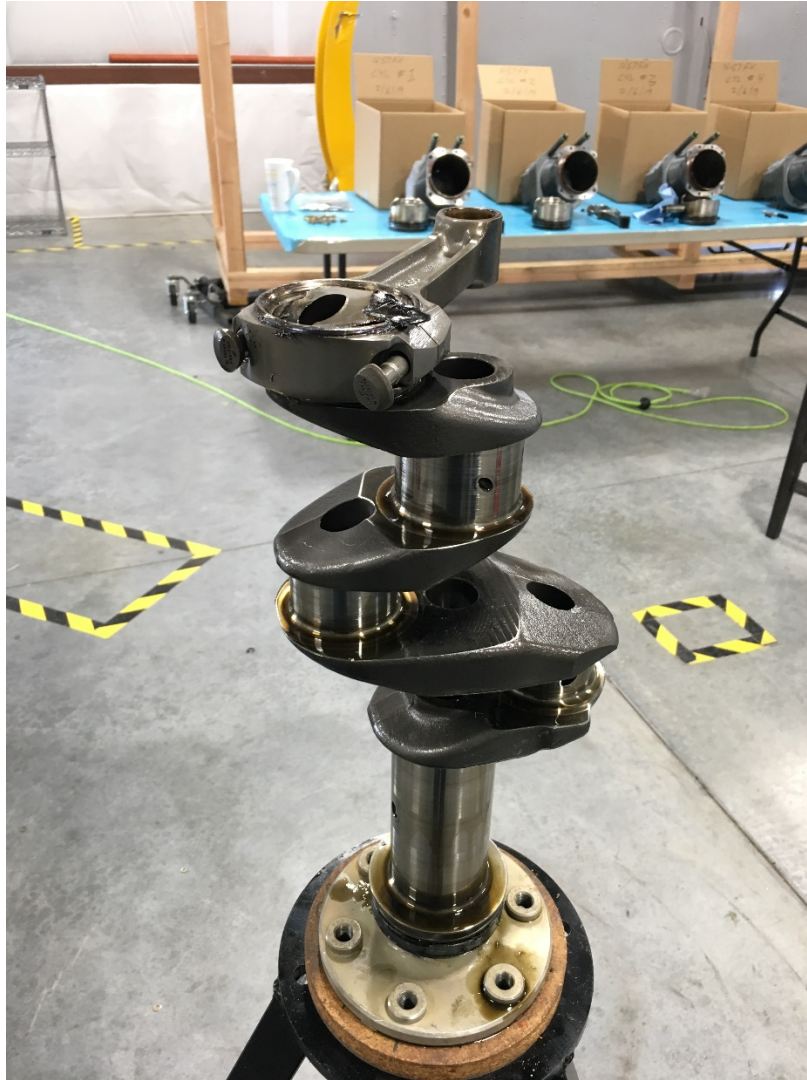
*Figure 6 Fractured Crankshaft FWD Section*

- The crankshaft (serial number TA06B000322) was fractured (full-thickness) aft of the number three connecting rod journal, adjacent to the counter weights. Both counterweights were in place and remained attached to the crankshaft.
